QC-7701

HANGOVER 2.4km

2019 Inspection

Crossing Name Side Creek

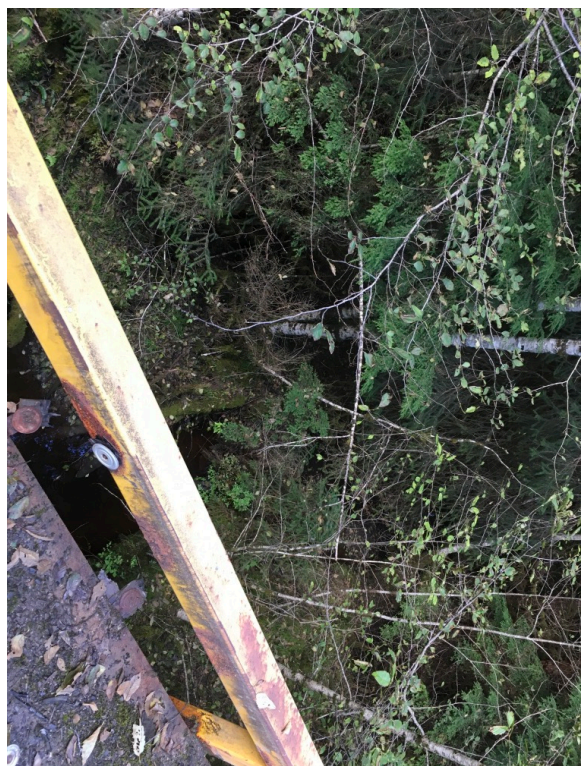
Right Bank Abutment when facing downstream

Both abutments have two high log cribs setback significant rot present in crib logs but lots of sound wood left in crib.

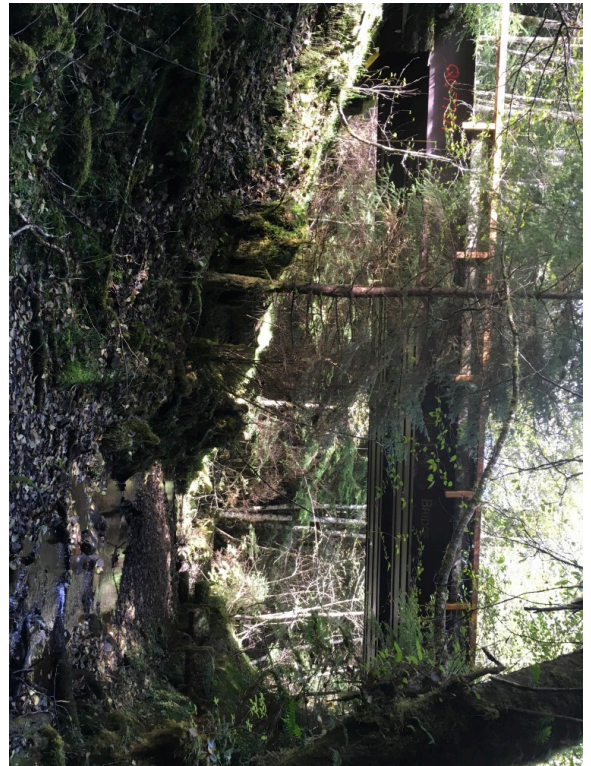
Structure ID

Inspector Comments Serial/ID Plate '02/00, 60FT, MBS L-165, #592-229-2'
