**FINAL REPORT**

# **BAKER CREEK WATERSHED ASSESSMENT – PHASES 1 & 2**

## **Volume 1: Report**

**Project 040-42.02**

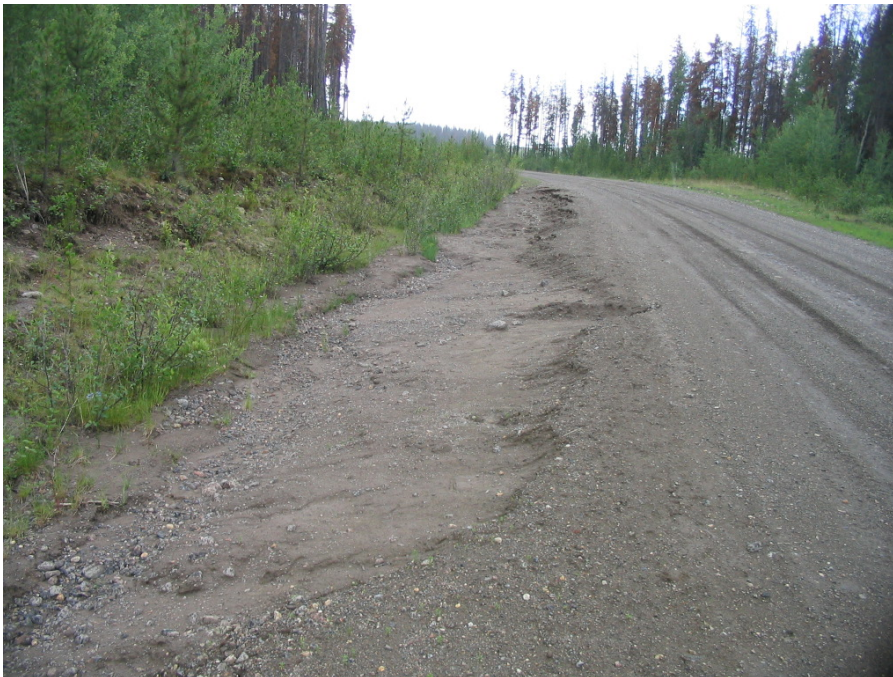
Photo 4 (July 10, 2006)

- On Lavington Road at km 23 (Site UB1 on Map 8), erosion along 50 m of roadcut had caused infilling of the ditch with sediment (Photo 4, Appendix D) thus reducing the effectiveness of the ditch. Ditch maintenance and armouring is recommended at this location; and
- Recent roadcut rehabilitation was noted upstream of the 3800 Road crossing of Baker Creek (Site UB2 on Map2) (Photo 5, Appendix D). It appears that gravel was spread along the cutbank upslope of the stream crossing to reduce sediment delivery to creek. While the works are functioning satisfactorily, silt fences in the ditch have fallen down and should be removed and replaced with rock weirs and small catch basins to reduce the risk of sediment delivery to Baker Creek.

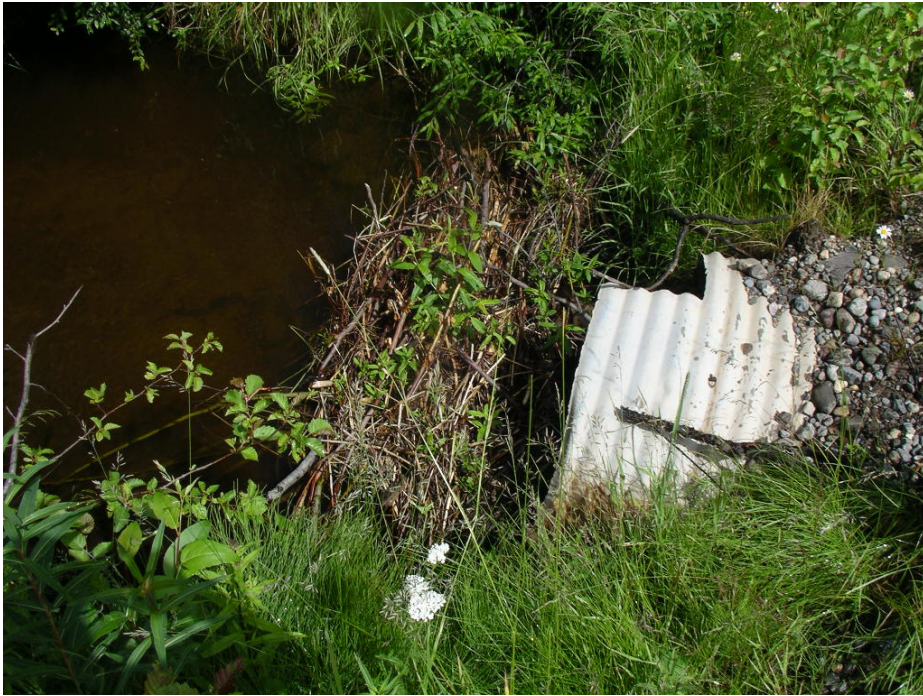
Photo 10 (July 13, 2006)

- At the Road 1200 crossing of Puntataenkut Creek (Reach 7) at km 6 a 1,500 mm diameter culvert is partially blocked by beavers (PT1 on Map 5) (Photo 10, Appendix D). Maintenance is recommended to clear the blockage;

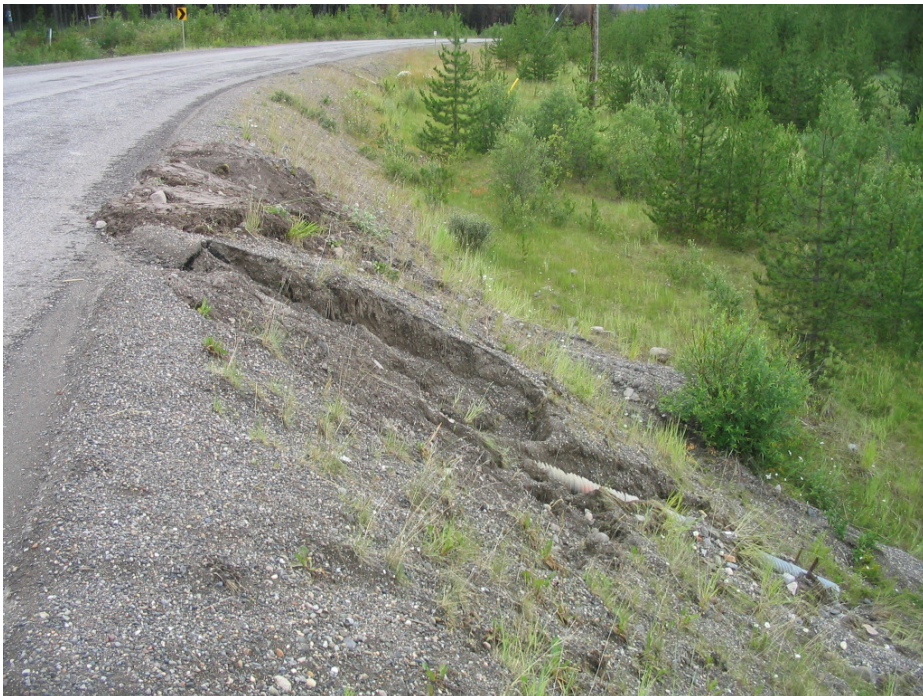
Photo 11 (July 12, 2006)

- At the Nazko Highway crossing of Puntataenkut Creek (PT2 on Map 5) road fill erosion and rilling was noted delivering sediment to creek (Photo 11, Appendix D). Work is recommended to protect the roadfill from erosion;

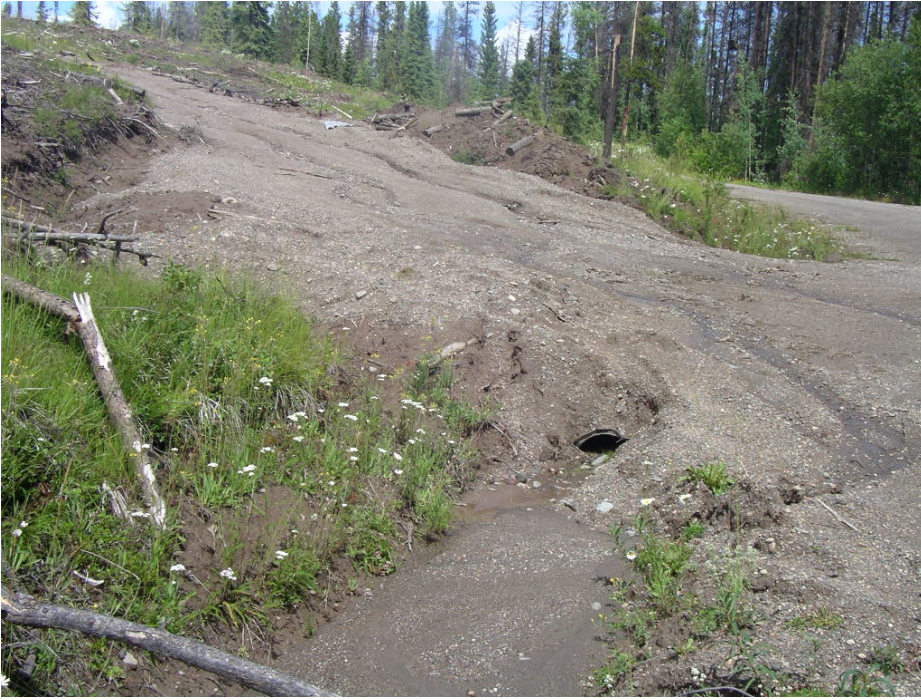
Photo 12 (July 13, 2006)

- On Road 3100 near km 1 (PT4 on Map 5), a spur road into a cutblock was constructed in highly erodible materials. As a result ditches have filled up and are non-functional (Photo 12, Appendix D). Maintenance of the ditches is recommended; and

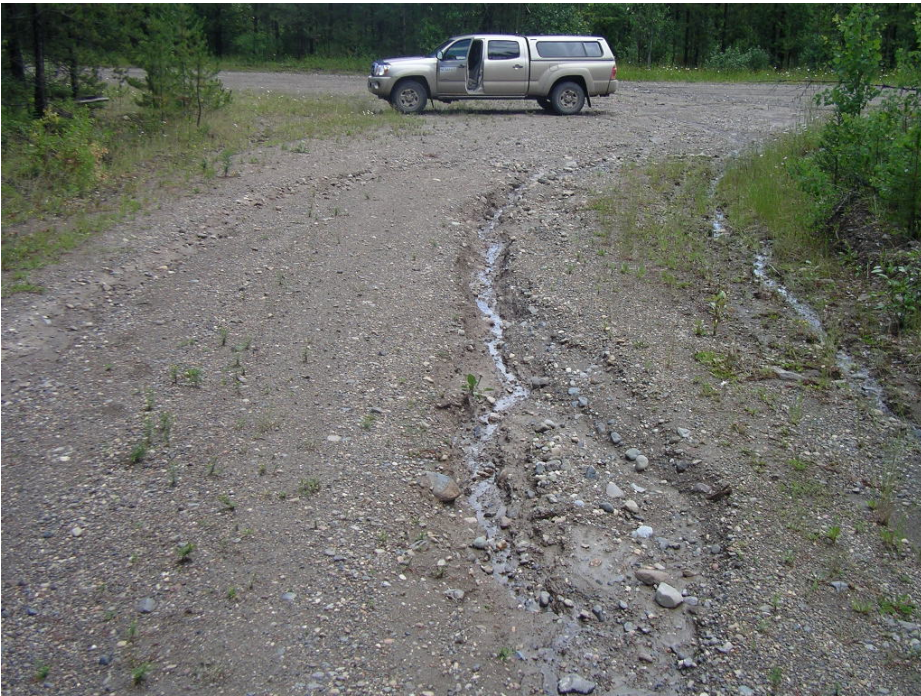
Photo 13 (July 13, 2006)

- On an unnamed road off Road 3100 at km 4 there is a considerable surface erosion along about 50 m of road surface (Photo 13, Appendix D). Road grading is recommended.

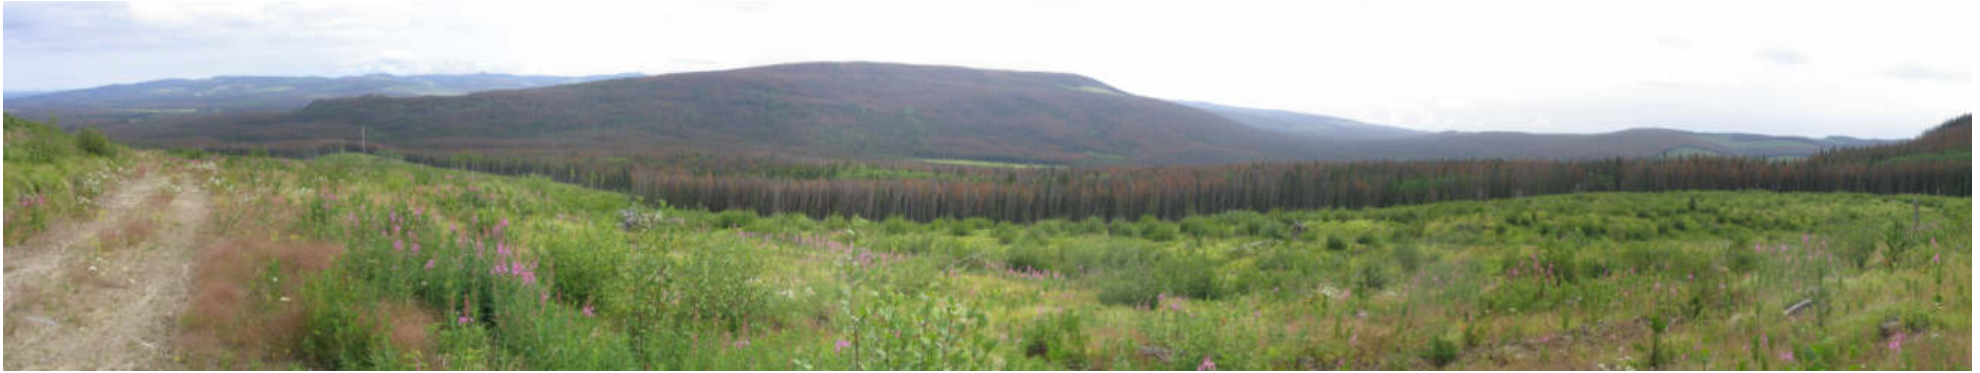
Photo 16 (July 14, 2006)

The Mount Creek sub-basin is dominated by pine-leading stands, particularly in the southeastern portion of the sub-basin. Spruce is common in moist sites and is typically found along the riparian zones at lower elevations. Beetle-kill is classified as severe or very severe in 47% of the sub-basin (Map 2). High risk of MPB mortality has been identified in 34% of the riparian zone within the sub-basin. The majority of the affected trees are located in the central and southeastern areas of the sub-basin – areas that have largely been undeveloped to date (Photo 16, Appendix D). Approximately 1% of the sub-basin has been affected by wildfire.

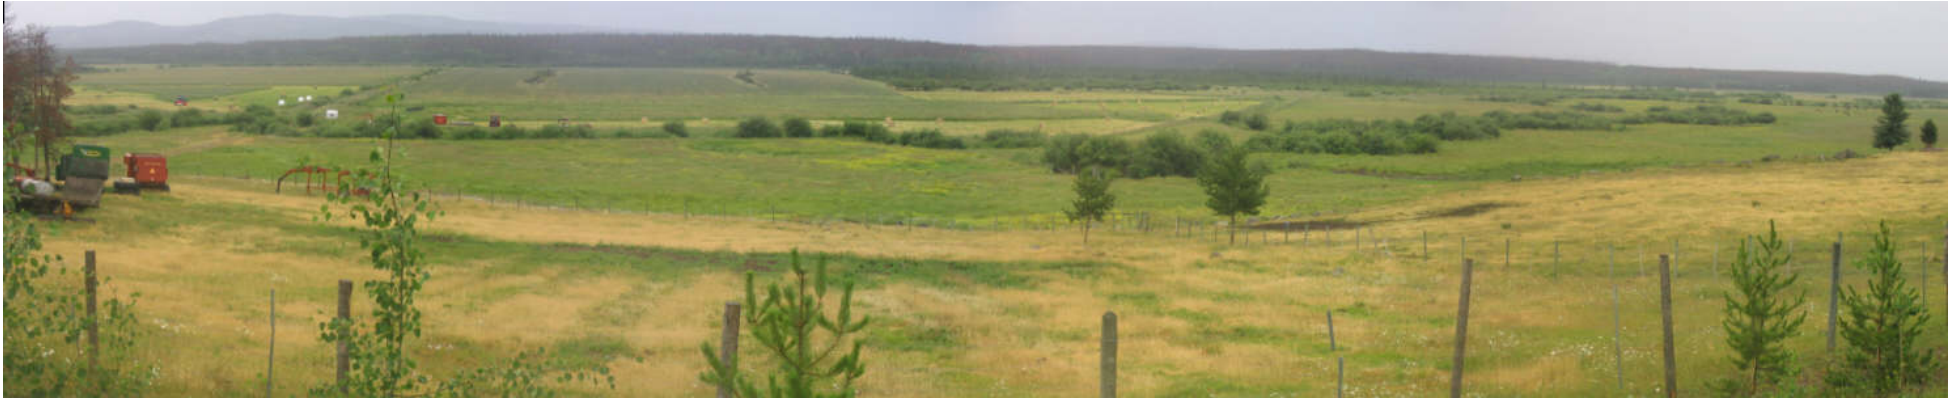
Photo 24 (July 11, 2006)

| Stream | Reach | Summary |
|---|---|---|
| Baker Creek | 12 | Reach 12 of Baker Creek flows through one of the most concentrated areas of ranching in the Baker Creek watershed and is characterized by a highly sinuous riffle-pool channel with sand bed and banks (Photo 24, Appendix D). Stream gradients are very low, stream banks are relatively low and thus the potential for flooding is high. When flooding occurs, much of the floodplain, which is about 2 km wide, may be inundated. In efforts to reduce flooding and promote drainage, a series of drainage ditches have been constructed by individual property owners. While most ditching is in the center of the valley, some ditching also has been constructed along the base of the hillslopes (i.e. near district lots 12429, 9911, 9912). Riparian conditions vary greatly along Reach 12. In some areas there is a fringe of dense shrubs, but in many areas all functional riparian vegetation has been removed during preparation of fields or by cattle access the creek. As a result, many banks have limited bank strength and are prone to slumping and erosion (Photo 25, Appendix D). Evidence of channel avulsions is widespread. The channel is therefore unstable and is highly disturbed. Channel sensitivity is <b>high</b> . |

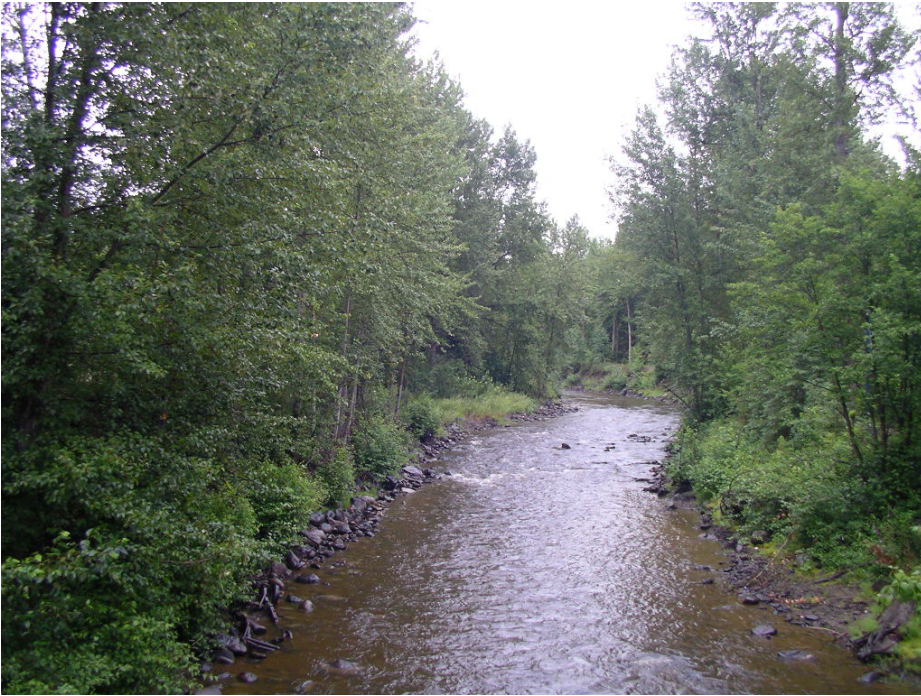
Photo 26 (July 15, 2006)

| Stream | Reach | Summary |
|---|---|---|
| Baker Creek | 1 | Reach 1 of Baker Creek flows through the City of Quesnel and has riffle-pool morphology with a gravel and cobble bed (Photo 26, Appendix D). The reach is partially confined and is lined by a narrow fringe of mature balsam poplar and shrubby vegetation. Given the proximity of development, several banks have been ripraped to protect from erosion. Overall, the channel is stable and disturbance is moderate. Channel sensitivity is <b>moderate</b> . |

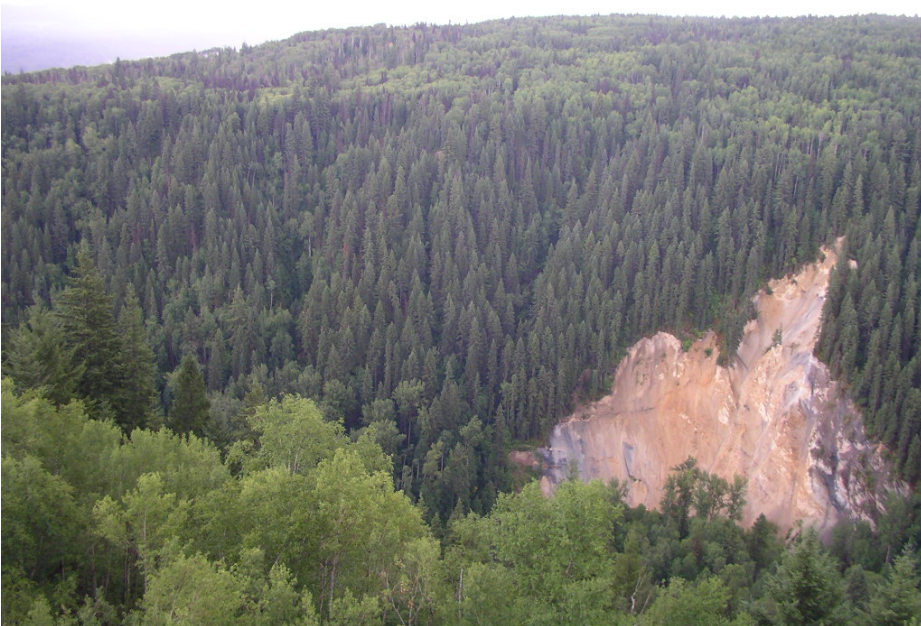
Photo 27 (July 13, 2006)

Although there are a considerable number of natural slide areas in the Lower Baker Creek residual area (Photo 27, Appendix D), particularly along Reaches 2 and 3, there were no significant development-related sediment sources identified.
