BC Ministry of Forests, Lands, and Natural Resource Operations  
and Rural Development

POST-WILDFIRE NATURAL HAZARDS RISK ANALYSIS  
AKOKLI FIRE (N71686)

February 8, 2022

Report Number: 21.510.01.04.02

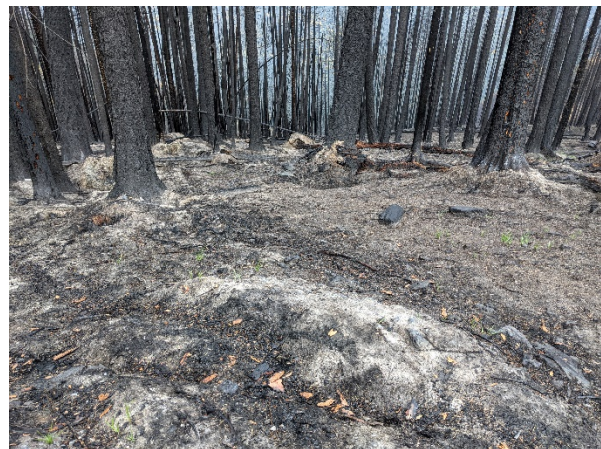
**Photo 10.** Example of high burn severity area

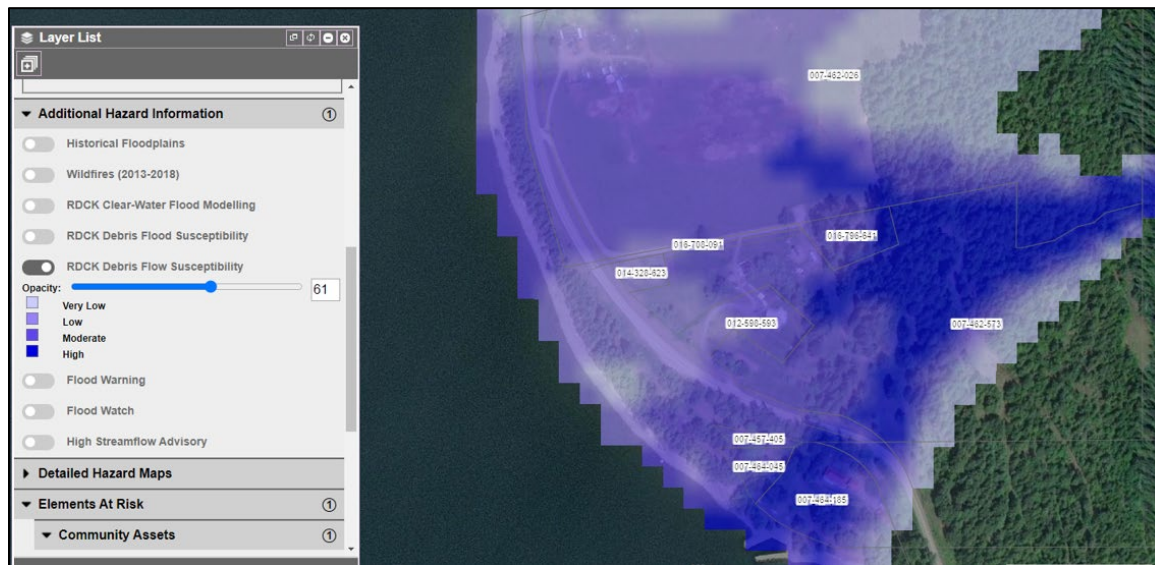
Figure 4 shows the debris flow susceptibility mapping available from the BGC Cambio Community Application (2020).

**Figure 4.** Debris Flow Susceptibility Map for McGregor Creek fan – Source: BGC Cambio Community Mapping.

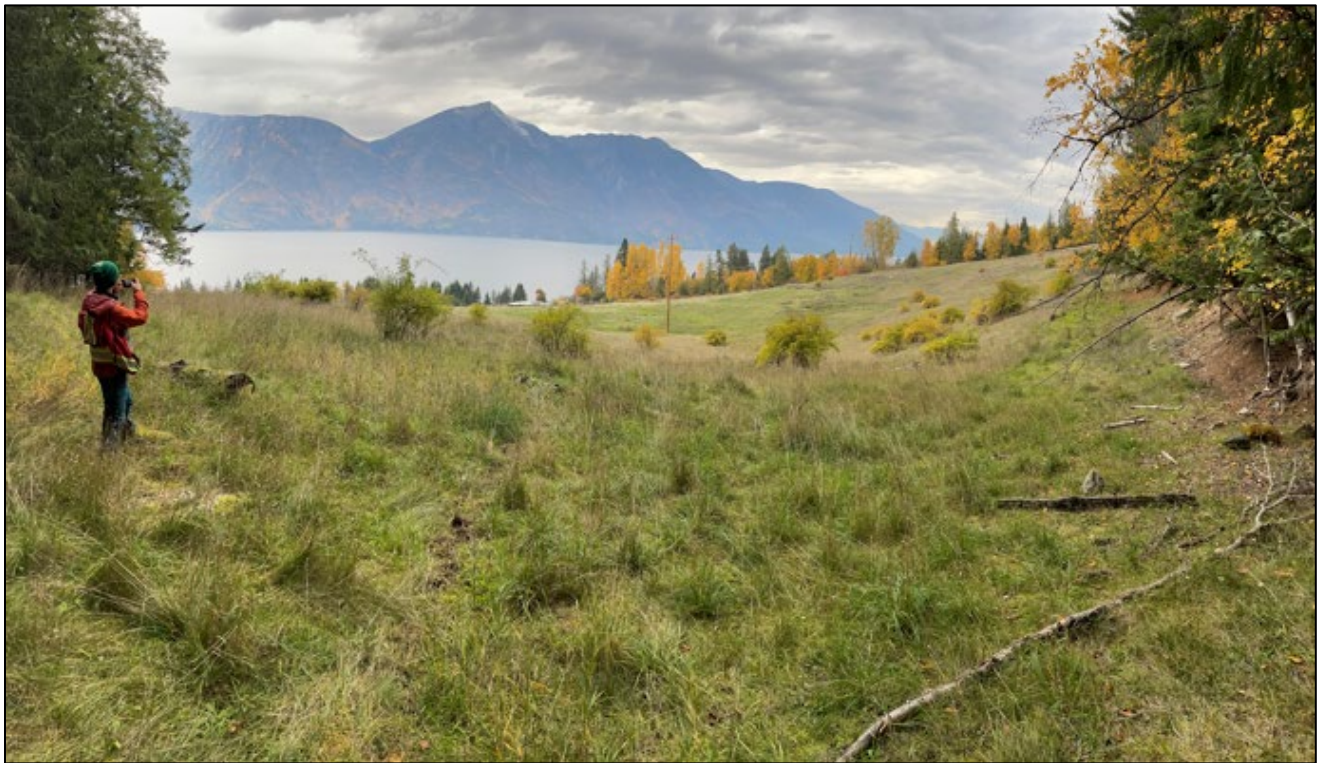
During a debris flow event there is a moderate likelihood that water and debris will be forced out of the gully by this obstruction resulting in overland flow down the south or north side of the fan towards the houses resulting in a MODERATE TO HIGH PARTIAL RISK TO THE HOUSES/RESIDENTS. The likelihood of this occurring can be reduced with the removal of the road crossing and water intake pond. In addition, the likelihood of a channel avulsion at this location could be reduced by the construction of a berm across the road on the south side of the channel and an excavation of material on the north side as shown in Photo 25. The berm on the south side would reduce the likelihood of debris flow material flowing down the fan towards the house at 12185 Hwy 3A. The excavation on the north side would encourage overflow from the gully on the north side to flow to the north into an open field away from the three houses (12260, 12220 & 12252) and the cemetery. Photo 26 is a photograph of the open field on the north side of the fan.

**Photo 26.** View looking north west to runout area for debris flowing to the north from the apex of the fan

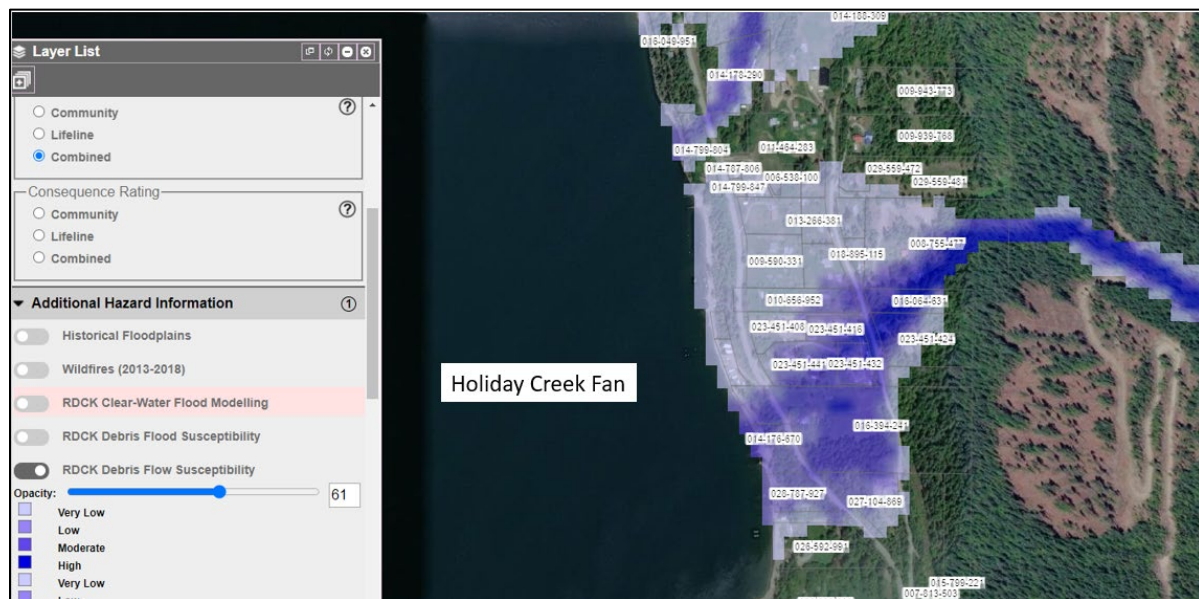
Figure 6 shows the debris flow susceptibility mapping available from the BGC Cambio Community Application (2020).

**Figure 6.** Debris Flow Susceptibility Map for Holiday Creek fan – Source: BGC Cambio Community Map (2020)

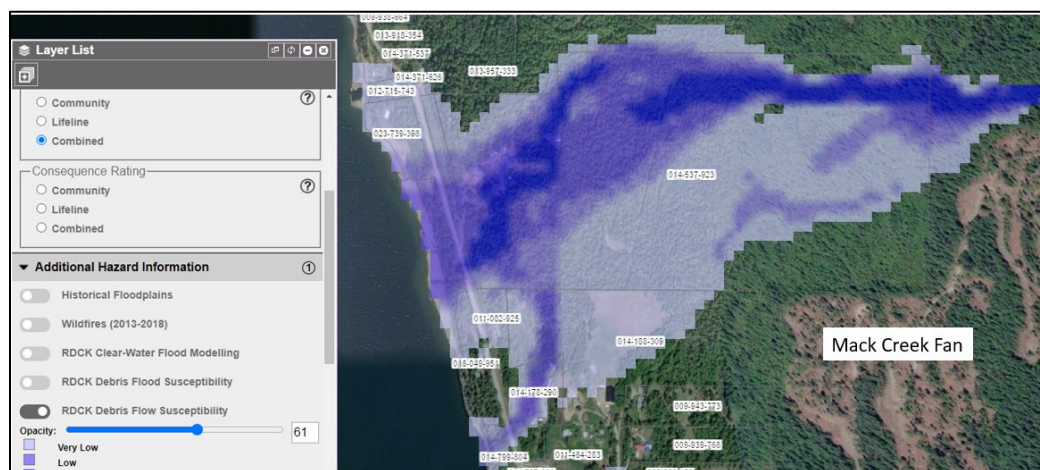
Figure 8 shows the debris flow susceptibility mapping available from the BGC Cambio Community Application (2020). Figure 9 shows the houses on the fan.

**Figure 8.** Debris Flow Susceptibility Map for Mack Creek fan – Source: BGC Cambio Community Map (2020)

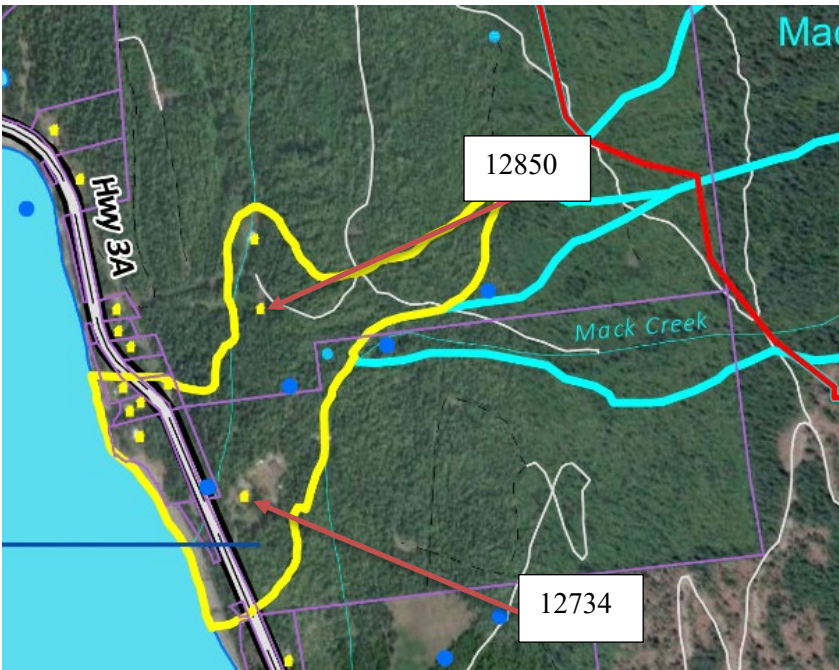
**Figure 9.** Mack Creek Fan showing houses on the fan – fan area is shown in yellow

While the overall fan surface gradient from the apex to the lake is 19%, the gradient from the apex to just above Hwy 3A is 15%. The dwelling at 12734 Hwy 3A is located approximately 400 m from the apex of the fan. The fan surface gradient upslope and proximal to the dwelling ranges from 8% to 14%. The PARTIAL RISK IS CONSIDERED LOW for this house location. This lower gradient and distance between the house and the apex of the fan, as well as the absence of gully features (Photo 29) that could direct flow towards the house renders the likelihood of debris flow material other than shallow slow moving sediment laden floodwaters reaching the houses as low.

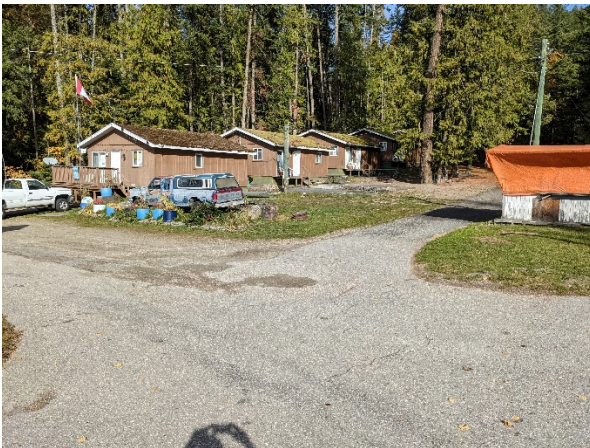
At the Lockhart Creek fan apex there is less than 2 m freeboard (Photo 33) and it is possible extreme flooding with debris could overtop at this location and flow over the left side of the fan (further upstream Lockhart Creek is incised in bedrock). There are five cabins (Photo 34) and an office/ house (Photo 35) between the creek and the access road that would be exposed to flooding and a marina business/restaurant below the highway (Photo 36).

**Photo 35.** Cabins and office/dwelling on Lockhart Creek fan.

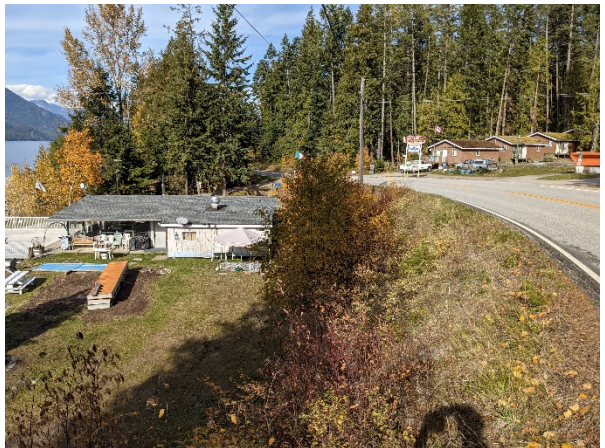
**Photo 36.** Restaurant/business below Highway 3A on Lockhart Creek fan.

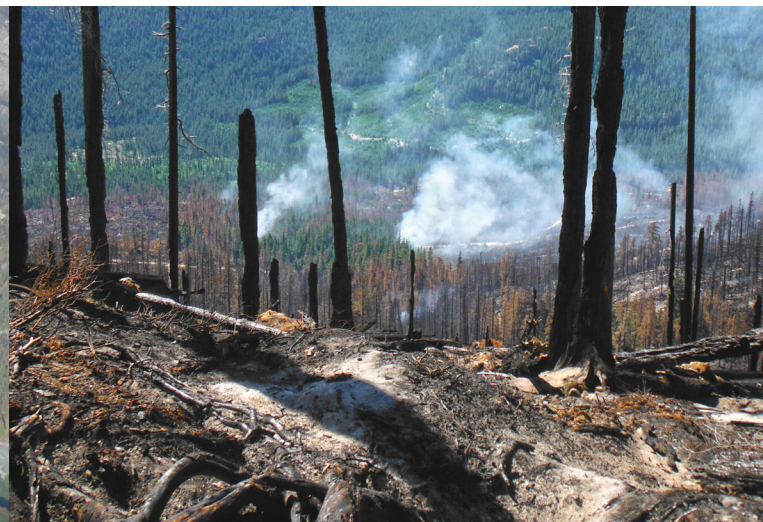
This is the Elaho drainage area in June 2015, showing evidence of how severe the wildfire was in that area.

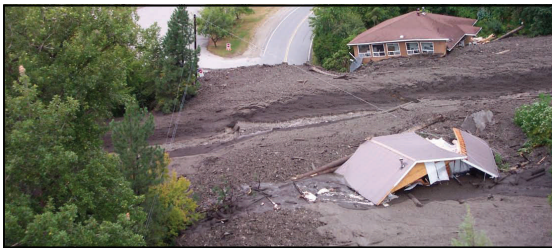
Figure 1. Debris flow material that was deposited on the Kuskanook Creek fan after a rainfall event in August 2004.

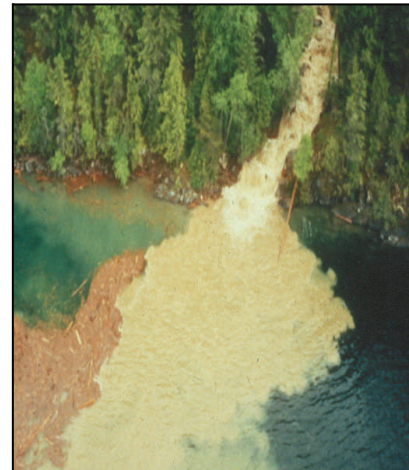
Figure 2. Debris flood on Memphis Creek. Note the large volume of floating debris in the lake and the uncharacteristically turbid water.

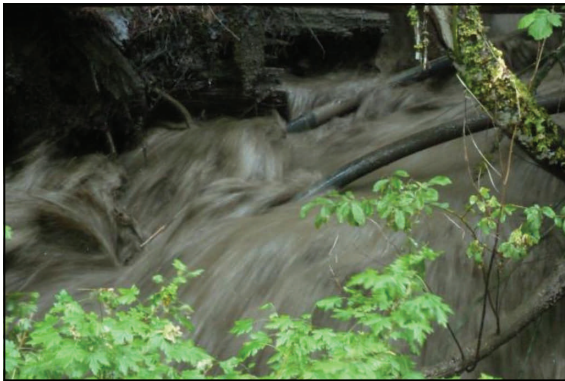
Figure 4. Turbid water in Gar Creek the day before the Johnson's Landing landslide on July 12, 2012.
