SC-8001

CLOWHOM 7.1km

2019 Inspection

| Crossing Name | Bear Creek | | |

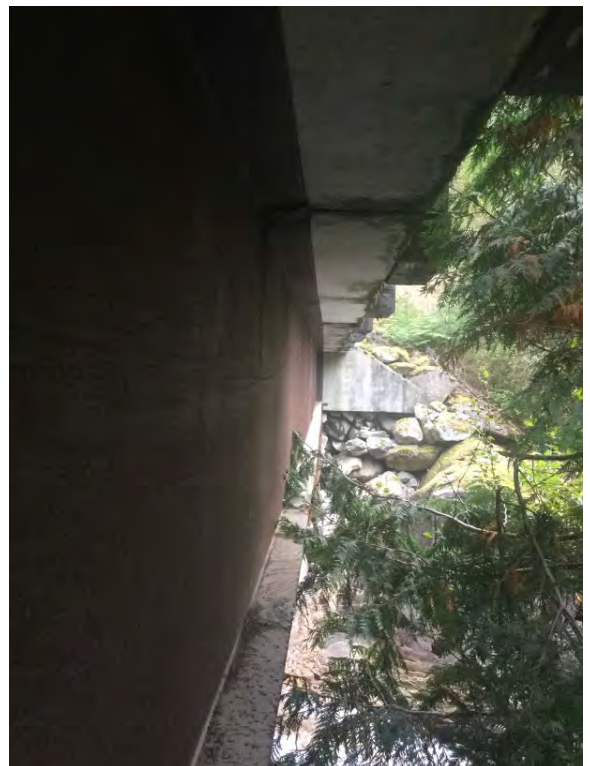
Downstream Profile

Both girders bowed towards downstream at middle. Both upper and lower flange, both sides. Likely done during installation, prior to placing deck. Estimated 10cm at midspan. Bolts bent on right abutment, towards right side. No apparent change since last inspection. Rust scale behind right abutment bearing, at end of bridge. Some joints have rust scale on upper flange. Monitor.
