SC-8625

2020 Inspection

Date of Inspection 2020-11-05 9:49:14 AM

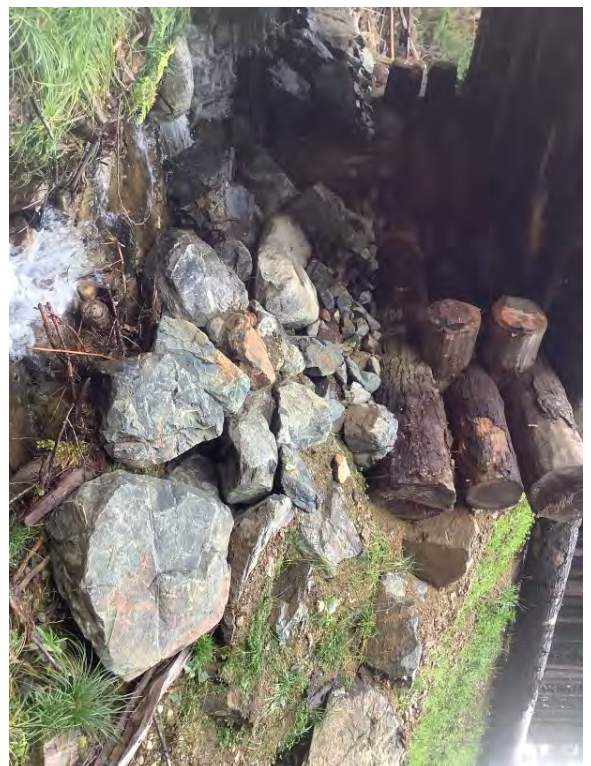
Left Bank Abutment when facing downstream

Over-steepened riprap on left side has minor scour. Some of the riprap has shifted, further destabilizing crib. Recommend continual monitoring of abutment during any industrial use. Less than 10mm rot all stringers
