SC-8640  
SC-8640

## SECHELT ROBERTS 1.12km

2021 Inspection

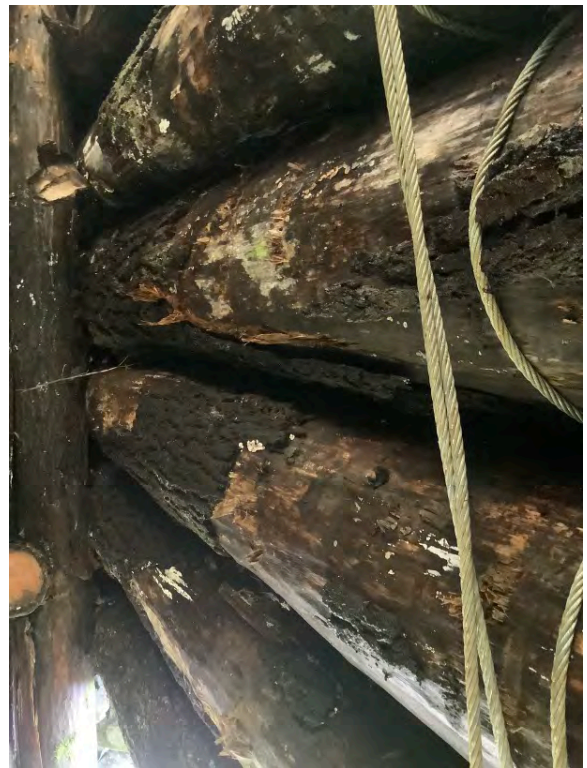
Stringers have 100mm sap rot, conks. Replace prior to industrial use. Max pickup only recommended

Conk, approx 100mm sap rot ave overall
