**RT-GPS Mapping of Fish  
Habitat and Fish Distribution  
Of Cheewhat Lake Tributaries;  
S2 (and Distributary S1), S3  
S4 and S5, September 2001.**

May 30,2002

**Nuu-chal-nulth Tribal Council  
Port Alberni, BC**

M.C. Wright and Associates  
2231 Neil Drive,  
Nanaimo, BC  
V9R 6T5  
Phone/Fax: (250)753-1055  
Email: [mcw-assoc@shaw.ca](mailto:mcw-assoc@shaw.ca)

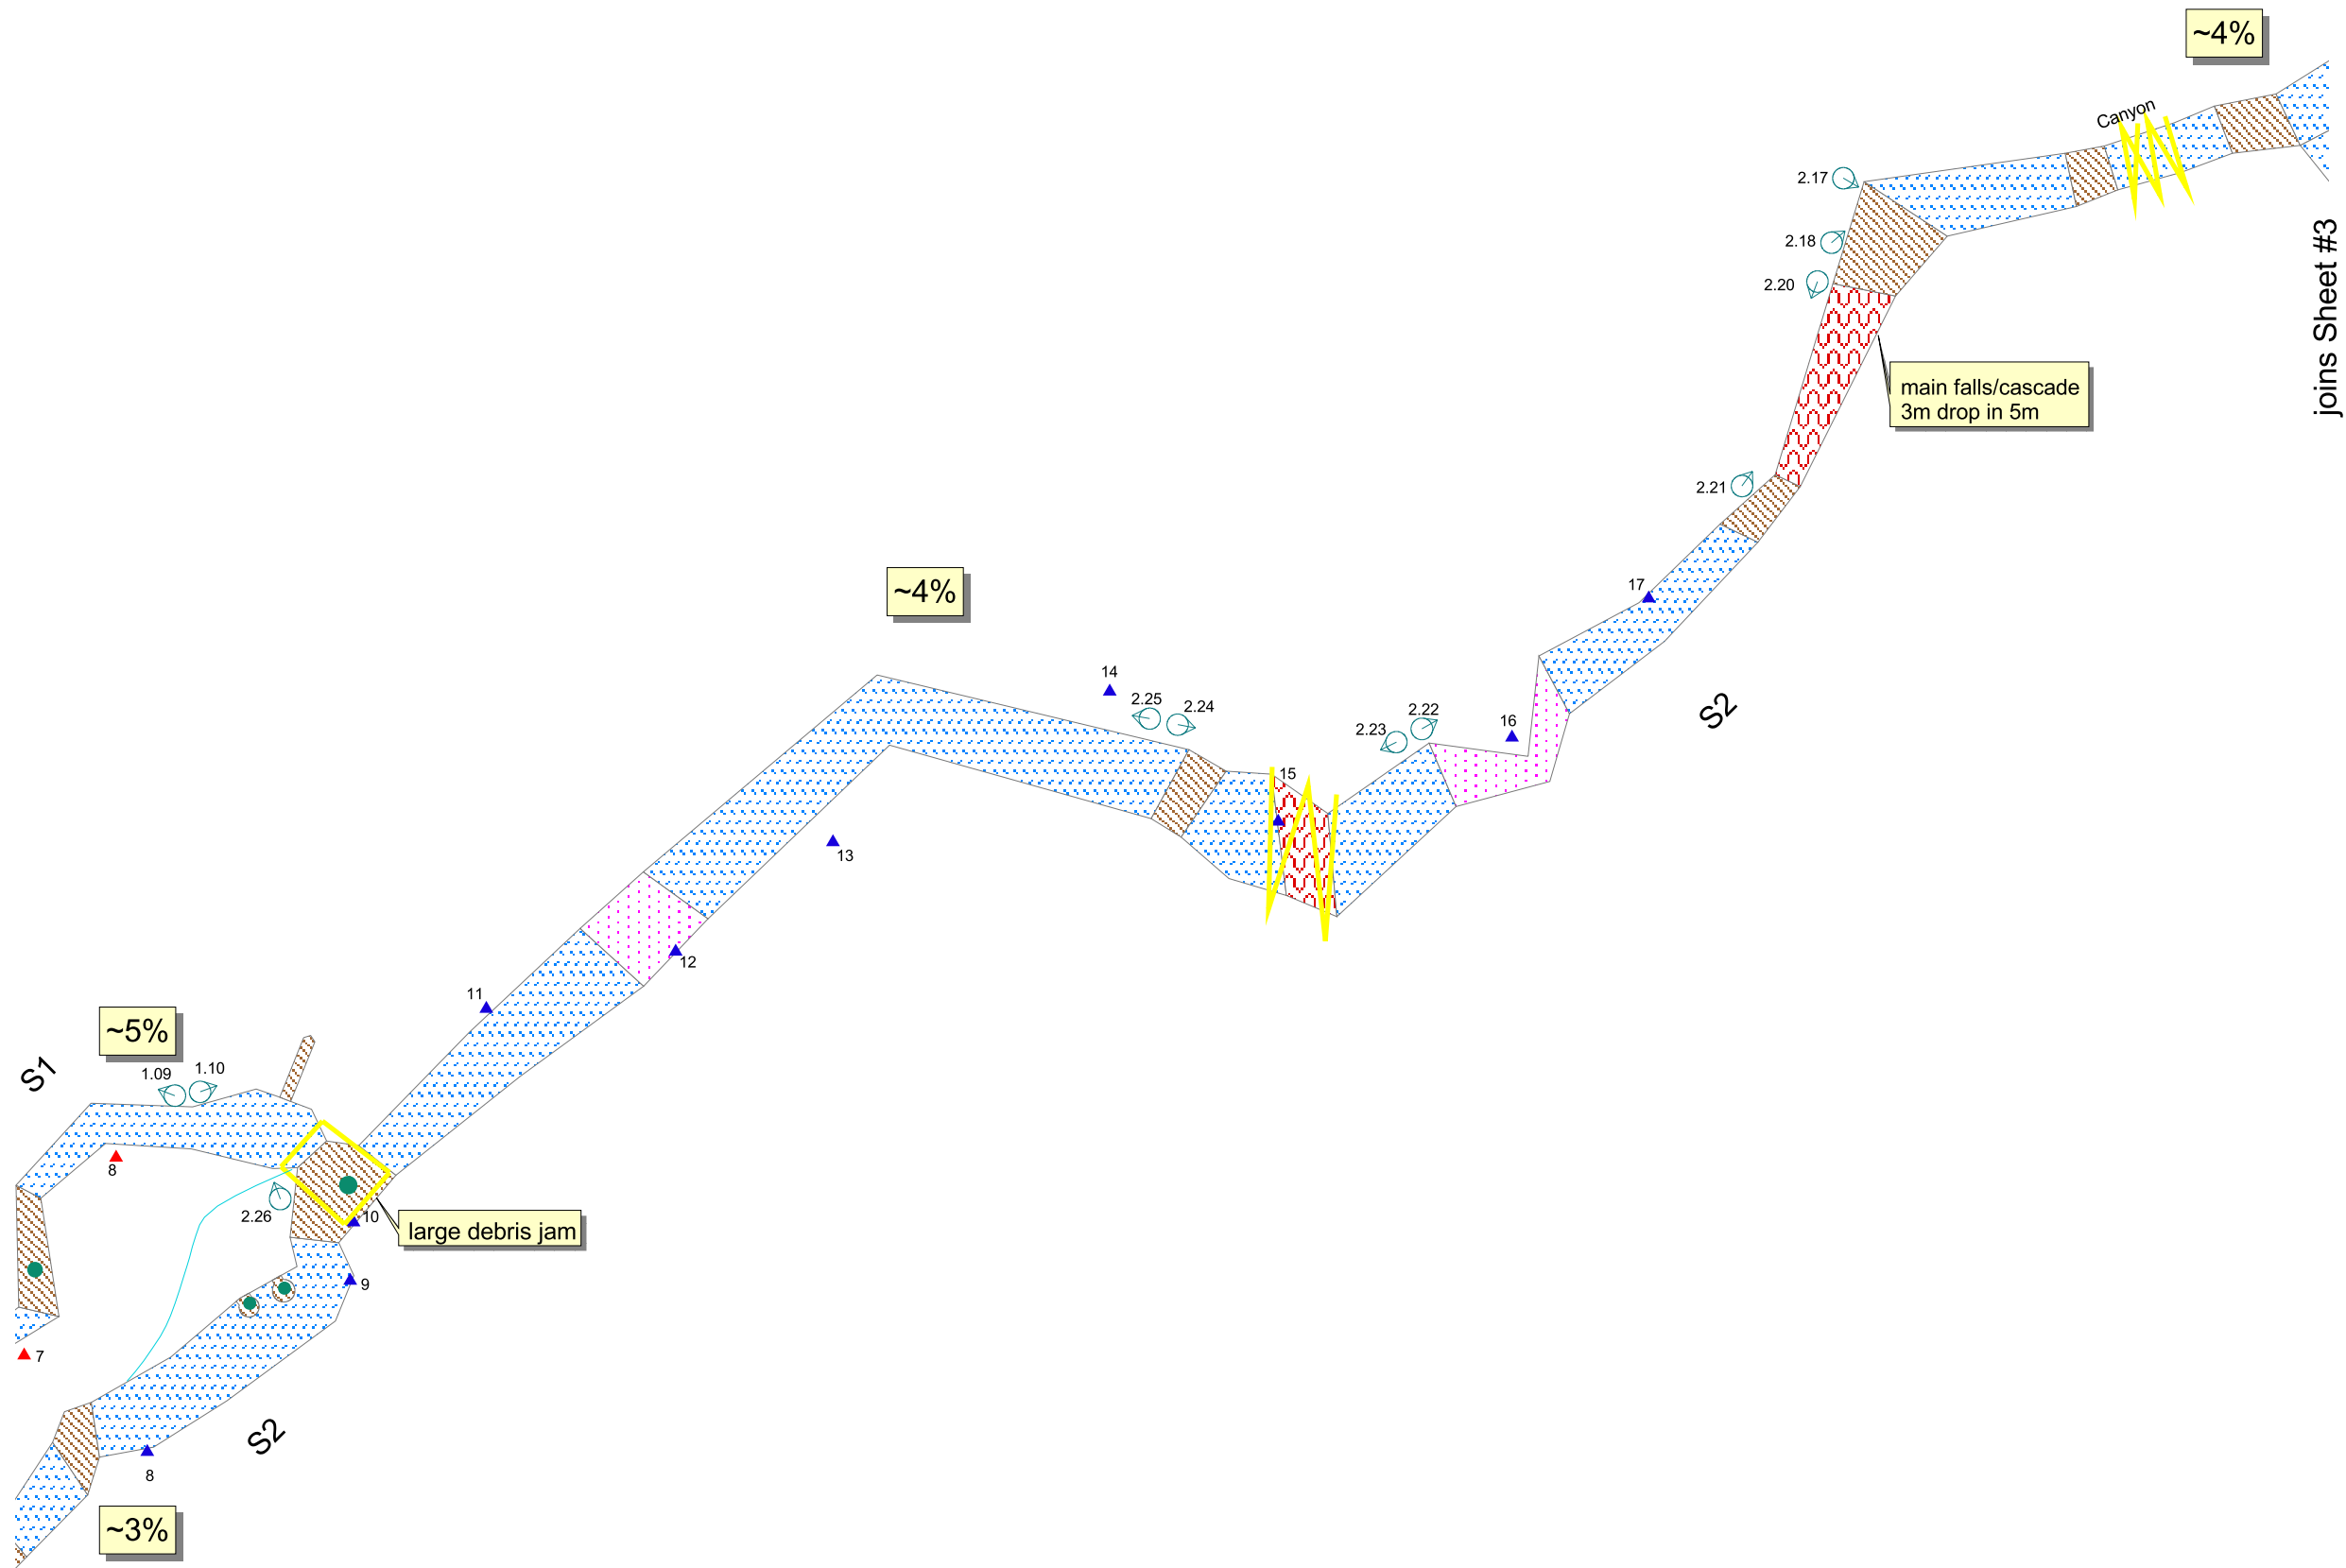
**Cheewhat  
S1 & S2  
Sheet #1**

The highest densities of juvenile fish (predominantly coho) were observed in S2 below M10 and in S1 (Overview #2 and Sheets 1 and 2). High densities (>500) of coho fry were also observed off of the mouth of S2 and S3. Low densities of fry were observed in S3, S4 and S5.

| Tributary | Location | Habitat Description | Habitat Impairment | Rehabilitation opportunities and additional information required |
|---|---|---|---|---|
| S1.1 | S1.1 is distributary to S1 and flows into the eastside of Cheewhat Lake. Overview #2 and Sheet #1 | S1.1 is predominantly glide pool habitat with a mean gradient of 2%. Substrate was mainly gravel with high fine content in the lower 50 m. The lower 50 m was dewatered with 2 isolated pools. Coho fry were observed throughout with >100 observed in the glide approximately 100 m upstream of the mouth. This channel has good spawning and rearing habitat. The channel is aggraded in the lower 50 m. | Logging impacts: impacts are low for this channel. Increases in peak flows may have increased bedload movement. | 1. Monitor fish use, adult and juvenile |

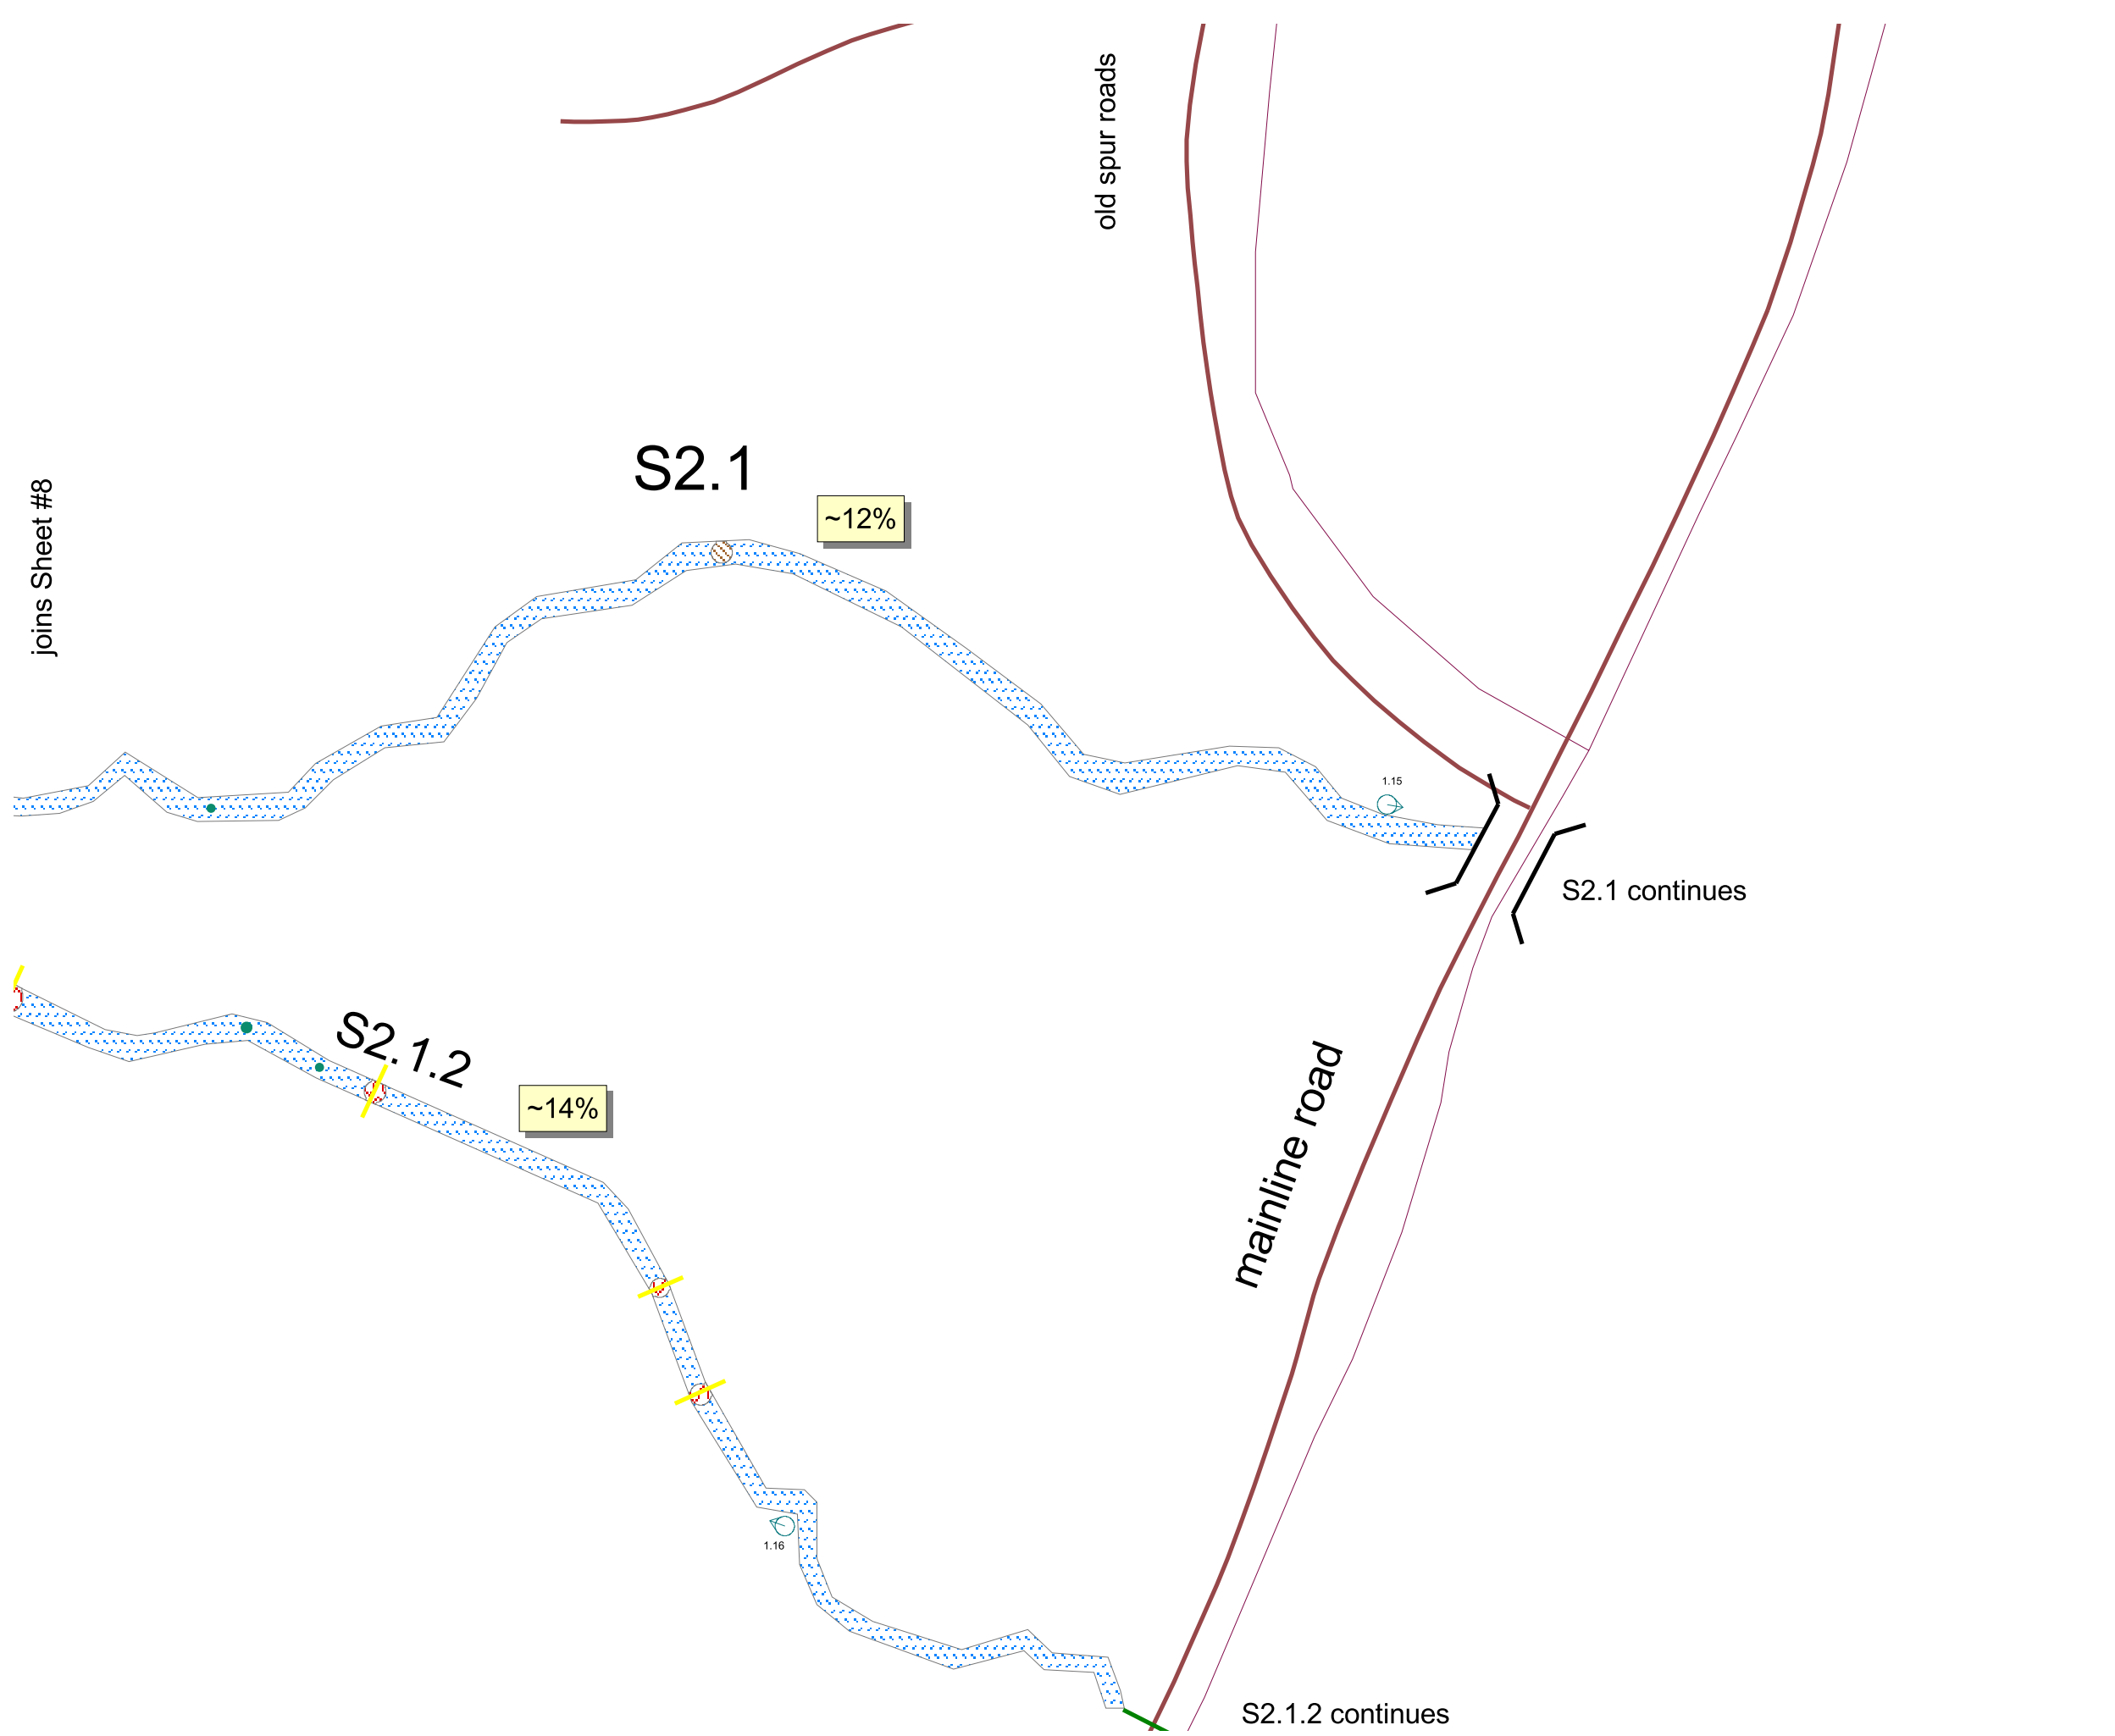
**Cheewhat**  
**S1 & S2**  
**Sheet #8**

| S2.1.2 | Flows into S2.1 left bank. Overview #2, Sheets 8 and 10. | This tributary is high gradient (approximately 14%) riffle/ cascade habitat with a few small pools. Cutthroat trout were observed in this tributary. See sheet #8 for locations of fish observations. This tributary has limited fish value. Substrate is predominantly boulder and cobble. | Logging impacts: Increase in channel sediment from original logging of the channel banks. | |

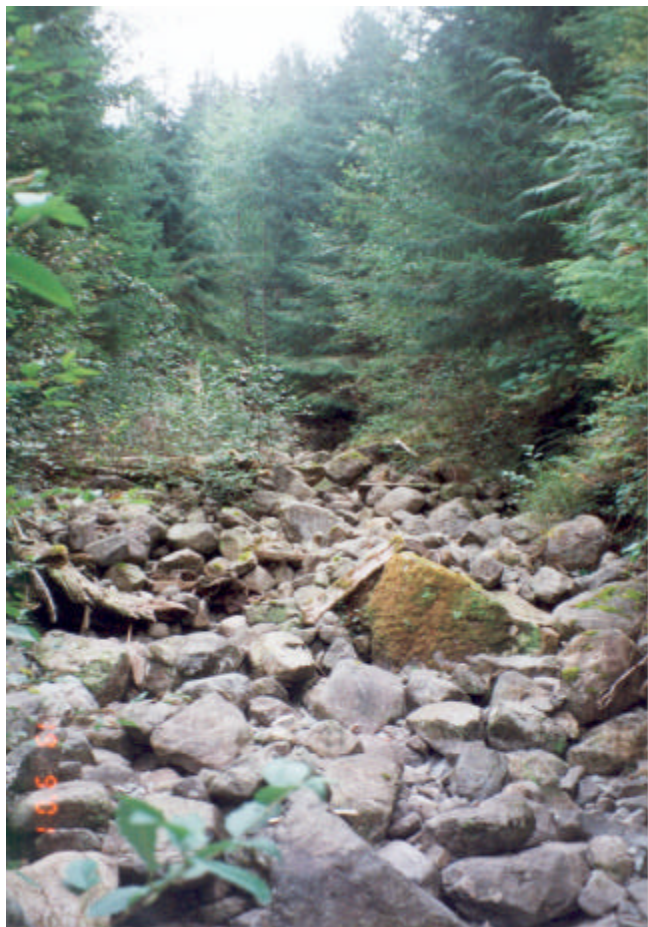
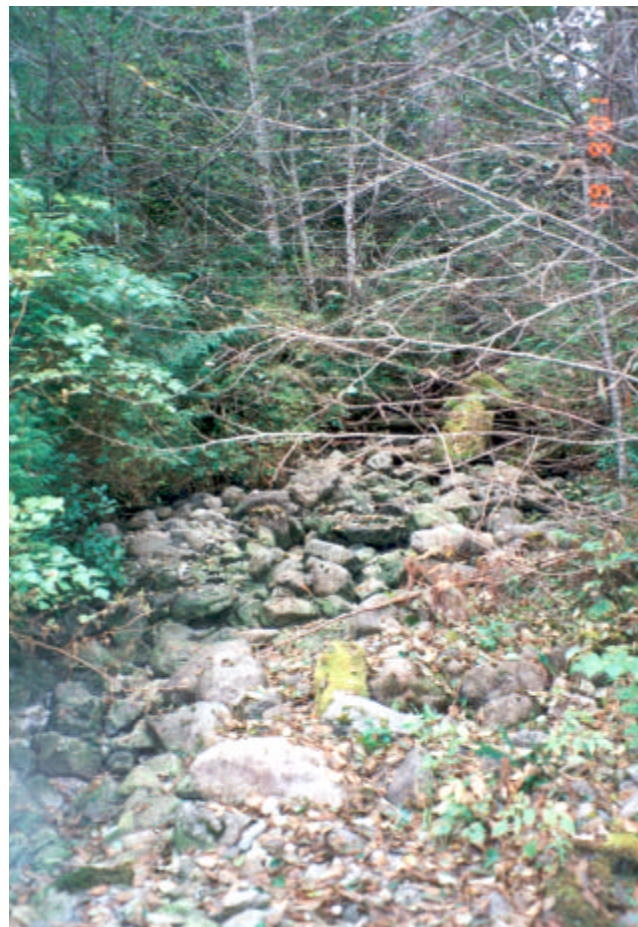
| <b>Description:</b> The following plates show Upper S-2 above the barrier noted on Overview Sheet #2. This photograph was taken looking downstream at Tributary S-2.1.1. This tributary was a long high energy cascade that was de-watered at the time. Plate 1.12 is a photograph looking upstream at the channel on Tributary S-2.1.1. This tributary has limited fish value. | | |

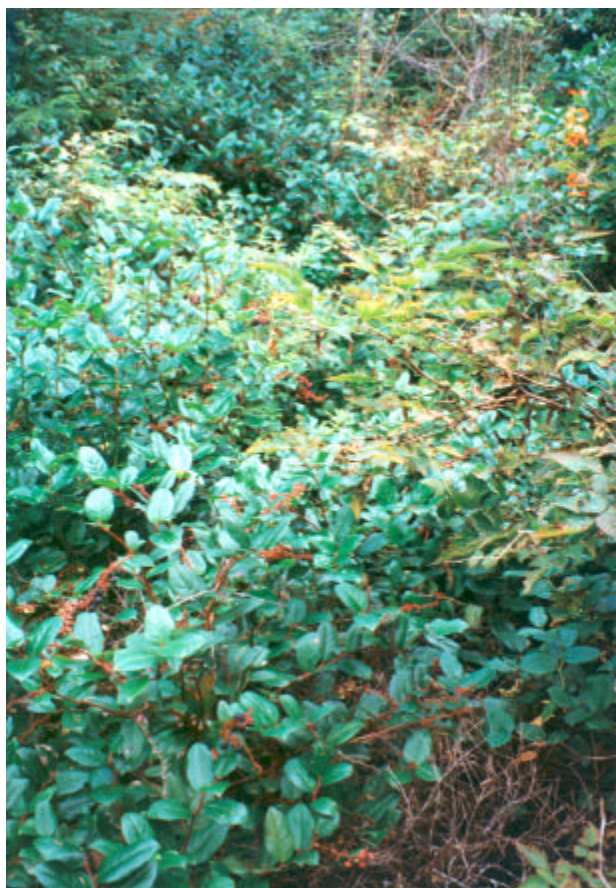
**Plate 1.22**

| <b>Description:</b> This photograph shows the dense vegetation at S-2. | | | |

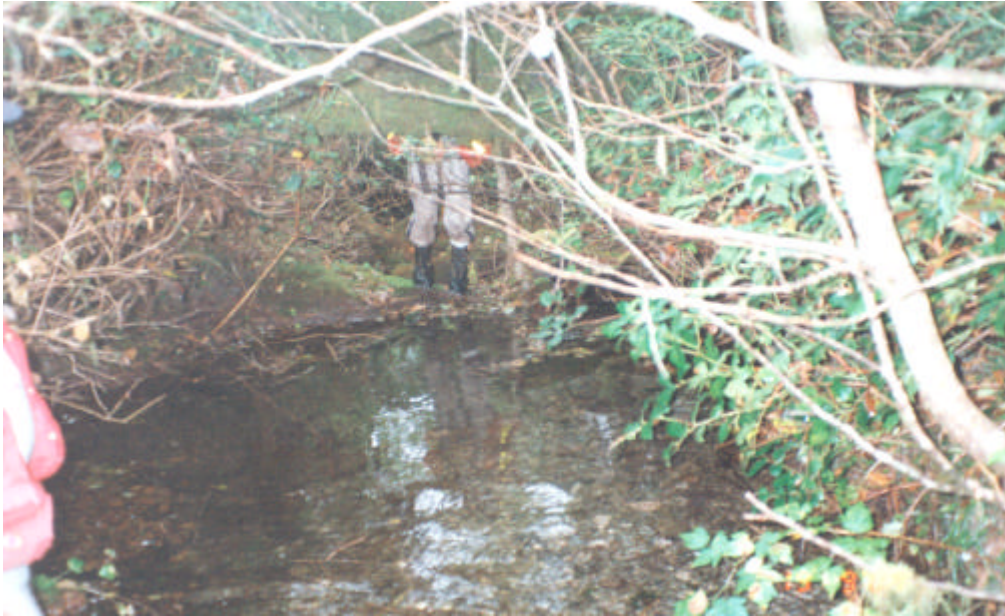
**Plate 1.23**

| <b>Description:</b> This photograph shows pool habitat with large and small gravels and a plunge pool on the downstream end of the riffle. There is good overhanging vegetation and small cuttbanks on both sides of the channel. | | | |

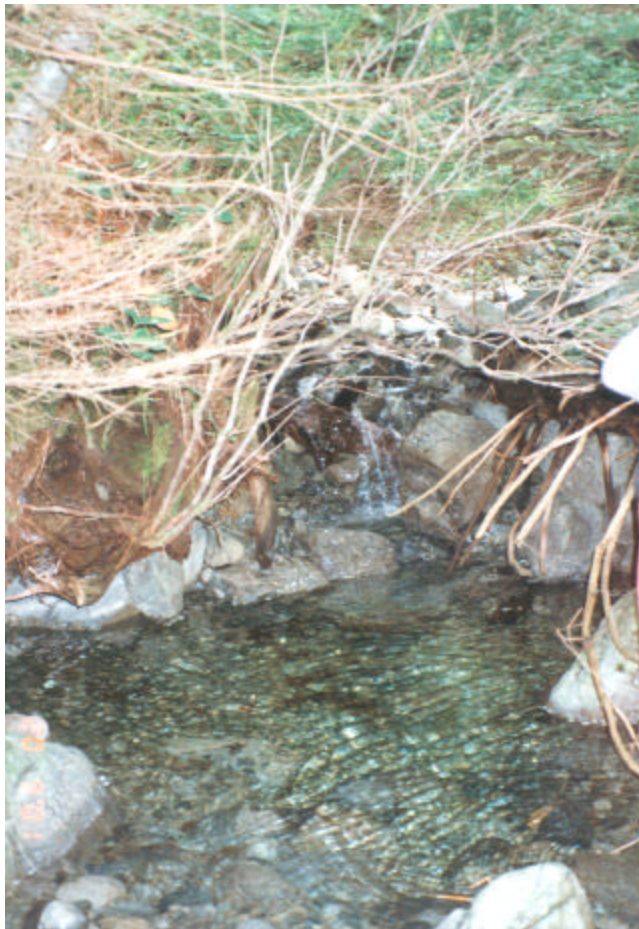
**Plate 1.29**

| <b>Description:</b> This photograph shows a plunge pool on S-2 below the Rosander Mainline. No fish were observed. | | | |

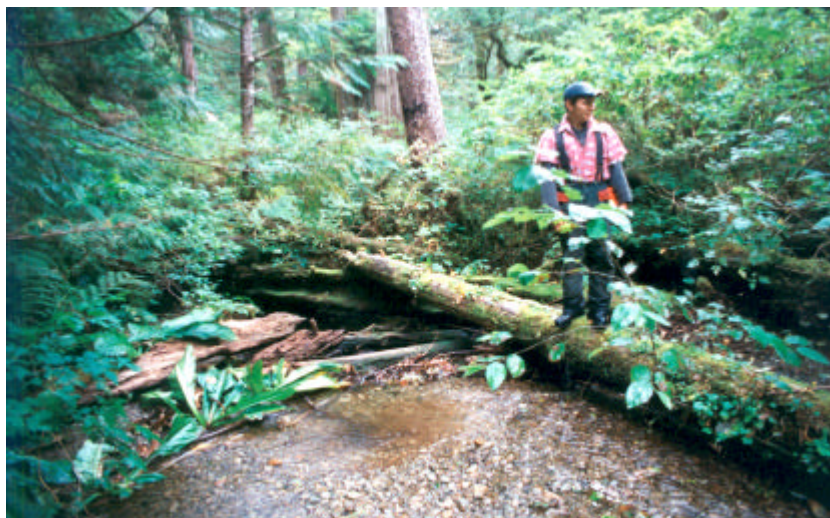
Plate 2.13.

| <b>Description:</b> These photographs were taken upstream of the confluence of S-2 and S-2S (side channel). Plate 2.13 was taken looking downstream at riffle/pool habitat in the side channel. Plate 2.14 was taken looking upstream at a riffle section of lower S-2. Pools in this area have infilled post logging of upper S-2. | | <b>Plate 2.14 Reference:</b> Sheet #1 |

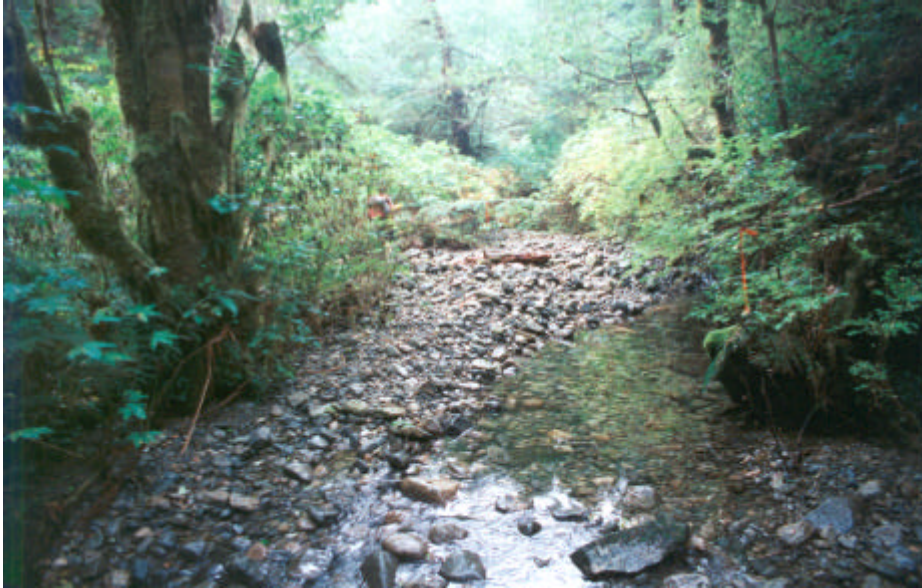
**Plate 2.15.**

| <b>Description:</b> This photograph was taken looking upstream at S-2.1 from the confluence of S-2 and S-2.1. It was taken on a bearing of 120°. | | |

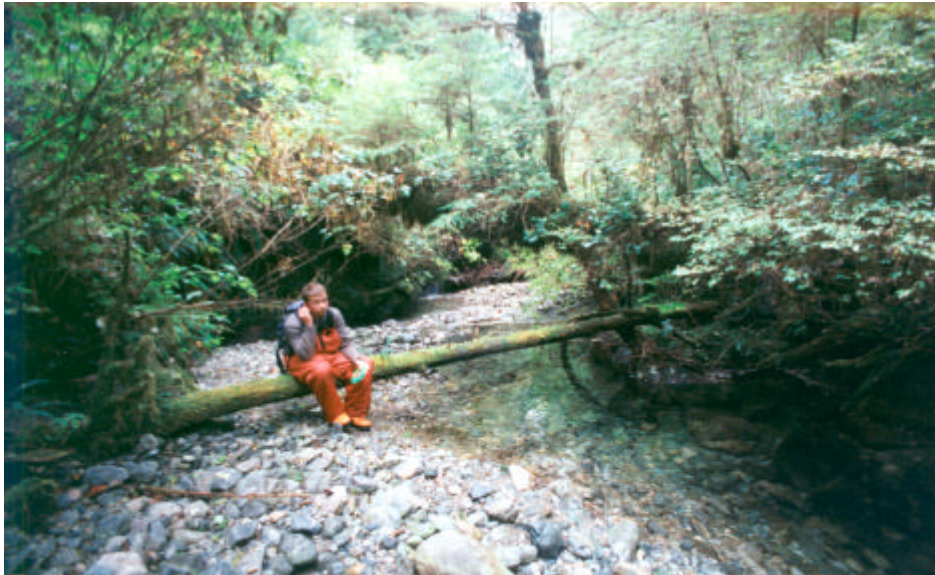
Plate 2.16.

| <b>Description:</b> This photograph was taken looking downstream at S-2 from the confluence of S-2 and S-2.1. This photograph was taken at a bearing of 248 <sup>o</sup> . | | |

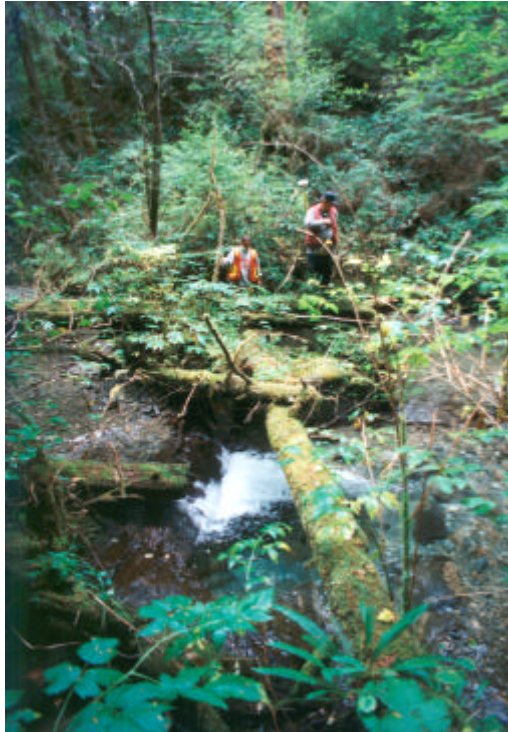
Plate 2.17.

| <b>Description:</b> Plate 2.17 was taken looking from left to right at a plunge pool above the barrier. Plate 2.18 was taken looking upstream at a pool associated with LWD in S-2 at a bearing of 63 0. Habitat in this area had good complexity with cover in the form of LWD and overhanging vegetation and plunge pools. | | <b>Plate 2.18 Reference:</b> Map Sheet #2 |

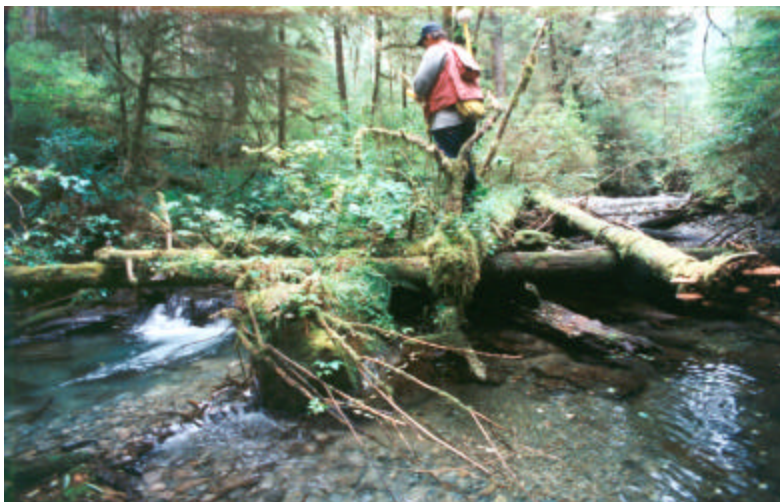
Plate 2.19.

| <b>Description:</b> Plate 2.19 was taken looking upstream at a plunge pool above the barrier in S-2 at a bearing of 90°. Habitat in this area had good complexity with cover in the form of LWD and overhanging vegetation in the form of LWD and overhanging vegetation and plunge pools. | | |

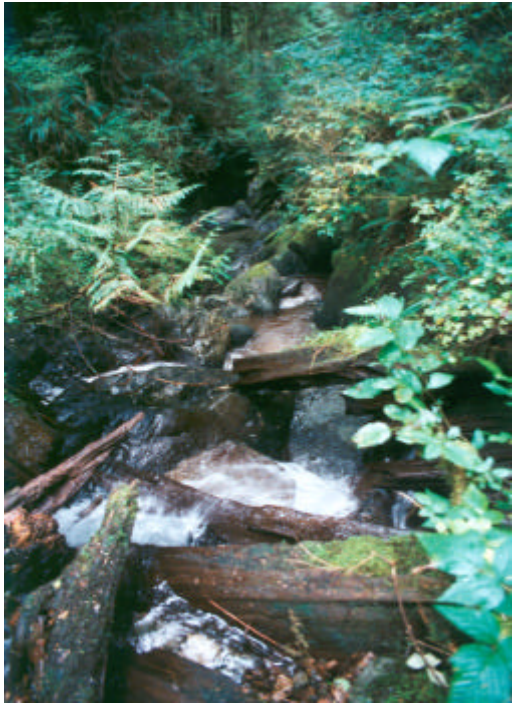
Plate 2.20.

| <b>Description:</b> This photograph was taken looking downstream from the top of the falls/cascade section of S-2. | | | | | |

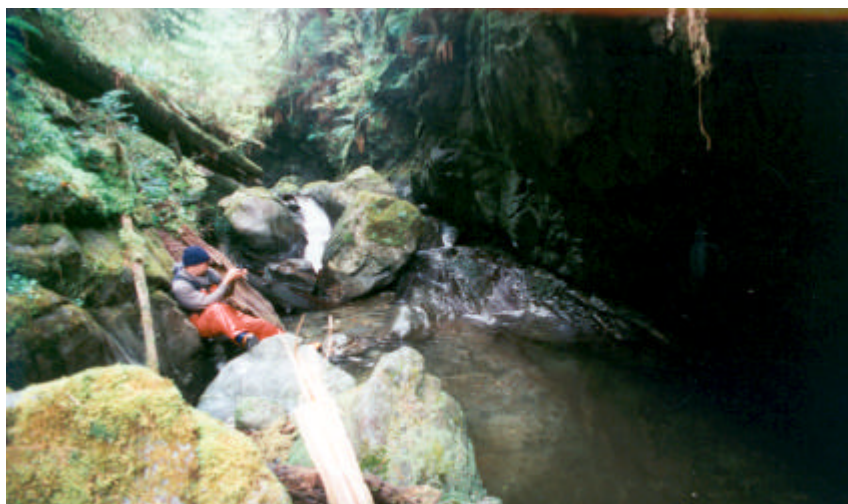
Plate 2.21.

| <b>Description:</b> This photograph was taken looking upstream at the falls/cascade section of S-2. Cutthroat were observed in the pool at the base of this cascade. This section is a bedrock canyon. | | |

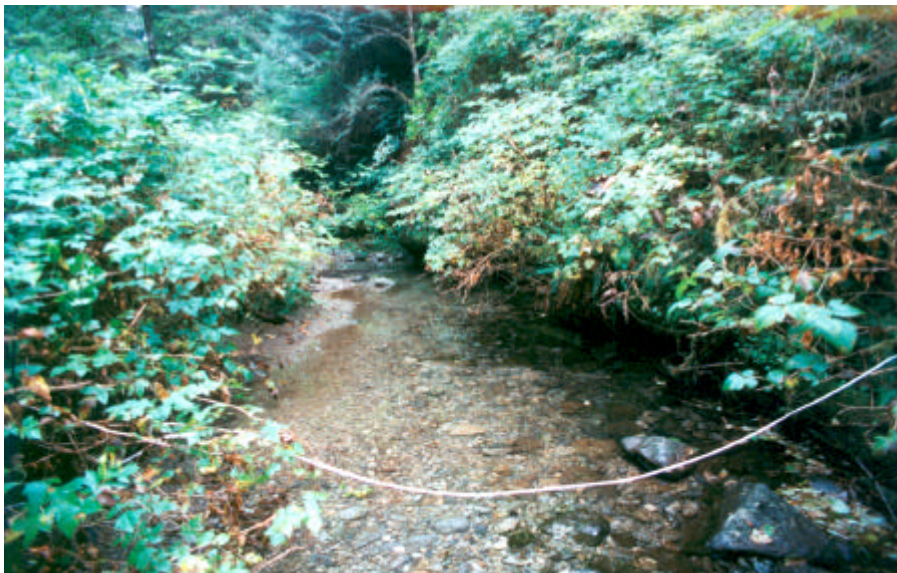
**Plate 2.22.**

| <b>Description:</b> This photograph was taken looking upstream at the channel in S-2. | | |

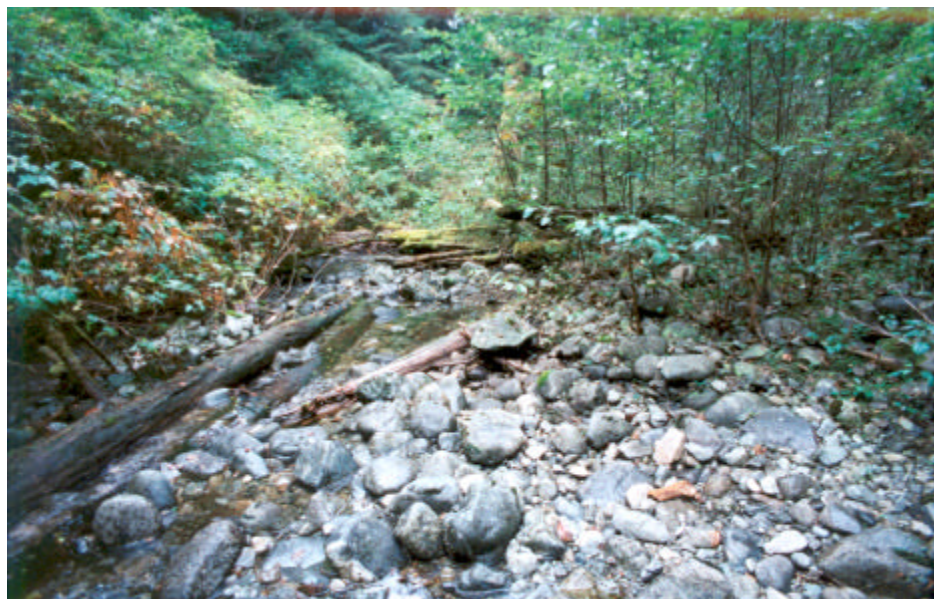
Plate 2.23

| <b>Description:</b> This photograph was taken looking downstream at a cobble riffle section in S-2 at a bearing of 244 <sup>0</sup> . | | |

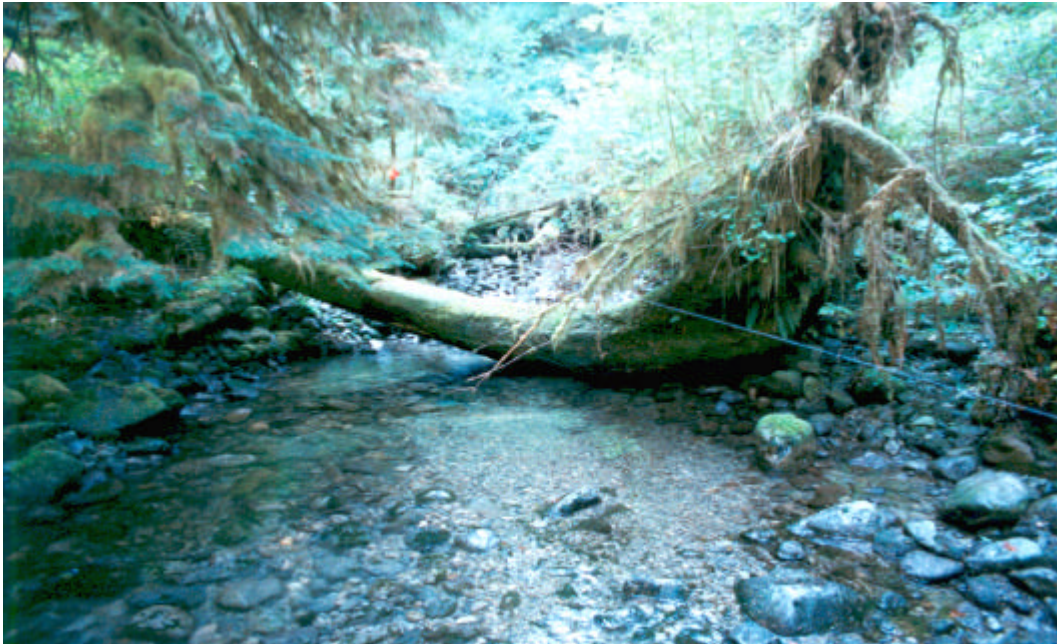
**Plate 2.24**

| <b>Description:</b> | This photograph was taken looking upstream at a riffle/pool section of S-2. | |

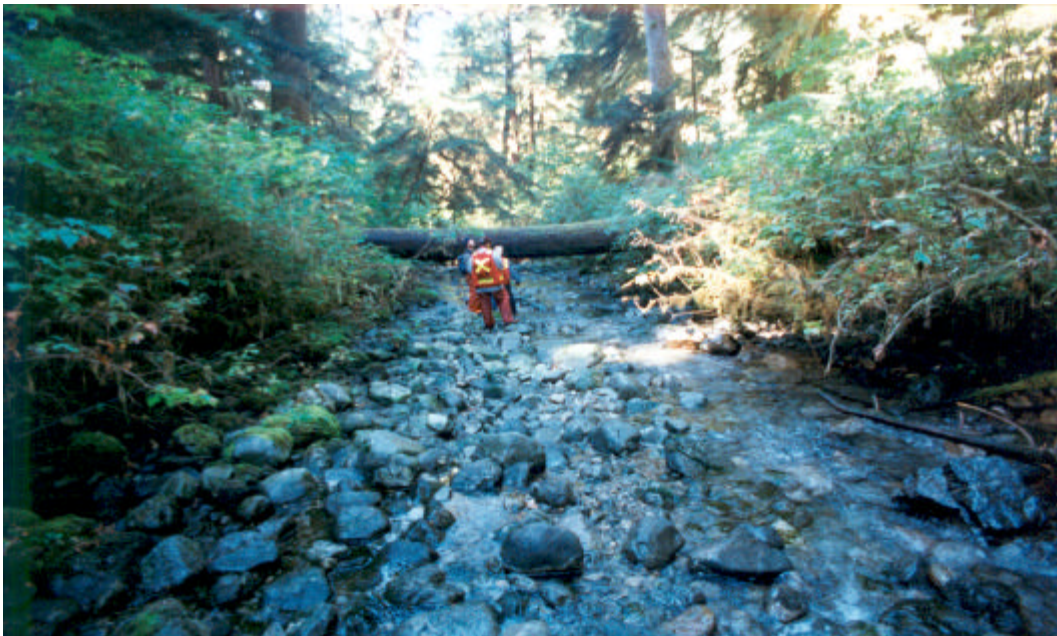
Plate 2.25

| <b>Description:</b> This photograph was taken looking upstream at a riffle section of S-2. | | |

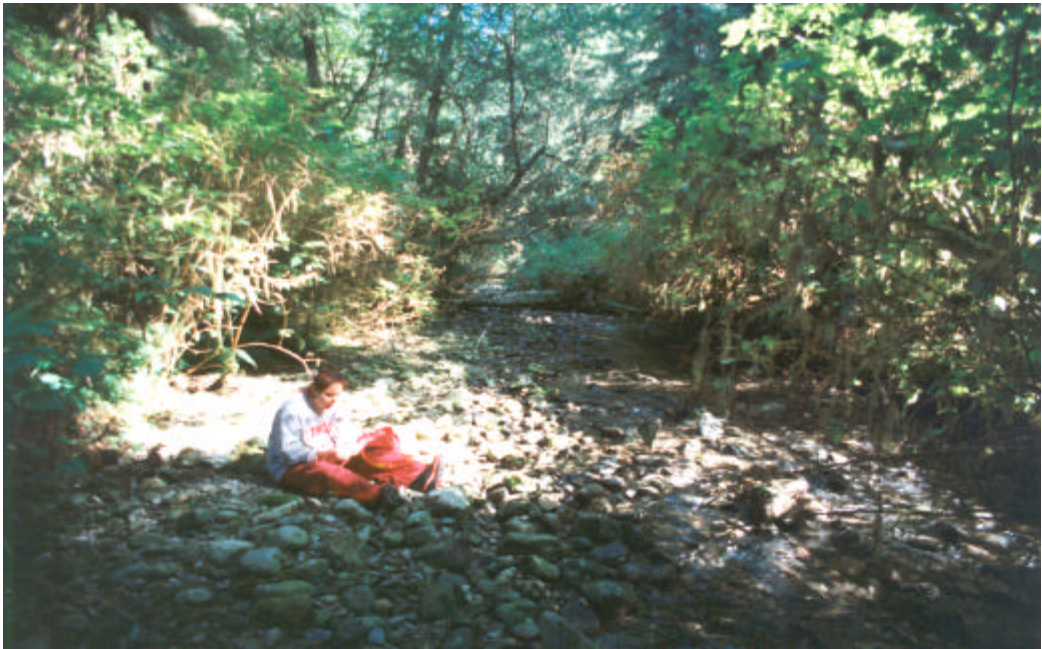
**Plate 2.27**

| <b>Description:</b> This photograph was taken looking upstream from the debris jam at marker 10. | | |

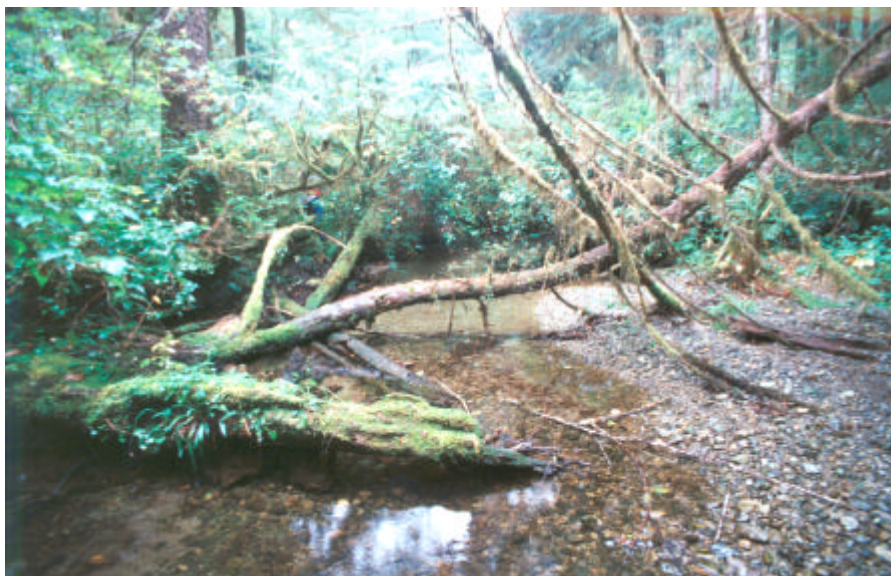
**Plate 30.**

| <b>Description:</b> This photograph was taken looking upstream at the channel from mid channel at marker 5 on S-2. | | |

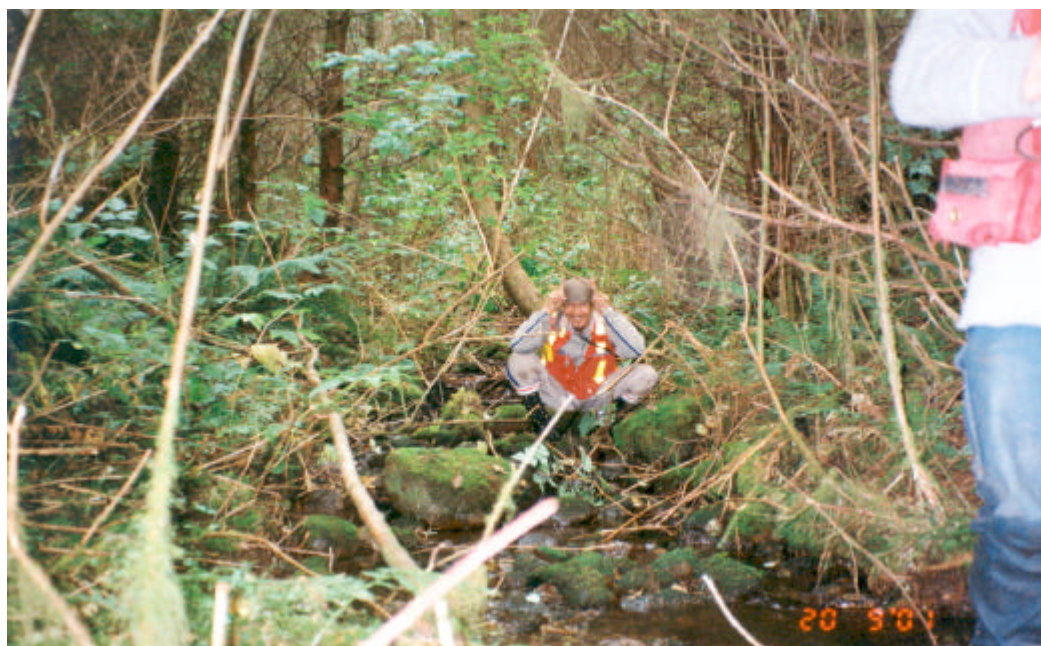
**Plate 3.01**

| <b>Description:</b> This photograph was taken looking upstream at a riffle section. | | | | |

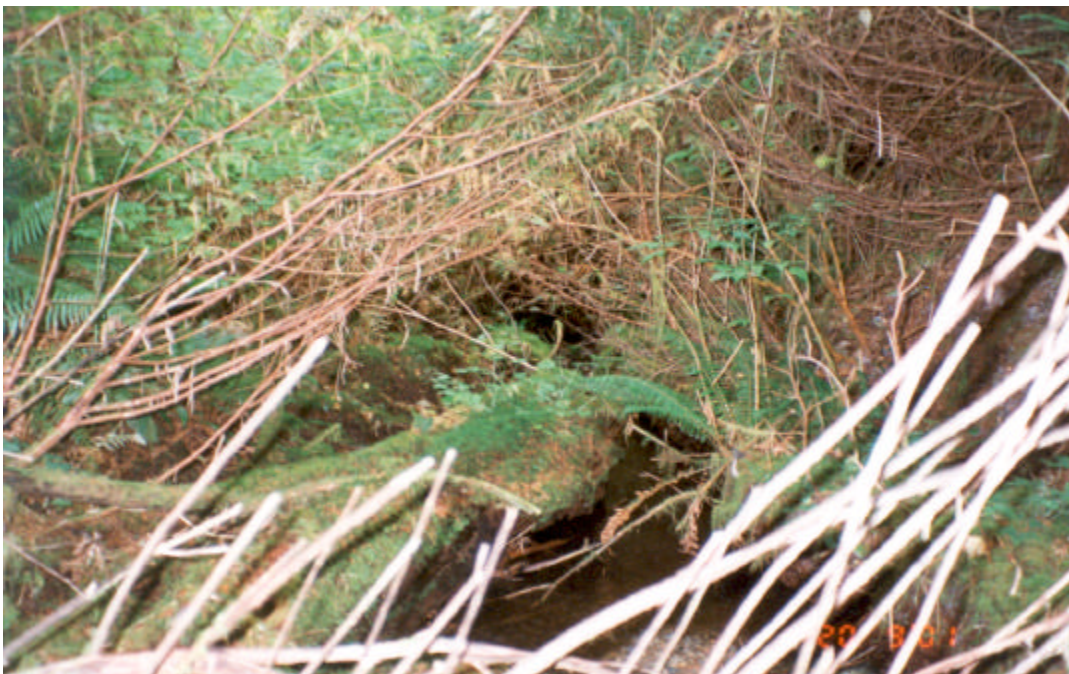
**Plate 3.02**

| <b>Description:</b> This photograph was taken looking downstream at S-2.2. | | | |

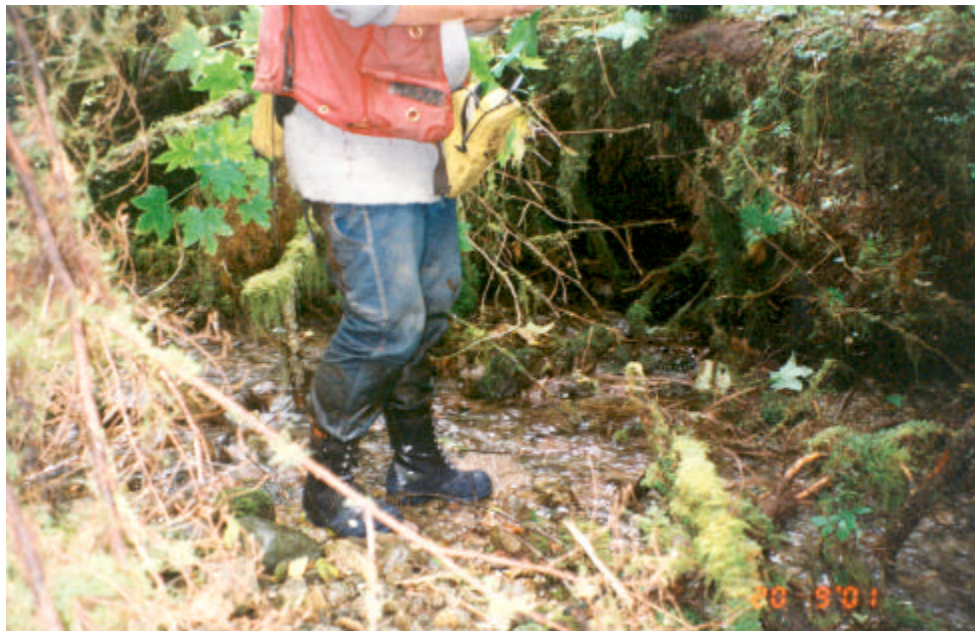
**Plate 3.03**

| <b>Description:</b> This photograph was taken at the confluence of S-2 and S-2.2 and looks upstream at a shallow riffle section of S-2. | | |

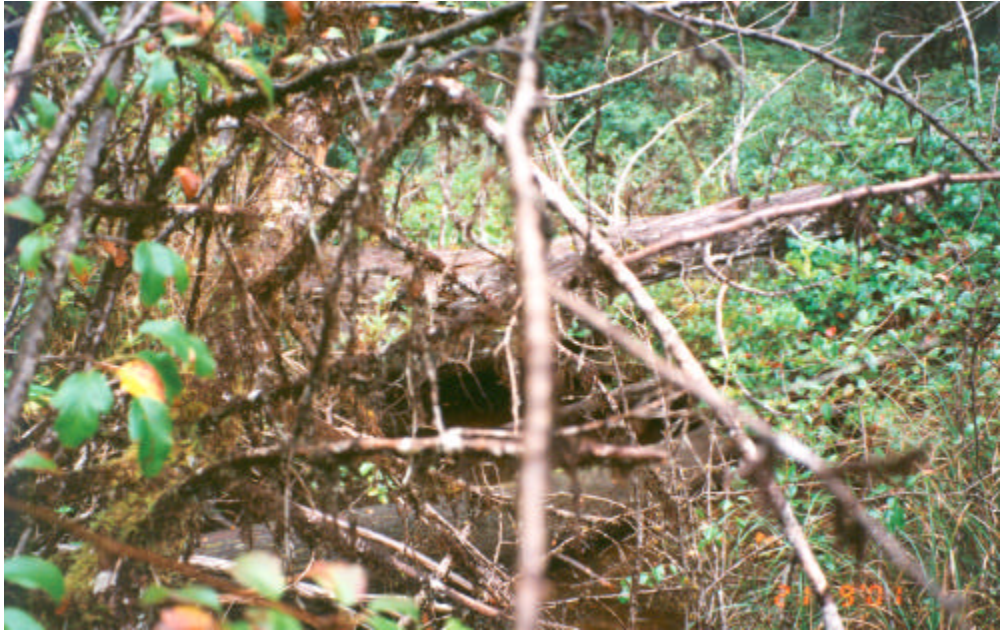
**Plate 3.06**

| <b>Description:</b> This photograph was taken looking upstream at a glide section of S-5. | | |

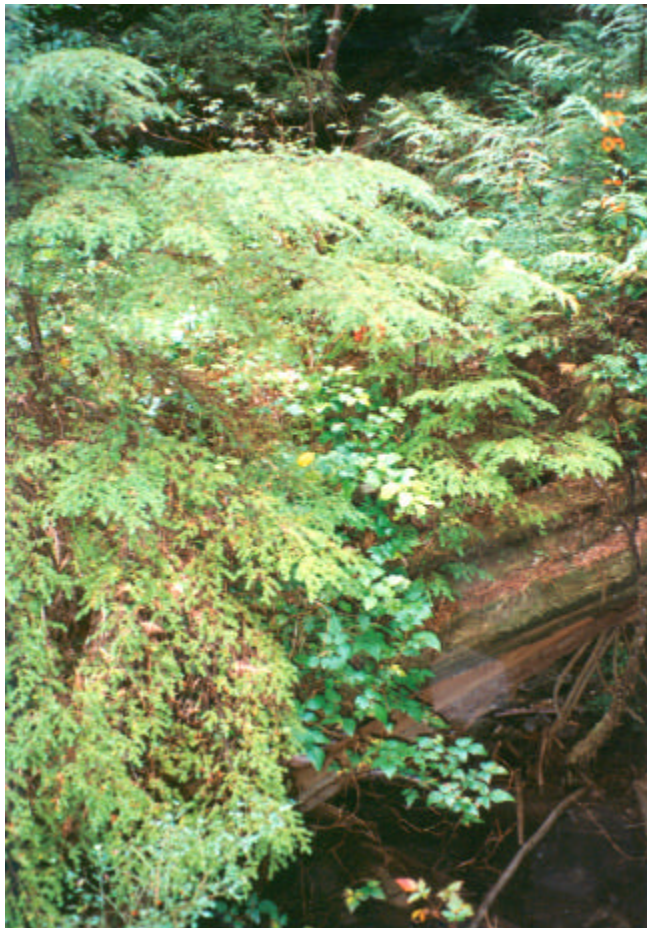
**Plate 3.08**

| <b>Description:</b> This photograph was intended to be a view looking upstream at the debris jam on S-5. | | | |

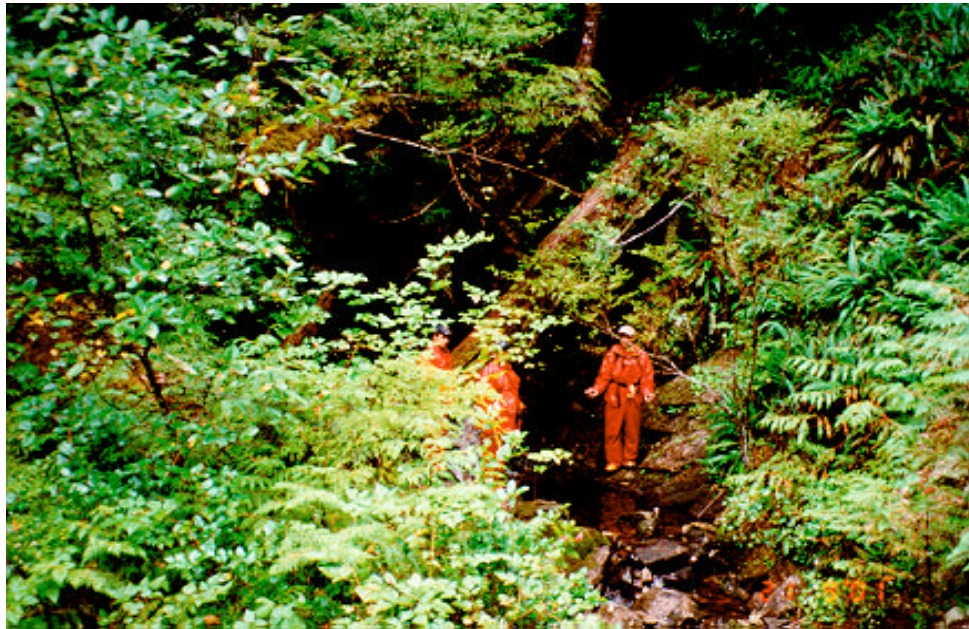
**Plate 3.09**

| <b>Description:</b> This photograph was taken looking upstream at a cascade/pool section of s-5. Beyond this point the channel continued to climb. The gradient was estimated at >45.0%. | | | |
