**RT-GPS Mapping of Fish  
Habitat and Fish Distribution  
Of Cheewhat Lake Tributaries;  
S2 (and Distributary S1), S3  
S4 and S5, September 2001.**

May 30,2002

**Nuu-chal-nulth Tribal Council  
Port Alberni, BC**

M.C. Wright and Associates  
2231 Neil Drive,  
Nanaimo, BC  
V9R 6T5  
Phone/Fax: (250)753-1055  
Email: [mcw-assoc@shaw.ca](mailto:mcw-assoc@shaw.ca)

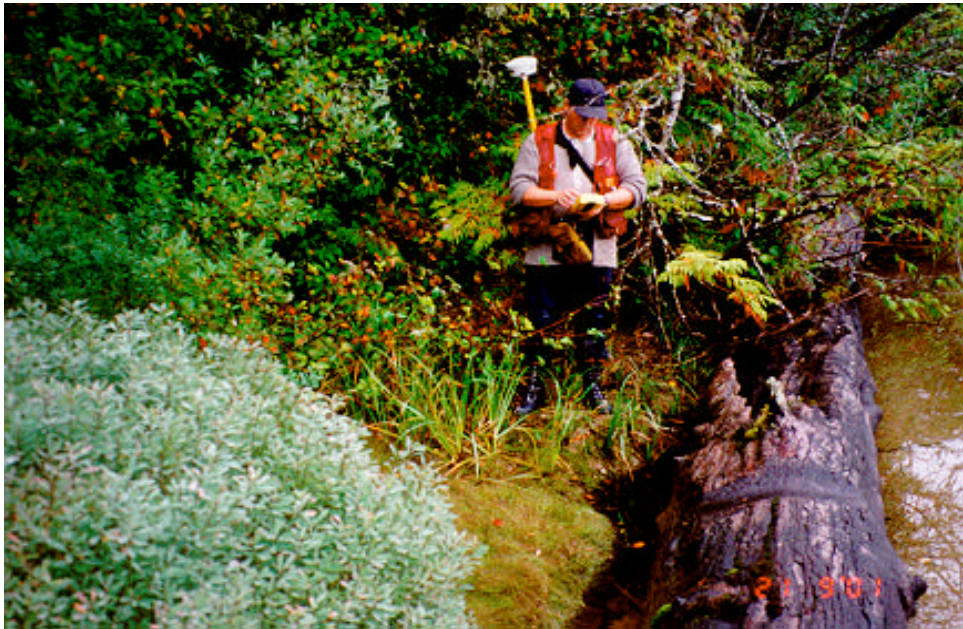
**Plate 3.11**

| <b>Description:</b> This photograph was taken at the mouth of S-4. | | | |

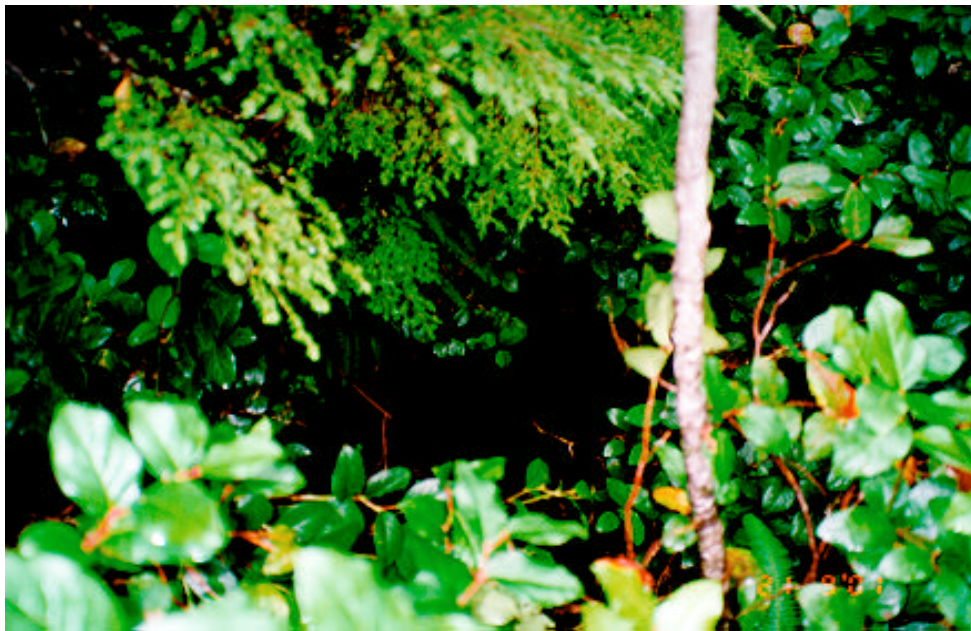
Plate 3.11

| <b>Description:</b> This photograph was taken to show the dense vegetation along the streambanks of S-4. | | | |

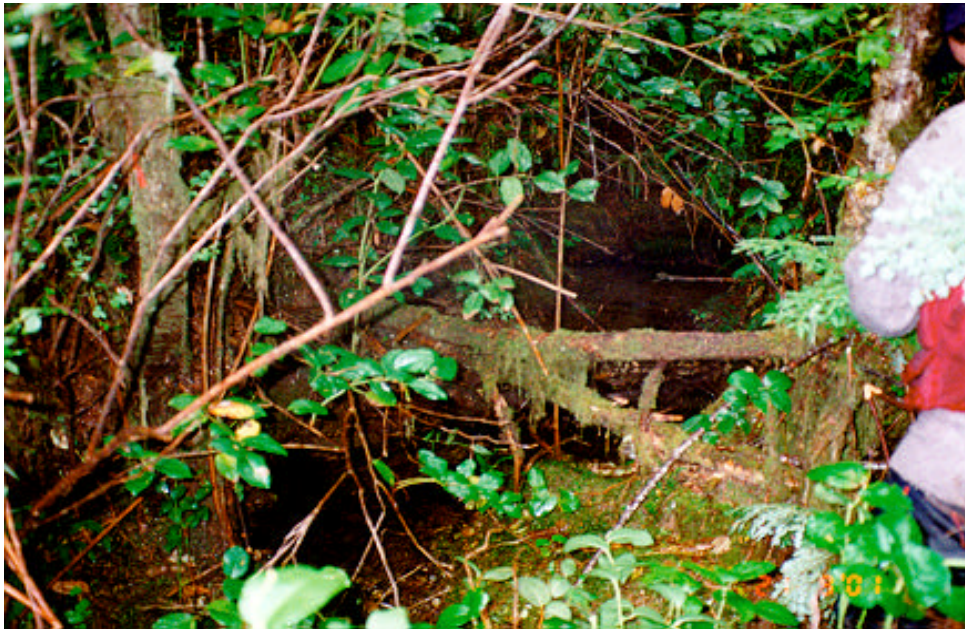
Plate 3.13

| <b>Description:</b> This photograph shows a riffle/pool section of S-4. | | | |
