SQ-3125

CHANCE CREEK 0.4km

2019 Inspection

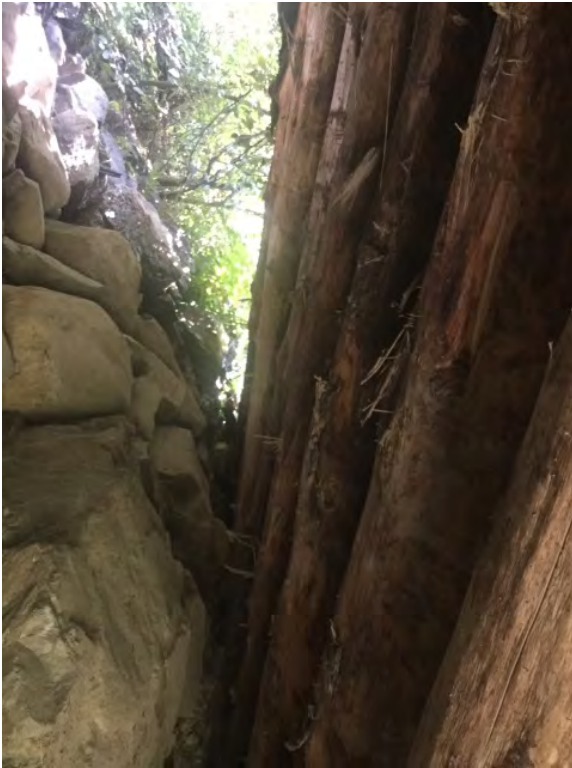
Superstructure

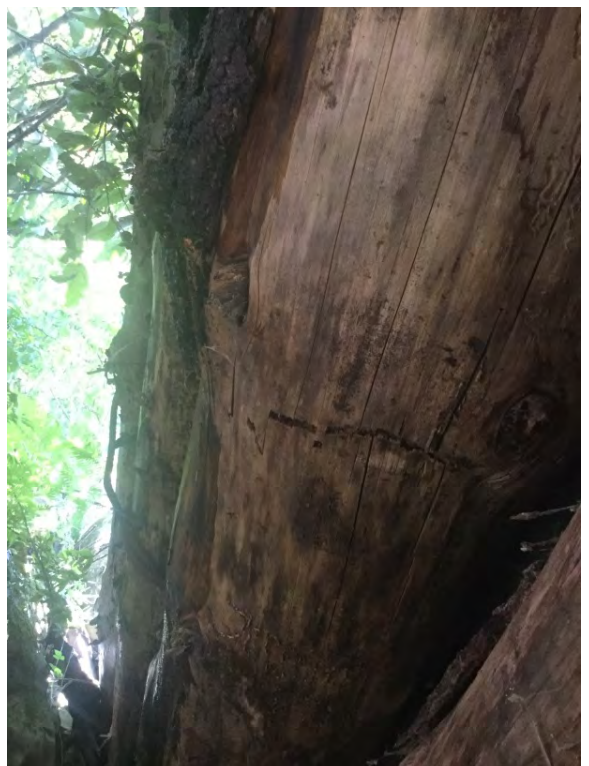
Old fir stringers with advanced rot. Stringers 10, 11, 12 have cracks midspan. Downrated to 5 tonnes. Replace.  
Update Sept 19, 2019: "Bridge closed" sign posted

| Stringer<br>Number | Species | Peeled | Diameter<br>(mm) | Rot Depth<br>(mm) | Condition | Comment |
|---|---|---|---|---|---|---|
| 10 | Fd | | | 100 | | Cracked midspan |

Stringer 10 crack
