SQ-3149

BRITANNIA 01 2.5km

2019 Inspection

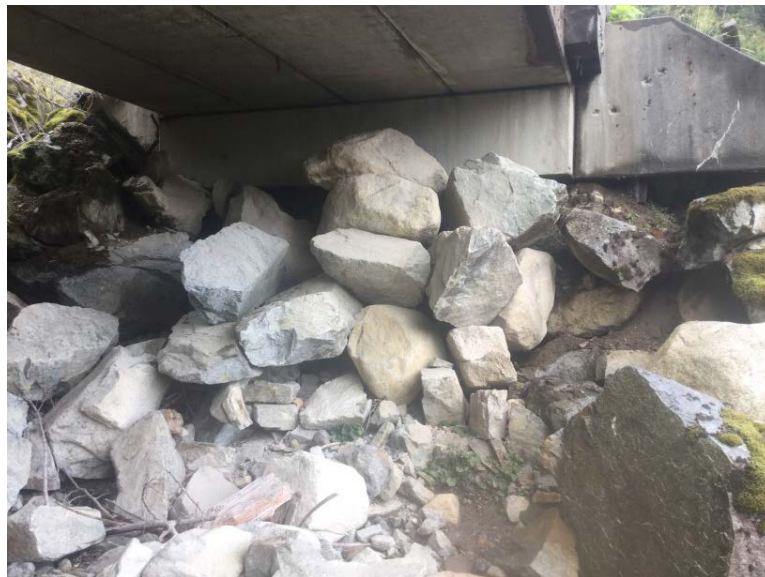
Left Bank Abutment when facing downstream

Concrete Deck Fair Damaged on camp side. Repair.

| Repair Item | Priority | Repair Description |
|---|---|---|
| 2 | Medium | Repair concrete deck |
