SQ-3185

HIXON 6.9km

2019 Inspection

| Crossing Name | Belknap Creek |

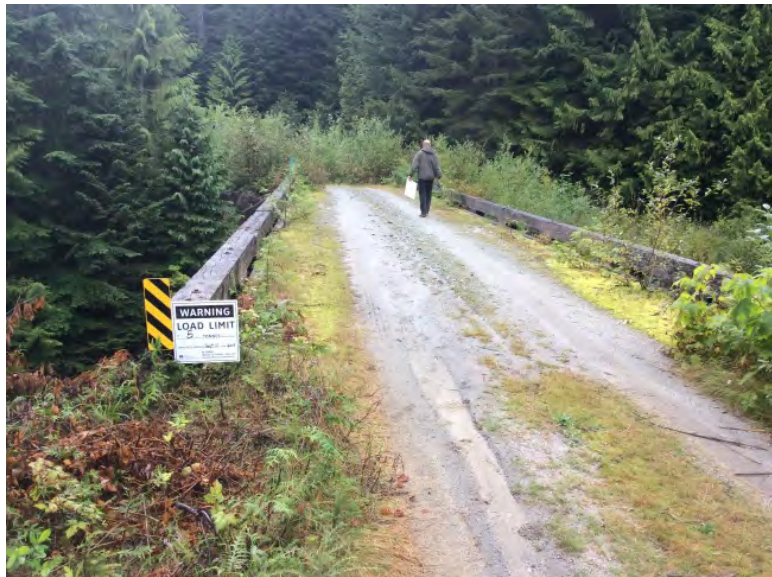
Load Rating Sign

Comments: Curb rails were subsequently replaced after the inspection. Load rating for bridge to be set at original load rating of L120 or 109 tonnes.
