SQ-3105  
SQ-3105

FURRY CREEK 02 0km

2021 Inspection

Crossing Name Phylis Creek #1

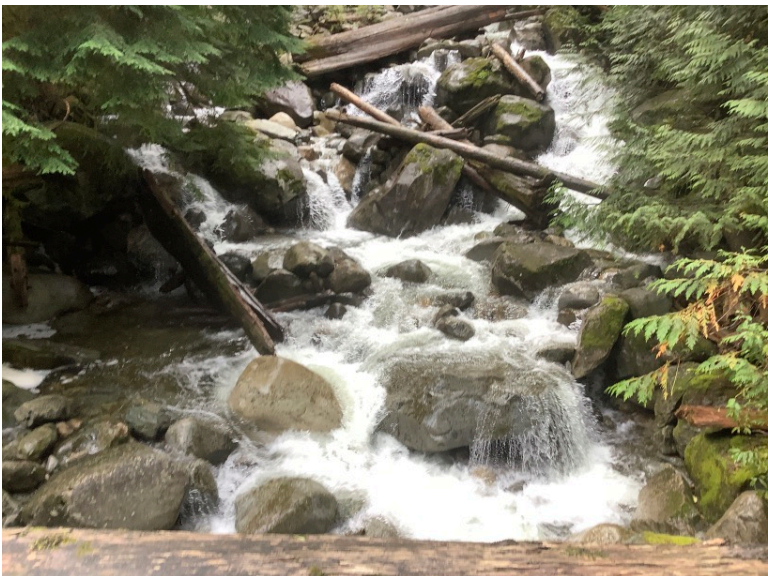
Comments: bridge closed due to deteriorated deck. Install standard Ministry timber deck or replace bridge.

Overall Deck Condition      Poor      Due to substandard deck type for rail car
