SQ-3010  
SQ-3010

RUTHERFORD 01 4.1km

2022 Inspection

Crossing Name Trib to Rutherford

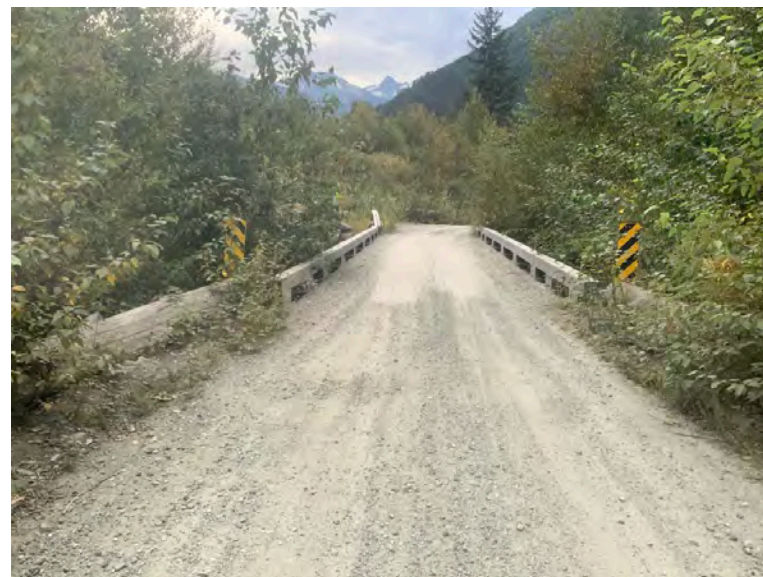
Concrete Deck      Fair      Surface wear, and damage to edges.

Deck, ballast wall. Town approach

| Repair Item | Repair Description |
|---|---|
| 1 Structure. Concrete structural maintenance. m². Priority:Medium | Repair damage to deck and ballast wall, town side |
