SQ-3058  
SQ-3058

IN-SHUCK-CH 10km

2022 Inspection

Crossing Name Twin One Creek

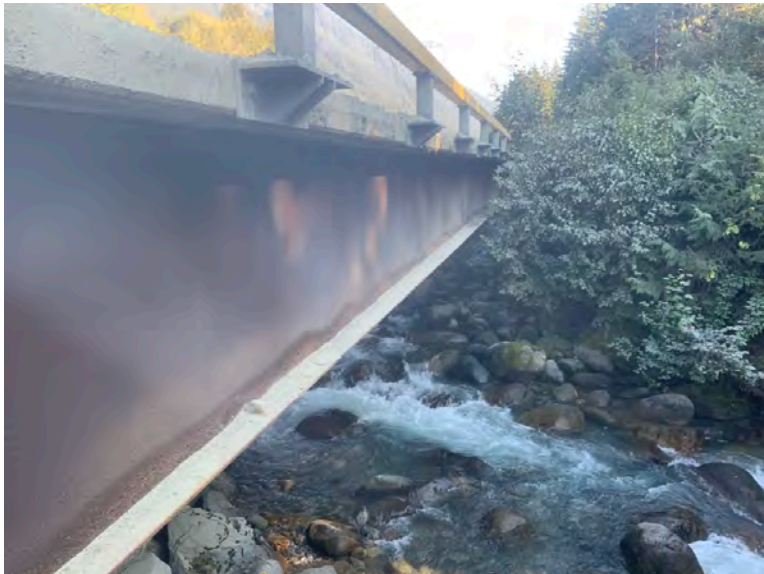
Superstructure

Steel ageing. Rusting and scaling, worse at bearings and splice (top and bottom flanges). Monitor and consider close proximity inspection.
