SQ-3113  
SQ-3113

LILLOOET WEST 72.9km

2022 Inspection

Crossing Name Fire Creek

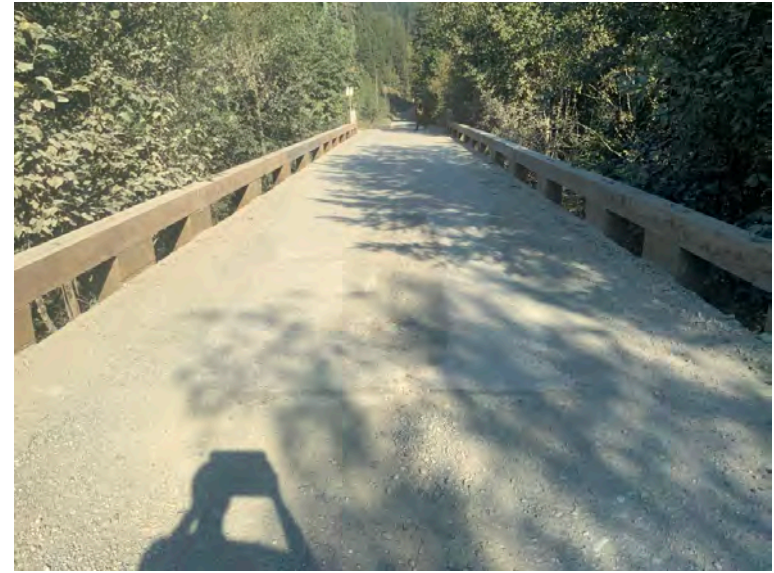
Concrete Deck      **Fair**      Minor surface damage. Rebar exposed underside.

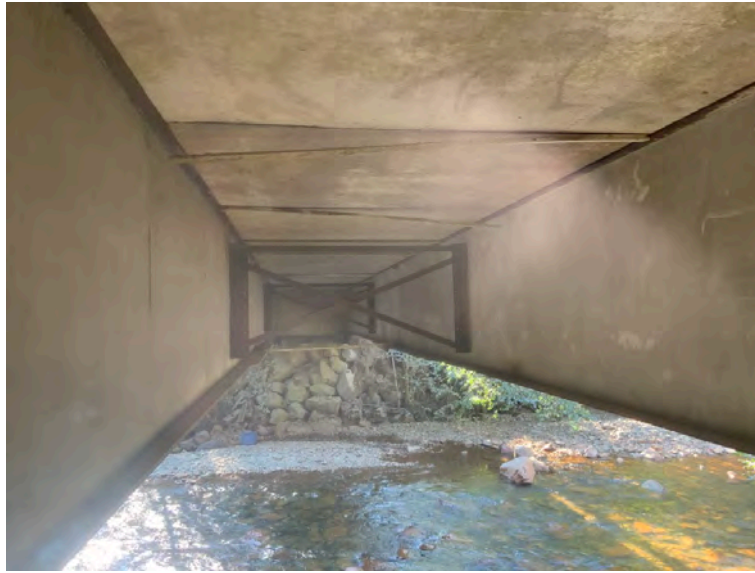
Superstructure

Concrete/steel girders. Hairline fractures have been identified and tagged previously (unknown when) New ones have appeared and grown since. Significant corrosion/flaking of girders under deck joints. Recommend close proximity inspection. Post inspection comments: tagged hairline cracks date back to 15 years or more. Hairline cracks in this type of girder is expected as determined by previous studies. Monitor during routine inspections, per g.dohm

Hairline cracks present in concrete. Corrosion.

| Item | Monitor Description | Frequency |
|---|---|---|
| 1 | Hairline fractures in girders, corrosion/flaking | Routine Inspection |
