***Gitanyow Fisheries  
Authority***

**Gitanyow Village and Surrounding Area Fish  
Habitat Restoration Feasibility Study – 2016/17**

Submitted to: Fisheries and Oceans Canada  
200 – 401 Burrard Street  
Vancouver, BC V6C 3S4

Date: June 26, 2017

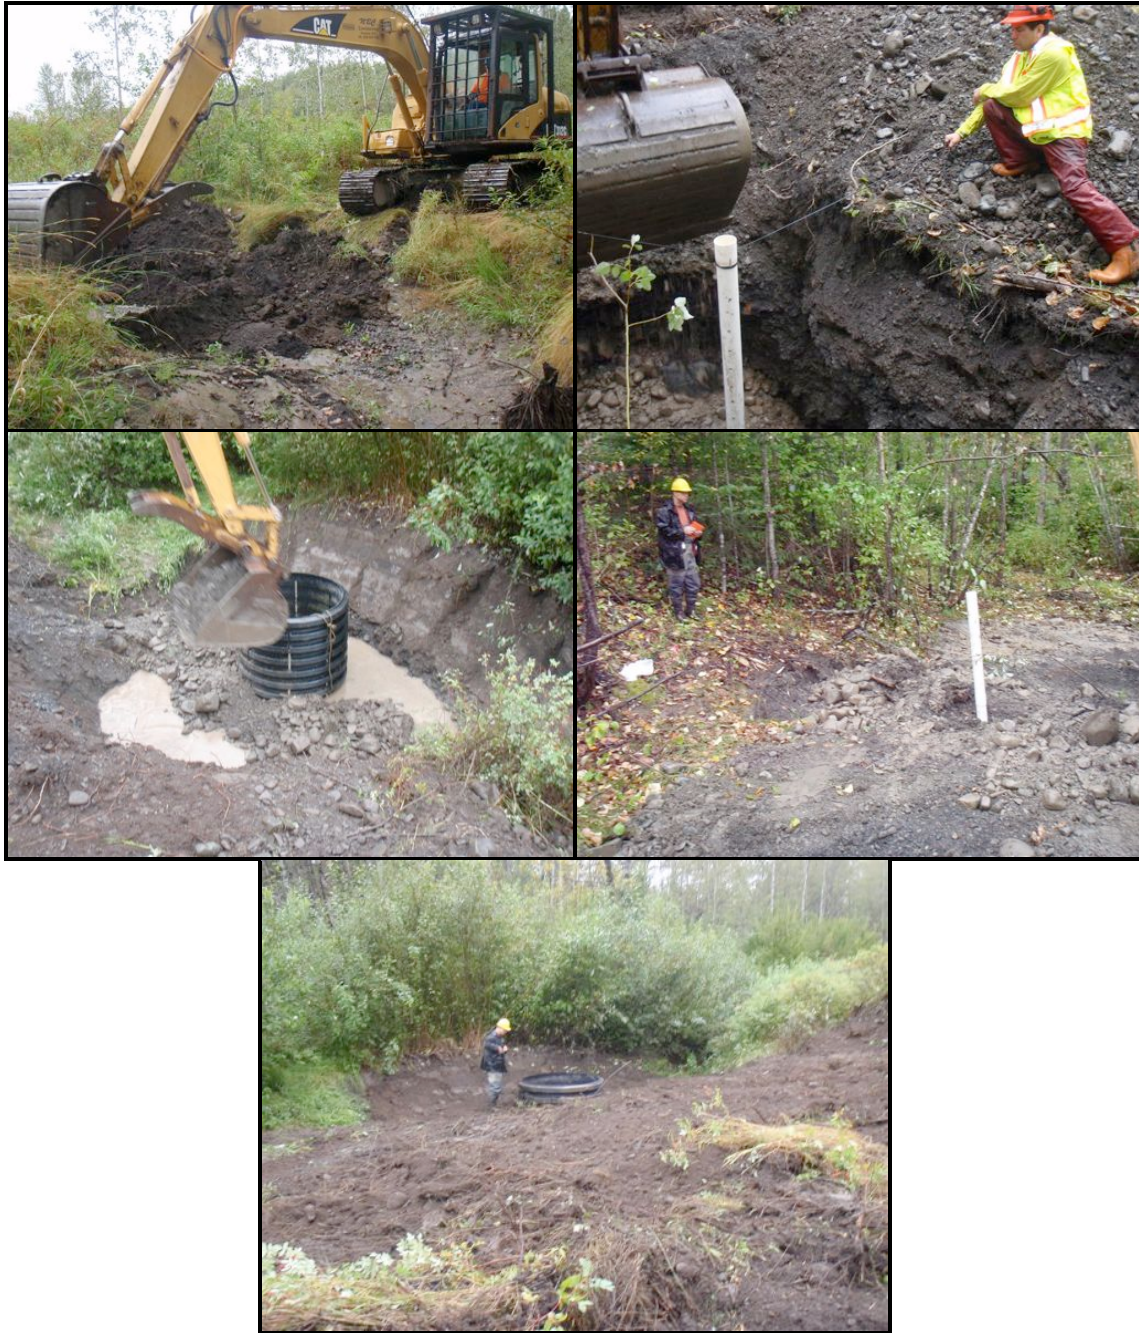
Five test pipes and two refuge pipes were installed in a completely dry channel on August 30, 2016 using an excavator and support labour. The 10cm (4") perforated PVC pipes were buried at about 2.5m below the stream bed, while the 1.6m diameter x 2m long refuge pipes were buried about 1.5m below the stream bed (Figure 3). The refuge pipes are designed to allow juvenile salmonids to enter the pipe as water recedes prior to dry periods. These pipes were provided by DFO to GFA on loan for the trial period. During excavation fine sediment material near the

surface was separated from underlying course gravel/cobble material into two piles. Once the pipes were placed in the hole, the excavator used the course material for bottom fill and the remaining fine material for top fill. This would allow improved groundwater flow to percolate through the bottom of the pipes. Following installation, the PVC pipes were capped and the refuge pipes were covered and secured using plywood with a hinged porthole for monitoring access into the pipe in order to prevent people or animals to accidentally fall into the pits.

Figure 5: Photo Series showing examples of test and refuge pipes installation on August 30, 2016: pit excavation (top left), test pipe installation (top right), refuge pipe installation (middle left), completed test pipe installation (middle right), and completed refuge pipe installation (bottom).

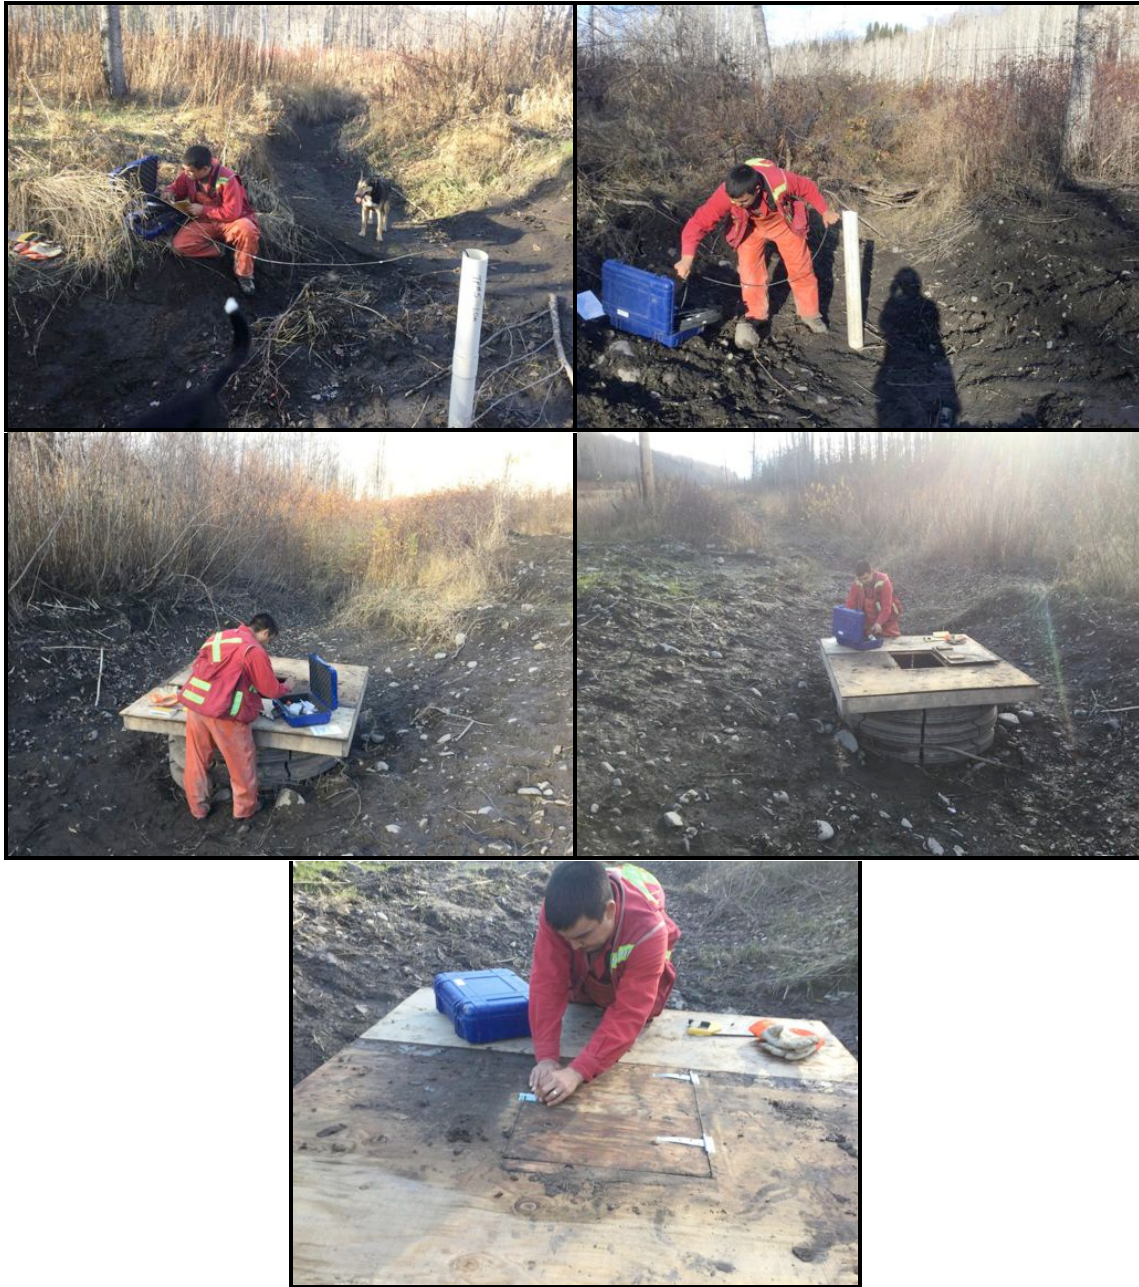
Figure 6: Photo Series showing examples of test and refuge pipe monitoring for groundwater level, temperature and DO in the fall of 2016 (October 31).

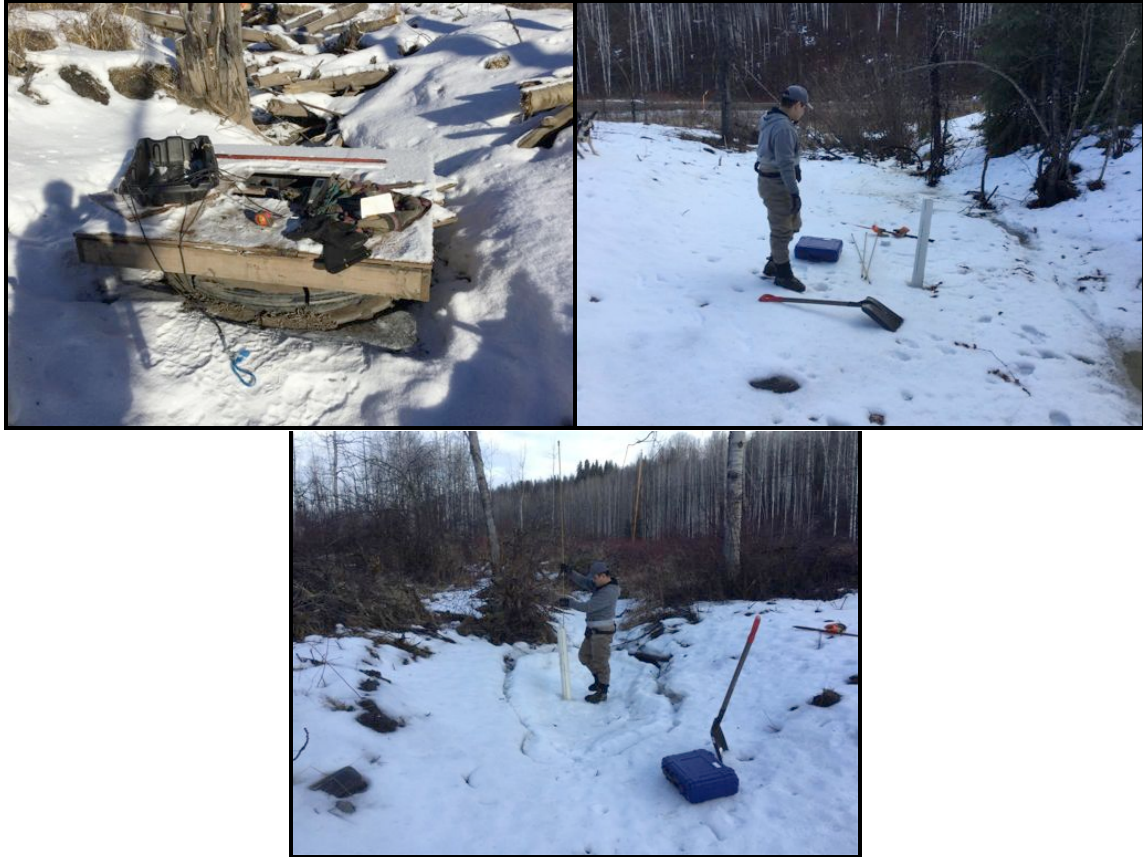
Figure 7: Photo Series showing examples of test and refuge pipe monitoring for groundwater level, temperature and DO in the winter of 2017 (February 14<sup>th</sup> and 17<sup>th</sup>). Note the unusually low snow pack in the area.

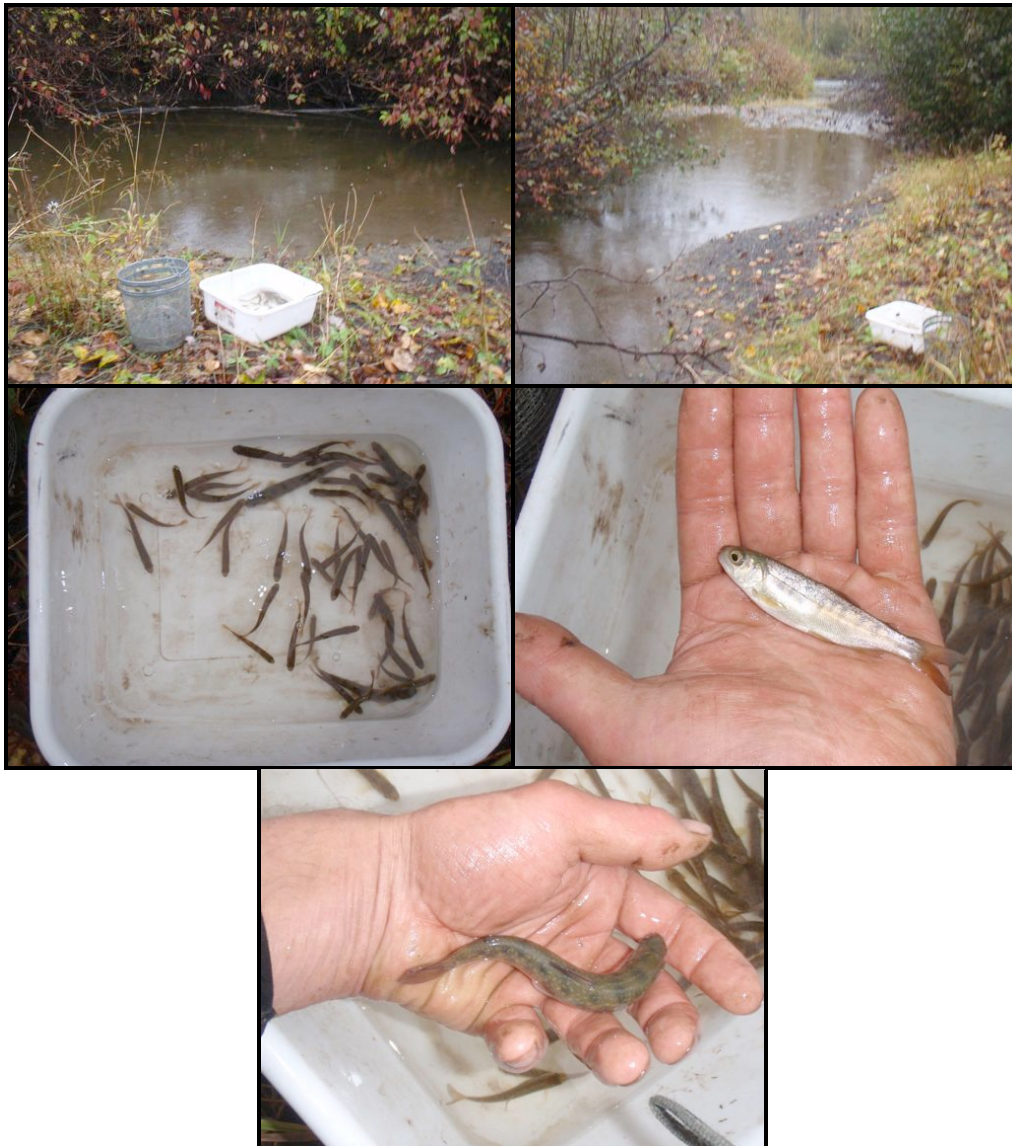
Figure 12: Photo Series showing the naturally scoured deep pool habitat and catch results along the left bank about 50m upstream of the channel outlet.

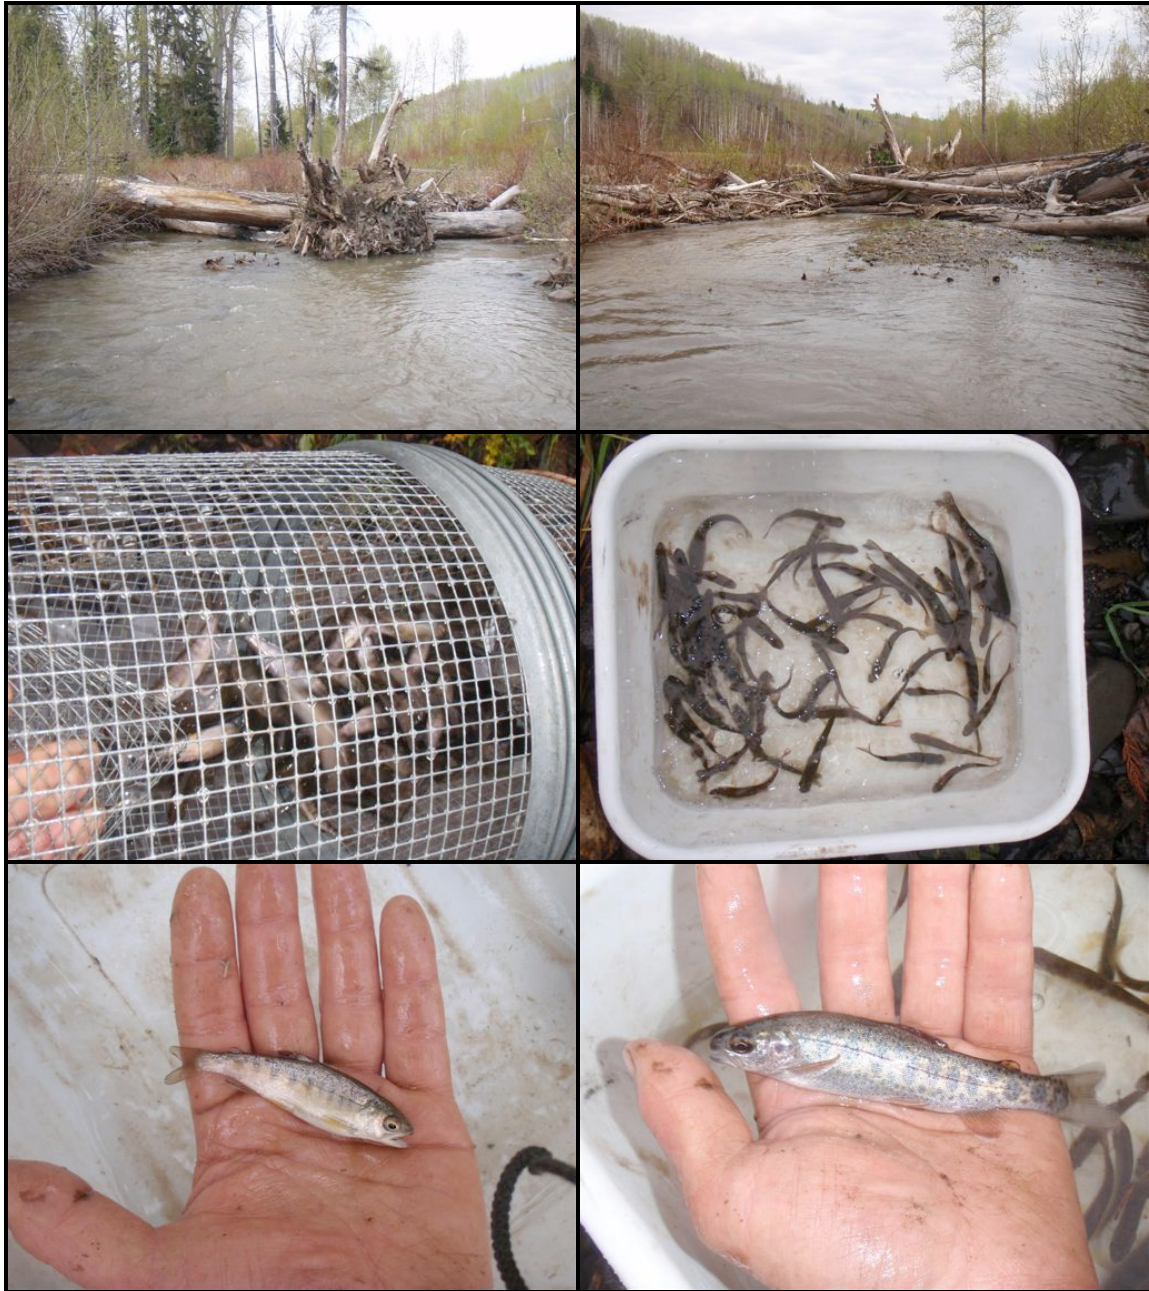
Figure 13: Photo Series showing the natural LWD cluster and catch results located about 110m upstream of the channel outlet.

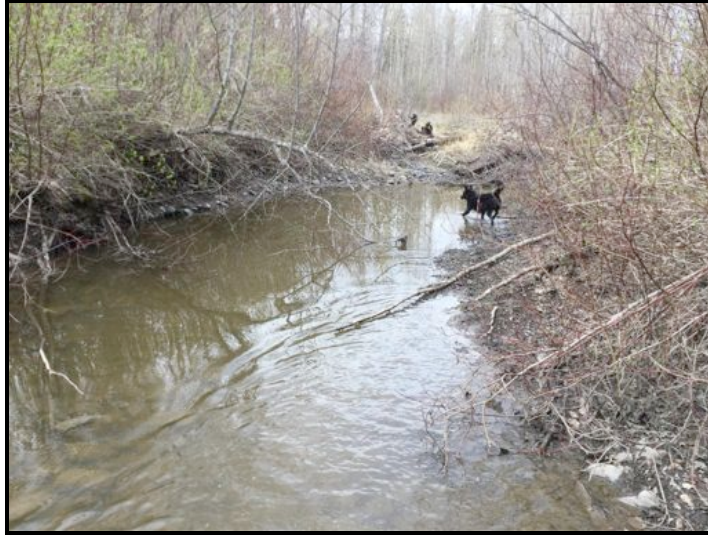
Figure 14: Photo Series showing the naturally scoured deep pool habitat about 10-20m downstream from the side channel inlet.

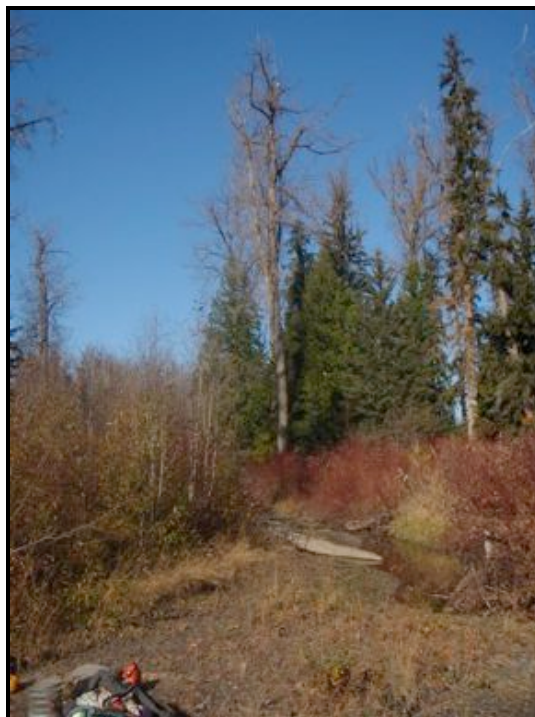
A certified faller cut one large cottonwood tree from a densely forested area near the worksite that was used for the two upstream structures (Figure 15; see cottonwood tree in center of photo surrounded by conifers). A large cottonwood that had fallen near the worksite in the recent past was used for the downstream structure. Along with the LWD installation, 1m-deep pools x about

Figure 15: Photo showing the standing cottonwood in center of photo used for LWD Placement material that was adjacent to a pocket of conifers.
