## BRIDGE INSPECTION

**BRIDGE NO./NAME**                      **62- 035: Black Creek- Bosk Lk FSR (1.00 KM)**

**Inspection Date:**                      September 11<sup>th</sup> 2012

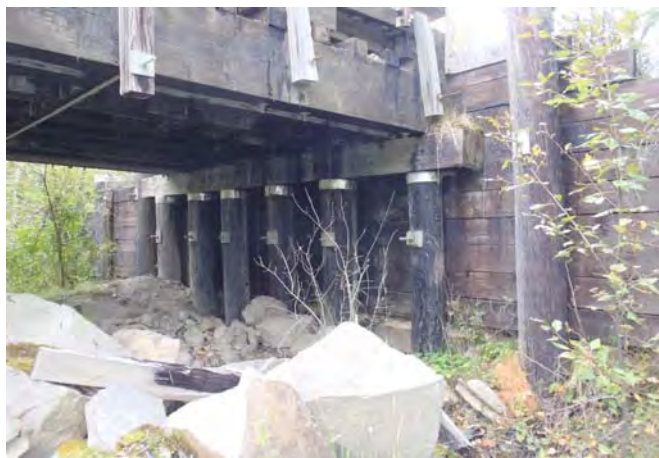
**Figure 1-23: Camp end abutment.**

- The both abutments are generally in fair condition.
- The camp end cap beam has an end check on upstream end.
- The cap beams of both abutments are sound.
- There are 130 mm and 75 mm wide gaps between the bottom breast wall planks of the camp end and woods end abutments respectively.
- The toe of the camp end breast wall is exposed in places. Minor scour and limited fill loss was noted from behind both abutment breast walls.
- Debris accumulation was noted on the exposed edges of both cap beams.
- Drilling pile 5 on the camp end and woods end abutments identified no rot.
- Camp end rip rap is on the embankment behind pier 3.
- Woods end riprap is on the embankment behind pier 1, poorly placed and lacking coverage.
