## BRIDGE INSPECTION

**BRIDGE NO./NAME** N4-059: Shelter Bay FSR (26.7 KM)

**Inspection Date:** September 21<sup>st</sup> 2012

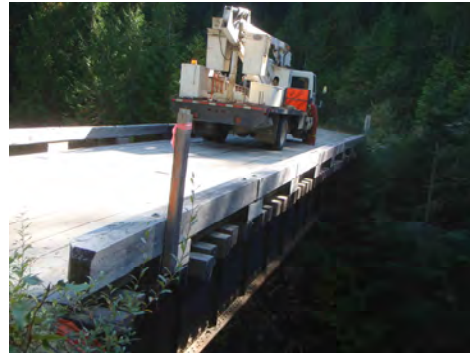
The bridge is generally in fair condition. There is limited access to inspect the concrete sills due to debris accumulation. The curb rails and risers have significant rot and require replacing. Since the actual age of the steel girders is unknown, we estimate that the steel girders have remaining service life of 10-15 years.
