# BRIDGE INSPECTION

**BRIDGE NO.** N2-068: Kootenay River  
FSR (32.80 km)

**Inspection Date:** September 23, 2012

## Permanent Bridge Inspection Report

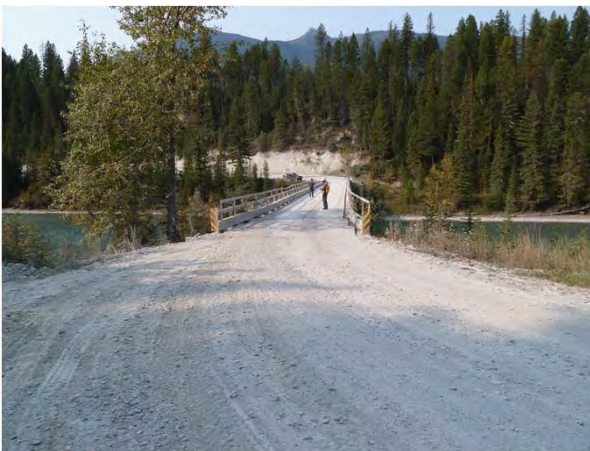
**Figure 1-5: Looking towards camp end.**

- The approaches are generally in fair condition.
- Horizontal curves on both ends of the bridge and vegetation limit visibility coming on to the bridge.
- Camp end approach is rough.
- No approach fenders.

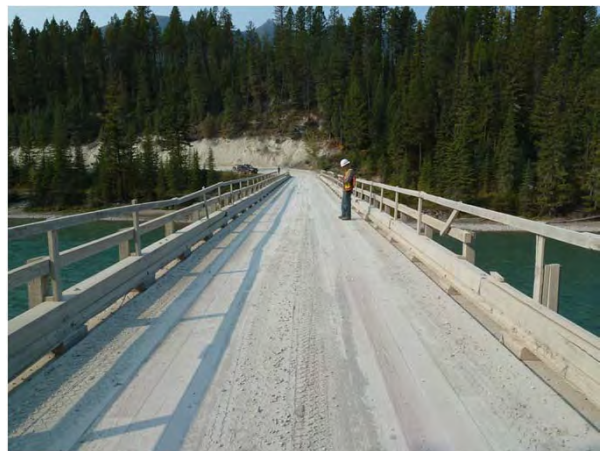
**Figure 1-6: Bridge deck looking towards camp end.**

- The deck is generally in fair condition.
- Over 30% of top curb rail is rotten.
- Handrail has missing/ damaged sections and construction is not consistent.

| Items | Description | Priority |
|---|---|---|
| 1. | Replace top section of curb rails and handrails. | High |

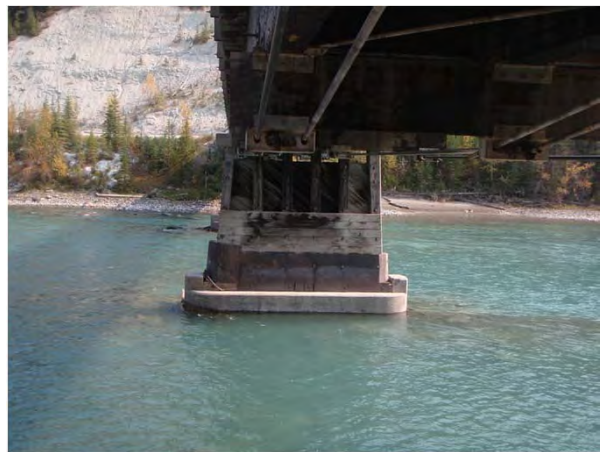
**Figure 1-22: Pier 3 from camp end.**

- The piers are generally in fair condition except Pier 1 which is in poor condition.
- Pier 1 is in poor condition, rot observed above posts 3, 5 & 6 and crushing observed at post 6.
- Limited access to hammer sound posts because posts have timber sheathing.
- Cast-in-place concrete base in fair condition.
- Timber nose on Piers 2 and 3 is rotten.
- Minor debris accumulation and aggradation on Piers 2 and 3.
- 300 mm of end rot on Pier 4 cap beam, does not affect structure.

| Items | Description | Priority |
|---|---|---|
| 3. | Replace timber nose on Piers 2 and 3. | Medium |
