## BRIDGE INSPECTION

**BRIDGE NO./NAME**      **N2-103: Kootenay By-Pass (9.50 km)**

**Inspection Date:**      September 23<sup>rd</sup>, 2012

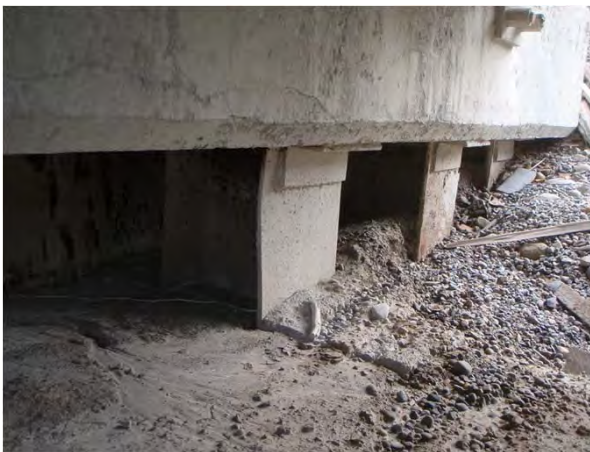
**Figure 1-15: Left end abutment piles.**

- The left end abutment is generally in fair condition.
- Minor hairline cracking noted on the concrete cap above the tiebacks and between the middle piles.
- A minimal amount of rip-rap is placed around the abutment, no signs of erosion noted.
- The right end abutment is generally in fair condition.
- A minimal amount of rip-rap is placed around the abutment, no signs of erosion noted.

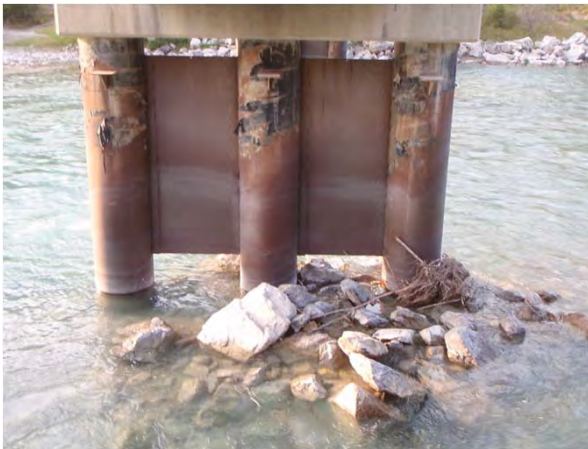
**Figure 1-19: Pier 2 from left end.**

- Pier 1 is generally in good condition.
- One small section of delamination (0.5 ft<sup>2</sup>) on the right end of the cap, not previously noted.
- Pier 2 is generally in good condition.
- No defects or deterioration noted.
- Pier 3 is generally in good condition.
- Debris is accumulating on top of concrete cap.
