## BRIDGE INSPECTION

**BRIDGE NO./NAME** SI - 3041: Mt. Brenton FSR (2.00 KM)

**Inspection Date:** October 31<sup>st</sup> 2012

| Structure # | Crossing Name | Forest Service Road | User km | CBR km | | | |

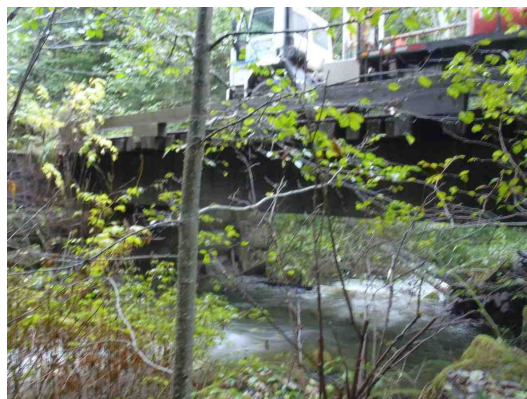
The bridge is generally in good condition. The glulam girders appear to be recycled from an older bridge. Although we did not observe any significant deterioration on the glulam girders, we found a number of previous repairs on the downstream girder. We recommend the Ministry to monitor the condition of the glulam girders to ensure the girders are in adequate service condition. Since the actual age of the glulam girder is unknown, we recommend the Ministry schedule the bridge for replacement within the next 5-10 years.

During the inspection, we noted significant water pooling on the wearing planks near woods end (approximately 1/3 of span length). Water accumulation would likely speed up the rate of decay in timber deck components and result in reduced service life of the bridge deck. Therefore, we recommend the Ministry to consider re-grading the approach roadway to allow better drainage of bridge deck.
