| Structure # | Crossing Name | Forest Service Road | User km | CBR km | | |
|---|---|---|---|---|--|--|
| SI-5635 | Kennedy River | Sproat Lake FSR | 0.5 | 0.5 | | |

| <div>Associated<br/>Engineering</div> | | <div>GLOBAL PERSPECTIVE.<br/>LOCAL FOCUS.</div> | | <div>BRIDGE INSPECTION REPORT</div> <div>BRIDGE INSPECTION PHOTOS</div> | | <div>BRITISH COLUMBIA</div> <div>Ministry of<br/>Forests, Lands and<br/>Natural Resource Operations</div> | |

October 3, 2011

**Re: CONDITION INSPECTION AND LOAD RATING OF THE KENNEDY RIVER BRIDGE**

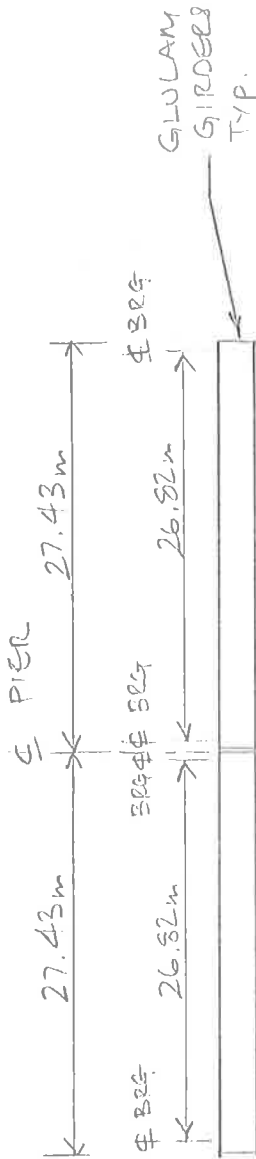
BRIDGE ELEVATION

The bridge comprises two 27.4 m simple spans and a 14 ft timber deck. The Glulam girders are grouped in two pairs at 10-ft centres. The bridge deck, curbs and cross-ties are in very poor condition (see **photo 2**).

Two concrete abutments and one pier support the spans. The pier is supported by a group of steel pipe piles. Both abutments are in good condition and the pier appears to be in good condition although we were unable to access it at the time of the inspection.

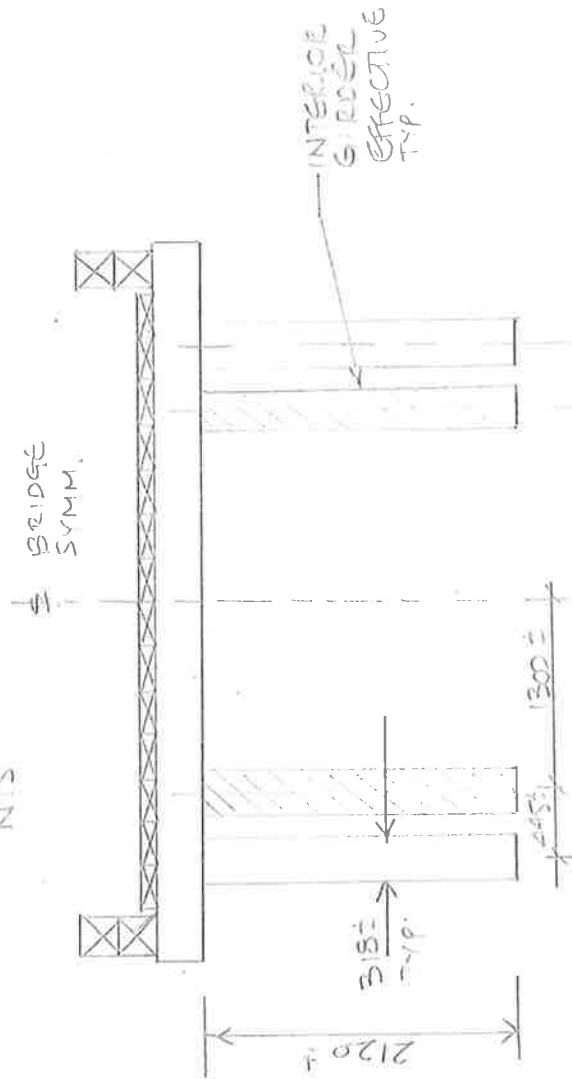
TYP. SECTION

To account for the crack, we did not include the top 400 mm of the girder (i.e., only assumed a 1700 mm deep girder). For the other girders, the whole section was considered effective (i.e., 2100 mm deep). Assuming all four girders share the live loads based on their stiffness, the 1700 mm deep girder carries 25% of the live load and the 2100 mm deep girder carries 46% of the live load.

- The two interior girders are in good condition with minor checks and cracks
- The tops of the girders were assumed to be sufficiently braced with diaphragms - four diaphragms at equal spacing, with one at each bearing to restrain torsional rotation
