| Bridge No./Name: | N2-068: Kootenay River FSR / Kootenay River (32.80 km) |
| Inspection Date: | August 1, 2015 |

**BRIDGE INSPECTION SUMMARY & RECOMMENDATIONS:**

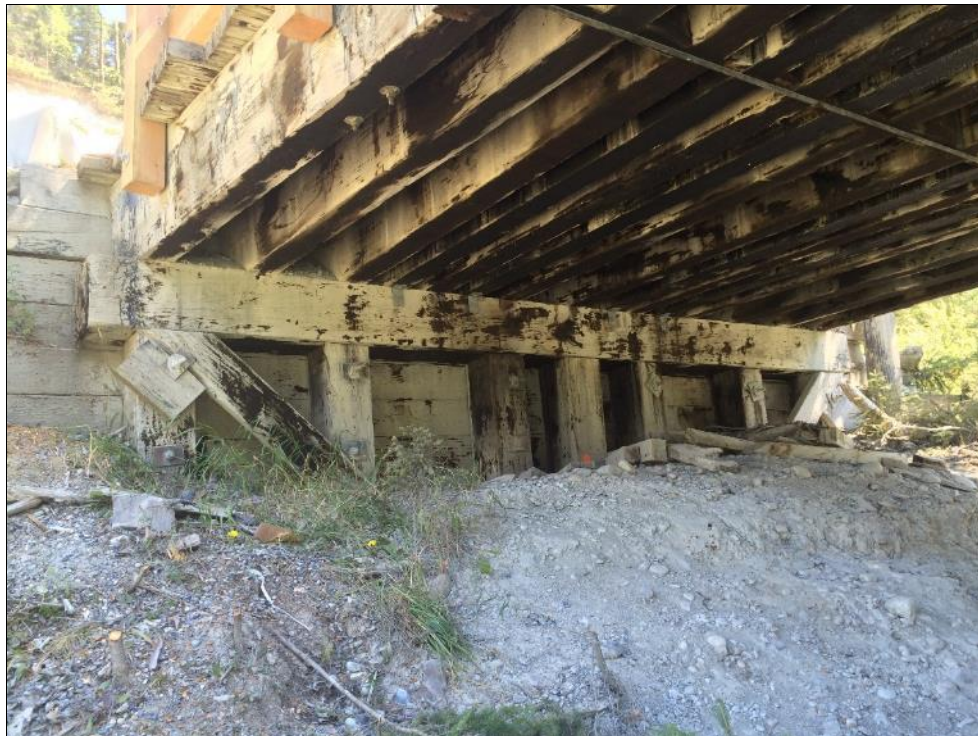
Photo #5  
Abutment 1

- Pile 4 was found to contain rot.
- Pile cap is rotated outwards, more extensively at the U.S side.
- Some sluffing of approach fill noted around wingwalls.

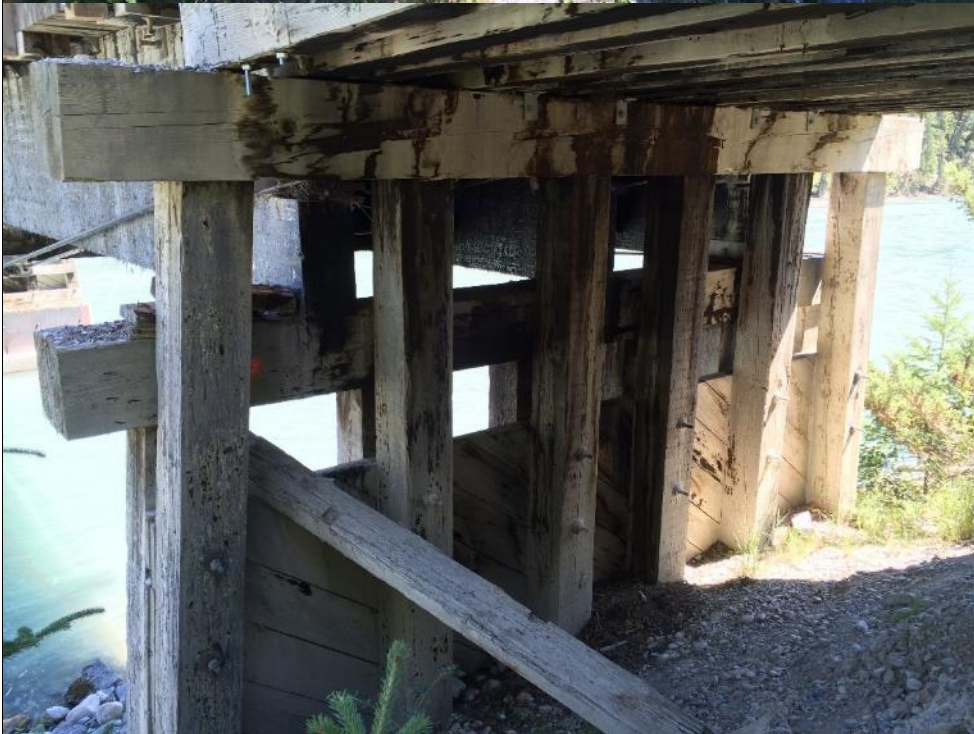
Photo #20  
Pier 4 – looking to Abutment 1 /  
D.S

- Pier 4, D.S pier cap (Abutment 1 side) was cored with no indications of rot, where orange paint indicator was previously applied (see photo log).

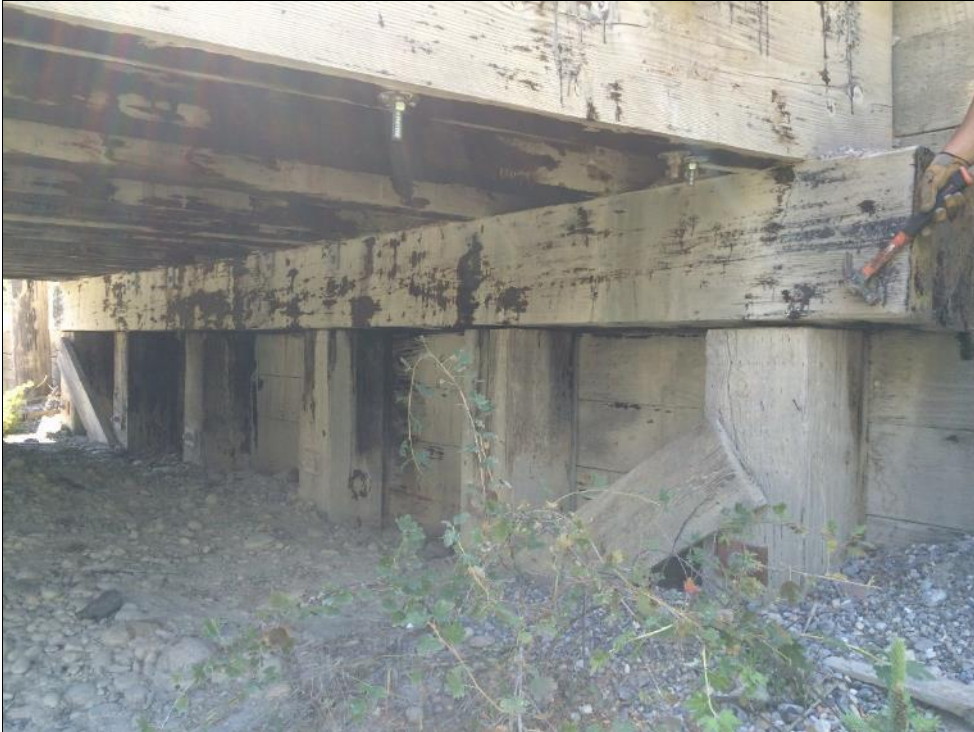
Photo #23  
Abutment 2 – U.S

- A2 cap is rotated outwards approx. 5°.
- Wingwall planks are not bearing on wingwall piles in regular locations.
- Timber elements sounded throughout and appear to be in fair condition.

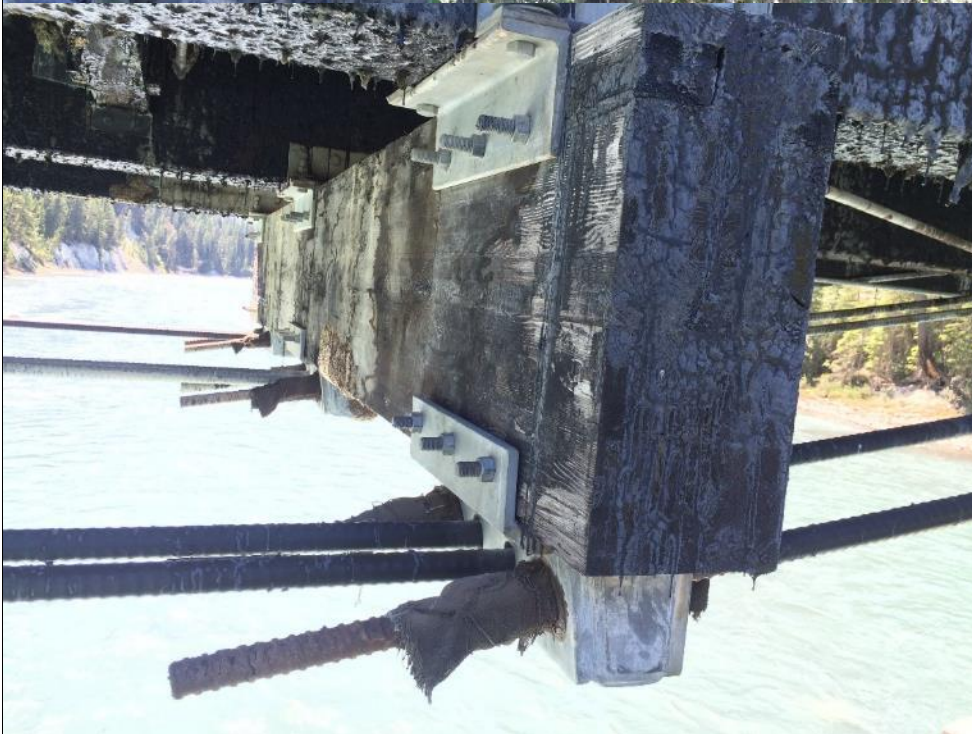
Photo #32  
Span 1 bolstering bracket 2

- 36mm dia high tension rods spaced at 450 mm c/c appear to be in good to fair condition. Exposed portions of the rods have light surficial corrosion.
- Bolstering struts are located at approx 1/3 span points, with creosote coverage of approx 50 – 75% remaining.
- Span 1, strut 1 has isolated narrow, shallow, short splits.
