## BRIDGE DATA:

| Bridge No./Name: | N2-130: White Swan FSR / White River (32.4km) |
| Inspection Date: | July 31, 2015 |

Steven Stanley, C.E.T.  
LEX3 Engineering Inc.

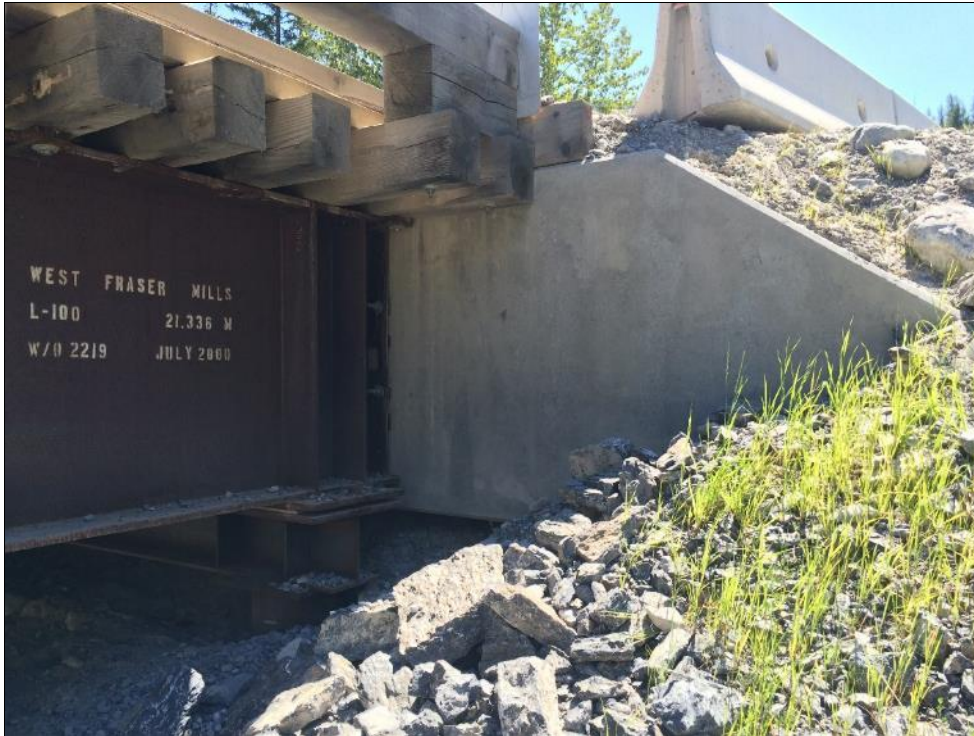
Photo #9  
Abutment 1 D.S. side

- Well armored with adequately sized riprap.
- Some sloughing of approach fill noted from under / through ballast wall.
- D.S end of timber pile cap has a full depth split.
- Isolated gaps noted between ballast wall planks.
- 2<sup>nd</sup> D.S wingwall, top of pile capping / flashing is damaged.
- 1<sup>st</sup> D.S wingwall pile is rotating inwards, towards the river approx 8°, remaining D.S wingwall piles are rotating outwards.

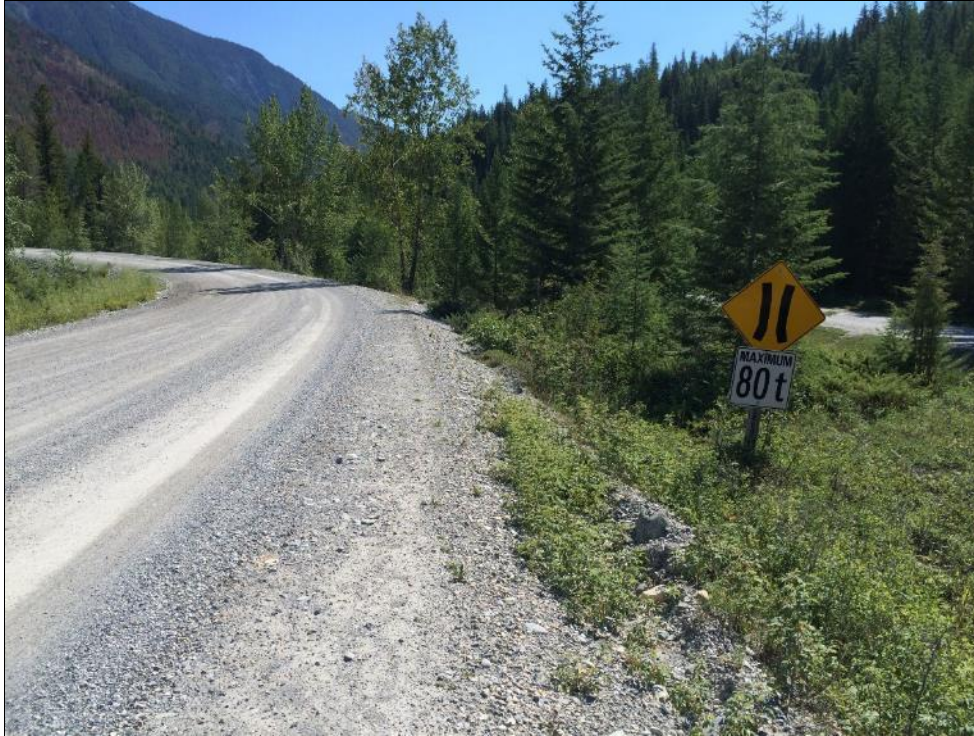
Photo #31  
Load posting sign ahead of  
Abutment 1

- Bridge load posting sign maximum – 80t.
- Minor rutting of approaches through wheel paths.
- All four delineators / hazard markers present, visible and in good condition. Additional delineators still in place from original span facing Abutment 1 are also in good condition.
- Precast concrete approach barriers present at all four corners and are in good condition. Barriers are placed tightly between segments but are offset from the beginning of the curb rail at all four corners by approx. 400mm. The barriers are not placed with an adequate plateau width on the backside to accommodate impact and may slide down the slope in that event.
