## NOTES FROM MAY 16, 1990 FIELD INSPECTION

## PROPERTY LOCATION

The subject property is located approximately 18 km south of Golden, near Drybed Creek (Figure 1). Drybed Creek is one of many drainages in the Golden area which are debris torrent prone. A debris torrent can be described as the rapid movement of saturated soil, rock, and other debris down a steep channel (Swanston and Swanson).

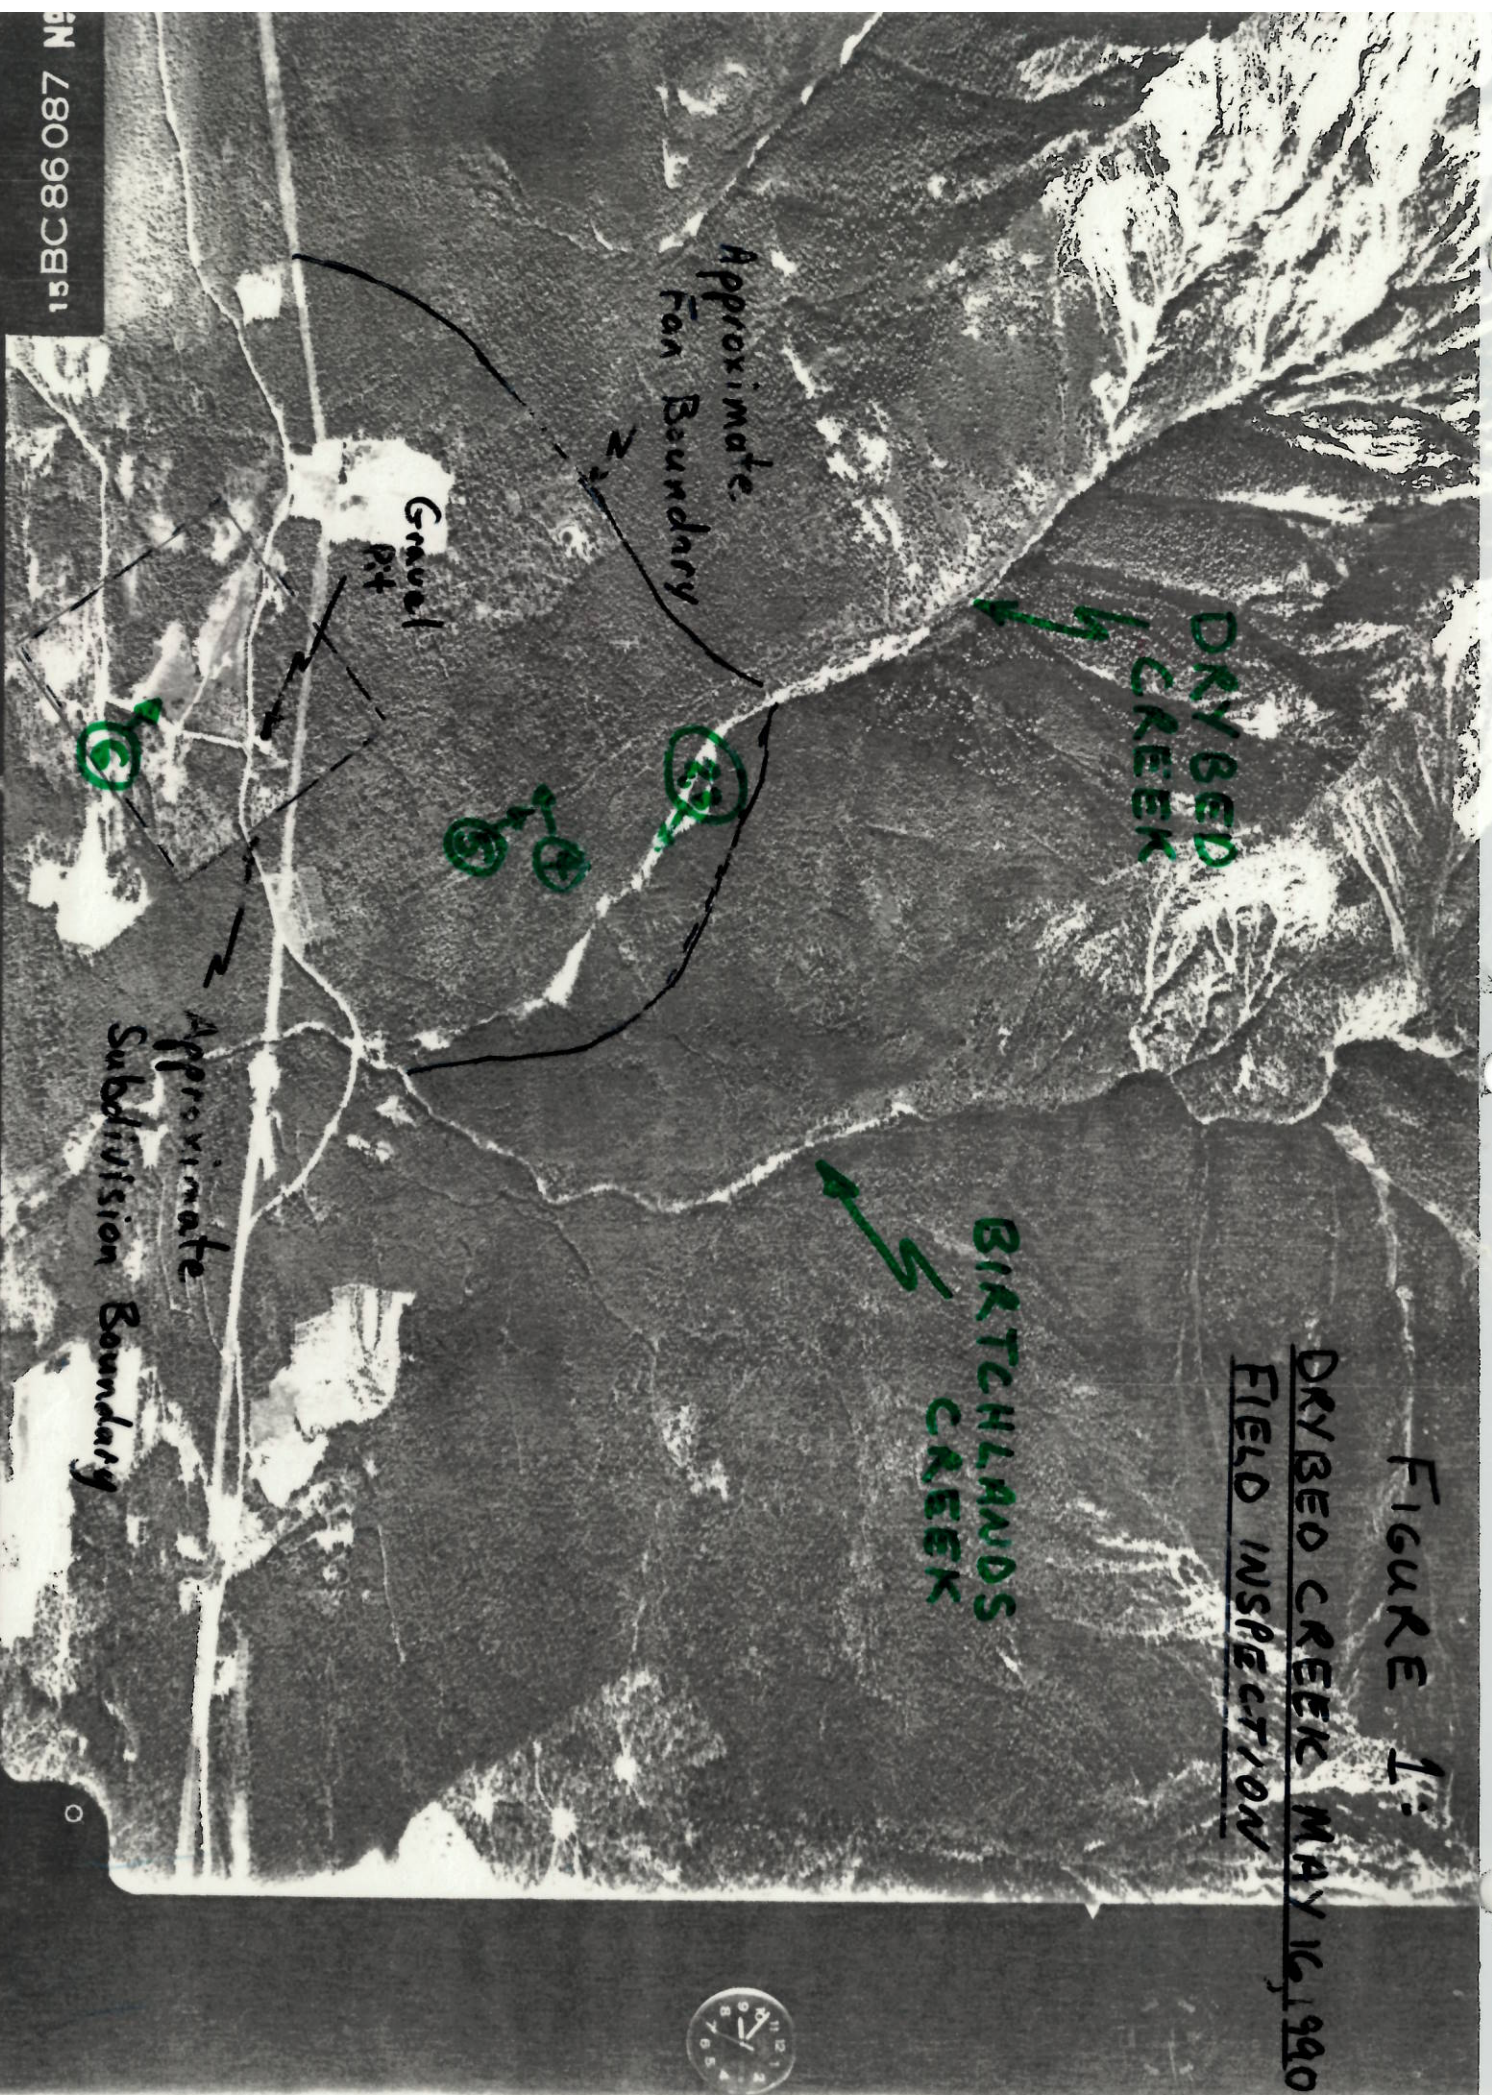
FIGURE 1:  
DRYBED CREEK MAY 16, 1990  
FIELD INSPECTION

3. **The runout zone:** The stream and land surface gradient is milder downstream of the main deposition zone. Material including mud, debris and rock have settled on the land to depths of 0.5 to 1.0 m (Photos 4 & 5). Massive debris torrent deposits were observed on an exposed face of a gravel pit adjacent to Campbell Road (located in Figure 1). Carbon dating procedures would be required to date these deposits.
