**TERRAIN STABILITY ASSESSMENT  
&  
SOIL EROSION ASSESSMENT**

**Proposed TSL TA0915  
Blocks 1, 2 and 3**

**Smallwood Creek and Garrity Creek  
Selkirk Forest District**

**Prepared by:  
Sitkum Consulting Ltd.  
Project No. 20-1561**

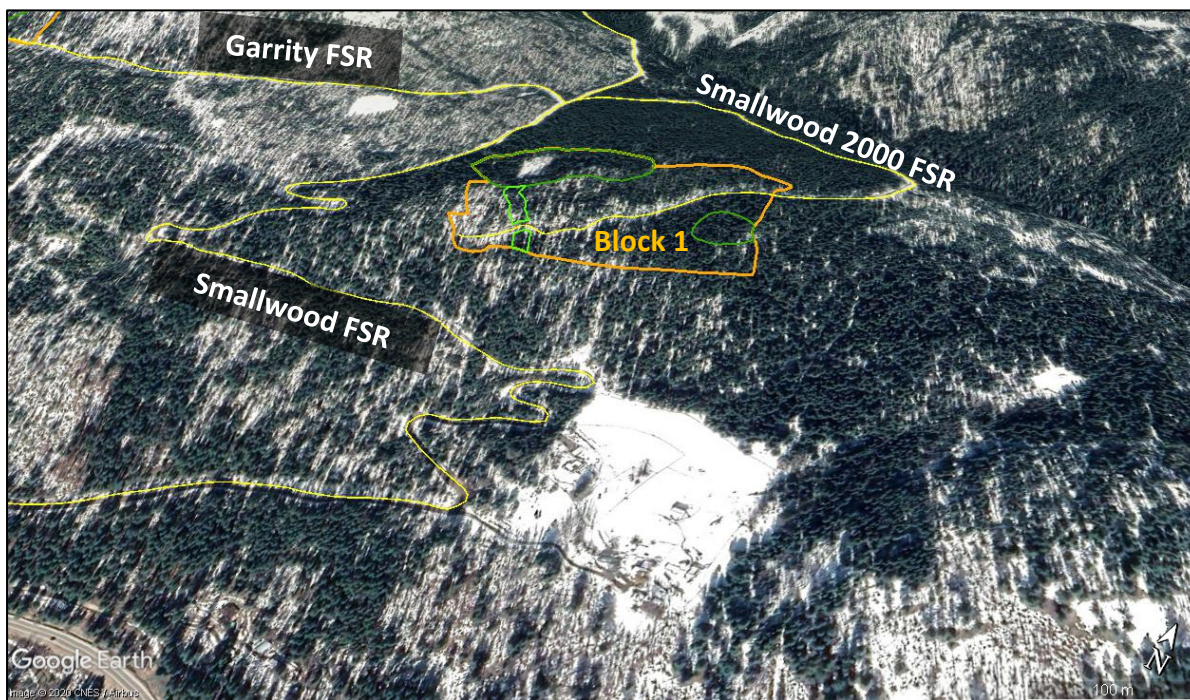
**Image 2:** oblique aerial view northwest at Block 1 using Google Earth imagery dated March 17, 2020. The block is located upslope of the switchbacks on Smallwood FSR and developed private land. The proposed block boundary is shown in orange, WTRA and reserve area boundaries in dark green and light green respectively, and existing roads in yellow.

A small debris slide, estimated to have involved 200 m<sup>3</sup> of material, occurred 85 m downslope of Block 1 approximately five years ago, depositing some material on Smallwood FSR (refer to Figure 3 for location, and Image 3 below). While the cause is unconfirmed, the debris slide appears likely related to a waterline break associated with PD27201, as indicated by a broken 3" diameter plastic pipe that is shallowly buried at the top of the headscarp. The landslide scoured a path that averages 5 m wide and 1 m deep down the 50% gradient slope.

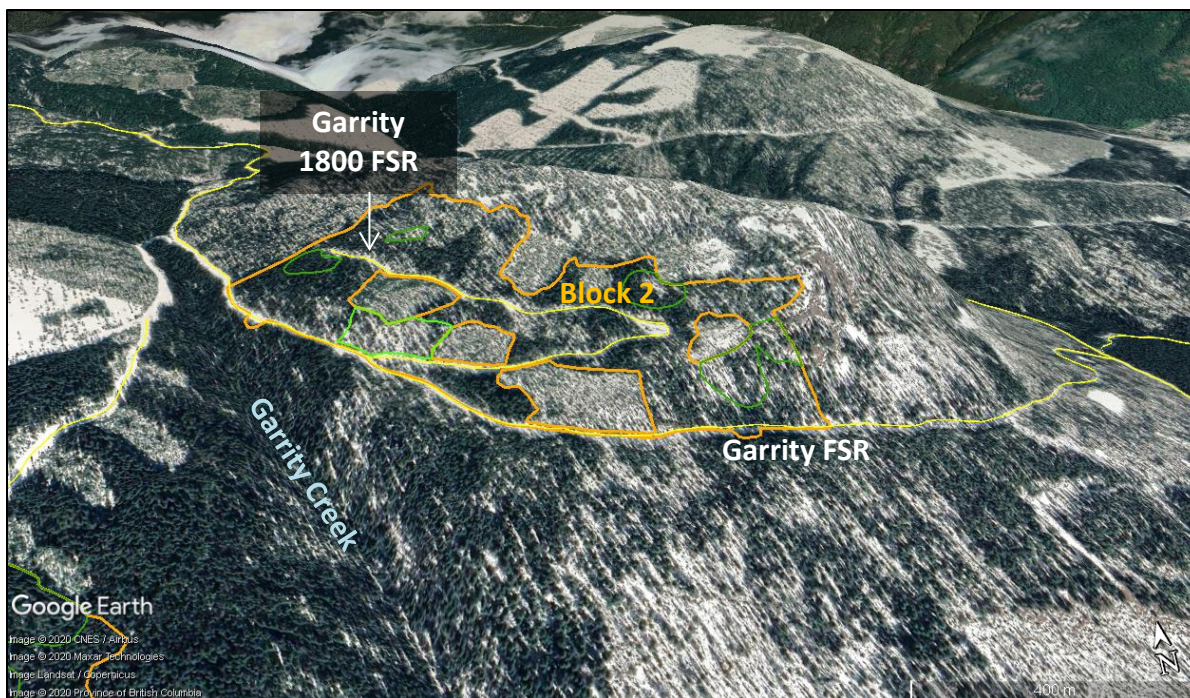
The proposed cutblock is located on a south to southwest aspect slope between approximately 1050 m and 1275 m elevation (refer to Image 4 and Figure 3). Five patch cuts approximately 1 ha to 4 ha in size harvested in the early 1990's are present within and immediately upslope of the block. The patch cuts were accessed by Garrity 1800 FSR as well as additional spur roads and trails, some of which were rehabilitated.

**Image 4:** oblique aerial view north at Block 2 using Google Earth imagery dated March 17, 2020. The proposed block boundary is shown in orange, WTRA and reserve area boundaries in dark green and light green respectively, and existing roads in yellow. Note the existing patch cuts within and immediately upslope of the block.

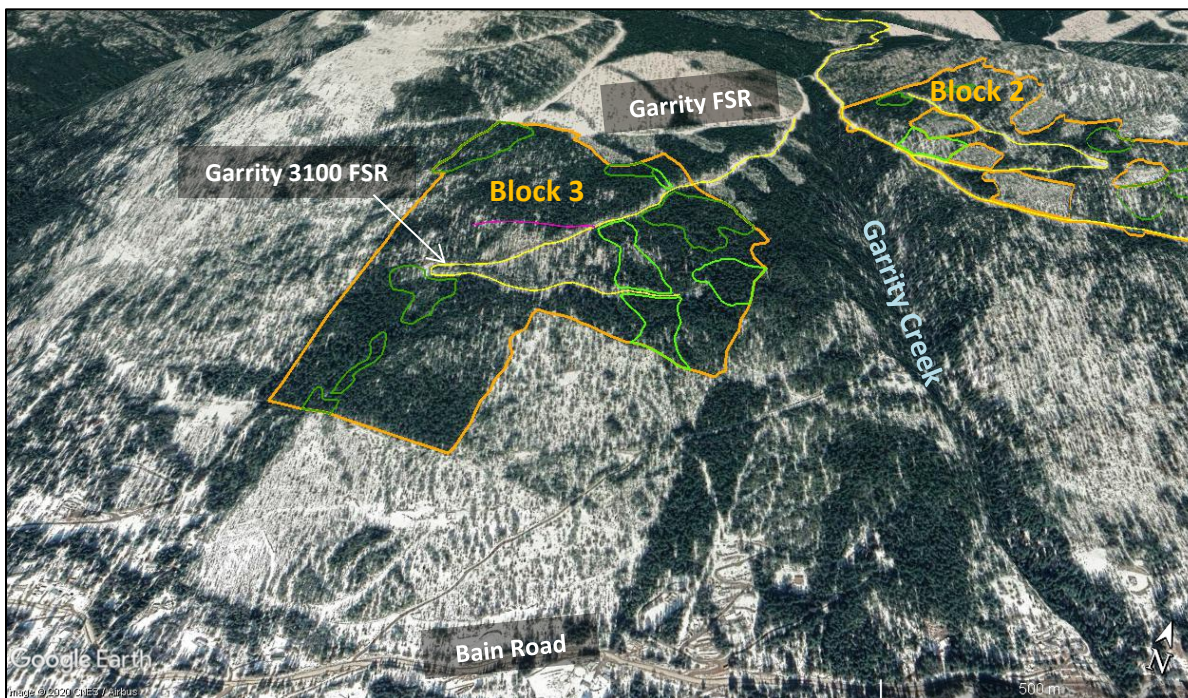
**Image 9:** oblique aerial view northwest at Block 3 using Google Earth imagery dated March 17, 2020. The proposed block boundary is shown in orange, WTRA and reserve boundaries in dark green and light green respectively, existing roads in yellow, and the proposed Garrity 3110 road in pink.

The proposed cutblock is located on a south to southeast aspect slope between approximately 850 m and 1185 m elevation on the face unit west of Garrity Creek. The Falls Creek Community watershed is located immediately west of Block 3, as shown on Figure 1. The recent hydrologic assessment completed for the proposed development (Statlu 2019) confirms that there is no harvesting or new road construction planned within the Falls Creek Community watershed, although a recent update by the British Columbia Geographic Warehouse to reflect refinements to the boundary using the LiDAR data acquired by BCTS indicates a spatial overlap in the mapping of less than 0.2 ha. No further consideration to the Falls Creek Community Watershed is considered necessary in this assessment given the very minor overlap in mapping, the lack of concern identified in the hydrologic report, and the lack of terrain stability or soil erosion concerns associated with harvesting along this watershed boundary.
