DOK | 2007 Bridge Inspection Review and Rating | Dec.1st, 2008

Issues in red require immediate attention  
Issues in bold black need attention for safety concerns

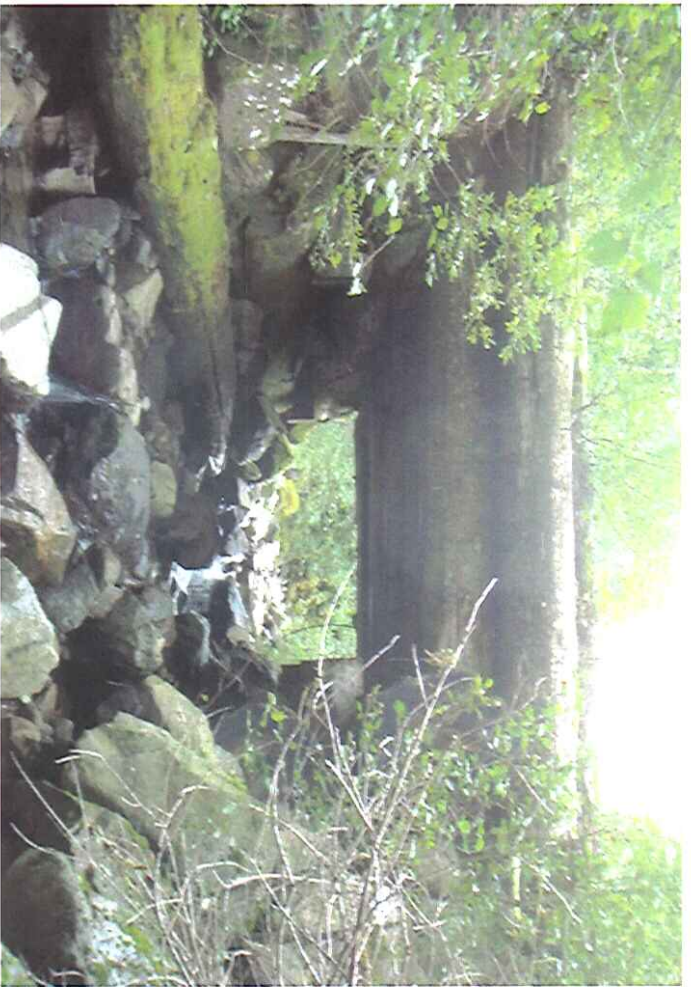
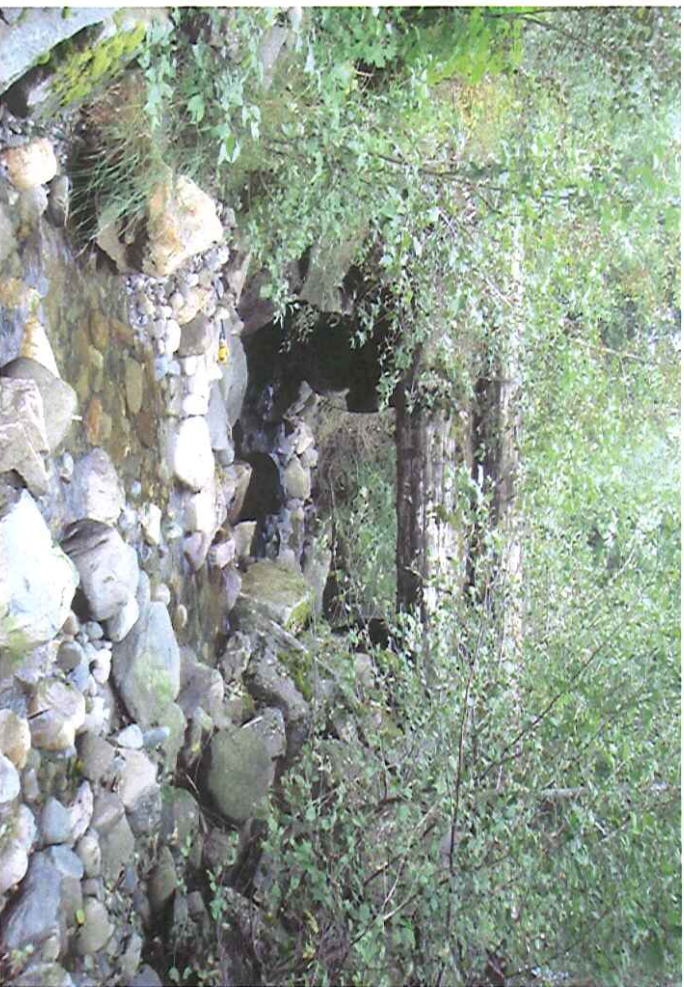
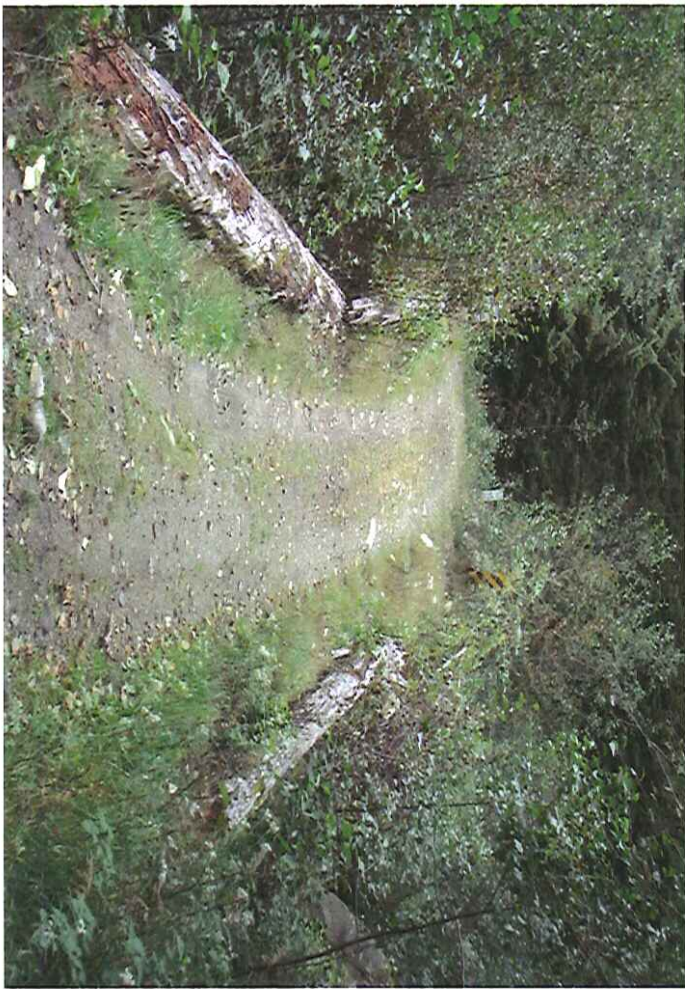
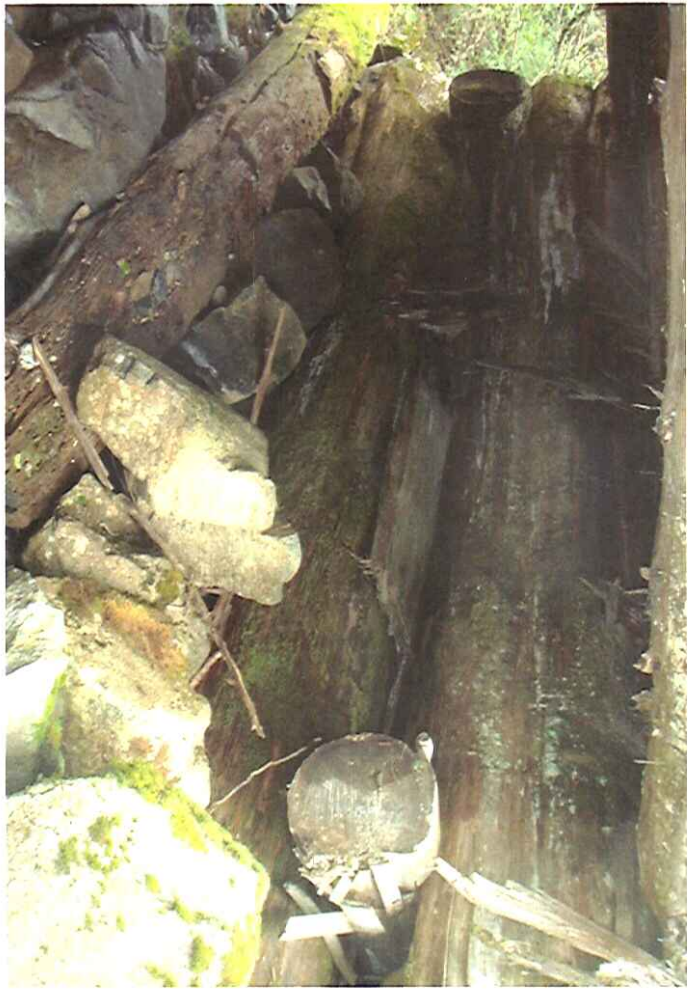
| CULVERT ELEMENT | CONDITION | | |
|---|---|---|---|
| Inlet | 4 | Partialaly blocked by a boulder. Town side of inlet damage | Remarks |
| Outlet | 4 | Deformation caused by poor backfill (CK-2004-a6). Invert | Remarks |

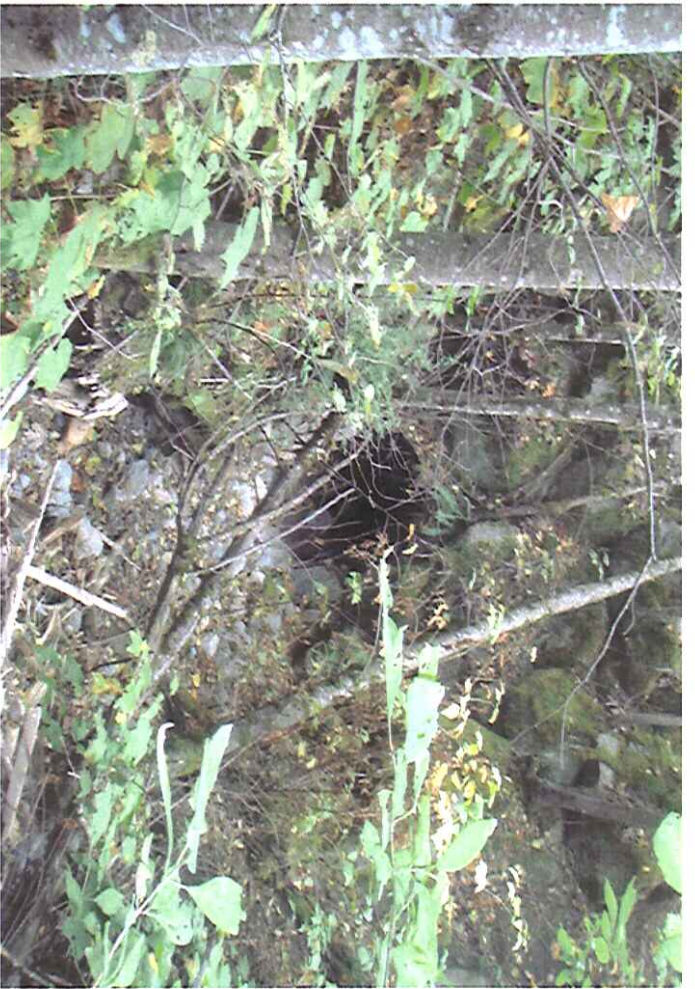
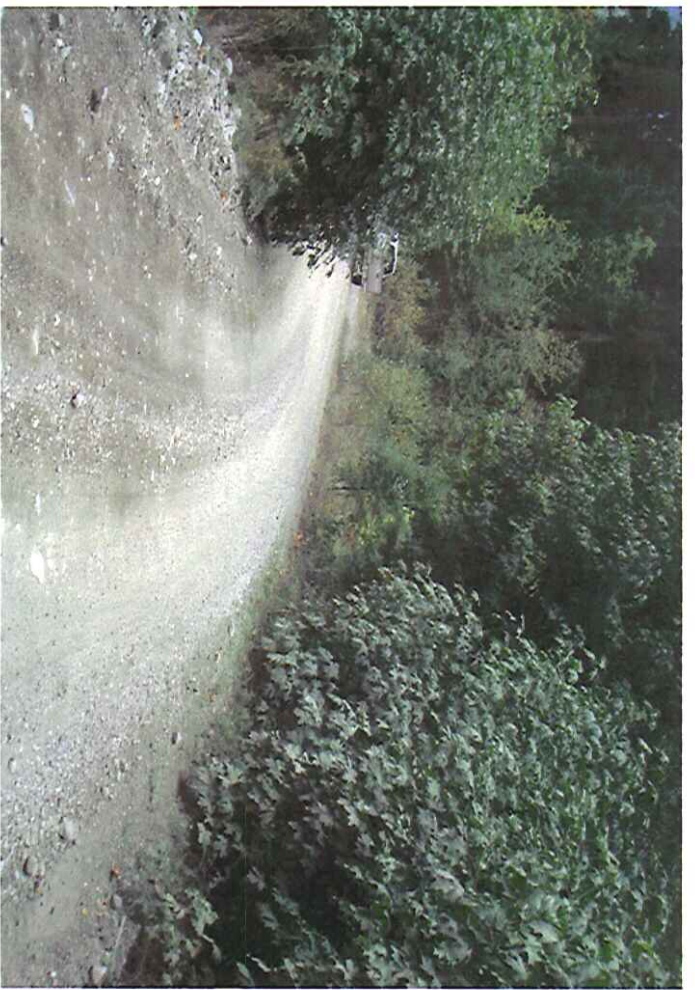
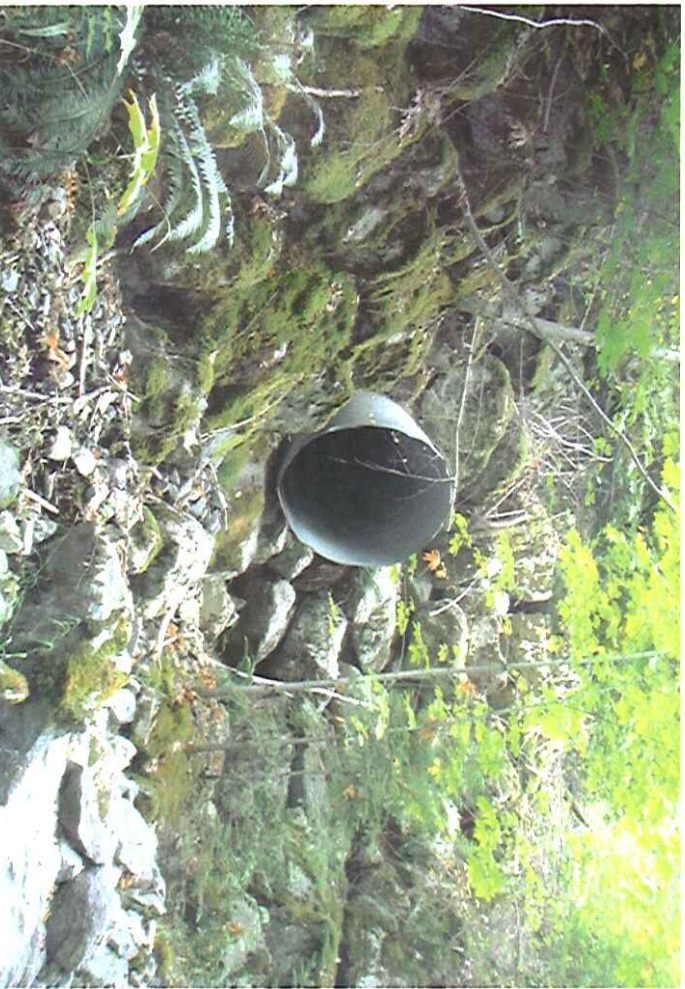
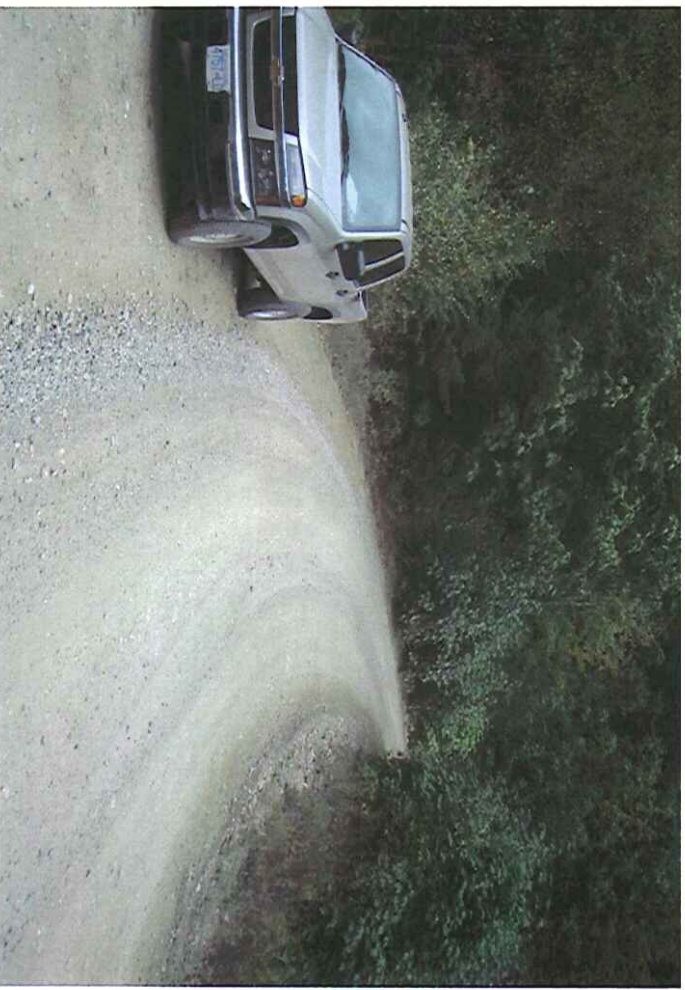
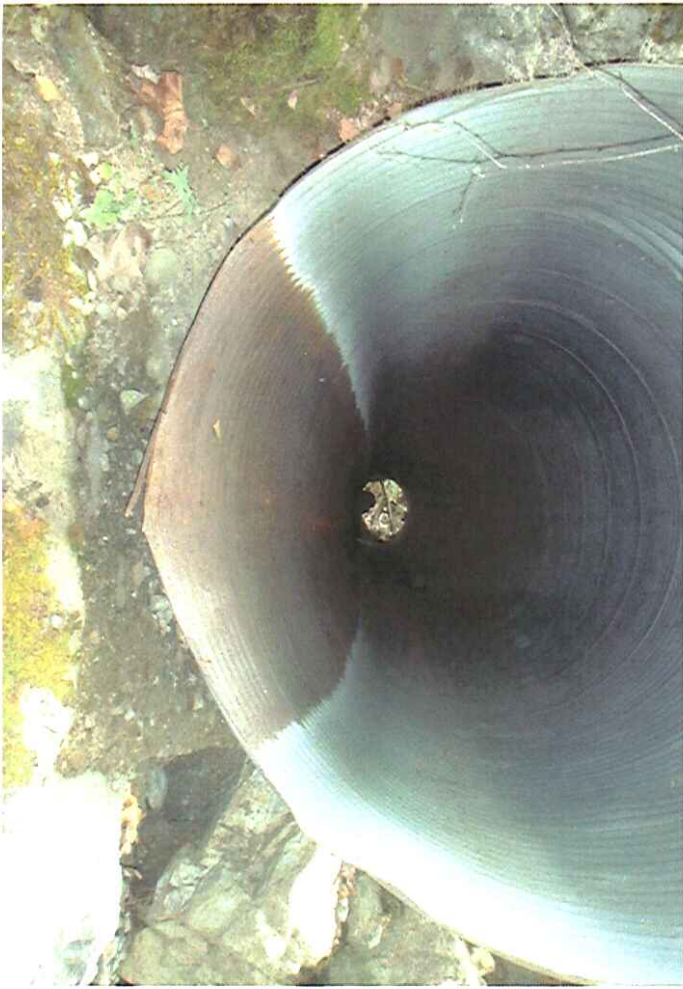
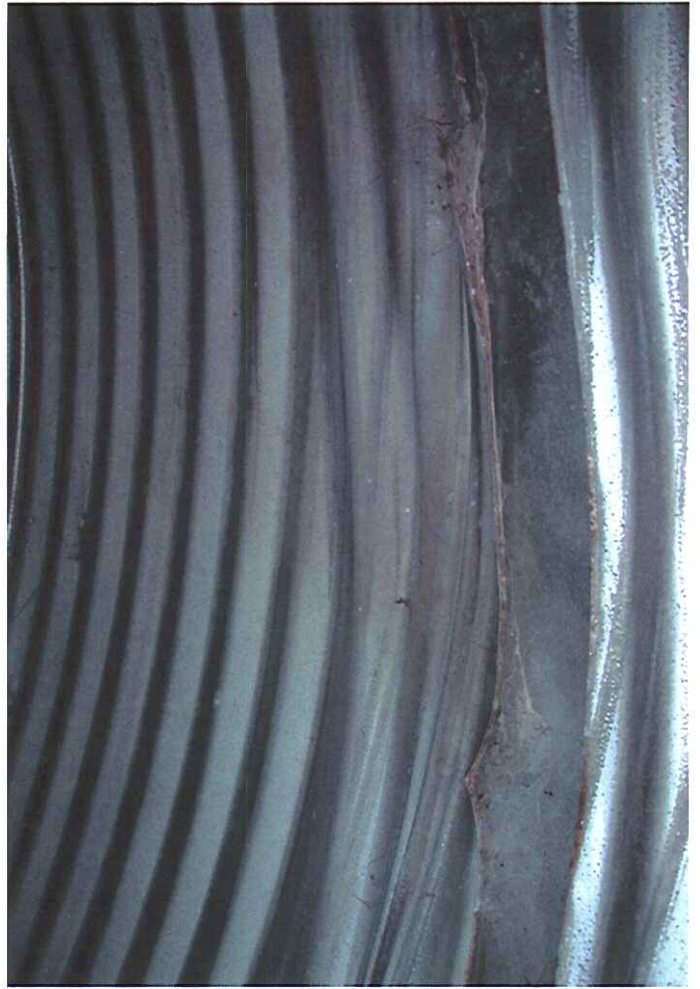
| CULVERT ELEMENT | CONDITION | Remarks |
|---|---|---|
| Outlet | 4 | Outlet damaged due to embankment collapse (CK-2005-a) |

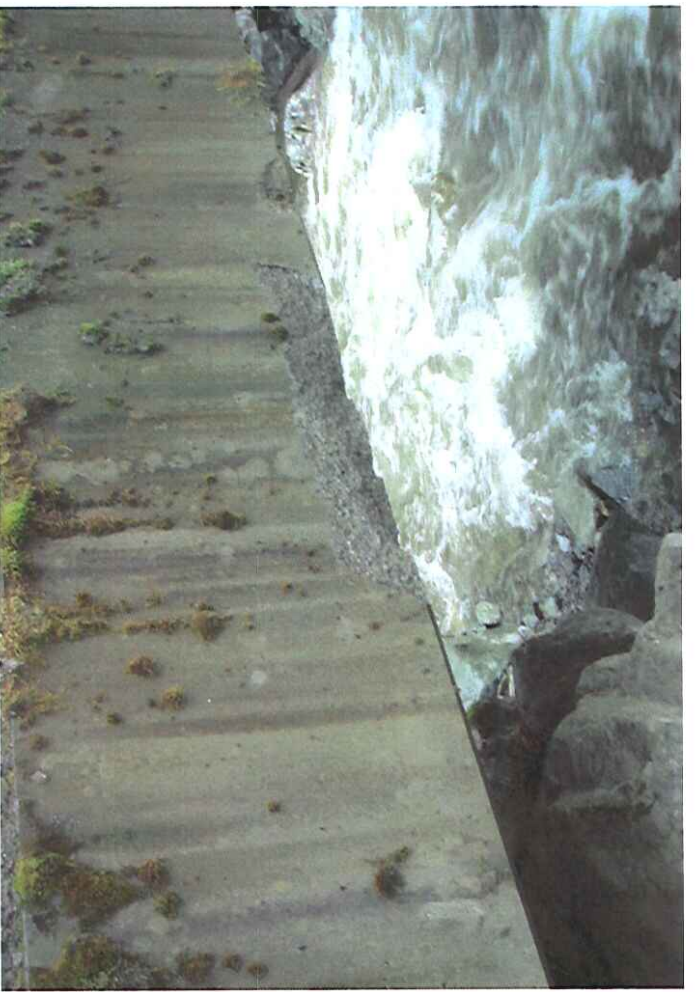
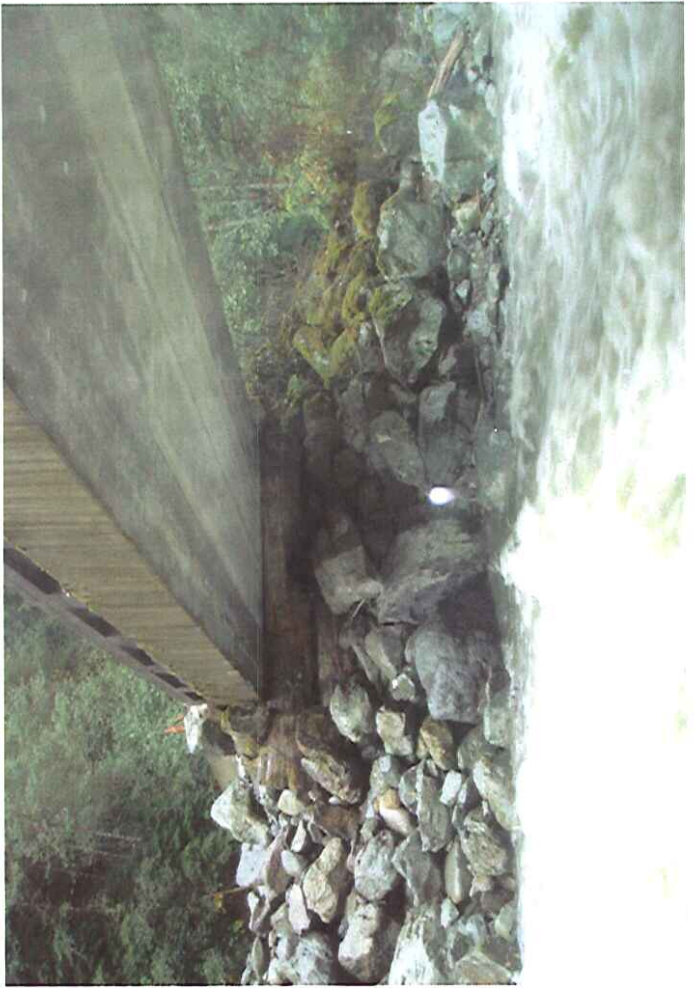
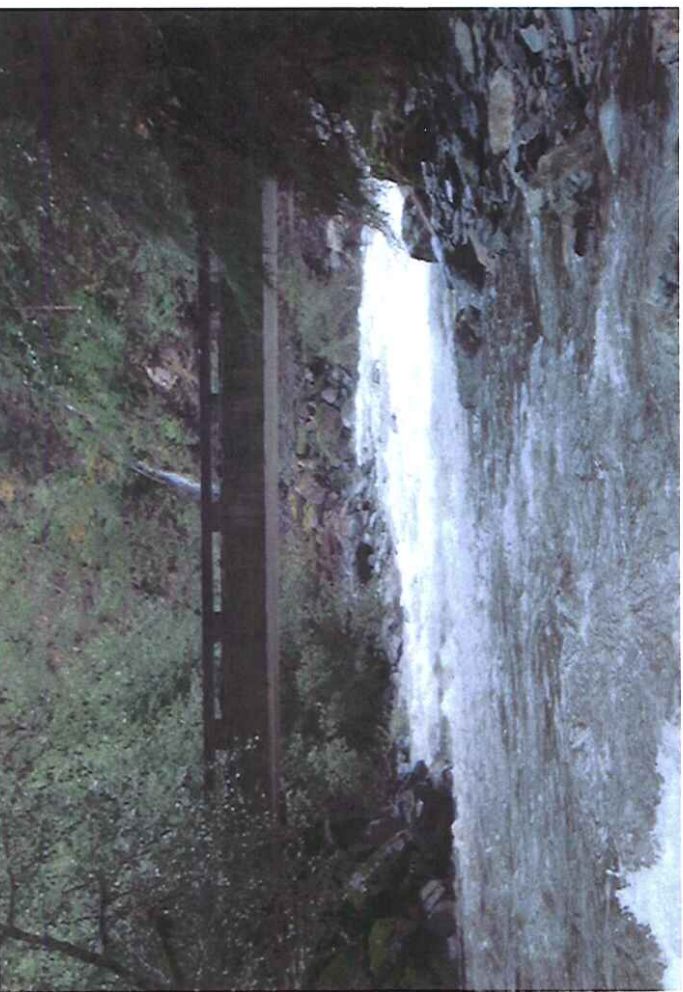
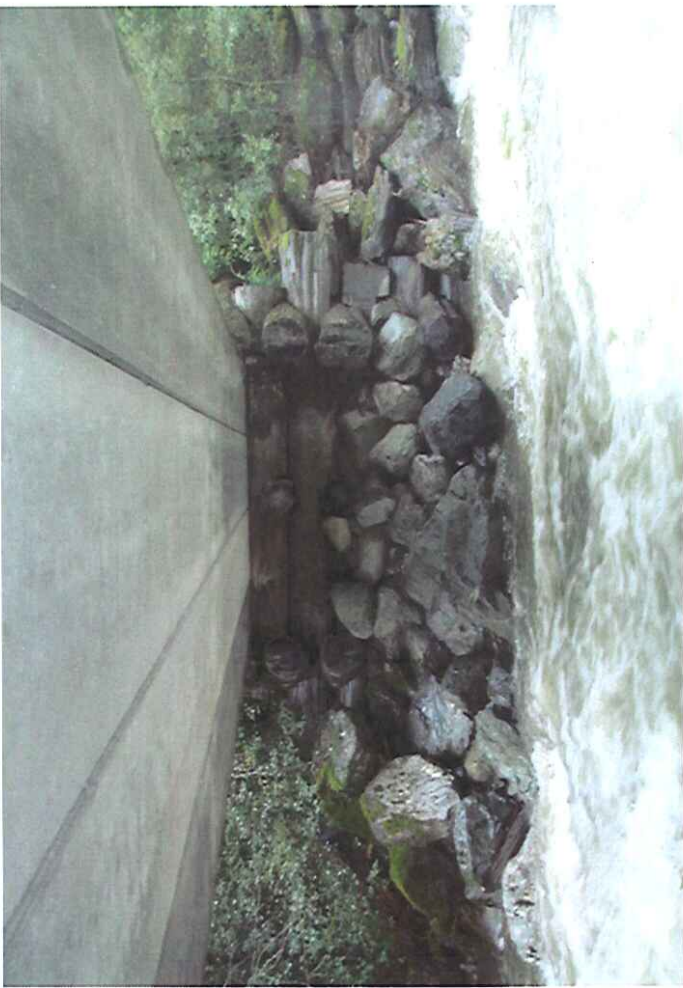
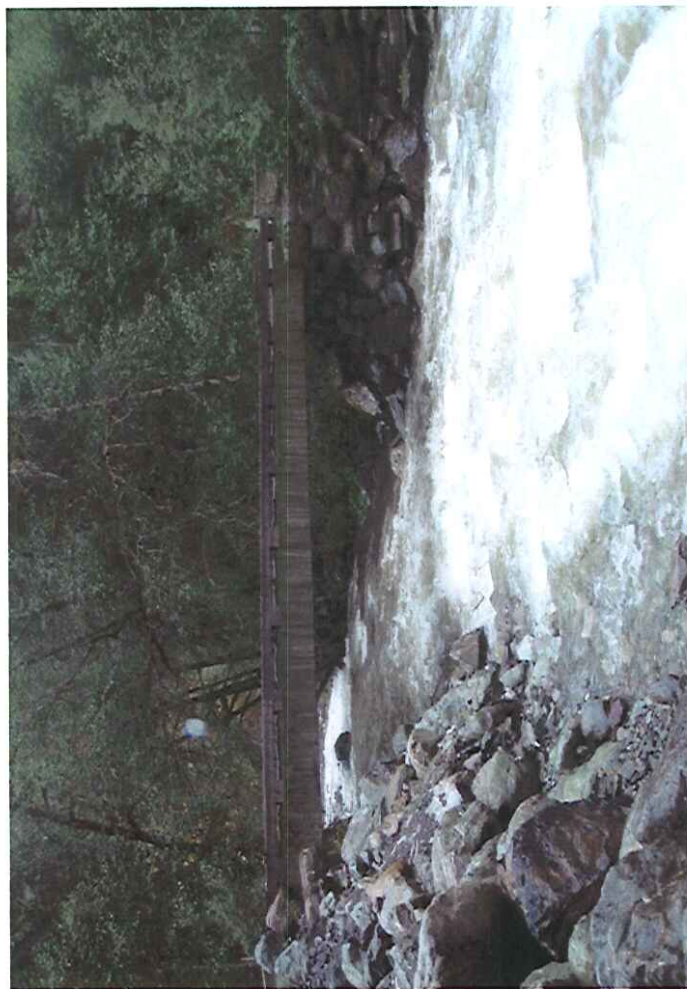
CK-2084

| BRIDGE ELEMENT | | CONDITION | REMARKS | |
|---|---|---|---|---|
| | Concrete Deck | 3 | Minor spalling at approaches at wheel path (CK-2084-a3 to a7). | Remarks |
| | Concrete | 3 | Precast concrete ballast wall. Spalling at bush side downstream corner (CK-2084 | Remarks |

Install missing delineators. Repair/monitor spalling at approaches.

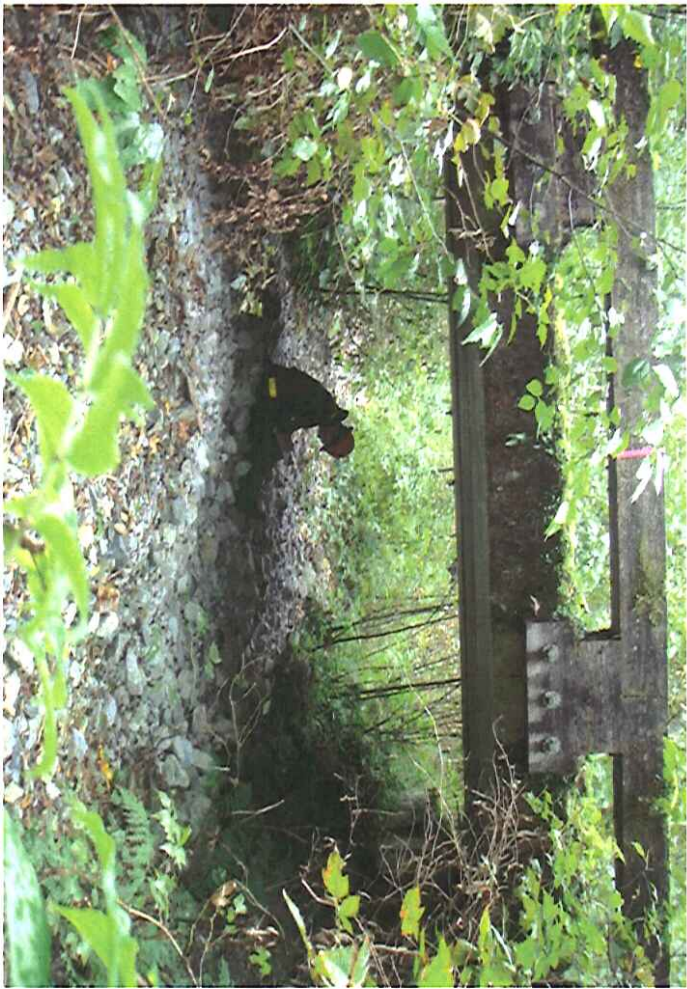
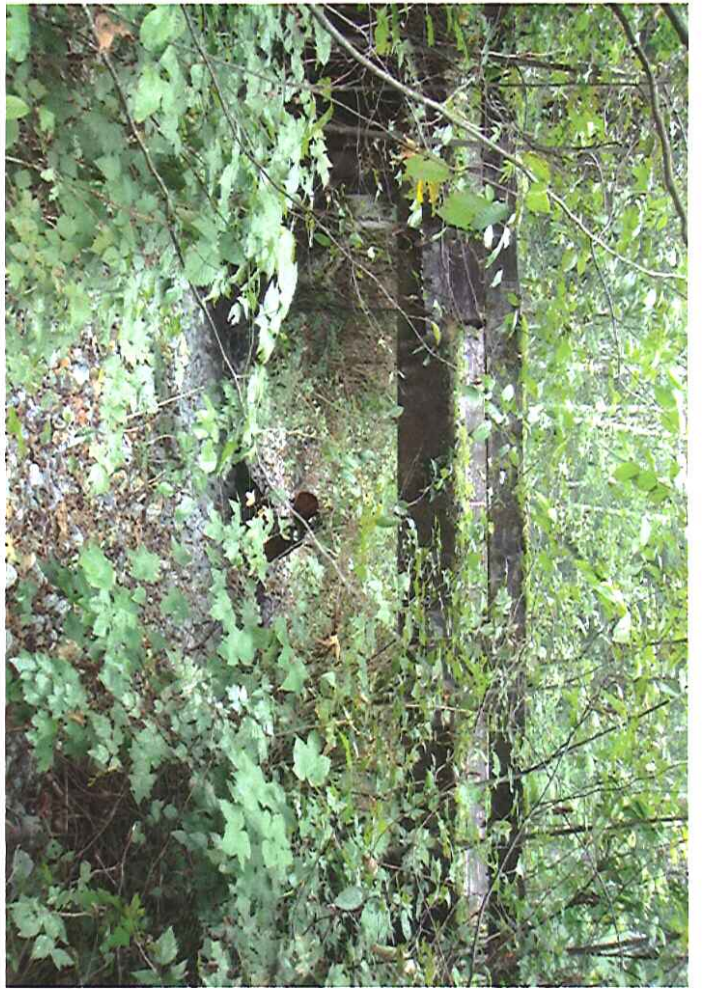
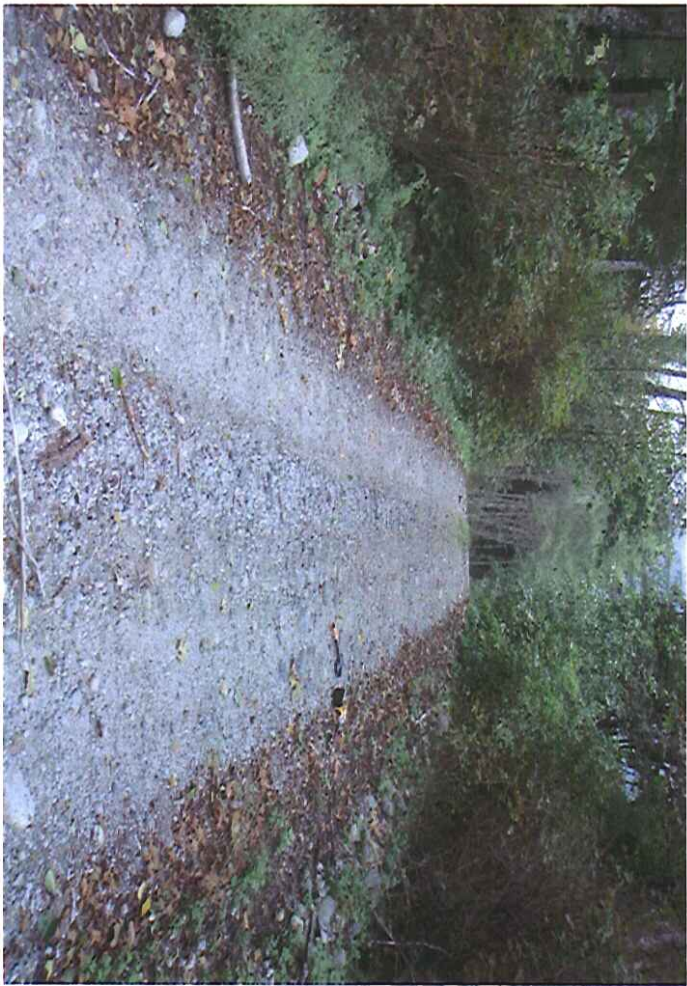
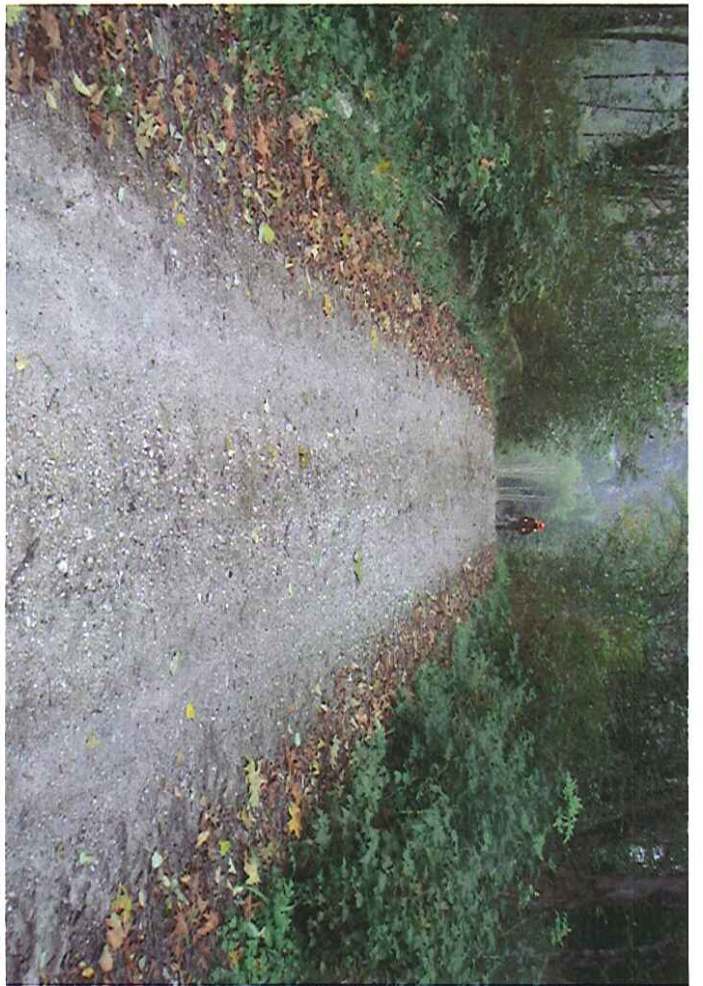
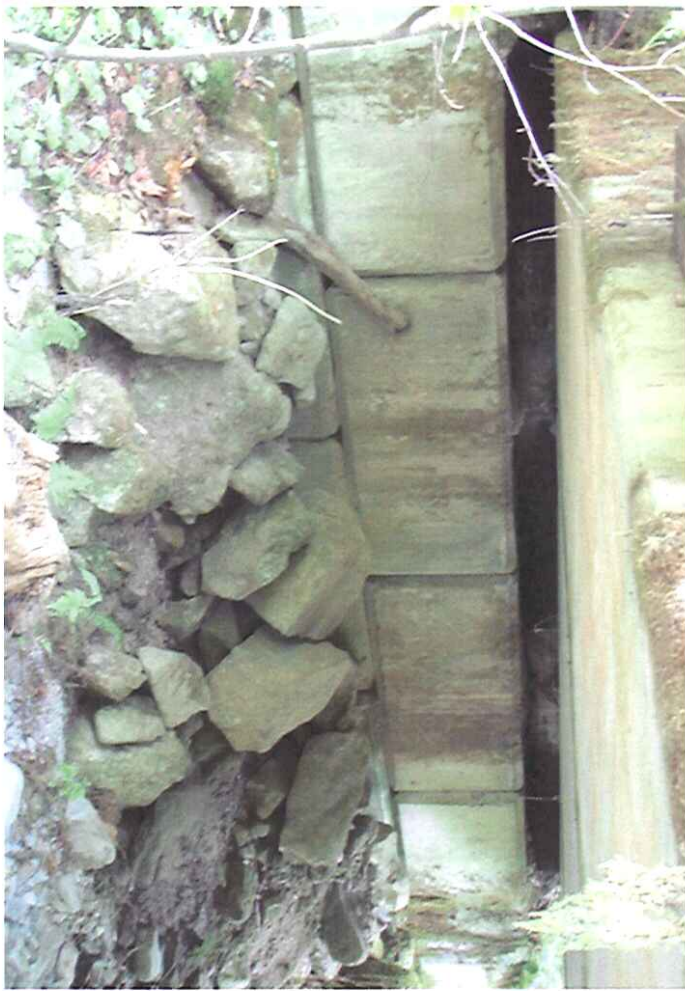
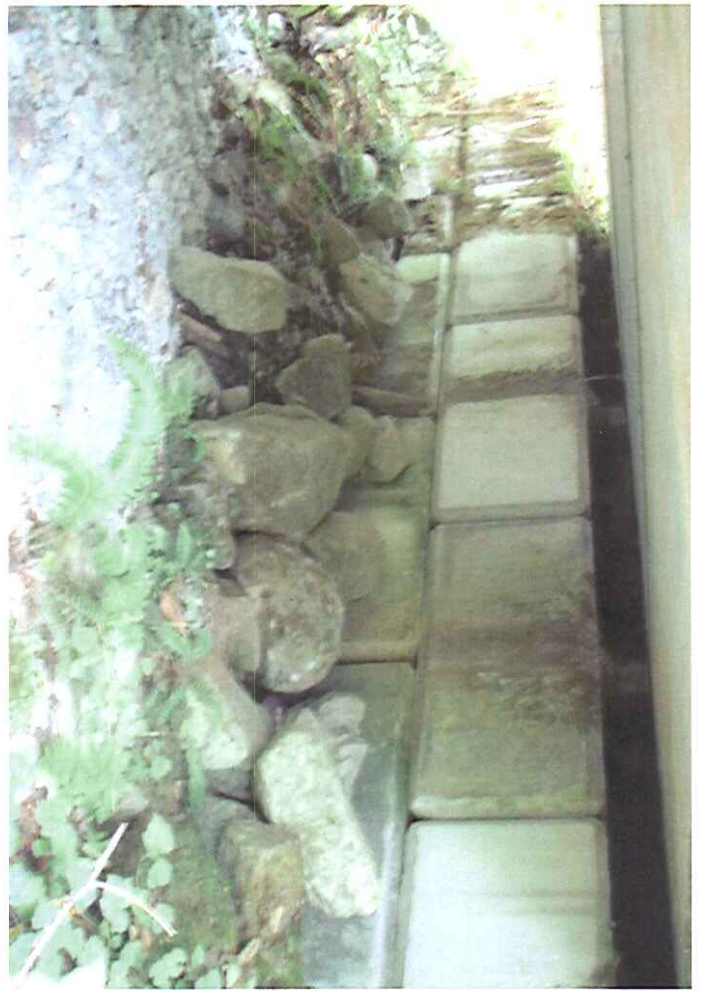
| BRIDGE ELEMENT | | CONDITION | REMARKS |
|---|---|---|---|
| DECK | Running Planks | 5 | 100mm x 250mm untreated fir with 30mm of sap rot. Planks are crushed at wheel |
| | Ties | 5 | 200mm x 200mm untreated fir with 60mm of sap rot. 50% of the ties are rotten (CK-2315-a8) |
| | Curbs and Blocks | 5 | 200mm x 200mm untreated fir with 70mm of sap rot (CK-2315-a8). |

Based on the very poor condition of the curbs, deck, ties and the poor condition of the stringers the overall condition of this structure is poor. We recommend this structure be replaced with one that meets the hydrological requirements of the drainage area.

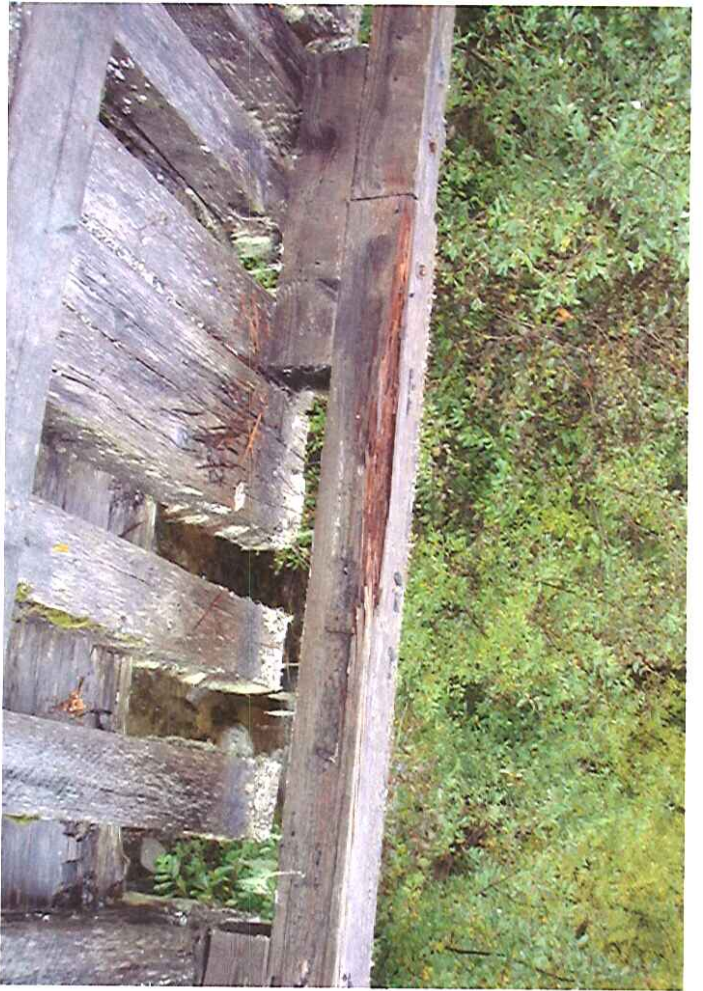
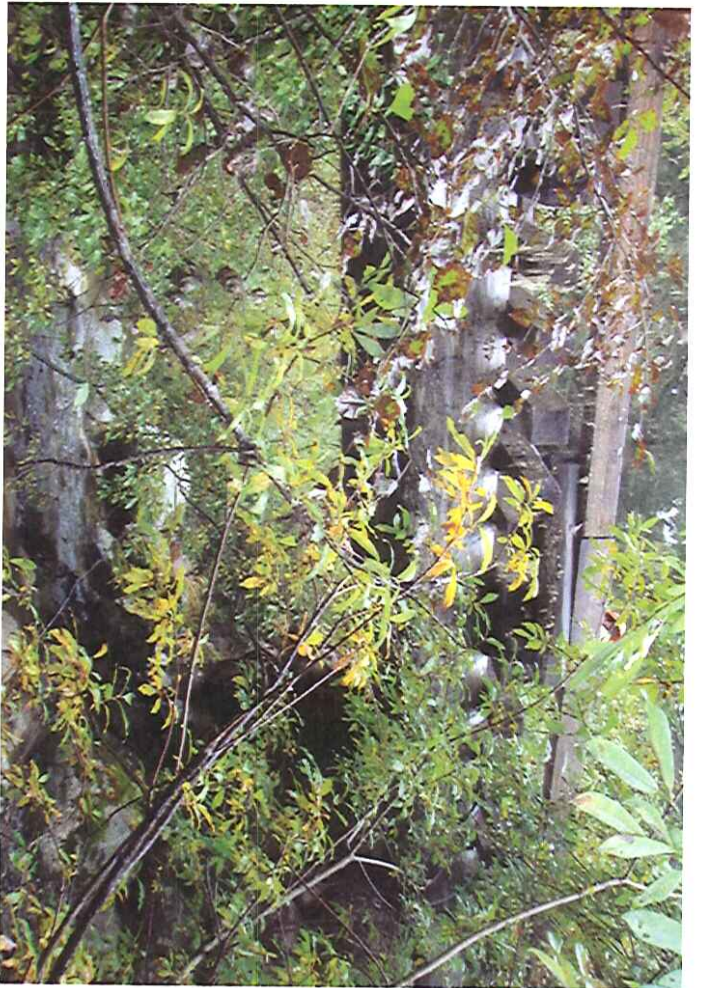
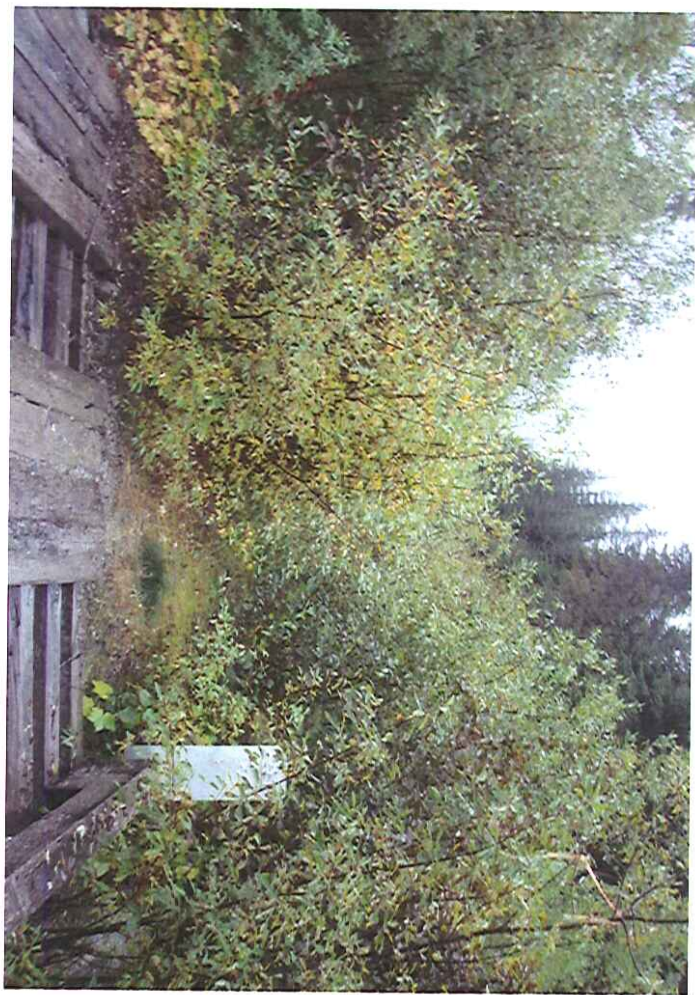
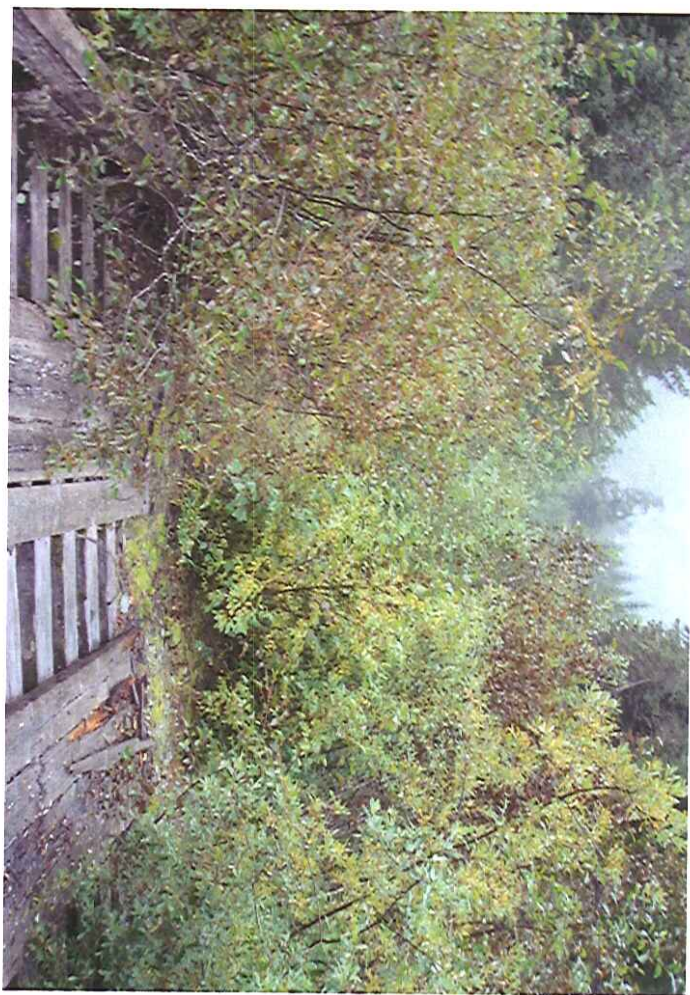
$\sim 350$     $\sim 400$     $\sim 350$     $\approx 11/m \text{ c/c.}$

| BRIDGE ELEMENT | | CONDITION | REMARKS | |
|---|---|---|---|---|
| DECK | Running Planks | 4 | 100mm x 300mm untreated fir, planks heavily worn and crushed (CK-2327-a3 to | Remarks |

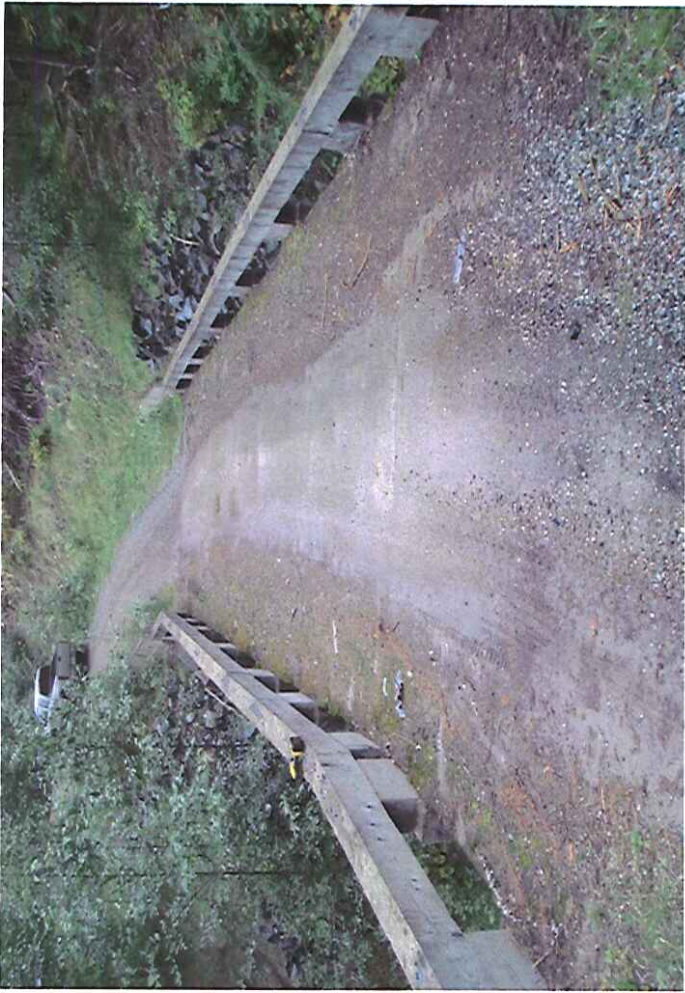
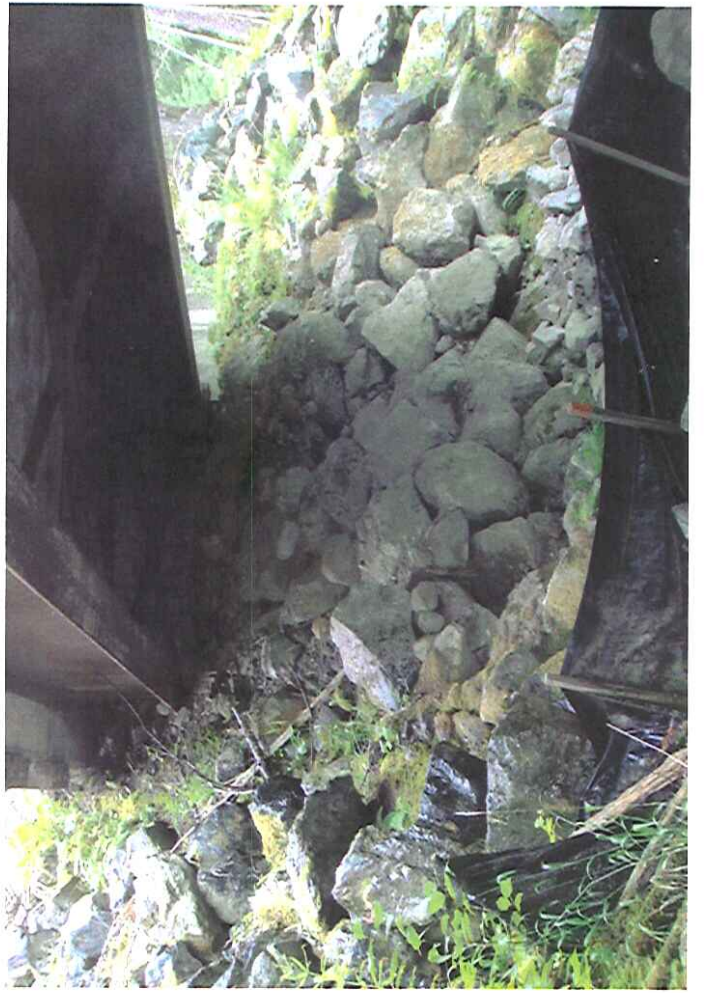
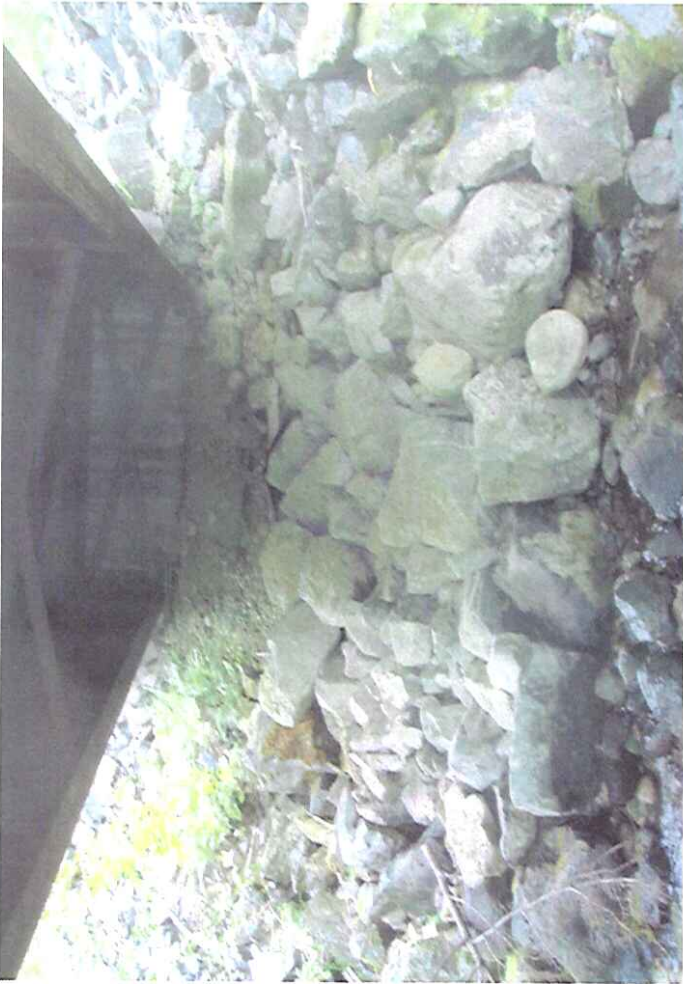
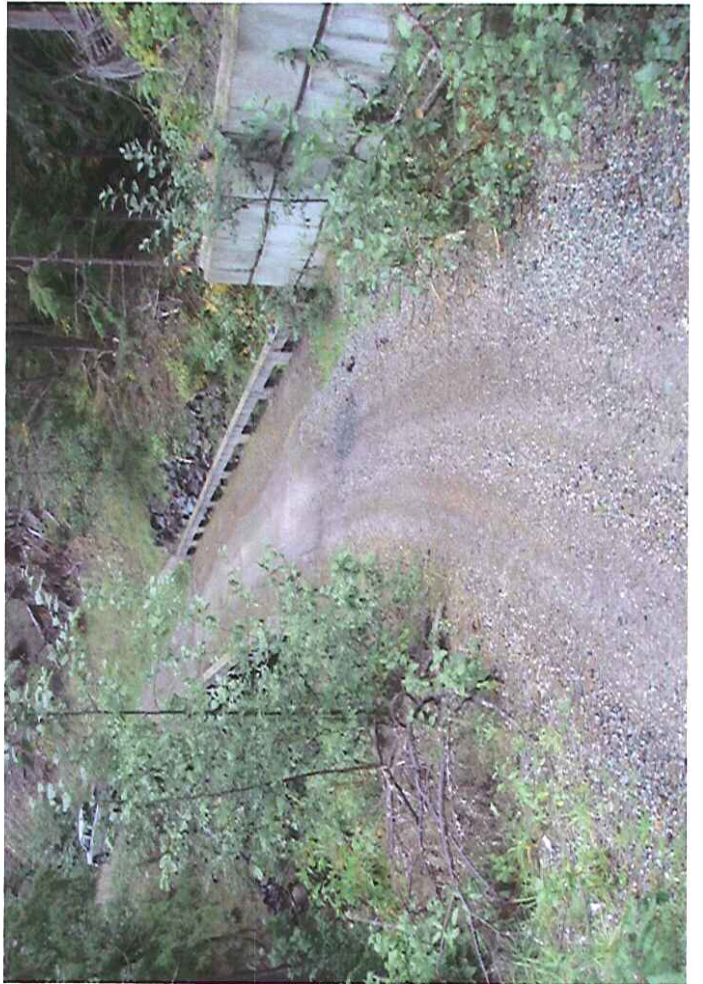
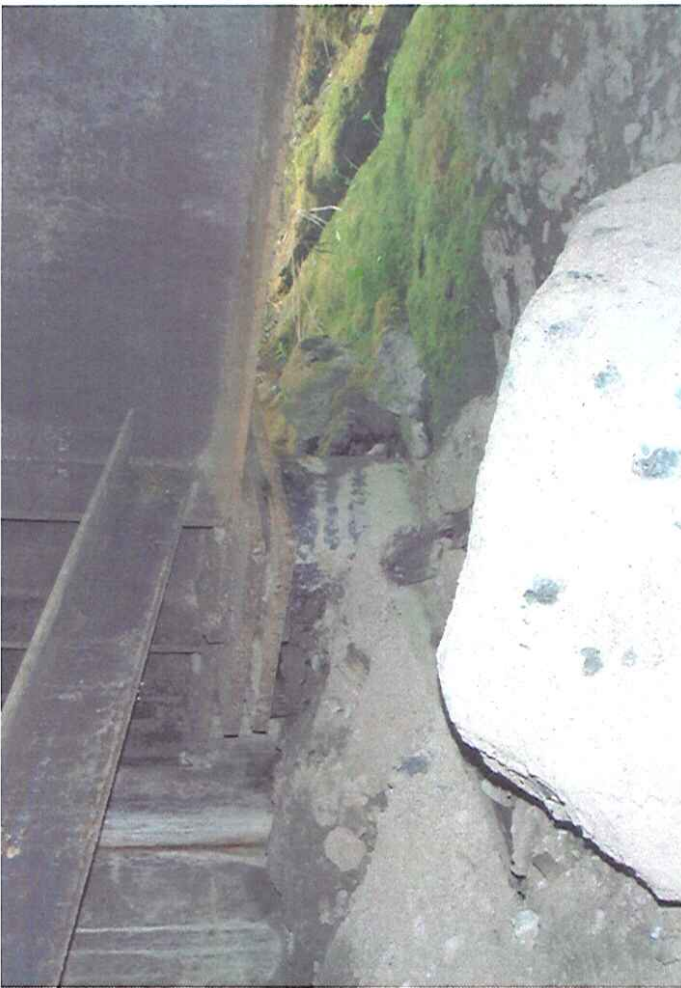
| BRIDGE ELEMENT | | CONDITION | REMARKS | |
|---|---|---|---|---|
| | Concrete | 3 | Concrete ballast walls, minor spalling at approaches (CK-2371-a3-a4). | Remarks |
