DOK | 2007 Bridge Inspection Review and Rating | Dec.1st, 2008

Issues in red require immediate attention  
Issues in bold black need attention for safety concerns

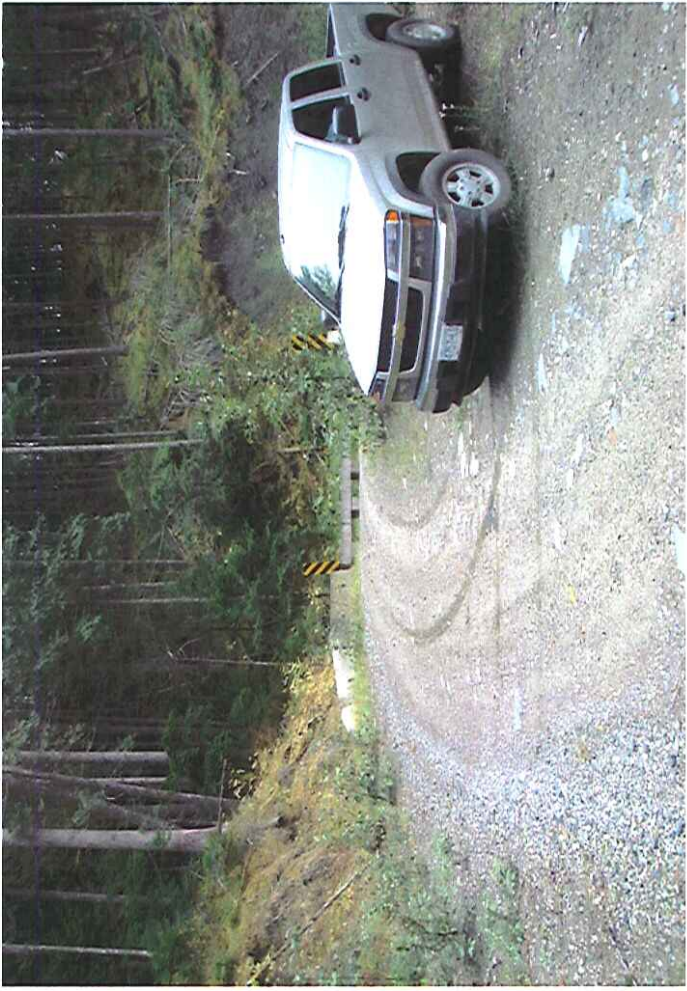
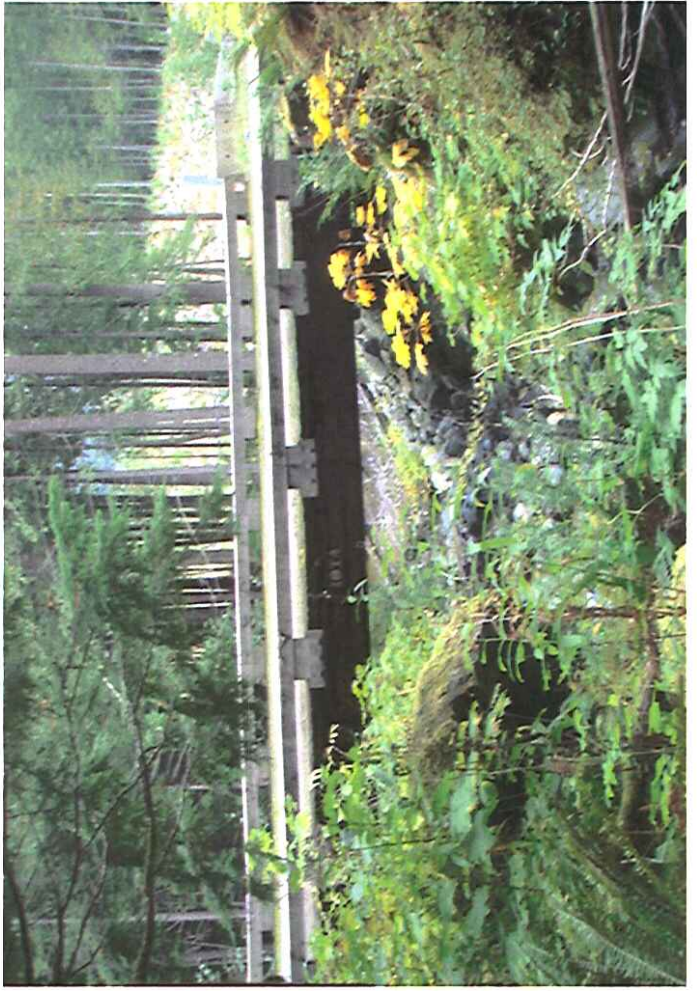
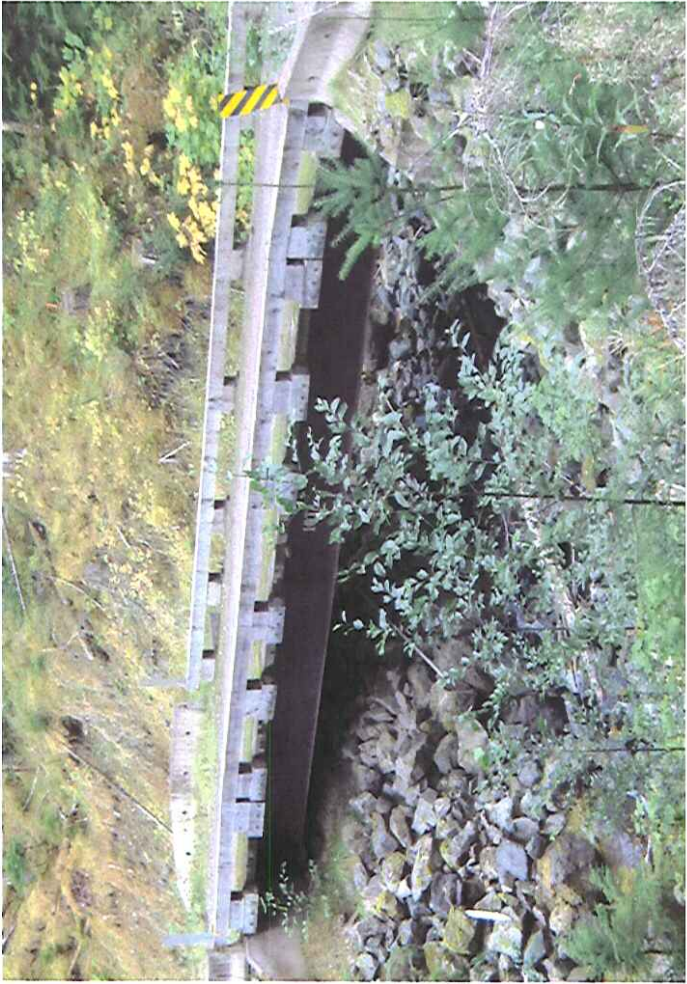
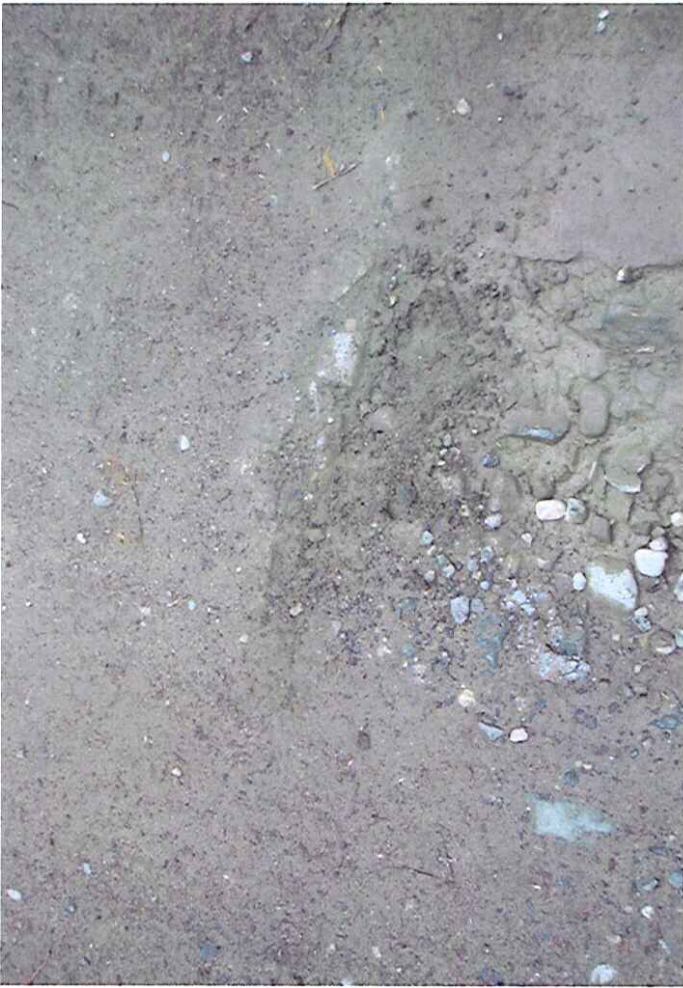
| BRIDGE ELEMENT | | CONDITION | REMARKS | |
|---|---|---|---|---|
| | Concrete Deck | 3 | Concrete deck, minor spalling at approaches along wheel path (CK-2378-a3 and | Remarks |
| | Concrete | 3 | Precast concrete ballast wall, minor spalling at town and bush side approaches | Remarks |
| APPROACHES | Riprap | 3 | Town side: Scour damage has created a 1.3m vertical face immediately below the | Remarks |

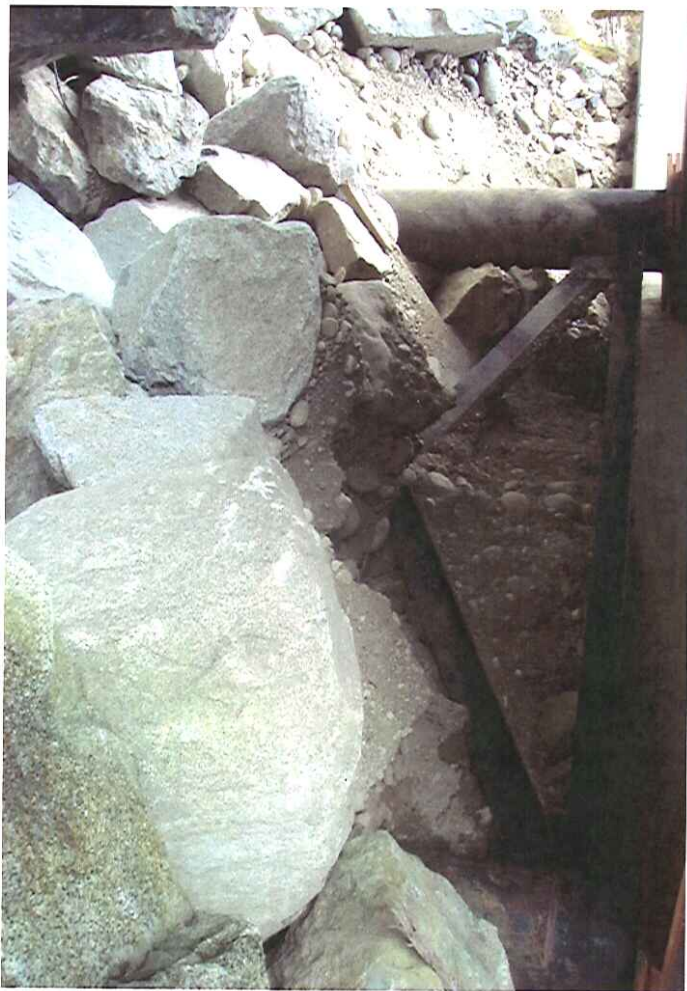
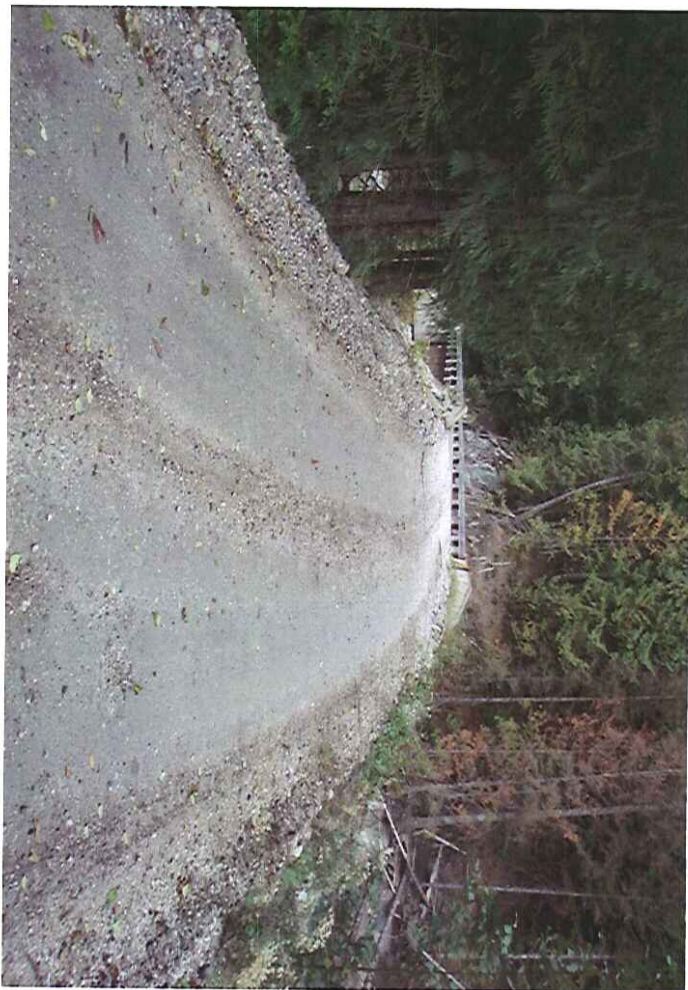
| BRIDGE ELEMENT | | CONDITION | REMARKS | Remarks |
|---|---|---|---|---|
| | Hardware | 1 | Grout pockets in good condition (CK-2387-a3). | Remarks |
