BC Ministry of  
Forests and Range

## Corporate Bridge Register (CBR) Structure Inventory Data Form "CULVERTS"

BC Ministry of Forests and Range  
Routine Condition Culvert Inspection Form

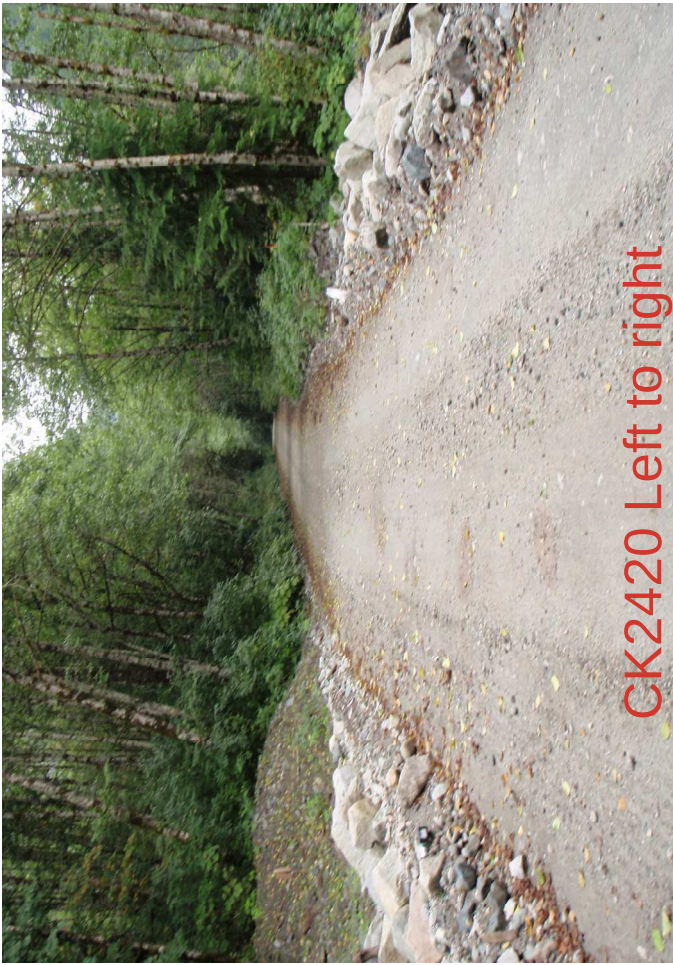
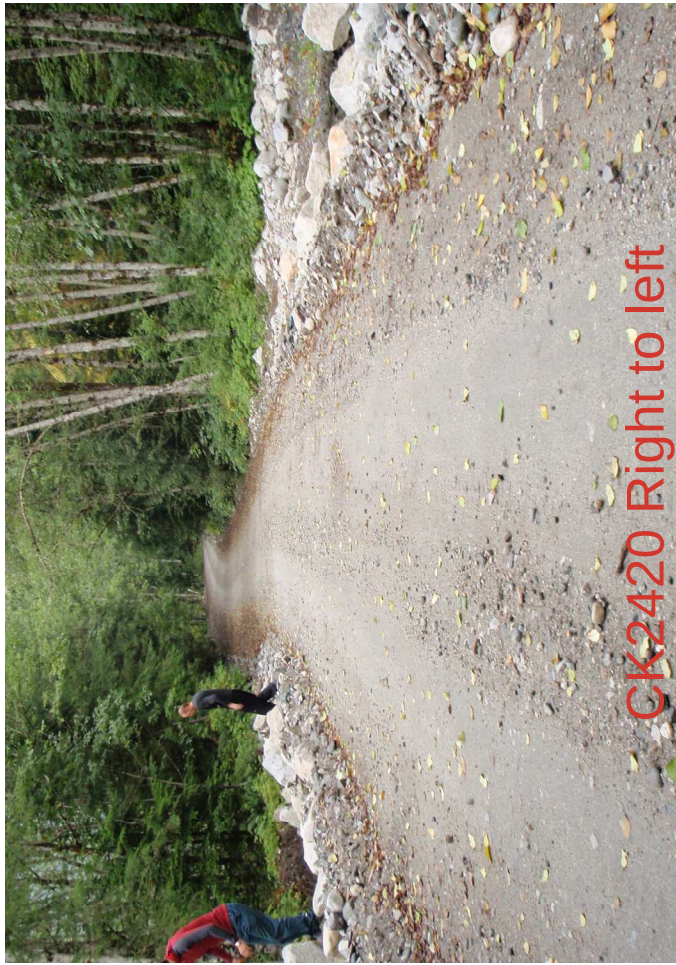
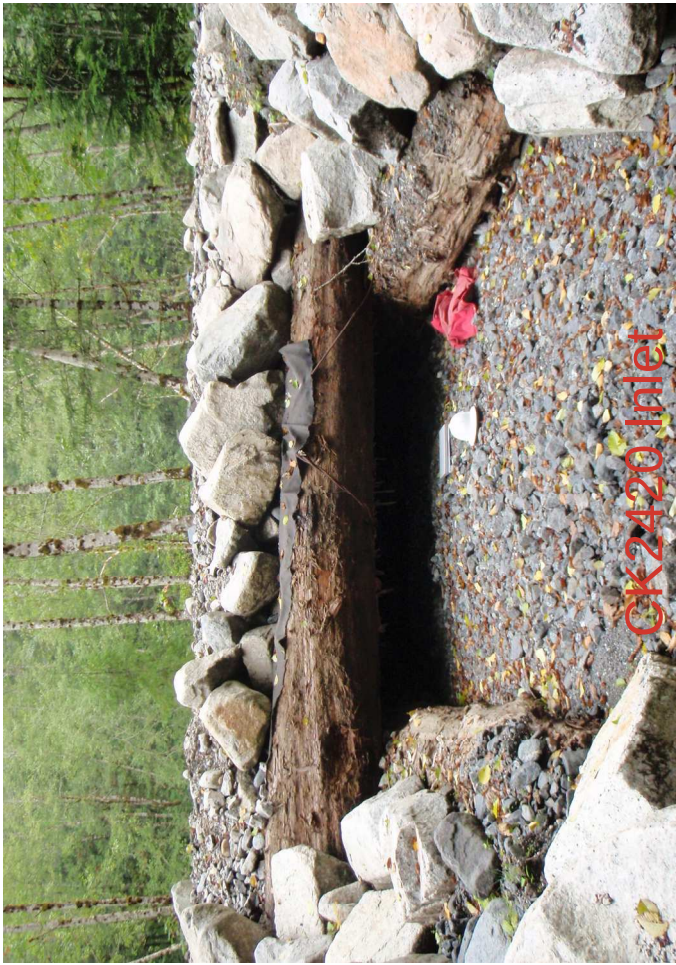
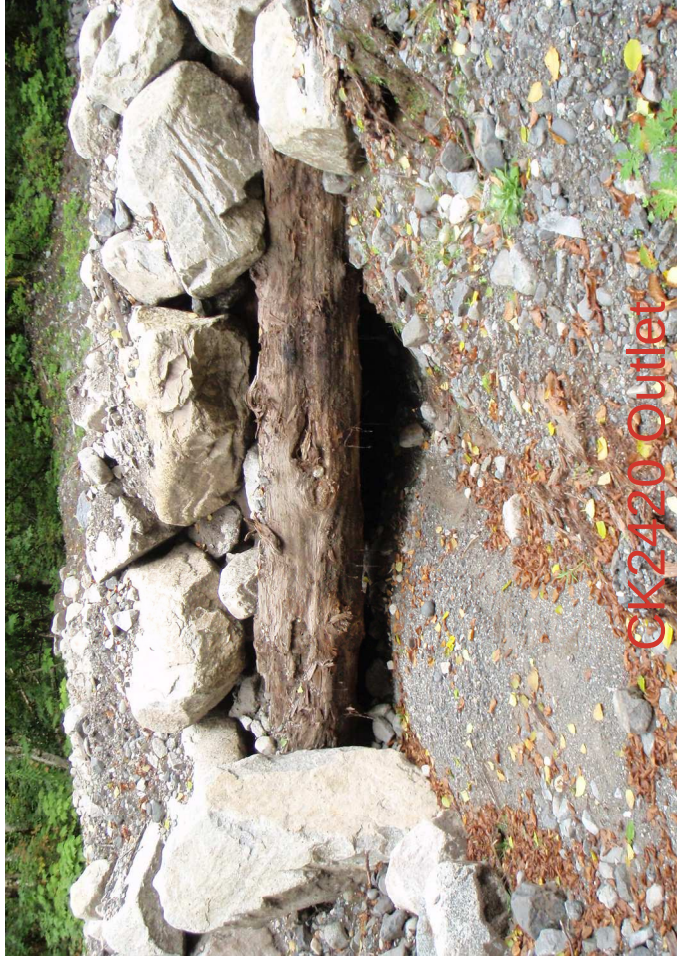
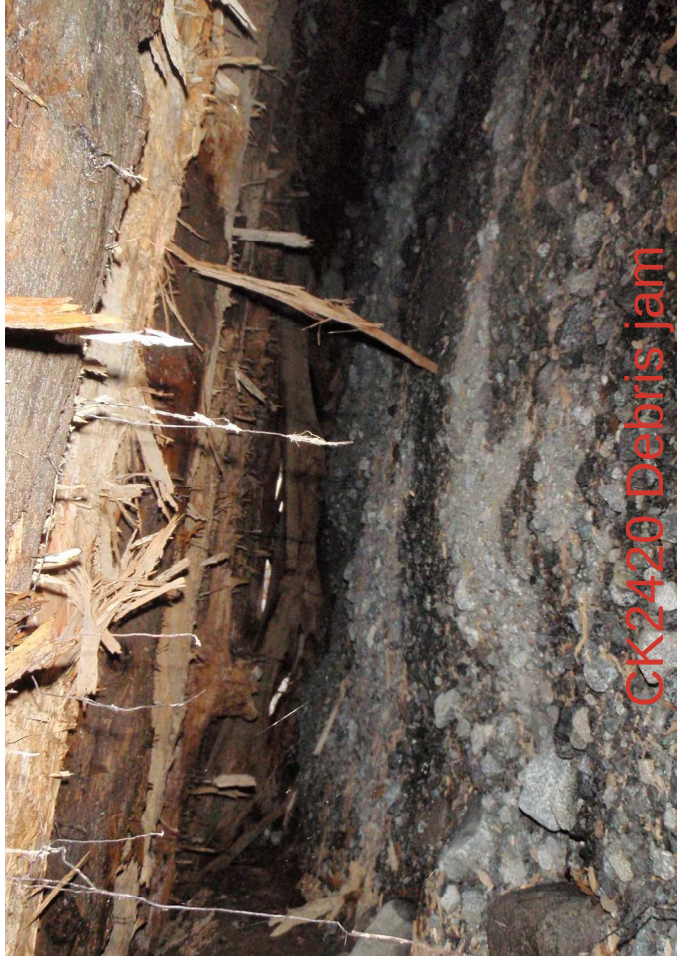
| This is a WBC. It appears one stringer is broken. Debris restricting flow at outlet creating washout hazard. Recommend repairing asap. Remove from CBR. | | | | | | | | | |

| Comments Since structure plugged partially, there is a potential hazard with this structure. | | | | | | | | | |
