Routine Condition Culvert Inspection Form

| *Site #: CK-2457 | | *Crossing Name: | | *Type/Class: <input checked="" type="checkbox"/> Major Culvert<br><input type="checkbox"/> Woodbox/Log Culvert | | *Project File ID# 10326 | |
| *FSR Name: Norrish | | *Forest District: DCK | | *Kilometres: 13.8km | | User km: 13.8km | |

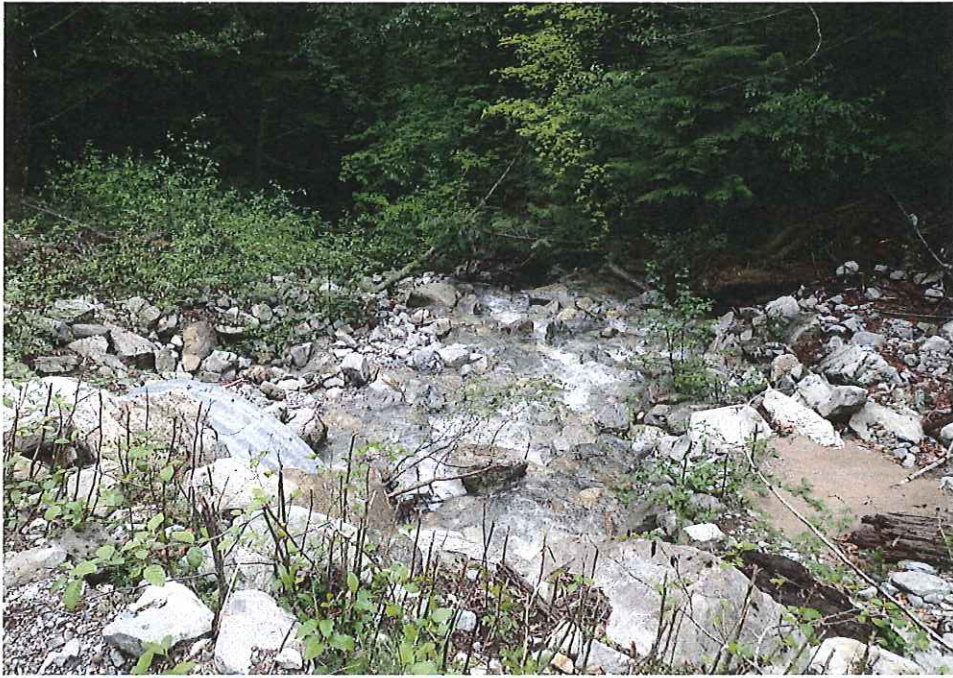
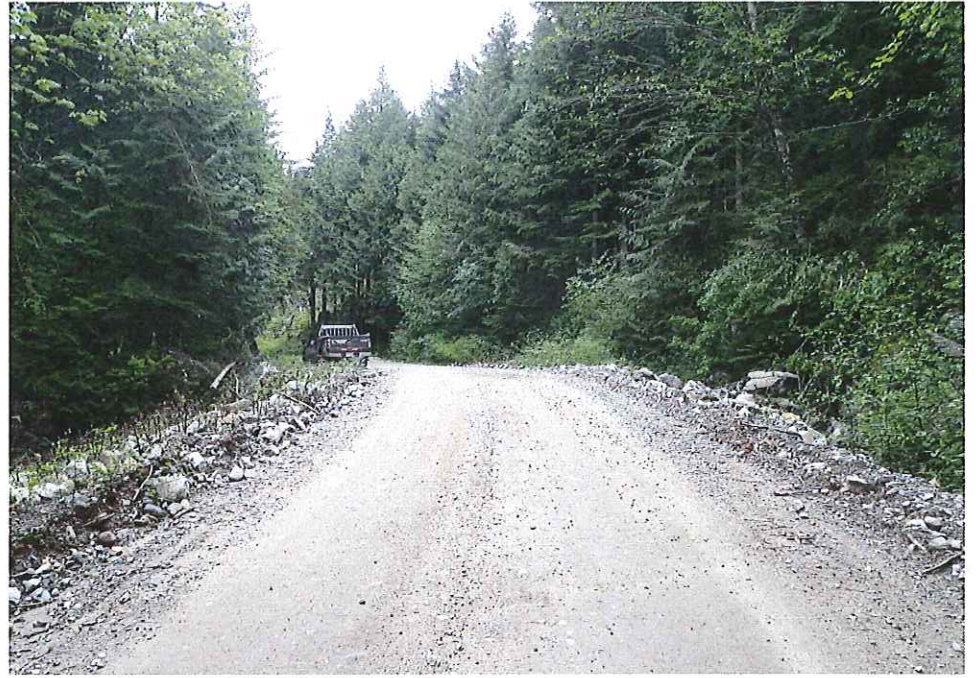
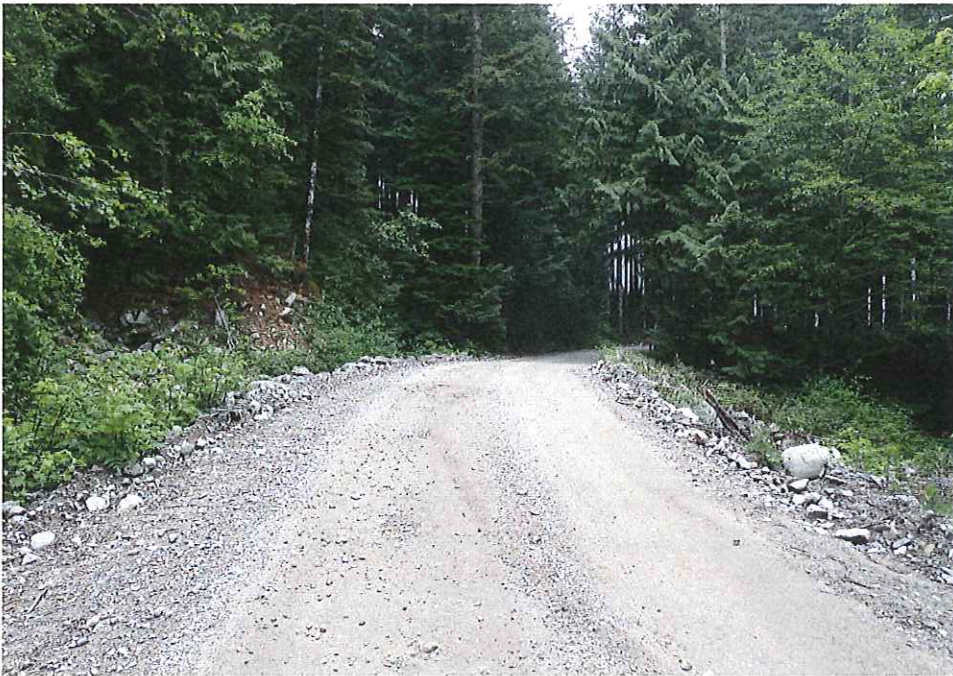
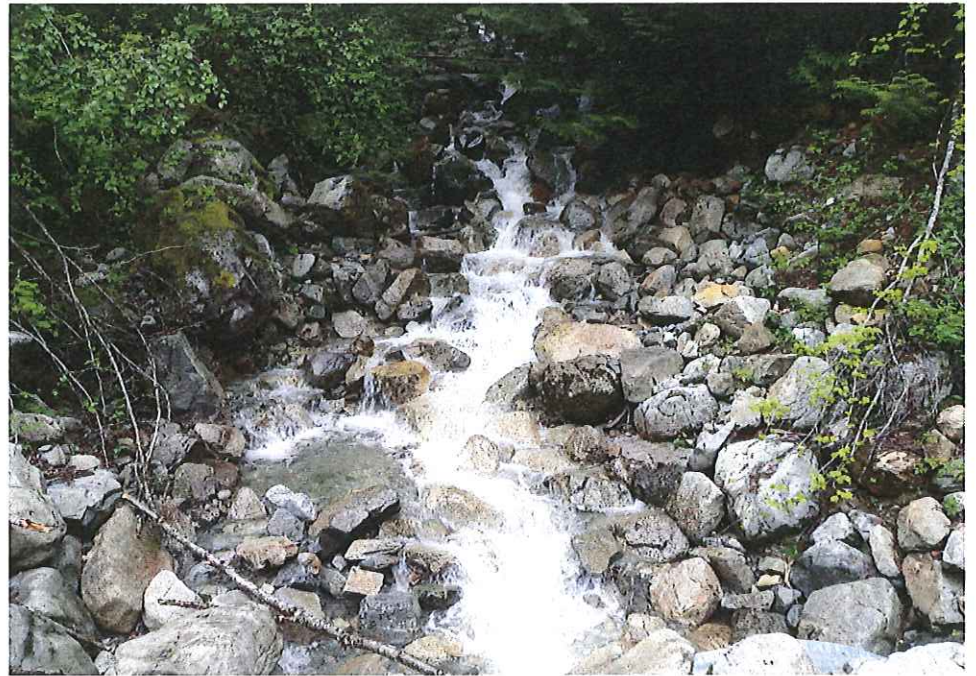
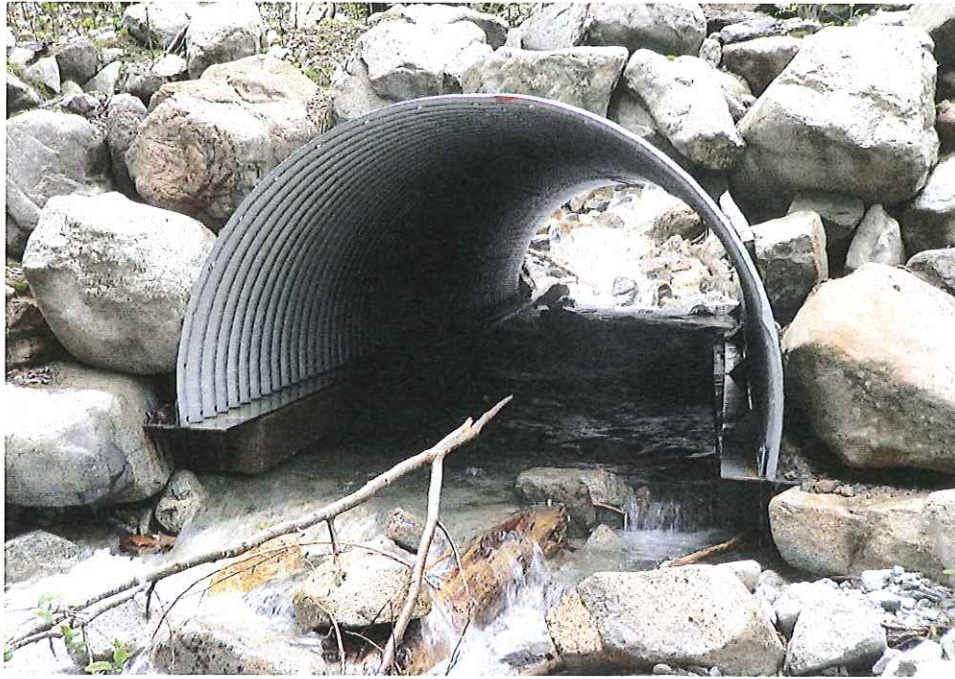
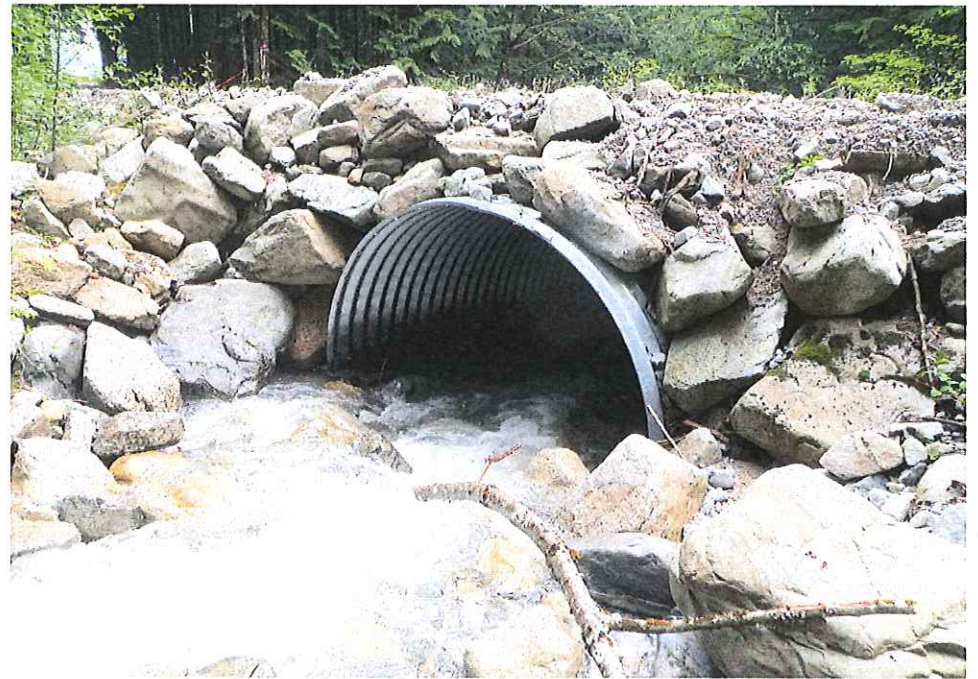
Consider burying riprap across stream w/ top exposed 0.1m above steel footing plate of culvert to help slow stream & further erosion of concrete footing pads. The riprap should be located approximately 2m from outlet of culvert. Either way need to monitor eroding footing pads. BCL-625 or 63 tonnes load rating.
