**DEWDNEY-ALOUETTE REGIONAL DISTRICT  
MISSION, B.C.**

**HATZIC PRAIRIE DRAINAGE STUDY  
VOLUME 2**

*August 1992*

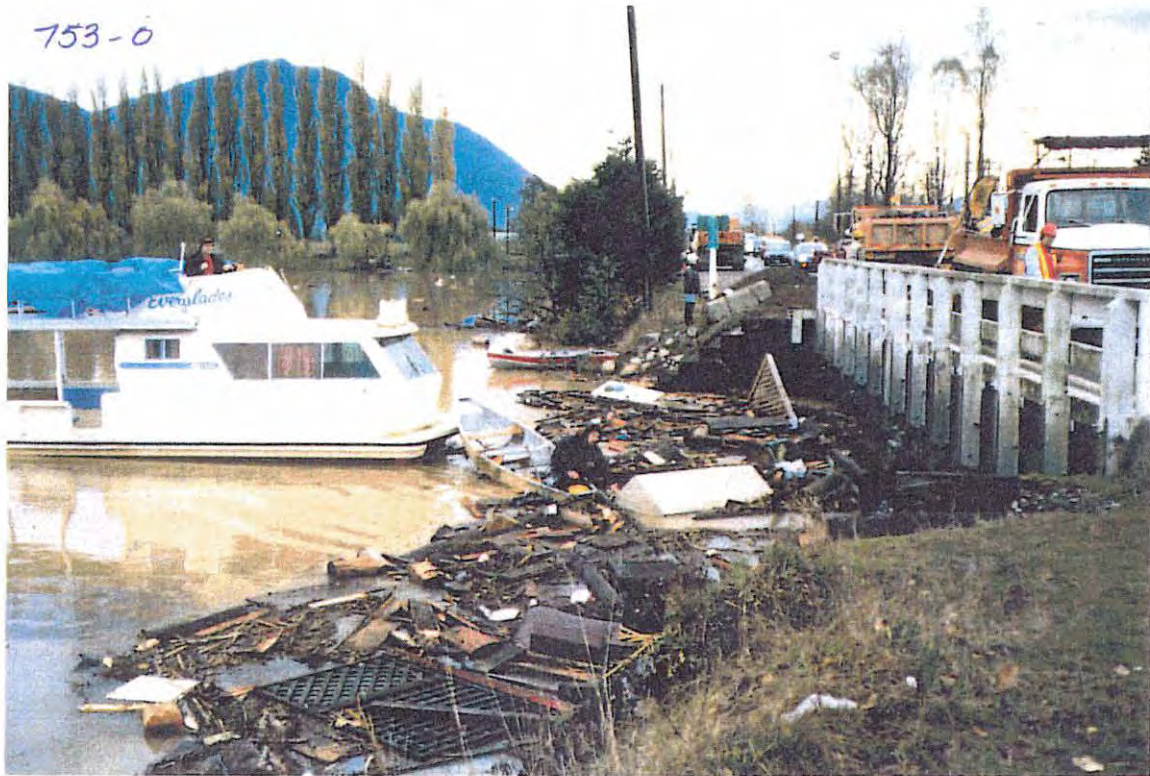
PHOTO No. 2.1

Hatzic Lake at Lougheed Highway and CPR culverts.  
Debris accumulation at the CPR culverts.  
(November 12, 1990)  
(Photo courtesy B.C. Min. of Environment)

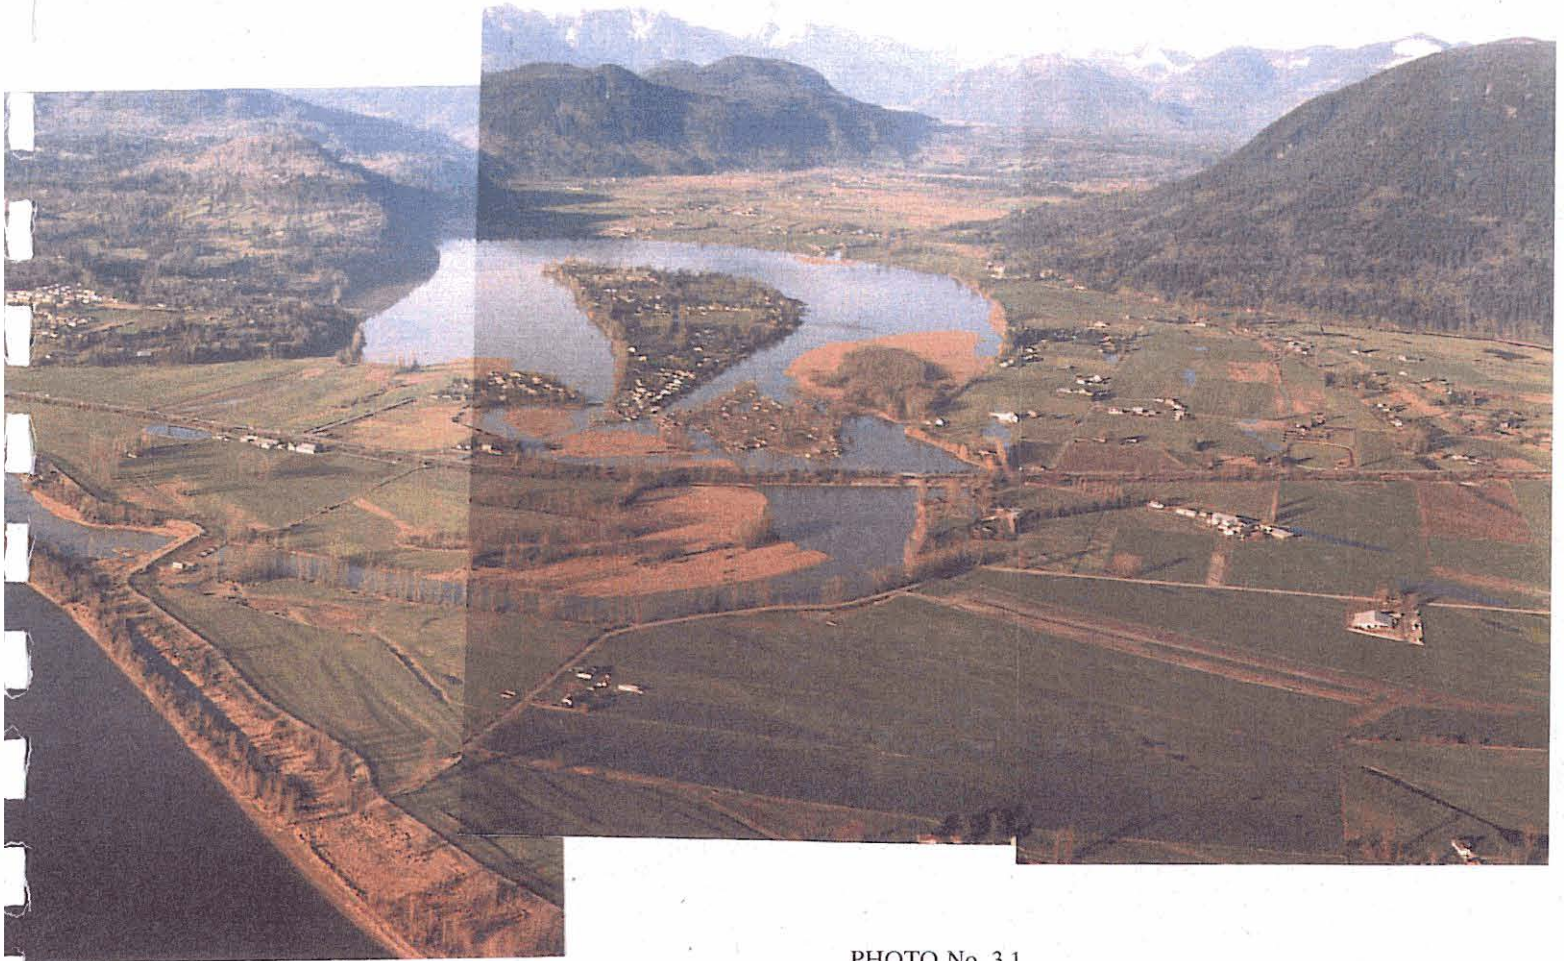
PHOTO No. 3.1

View of Hatzic Lake and Hatzic Prairie.  
The floodboxes at the outlet to Fraser River are at the  
left, the lake is in the middle of the photo.

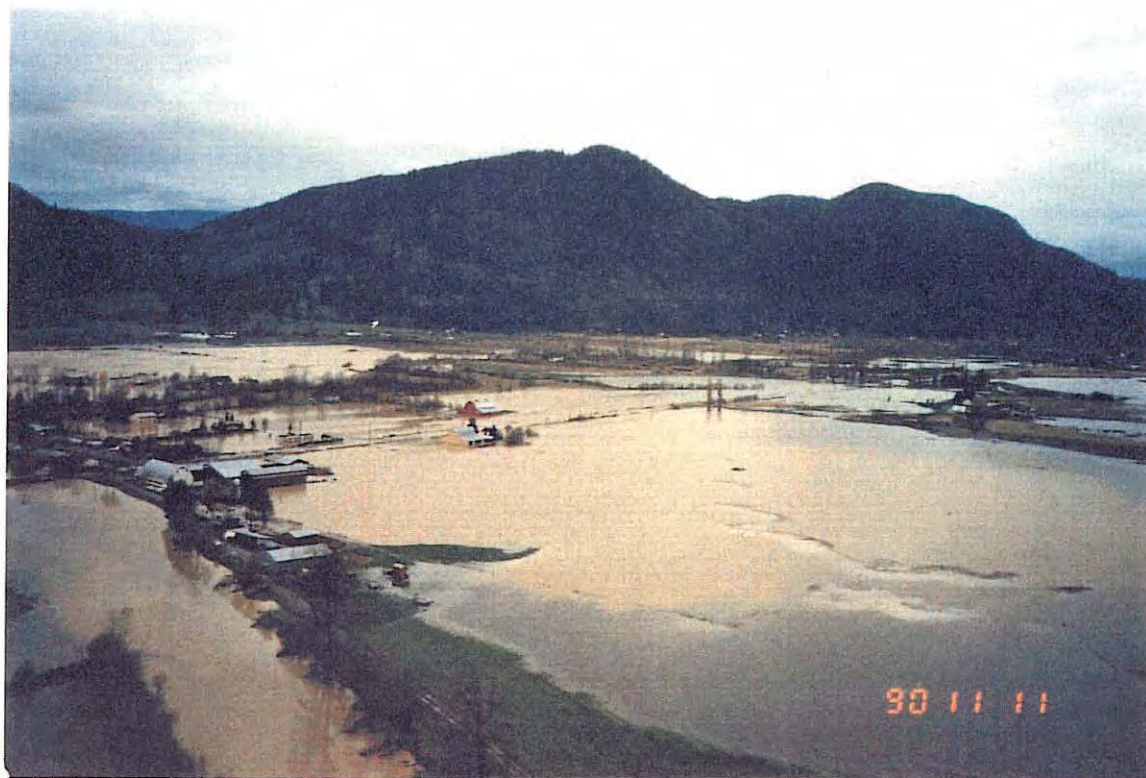
PHOTO No. 3.2

Flooding of Hatzic Prairie.

Lagace Creek flows within the treed area in the middle of the photo and Farms road is between the two barns (red and yellow).

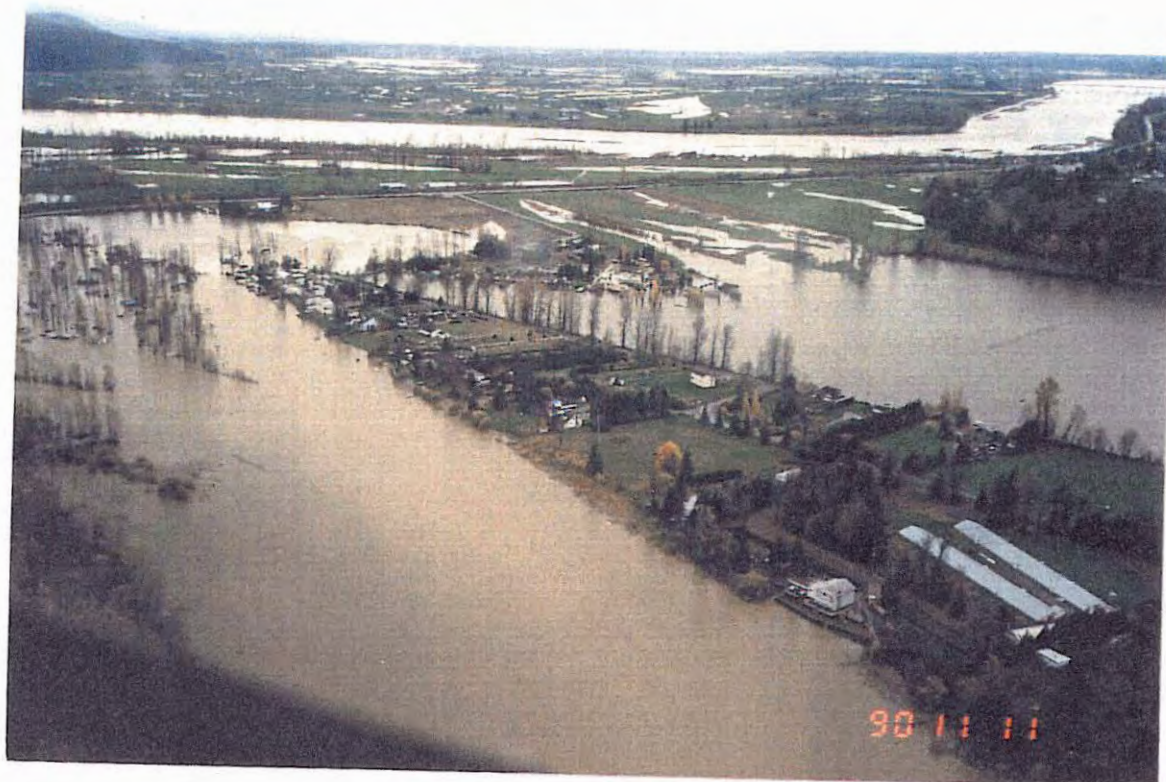
PHOTO No. 3.3

Flooding at the south end of Hatzic Lake.  
The Fraser river is flowing left to right in the background.

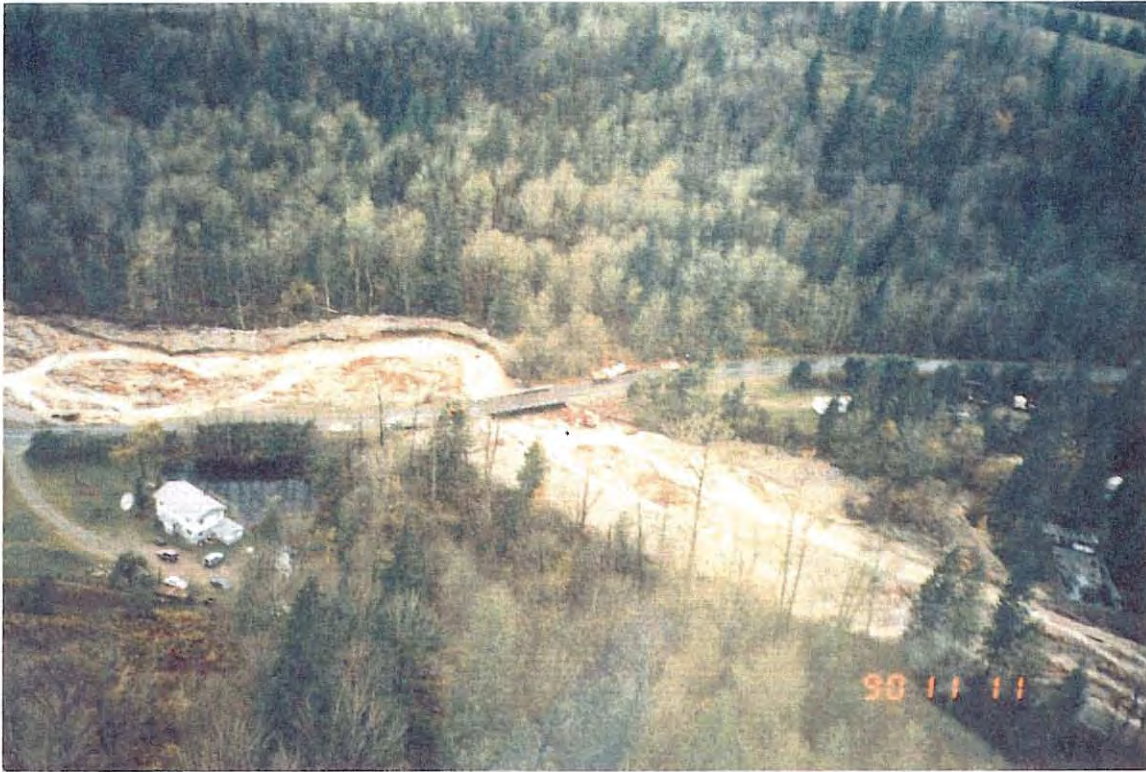
PHOTO No. 3.4

Bank erosion upstream and downstream from Sylvester Road Bridge during November, 1990 flood. Flow is right to left. The debris flow deposit along the right bank downstream from the bridge has been eroded as well as the left bank adjacent to the highway.

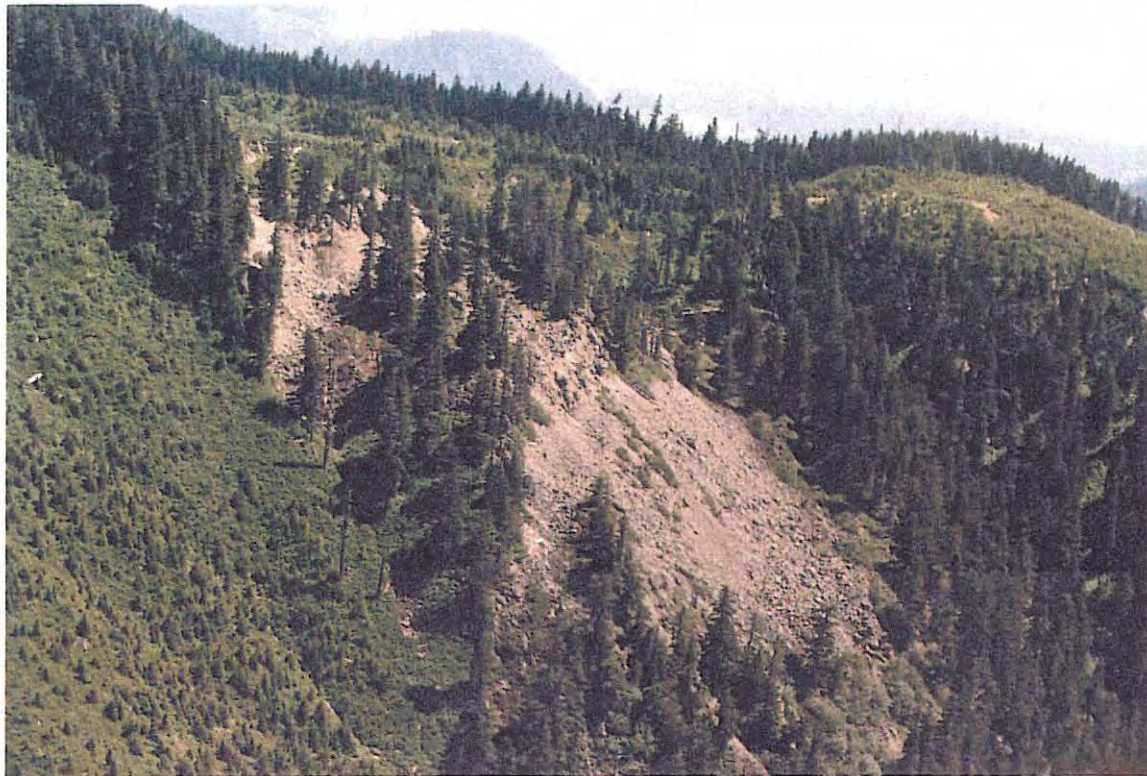
PHOTO 3.5

First landslide (Slide A) in Pattison Creek Watershed.  
The slide occurred in 1935 prior to any logging  
and is now inactive.

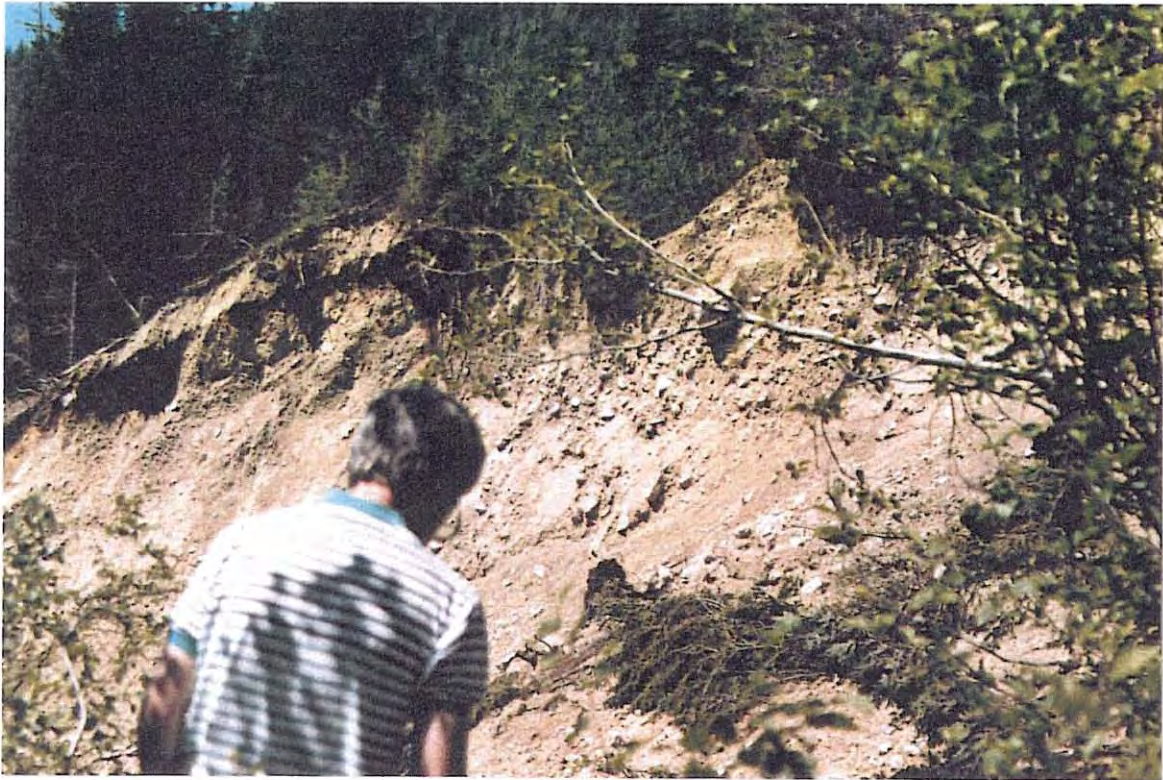
PHOTO No. 3.6

Material at the upper portion of landslide C.  
The material consists of sand, gravel and cobbles.  
The remnants of a logging road is evident in the middle of the photo.

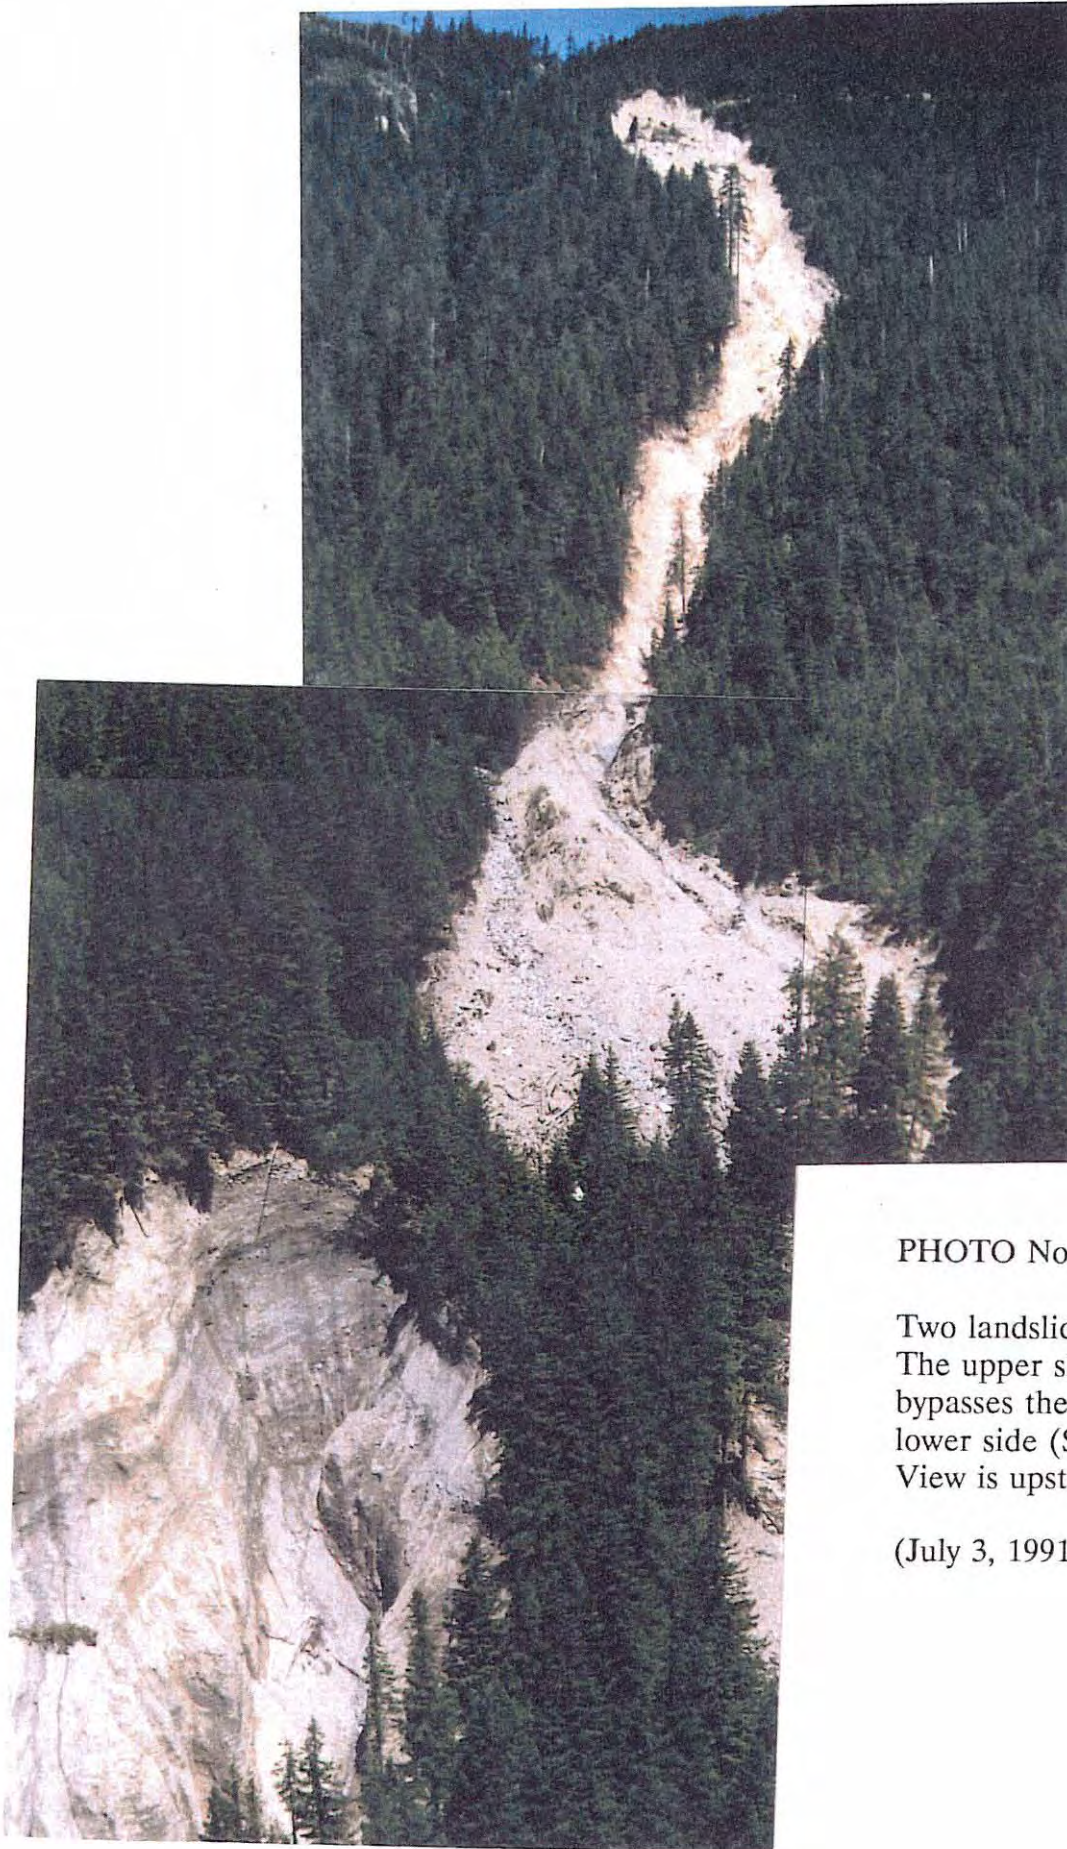
PHOTO No. 3.7

Two landslides on Pattison Creek  
The upper slide (C) completely  
bypasses the much deeper  
lower side (Slide B)  
View is upstream to the watershed.

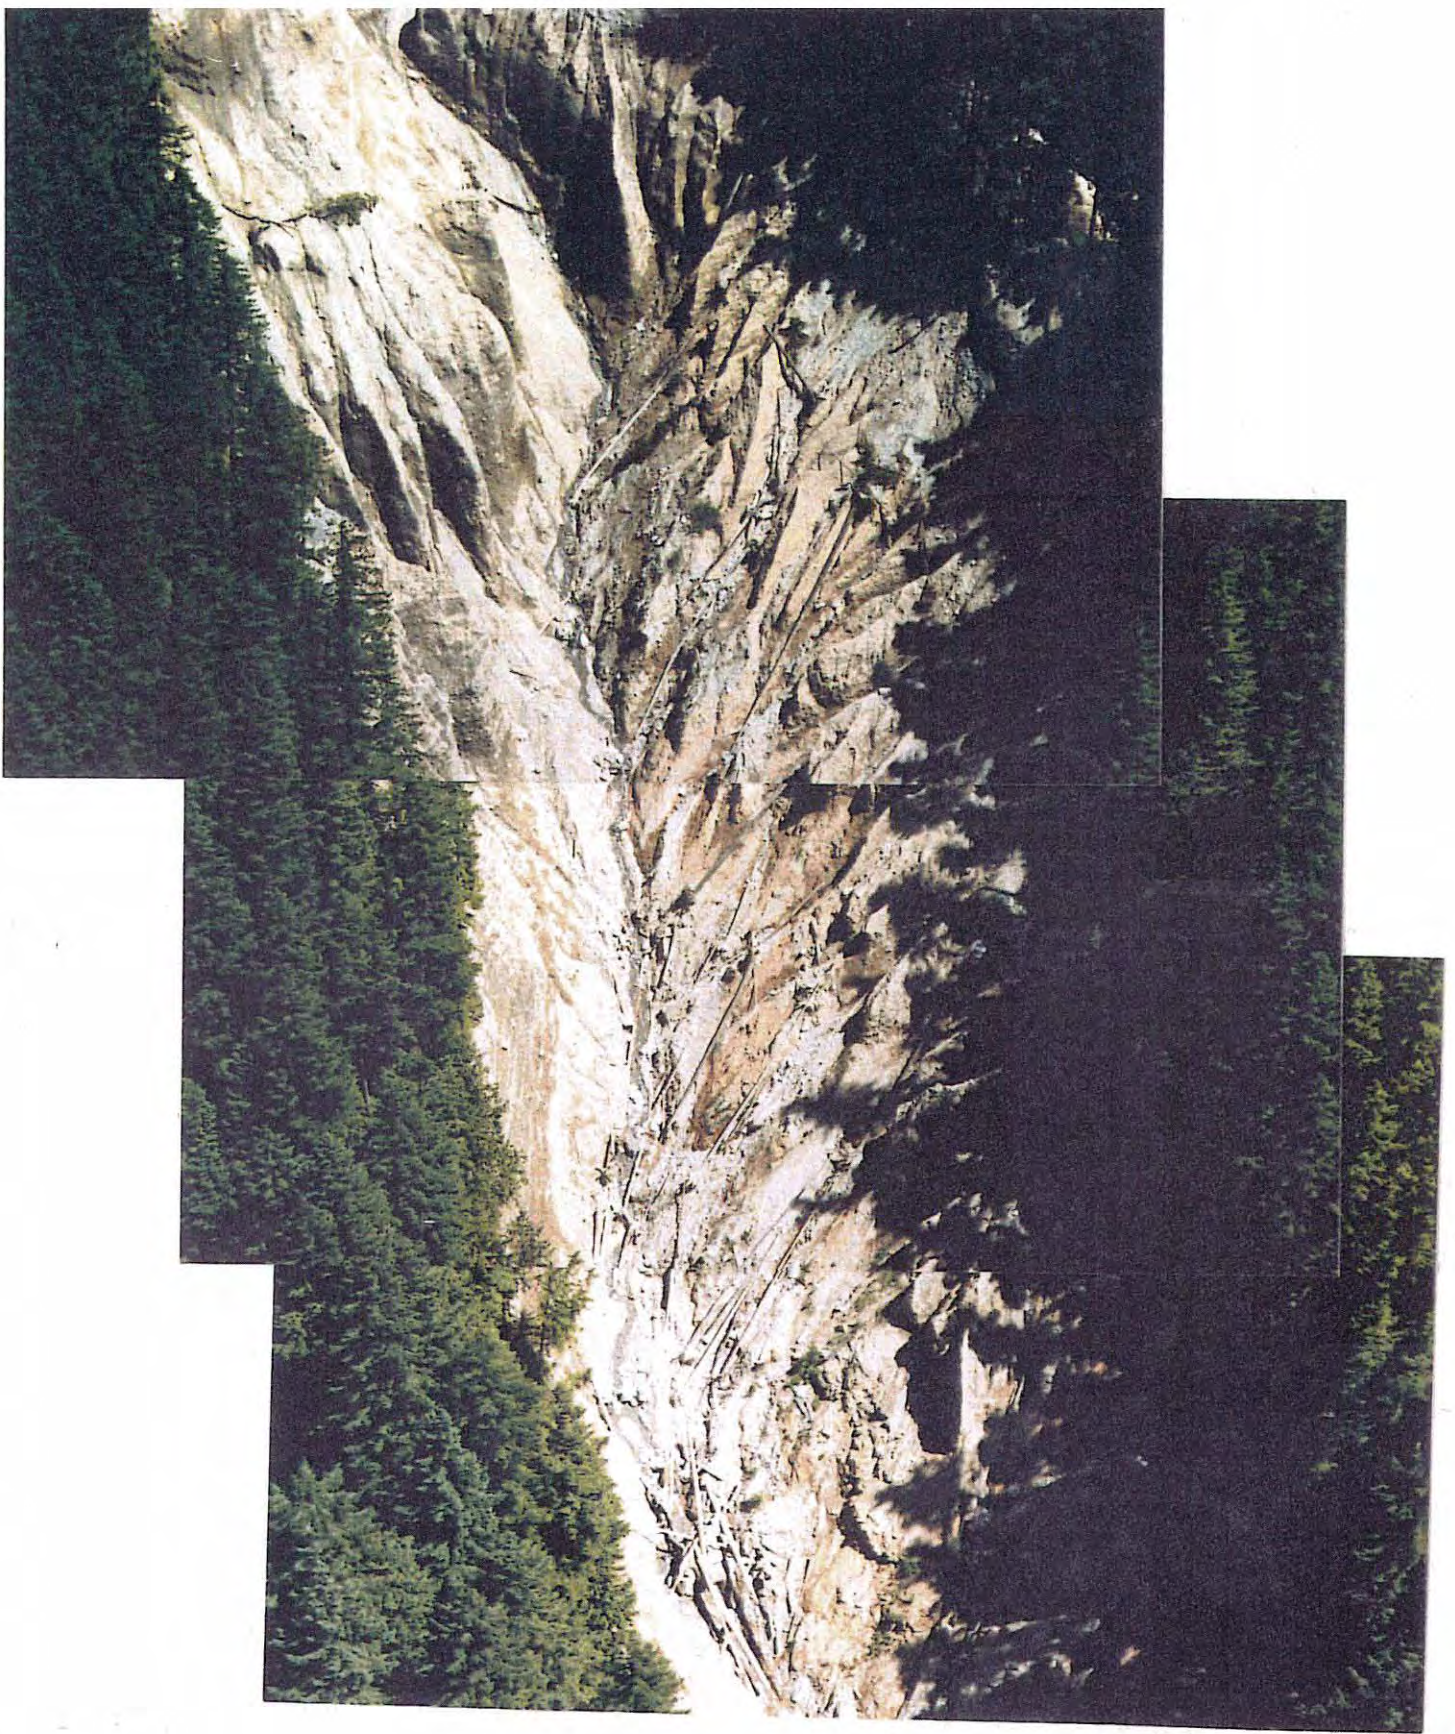
PHOTO No. 3.8

Upslope View of lower Slide (B)  
showing stiff sides and trees at the base  
of the eroded area.

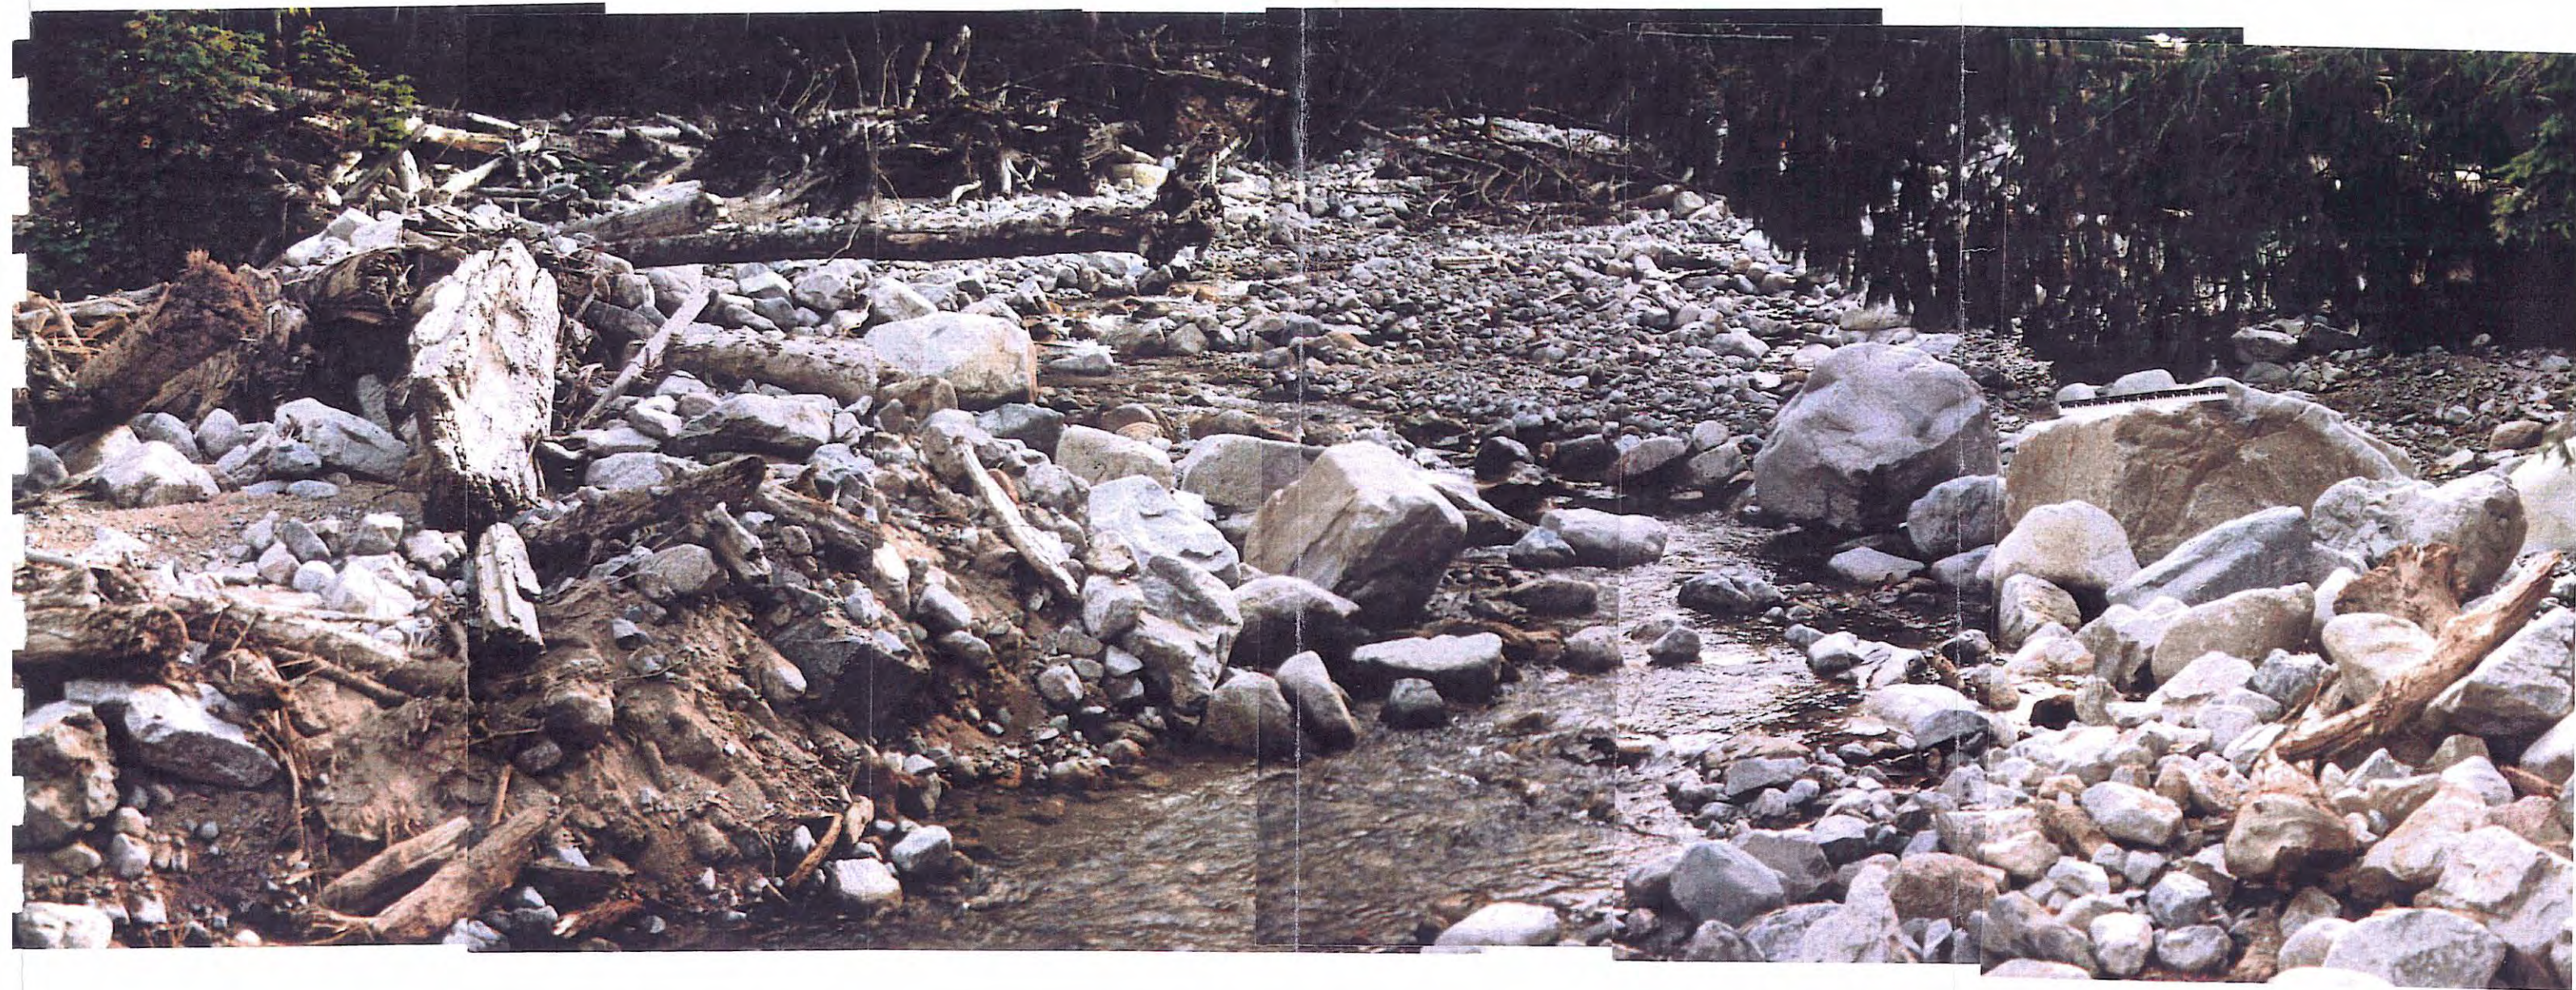
PHOTO 3.9

PATTISON CREEK

Looking upstream at alluvial fan just downstream from waterfall (approx. Sta. 6+200 m). The largest boulders are up to 2.0 m along the longest axis, and the deposited material ranges from sand to boulders. Extensive log jams have induced deposition over the confined alluvial fan. The scale on the boulder at the right side is one metre long.

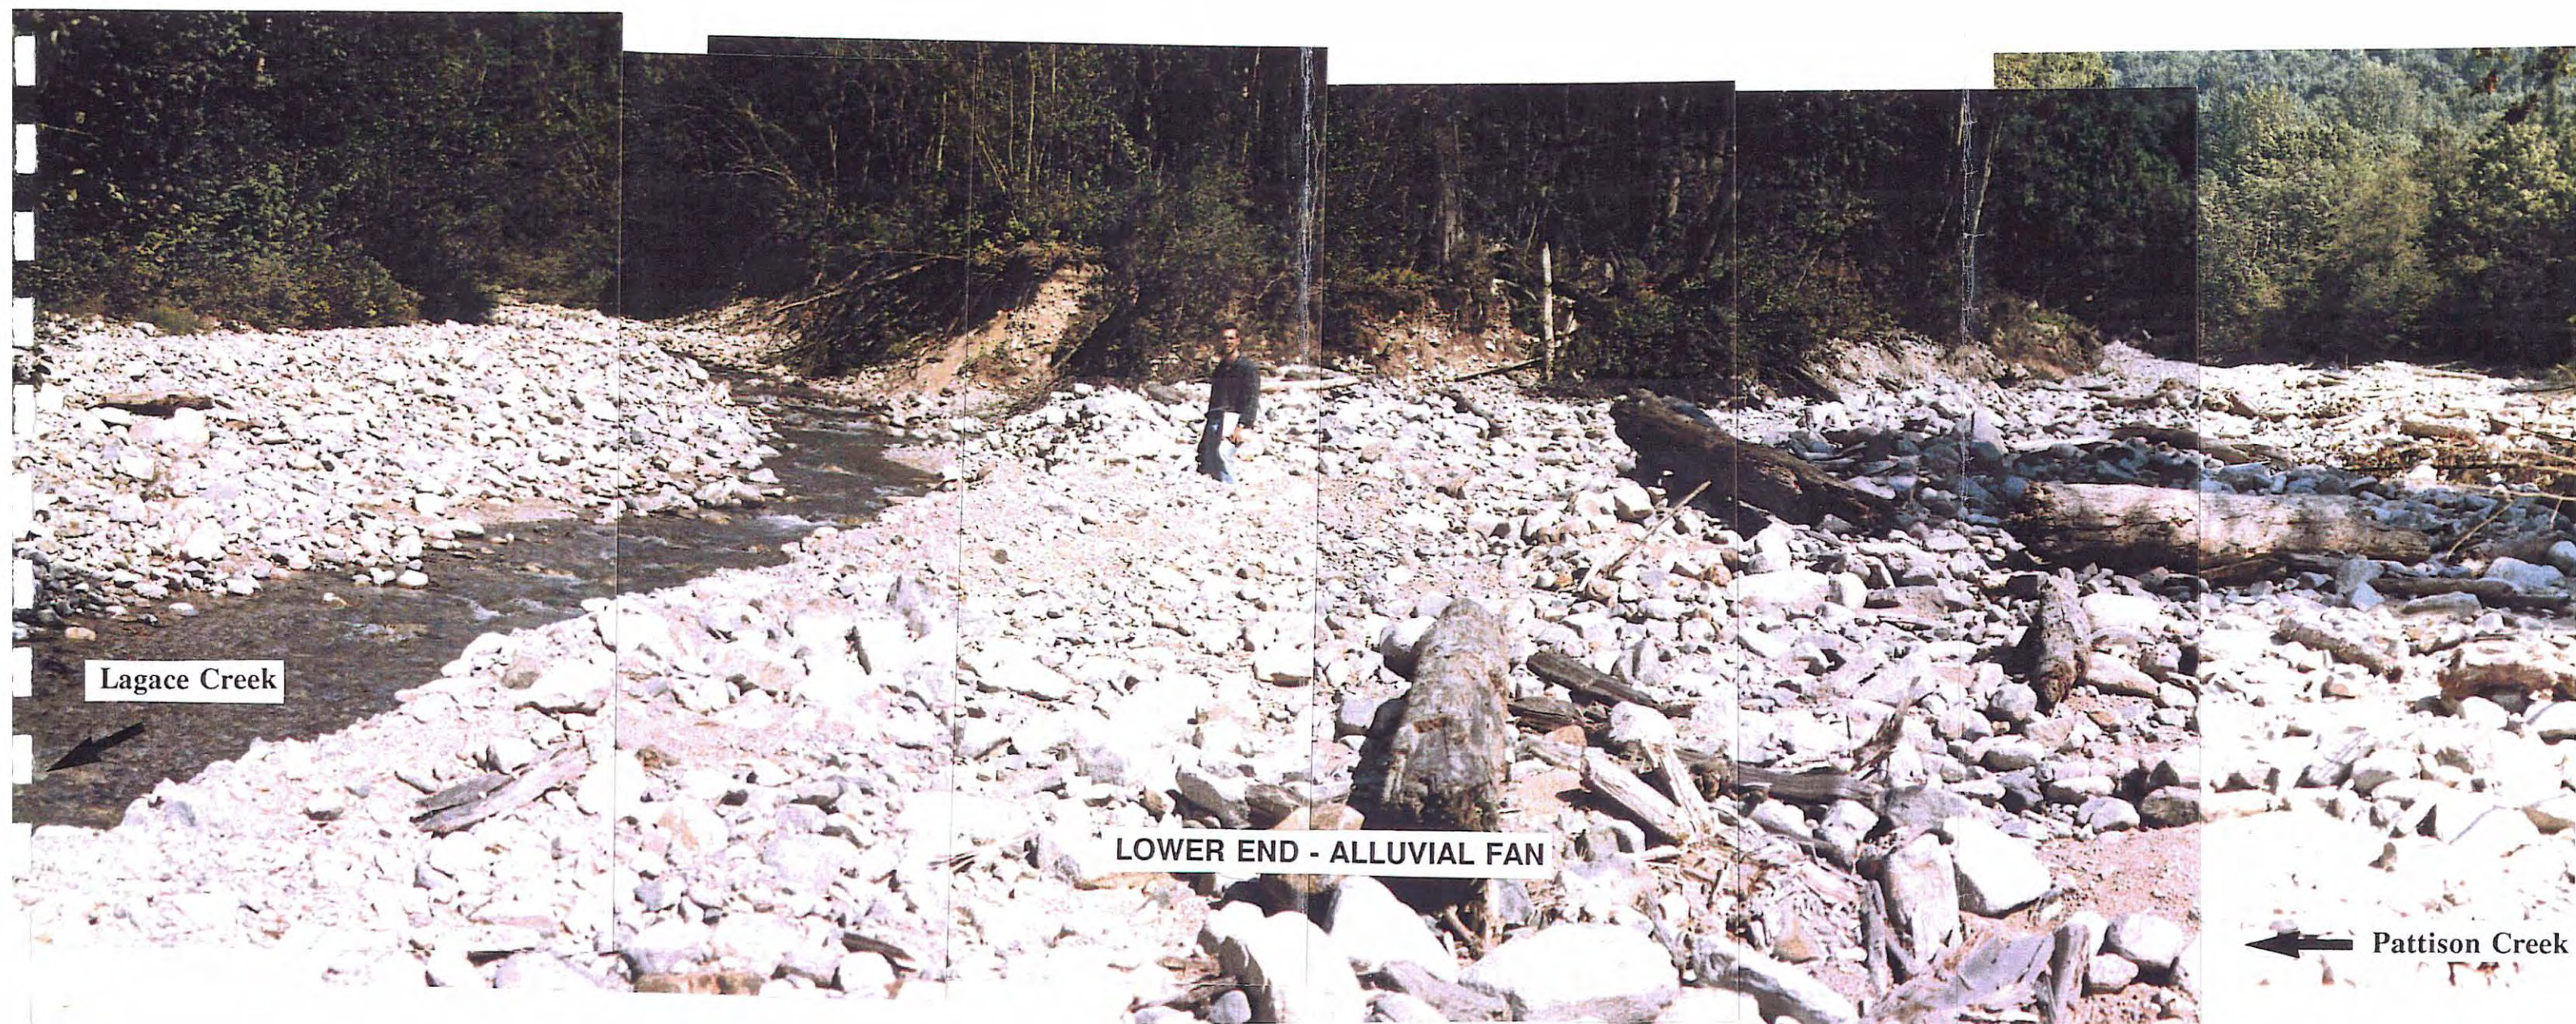
PHOTO No. 3.10

Confluence of Pattison and Lagace Creeks.  
Debris flow appears to have run out at or near confluence.  
Pattison Creek enters from the right of the photo.

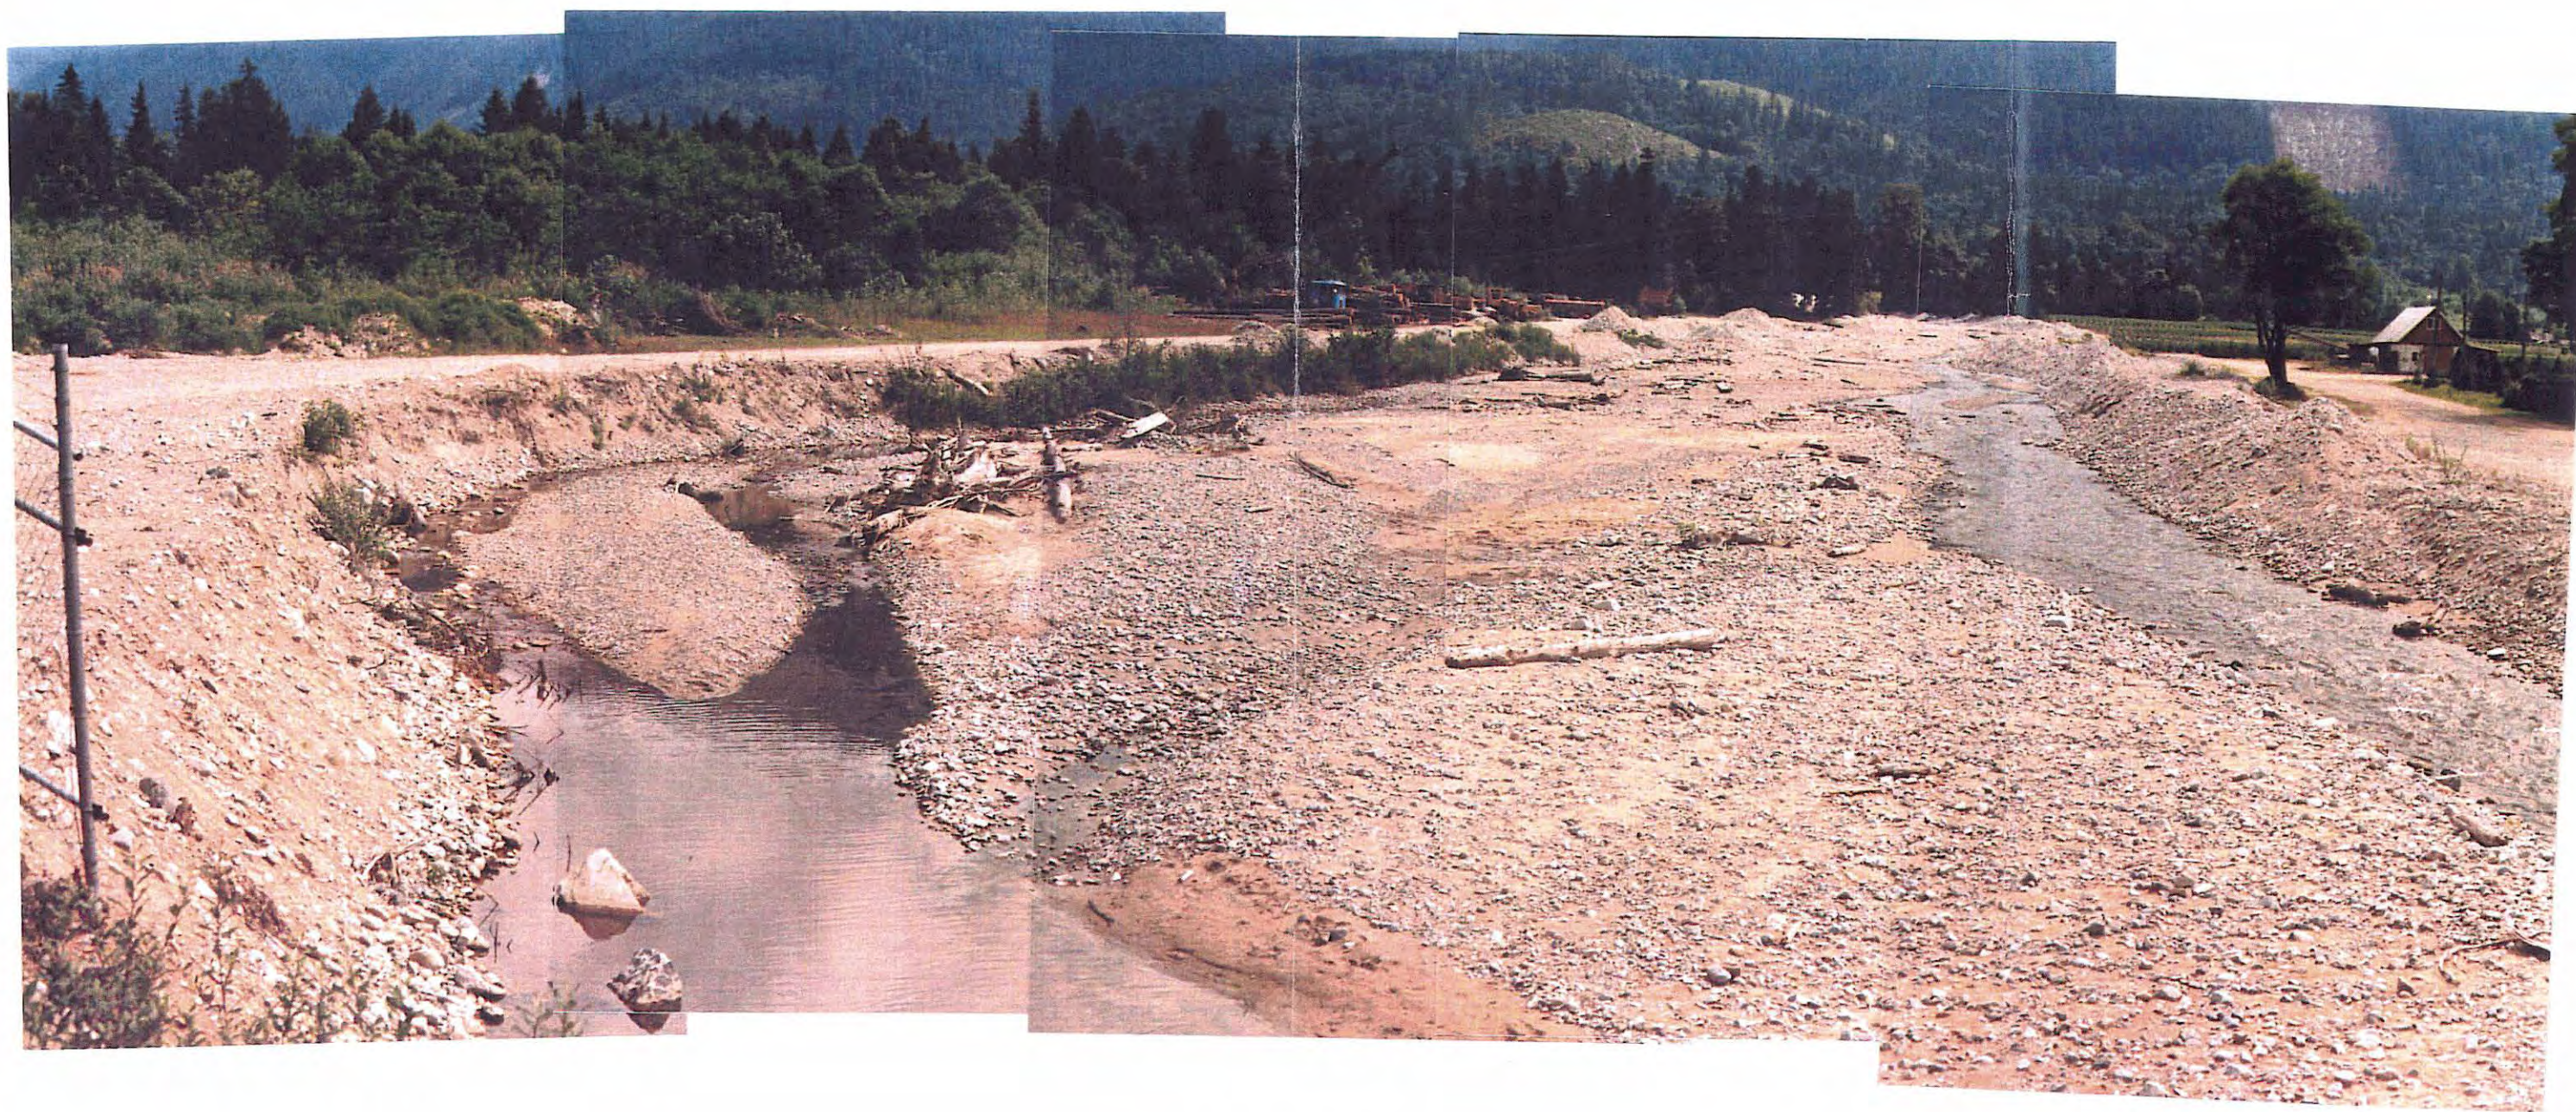
PHOTO No. 3.11

Lagace Creek - upstream view from Farms Road Bridge (Sta. 2+284)

The channel is about 30 m wide through this reach.

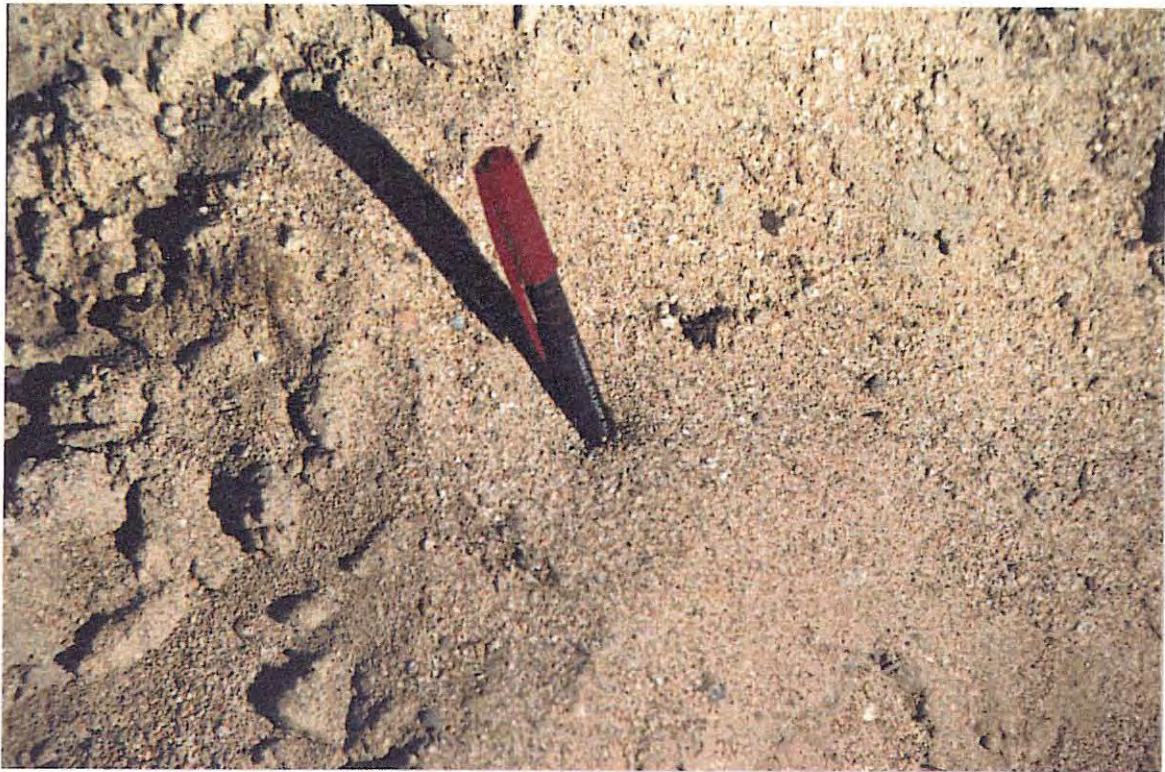
PHOTO No. 3.12

Coarse sand excavated from bed of Lagace Creek at Dale Road Bridge.

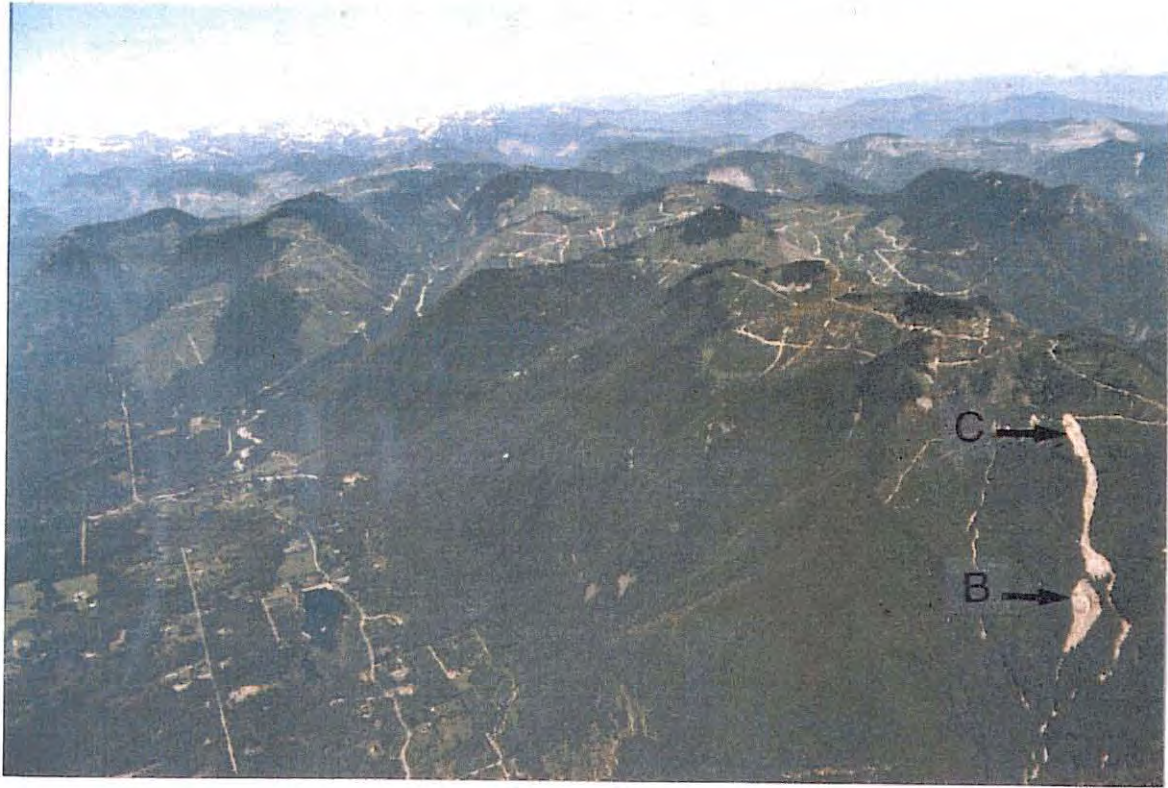
PHOTO No. 3.13

Looking upstream to the Pattison Creek watershed on the right, showing landslides B and C, and the eastern slopes of the Lagace Creek Watershed. Allen Lake is located near the bottom of the photo.

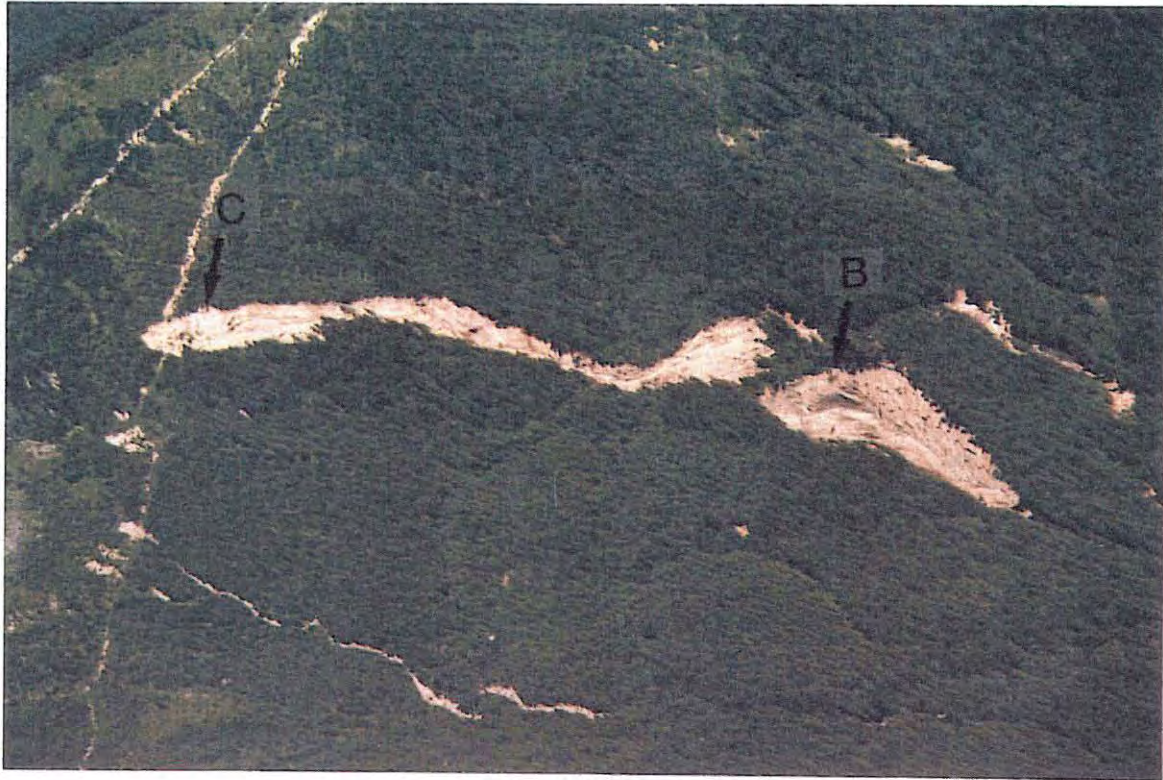
PHOTO No. 3.14

Upper portion of Pattison Creek Watershed  
showing potential for three landslides on the upper road  
and a potential headcutting of Slide B into the  
debris torrent path of Slide C.
