**DEWDNEY-ALOUETTE REGIONAL DISTRICT  
MISSION, B.C.**

**HATZIC PRAIRIE DRAINAGE STUDY  
VOLUME 2**

*August 1992*

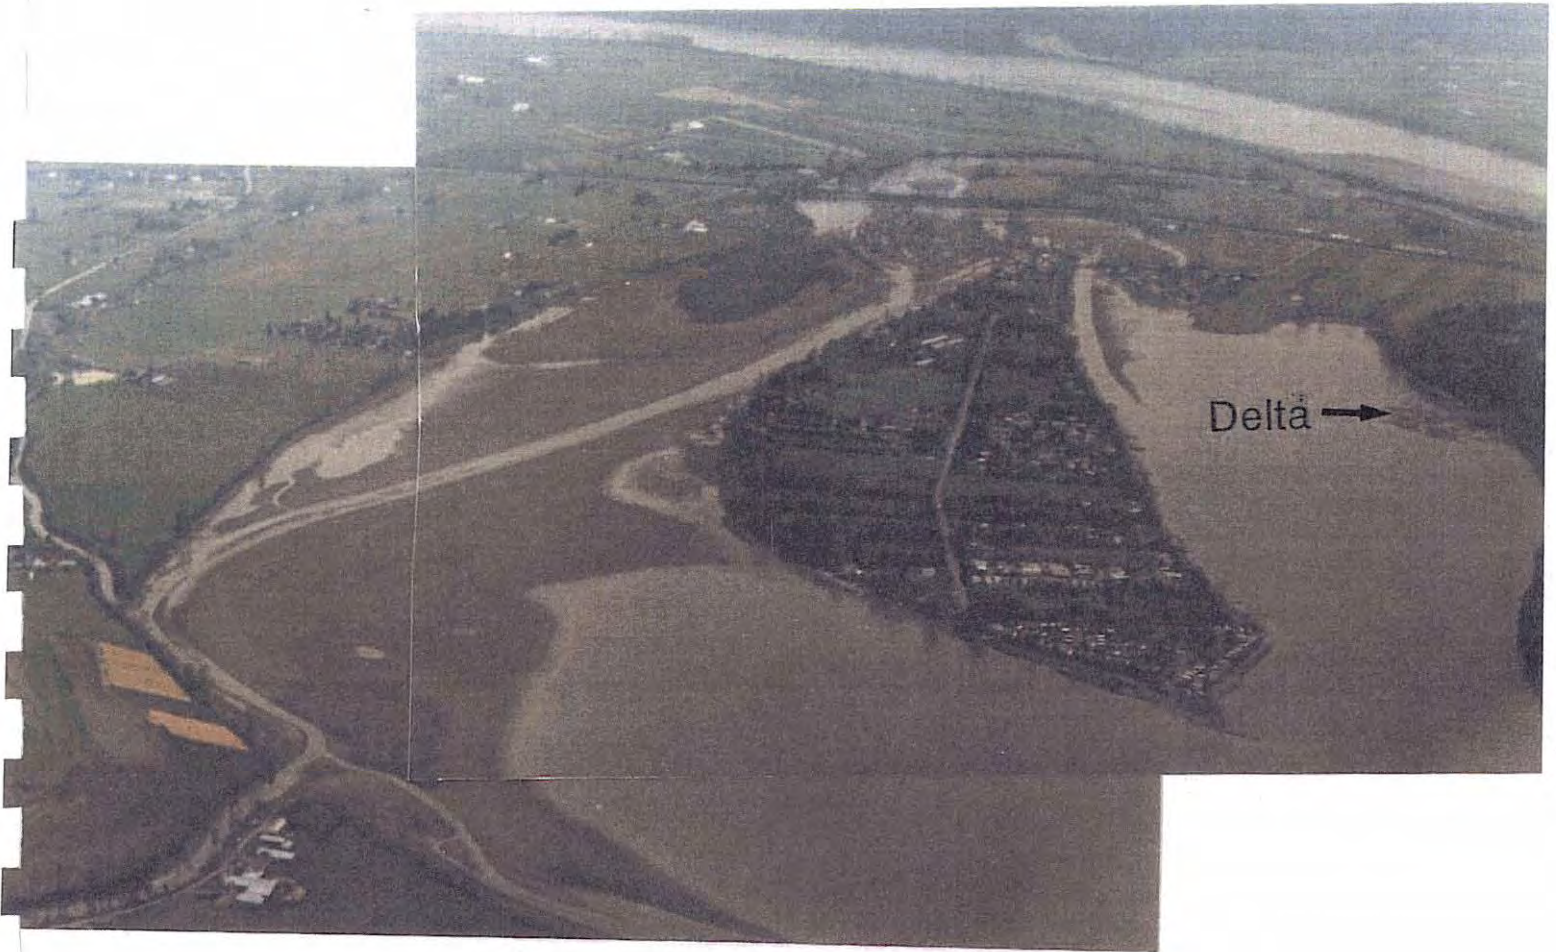
PHOTO No. 3.15

Hatzic Lake - downstream view to south end of lake.  
A small delta developed by Draper Creek is evident on the right  
and the deposition on the left (east side) appears to be  
from sediment originating in Pattison and Lagace Creeks.

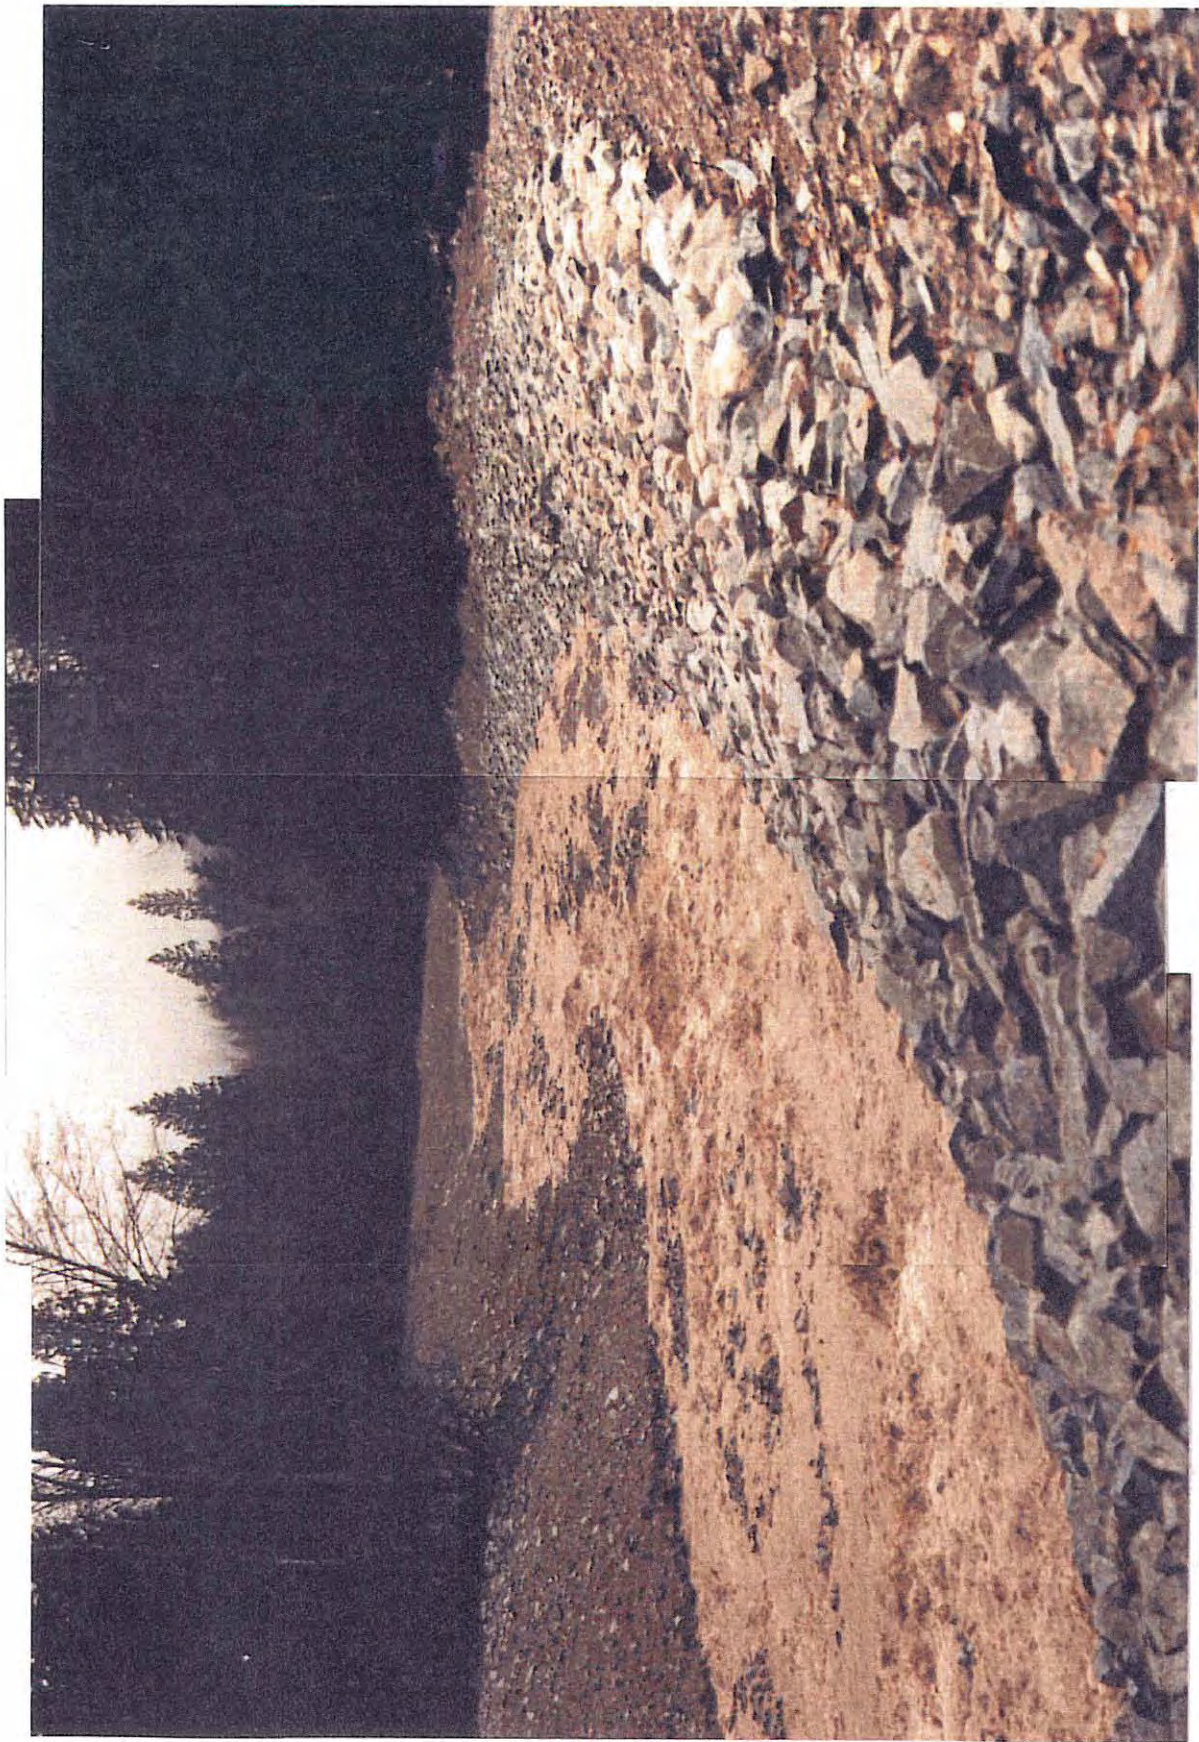
PHOTO 3.16

Pattison Creek upstream from Sylvester Road Bridge (Upstream View)  
The low flow is rapidly moving sand, gravel and silt from the creek bed.

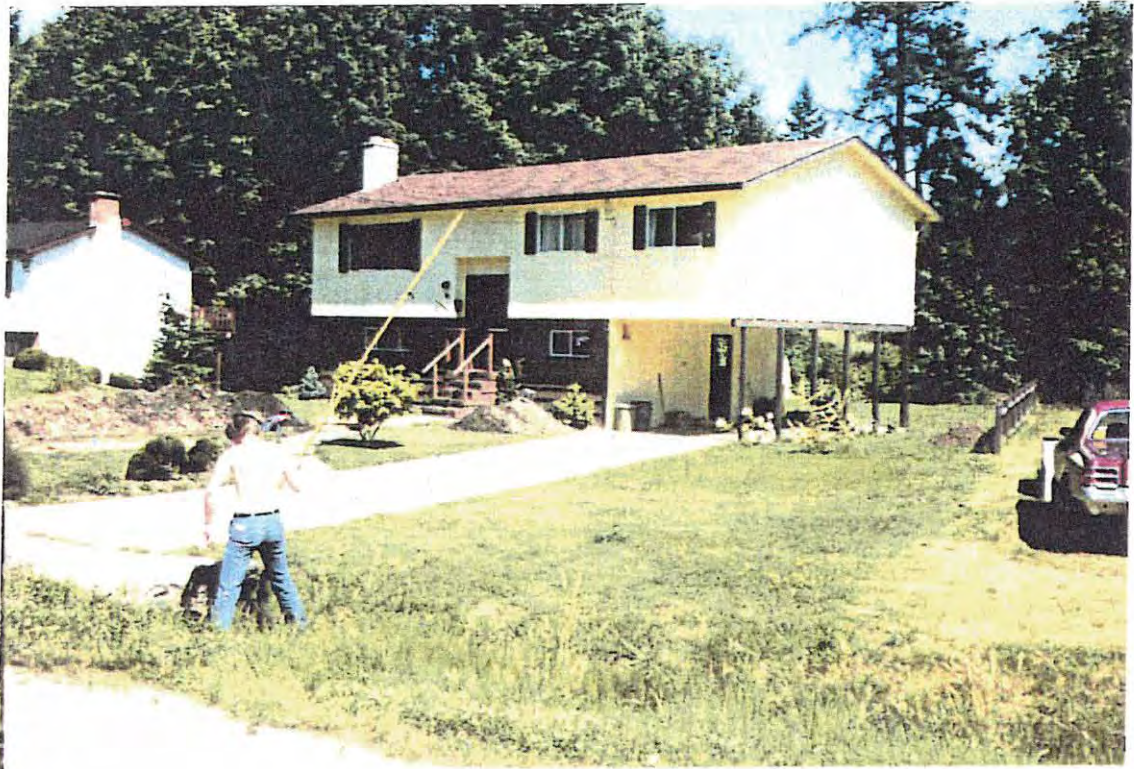
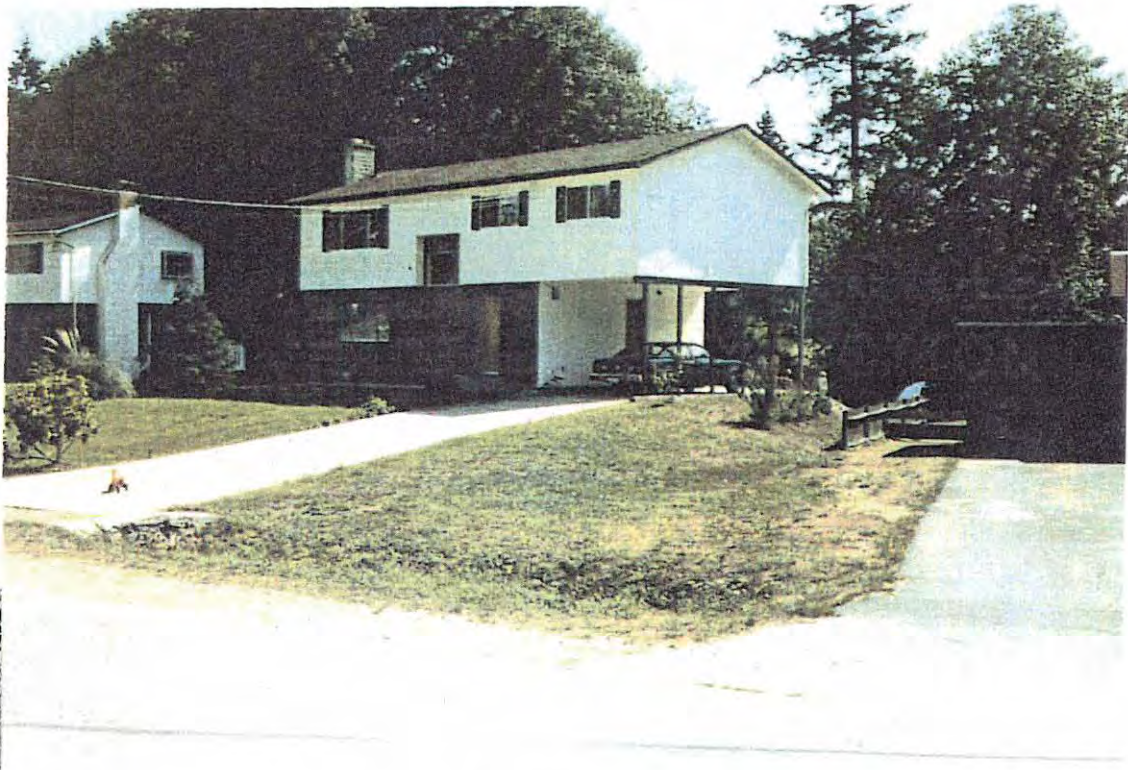
PHOTO 4.2

House raising for flood protection at Marler Drive

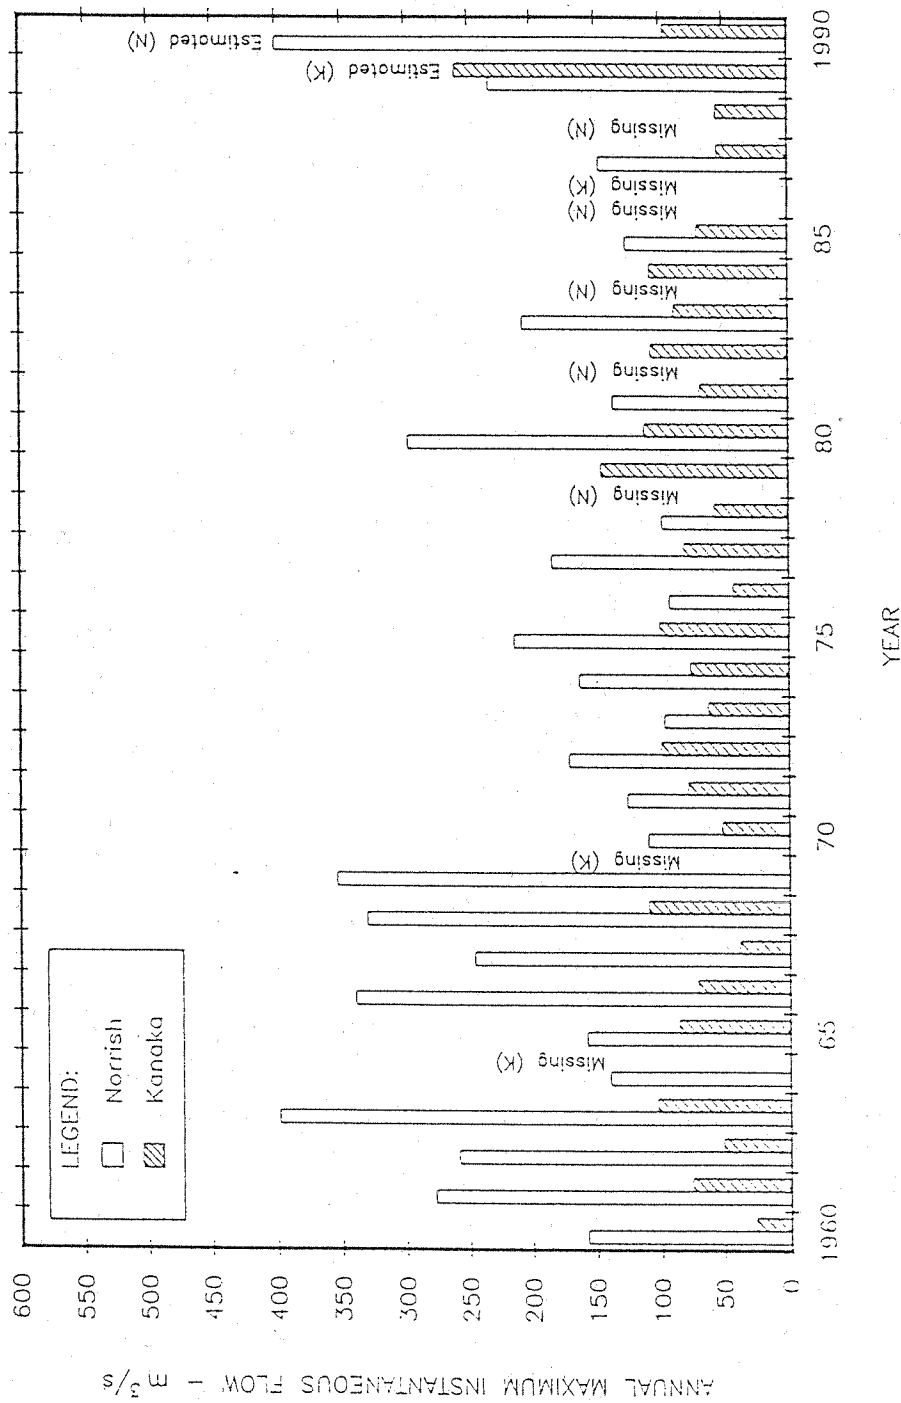
Annual Maximum Instantaneous Flows  
 Norrish and Kanaka Creeks

Sequences of reported annual maximum instantaneous flows;  
 Norrish and Kanaka Creeks, 1960 - 1990.

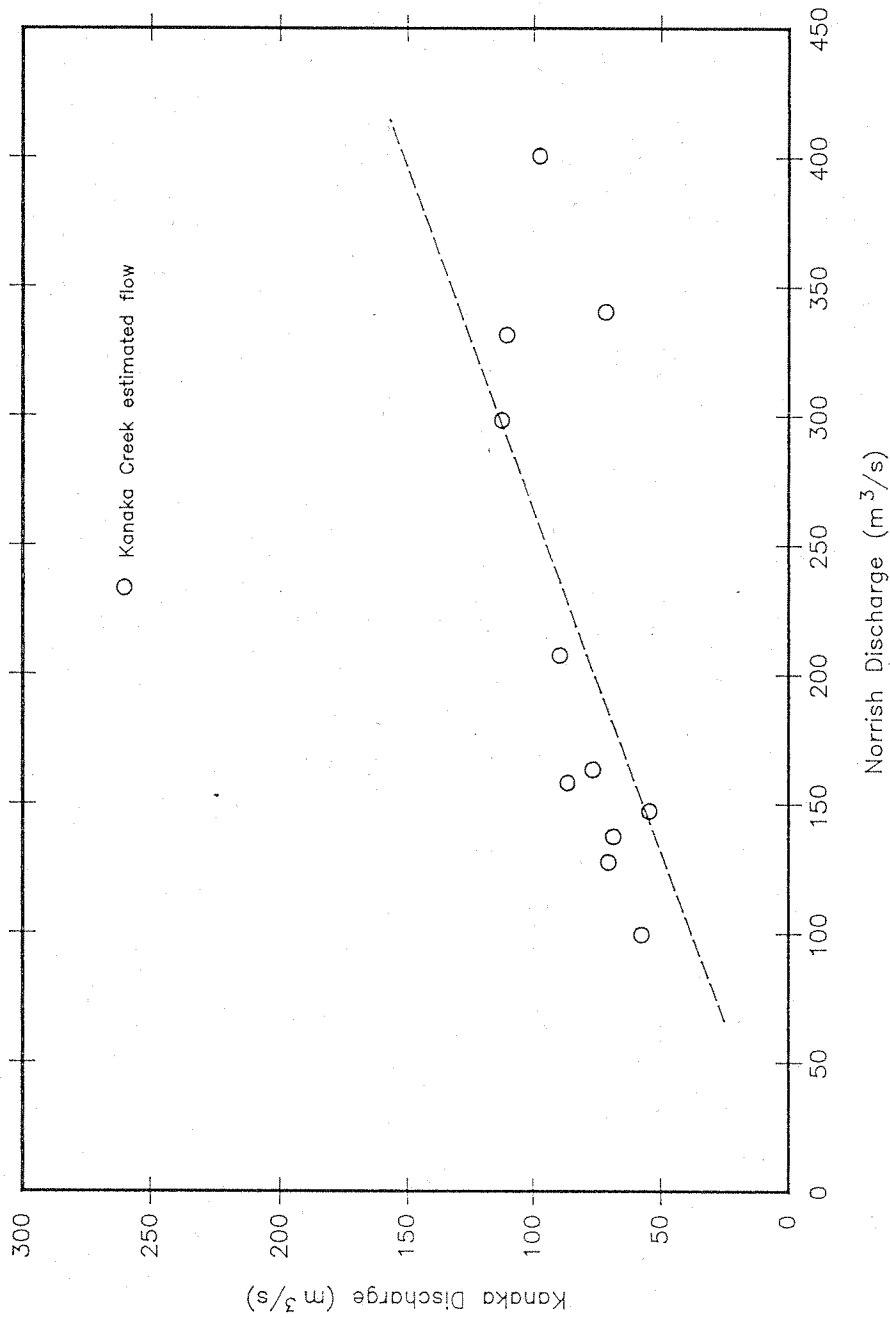
Correlation of annual maximum instantaneous flows in Kanaka and Norrish Creeks due to the same storm events.

Correlation of Annual  
Maximum Instantaneous Flows  
Norrish and Kanaka Creeks

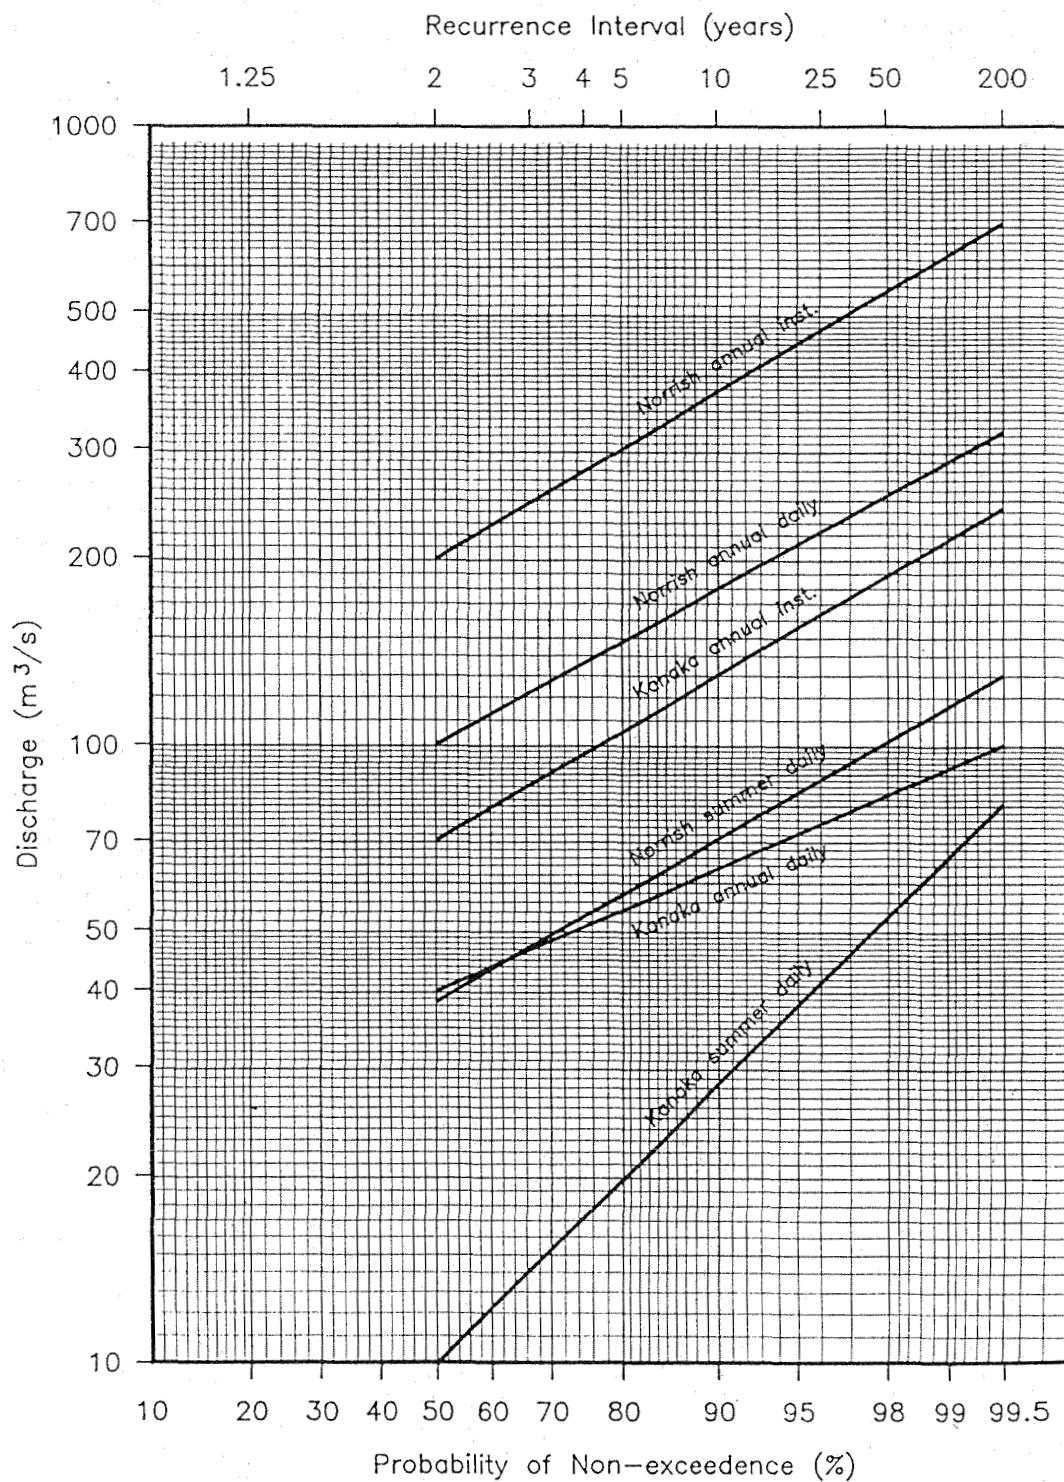
Flow Frequency Relationships  
Norrish and Kanaka Creeks

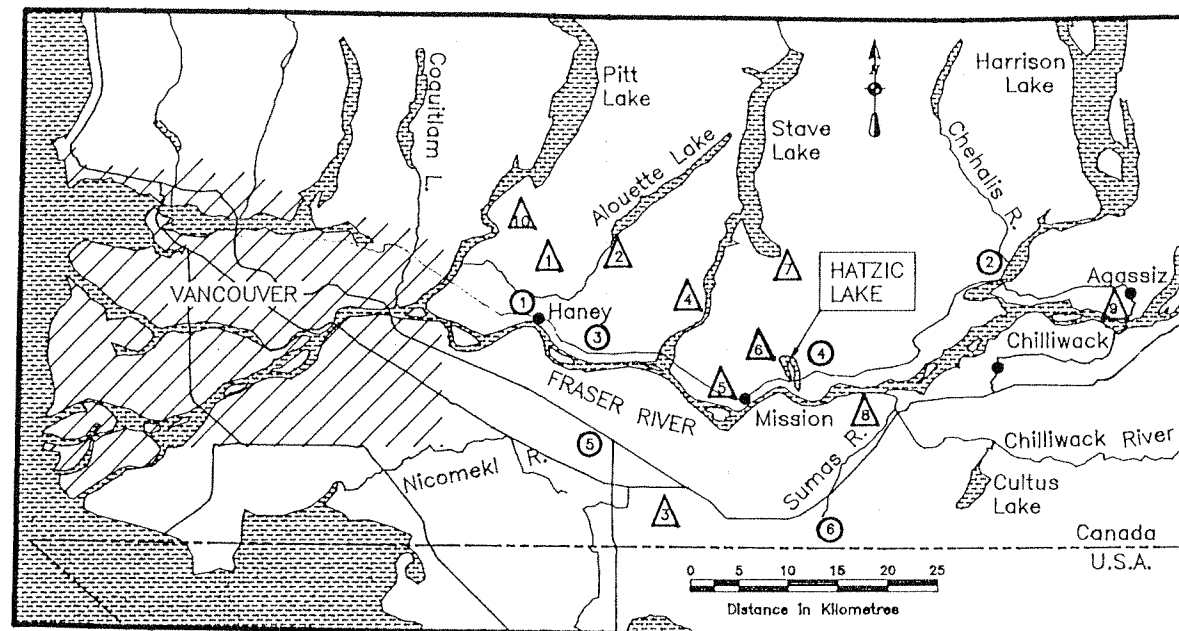
Storm Event Data  
December 1980

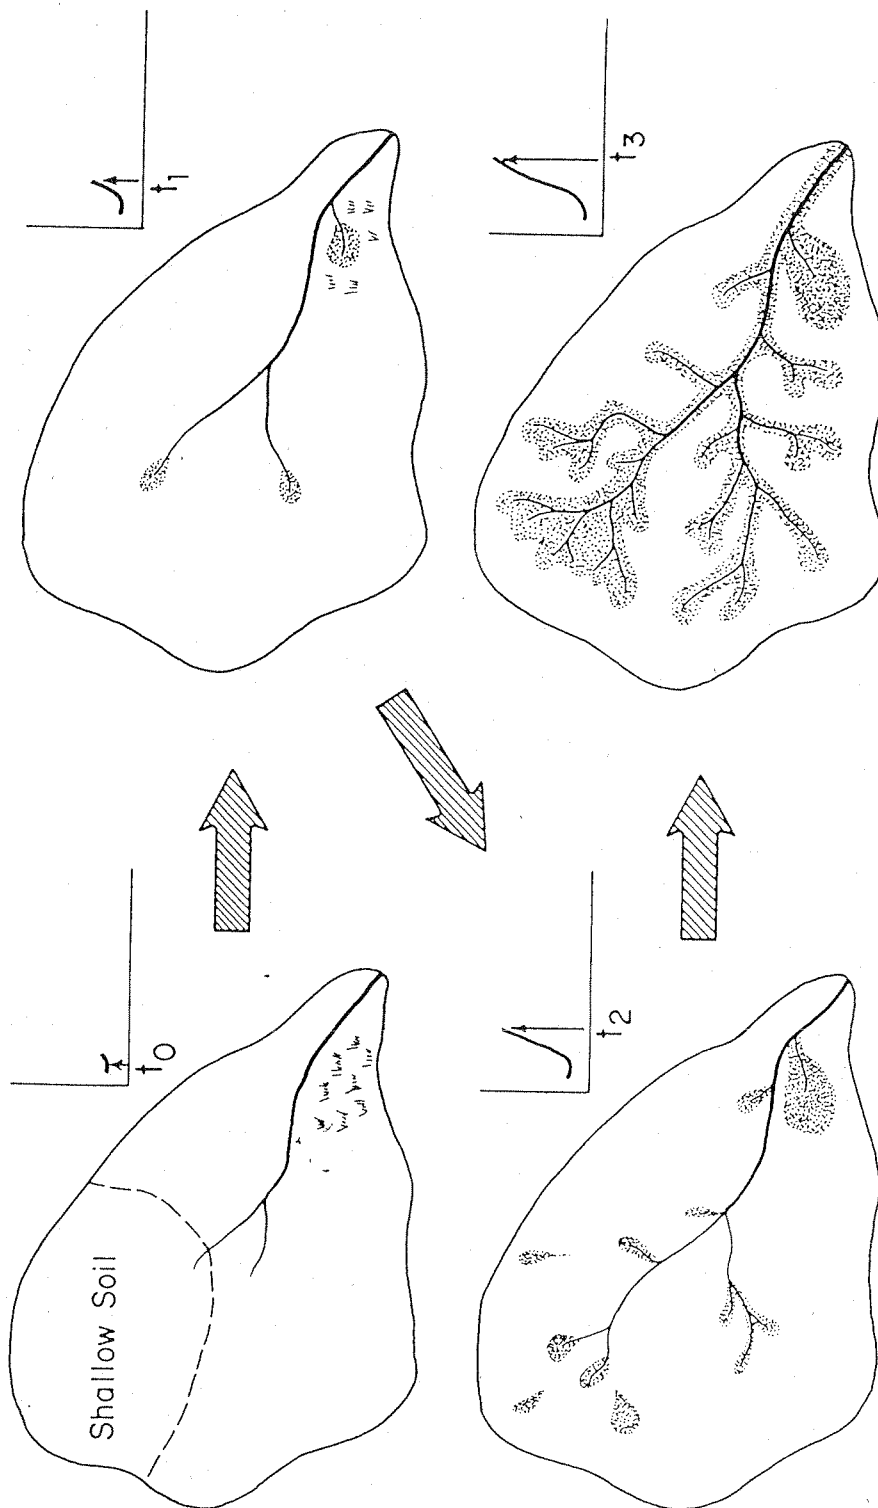
Concept of Variable Source Area  
during Storms

Notes:

1. The small arrows in the hydrographs show how streamflow increases as the variable source extends into swamps, shallow soils and ephemeral channels. The process reverses as streamflow declines.
2. After Hewlett, 1982.

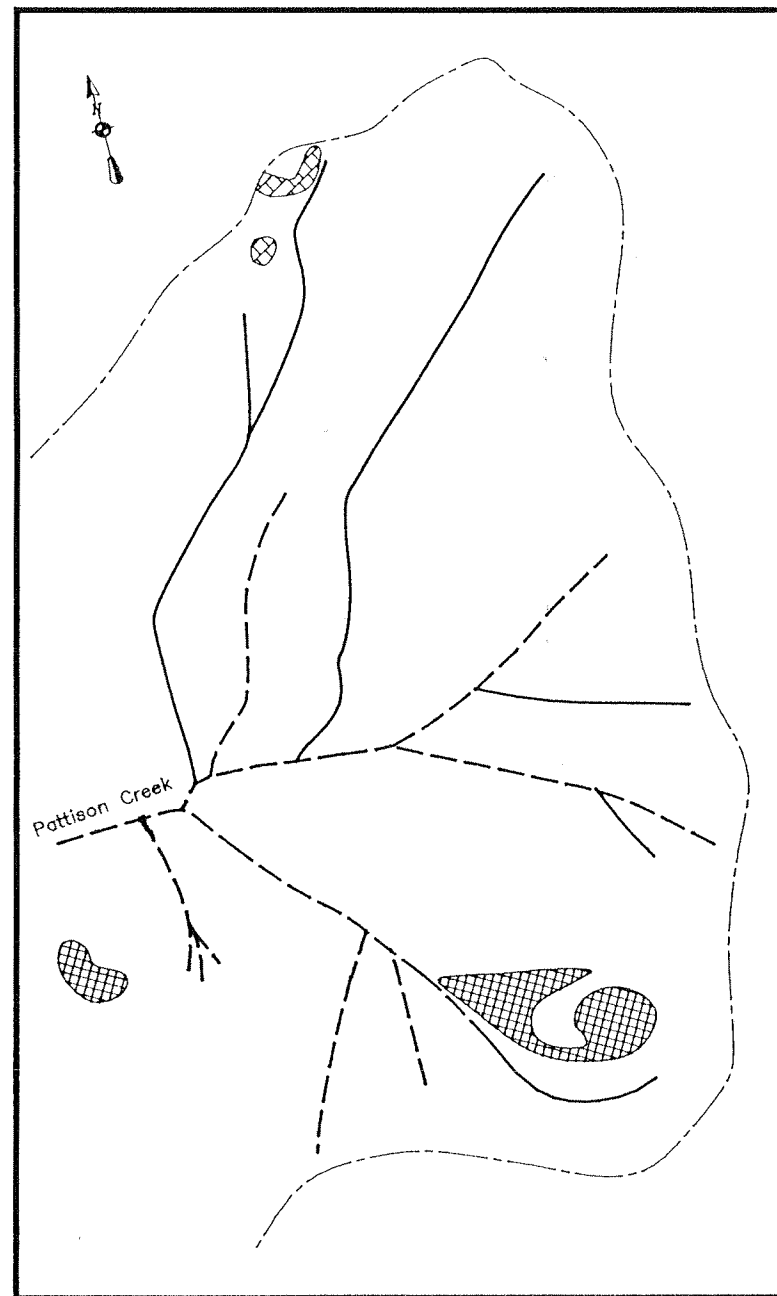
15 July, 1940

From air photos BC203 (#110-113), BC204(#5-8)

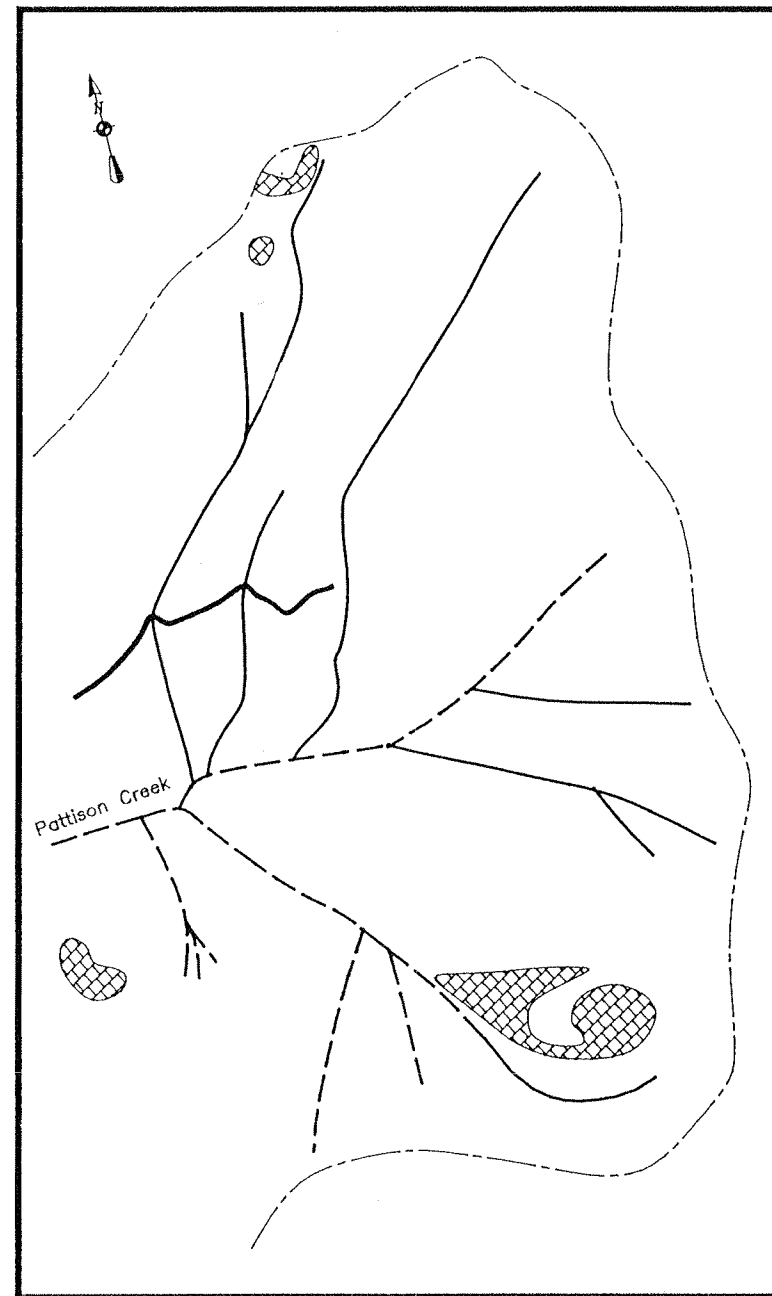
01-02 October, 1952

From air photos BC1621 (#44-45, 66-68)

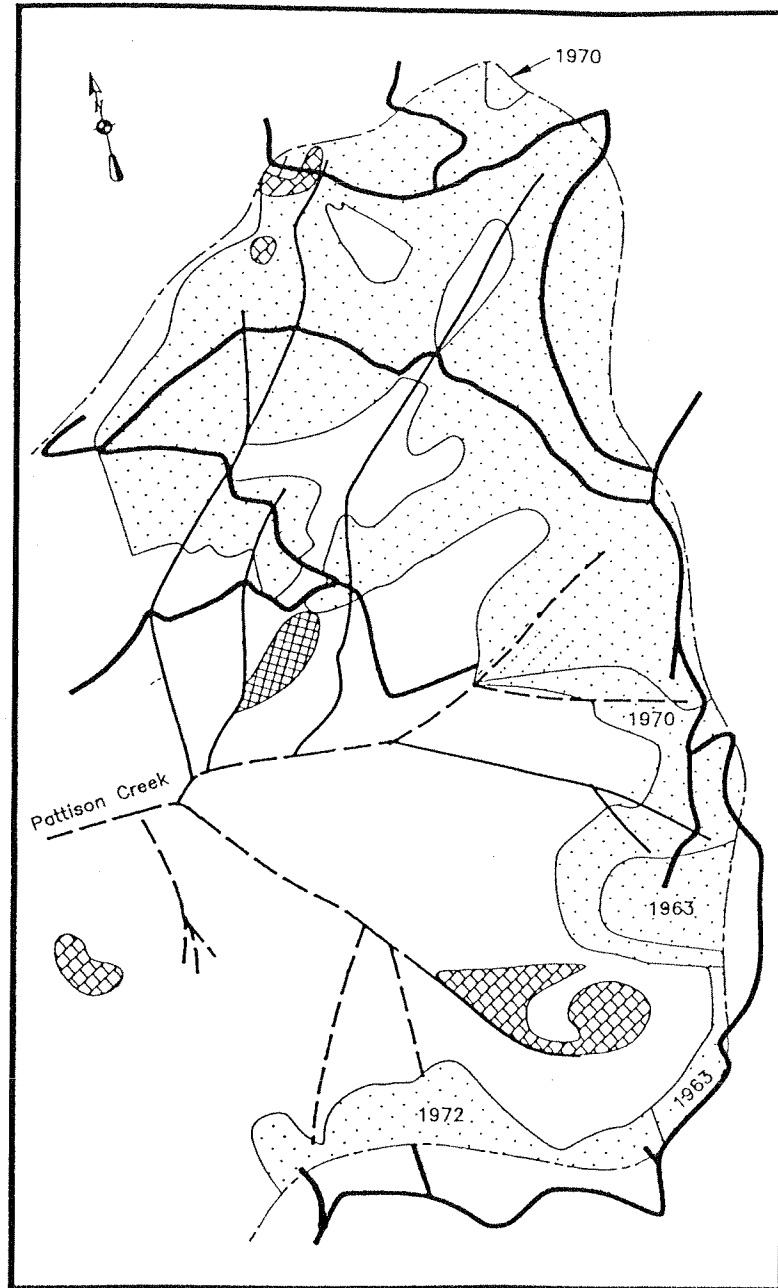
31 May, 1974

From air photos BC4067 (#211-214)

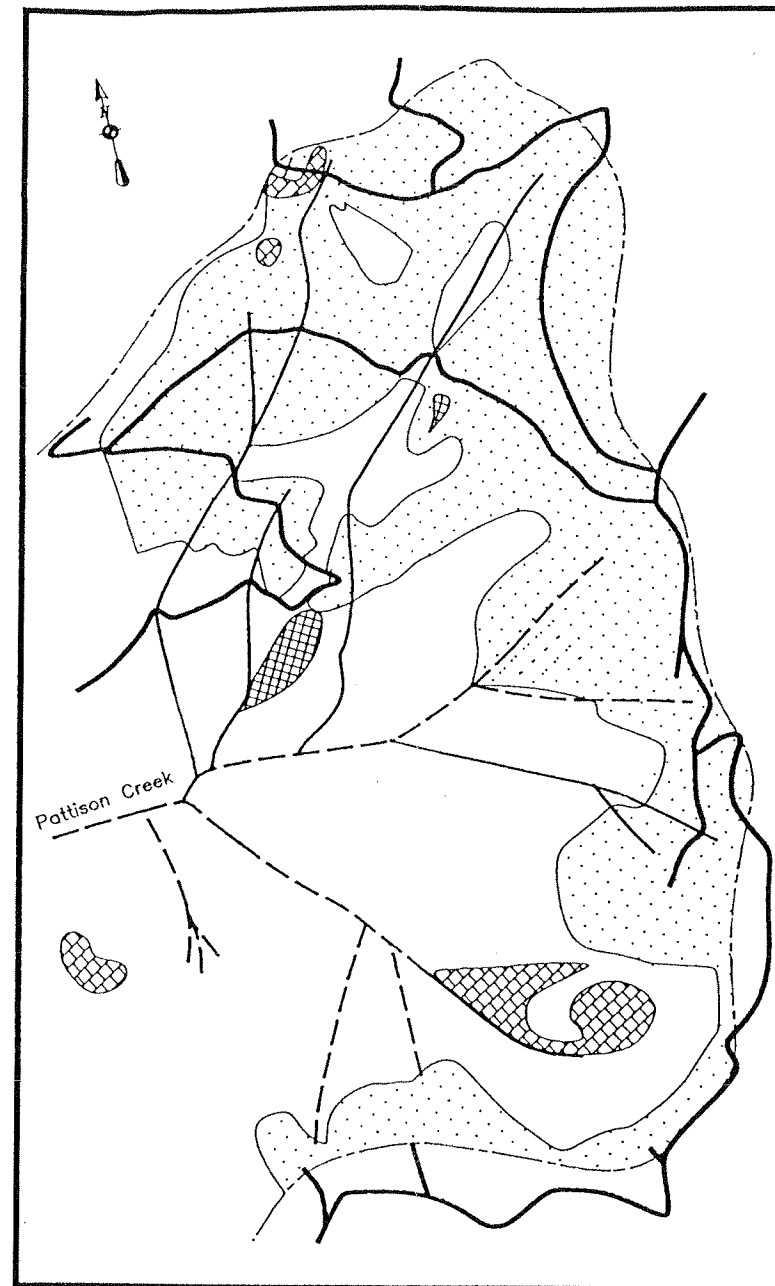
20,28 September, 1983

From air photos BC5580 (#42-45, 90-93)

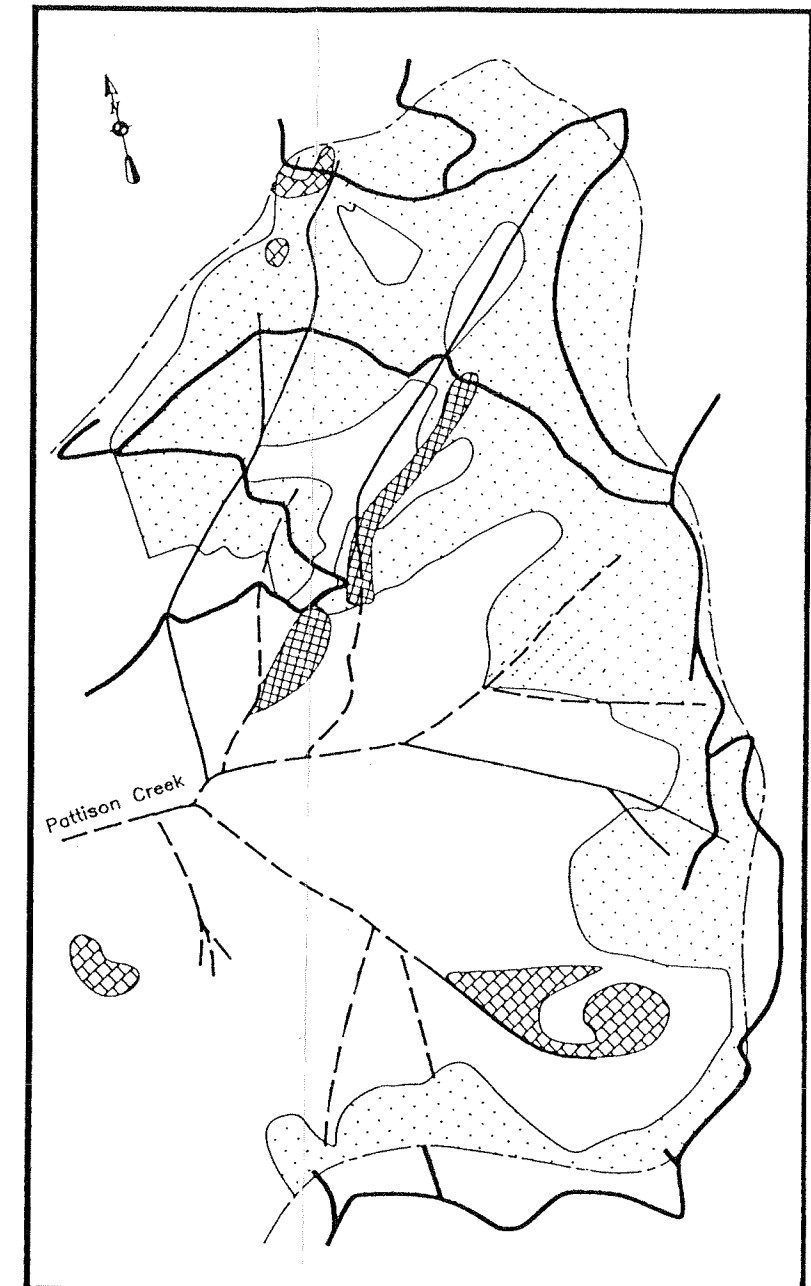
11 November, 1990

From air photos BC83057 (#124-125), BC83058 (#202-203)

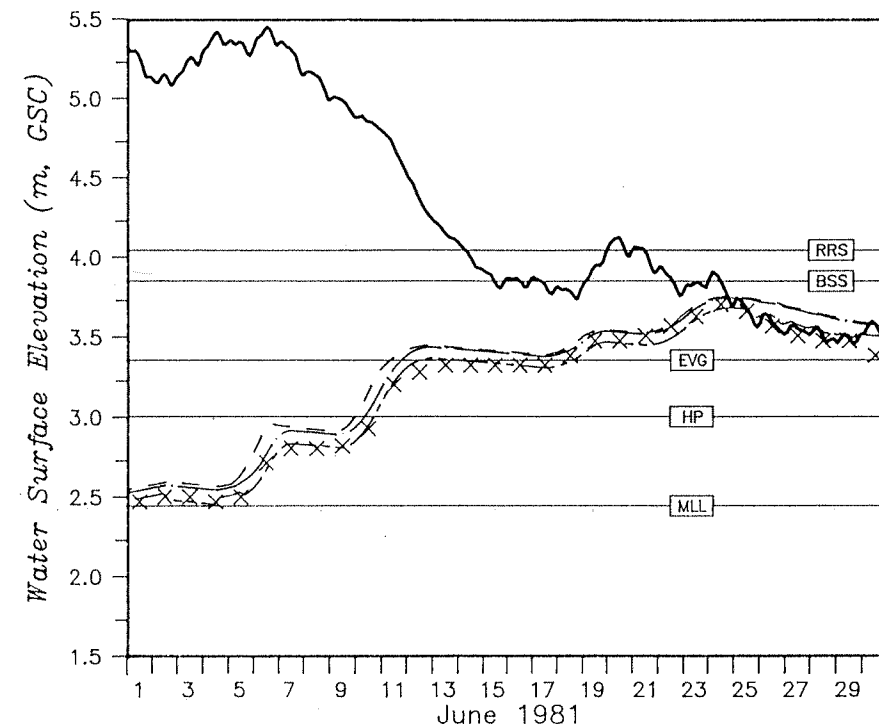
Calculated Water Surface Elevations  
Existing Conditions

- Estimated Fraser River level at Hatzic Pumphouse
- - - Calculated Water surface elevation of Lagace Creek at Dale Road Bridge for EXISTING CONDITIONS
- . - Calculated water surface elevation of Hatzic Lake for EXISTING CONDITIONS

- . - Calculated water surface elevation at Hatzic Pumphouse for EXISTING CONDITIONS
- x Observed water surface elevation at Hatzic Pumphouse (as recorded in the Pumplogs)

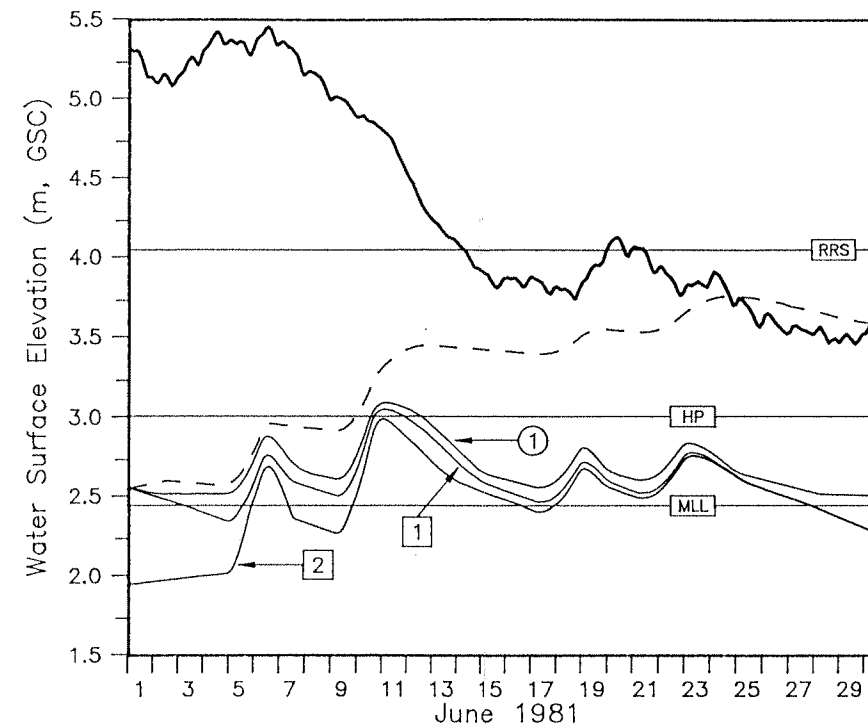
Predicted Water Surface Elevations  
Lagace Creek at Dale Road Bridge

- ① Water surface elevation for EXISTING CONDITIONS with ADDITIONAL PUMPS.
- ① Water surface elevation for EXISTING CONDITIONS with ADDITIONAL PUMPS. Additional pumps operating for levels above 1.8 m GSC and existing pumps operating for levels above 2.41 m GSC. Initial level at pumphouse as recorded for the storm.

- ② Water surface elevation for EXISTING CONDITIONS with ADDITIONAL PUMPS. Additional pumps operating for levels above 1.8 m GSC and existing pumps operating for levels above 2.41 m GSC. Initial level at pumphouse set at 1.80 m GSC

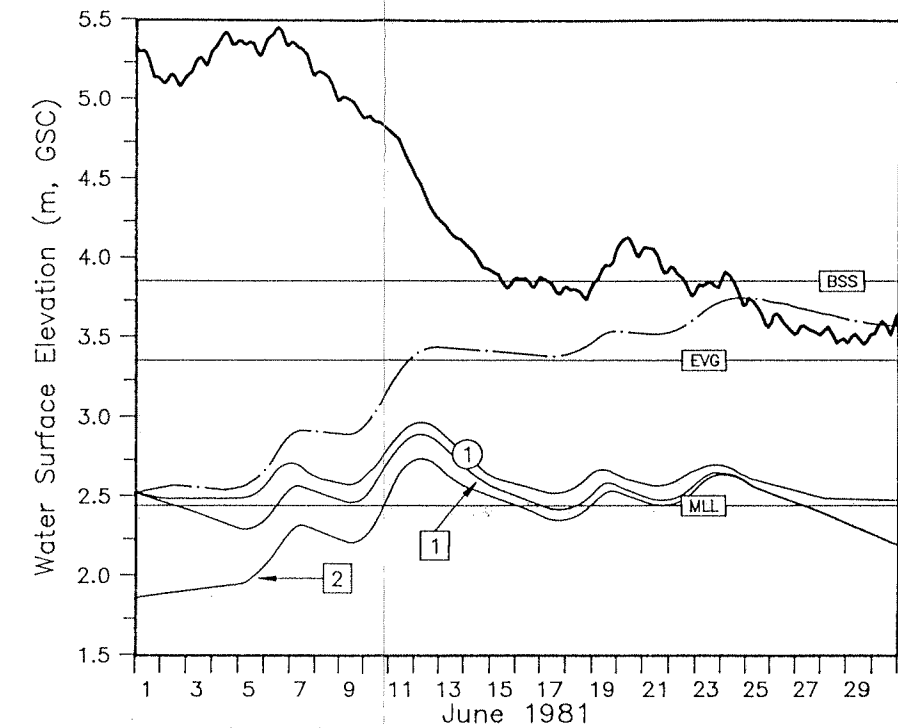
Predicted Water Surface Elevations  
Hatzic Lake

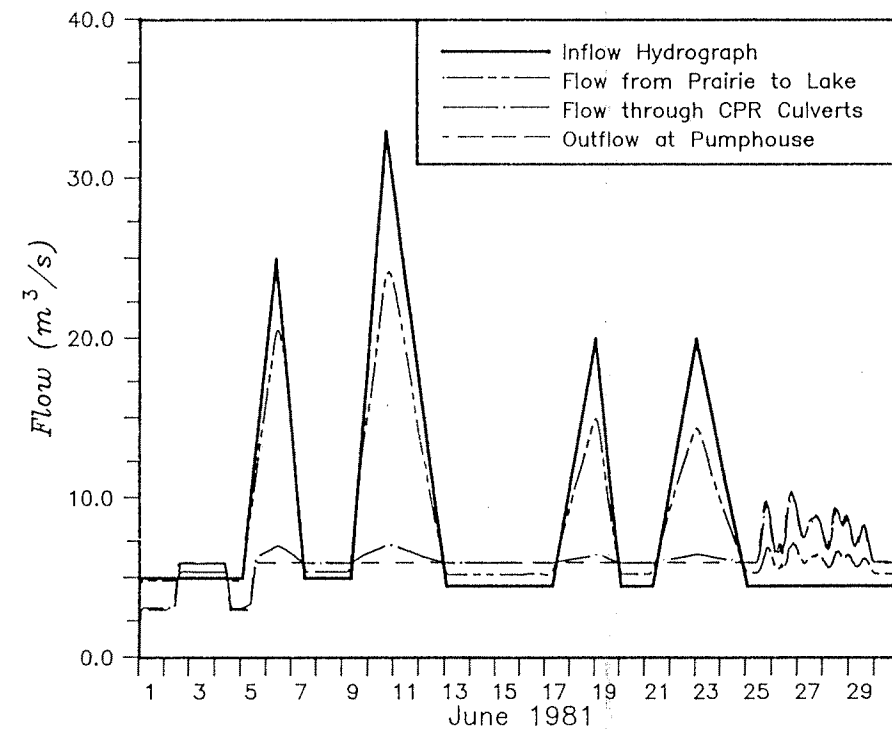
Inflow Hydrograph & Flows  
Existing Conditions

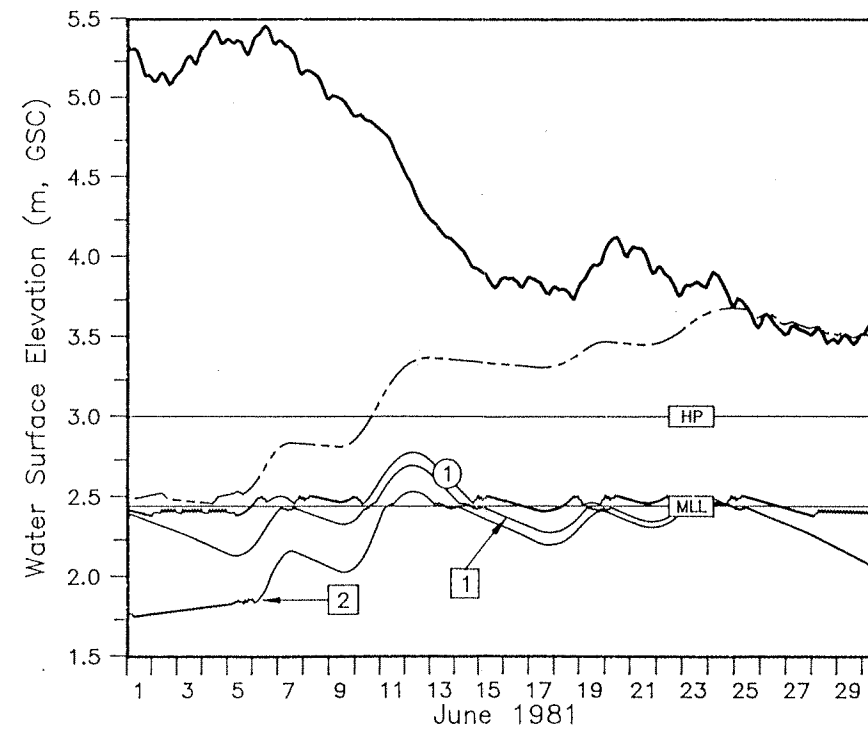
Predicted Water Surface Elevations  
Hatzic Pumphouse

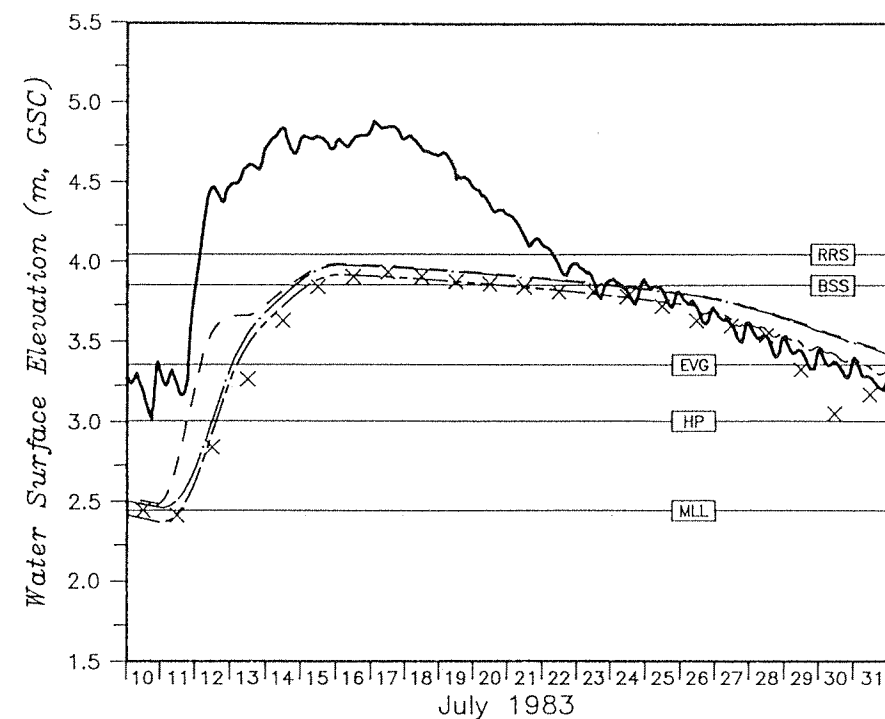
Calculated Water Surface Elevations  
Existing Conditions

- Estimated Fraser River level at Hatzic Pumpouse
- - - - - Calculated Water surface elevation of Lagace Creek at Dale Road Bridge for EXISTING CONDITIONS

- - - - - Calculated water surface elevation of Hatzic Lake for EXISTING CONDITIONS
- - - - - Calculated water surface elevation at Hatzic Pumpouse for EXISTING CONDITIONS

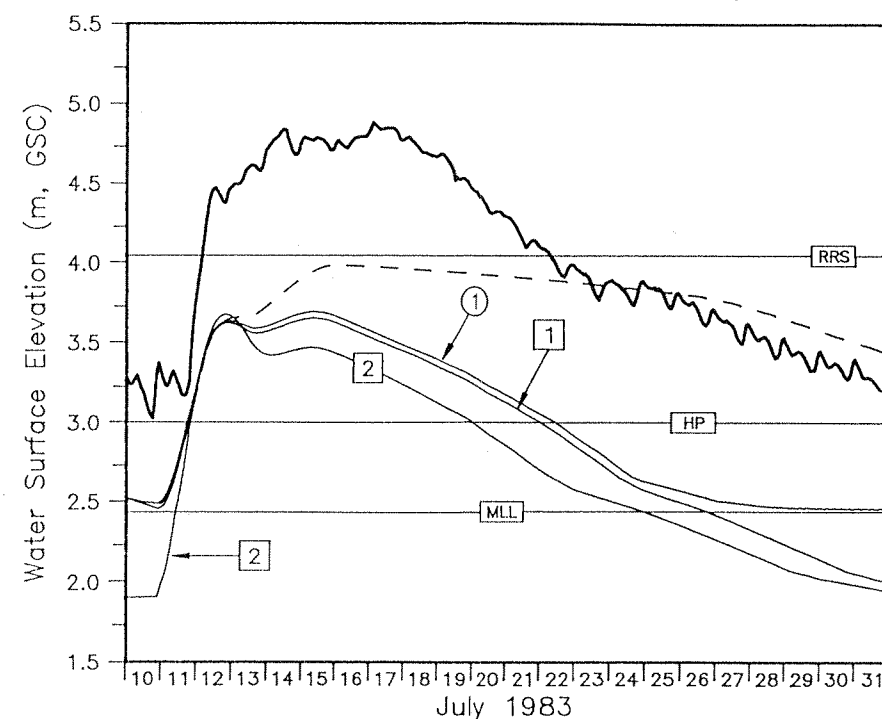
Predicted Water Surface Elevations  
Lagace Creek at Dale Road Bridge

- x Observed water surface elevation at Hatzic Pumpouse (as recorded in the Pumplogs)
- ① Water surface elevation for EXISTING CONDITIONS with ADDITIONAL PUMPS. Additional pumps operating for levels above 1.8 m GSC and existing pumps operating for levels above 2.41 m GSC. Initial level at pumpouse as recorded for the storm.

- 1 Water surface elevation for EXISTING CONDITIONS with ADDITIONAL PUMPS. Additional pumps operating for levels above 1.8 m GSC and existing pumps operating for levels above 2.41 m GSC. Initial level at pumpouse set at 1.80 m GSC

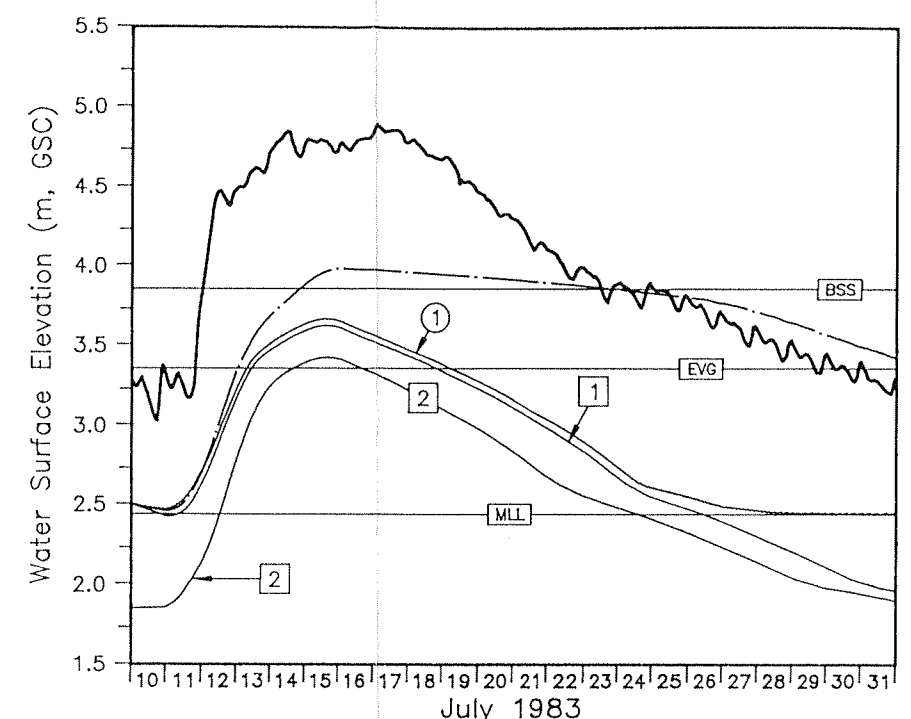
Predicted Water Surface Elevations  
Hatzic Lake

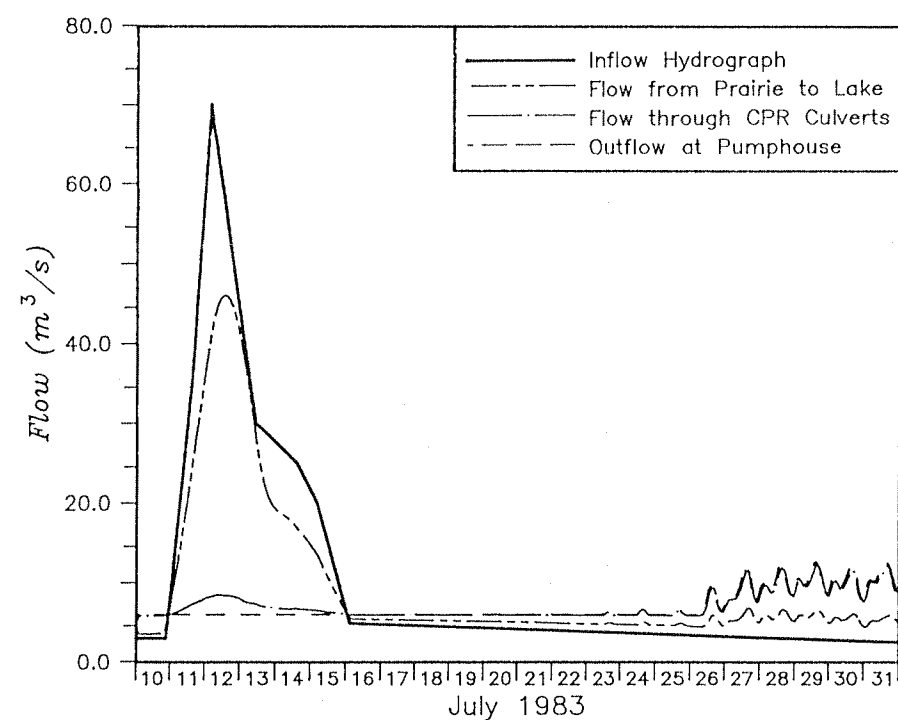
Inflow Hydrograph & Flows  
Existing Conditions
