**DEWDNEY-ALOUETTE REGIONAL DISTRICT  
MISSION, B.C.**

**HATZIC PRAIRIE DRAINAGE STUDY  
VOLUME 2**

*August 1992*

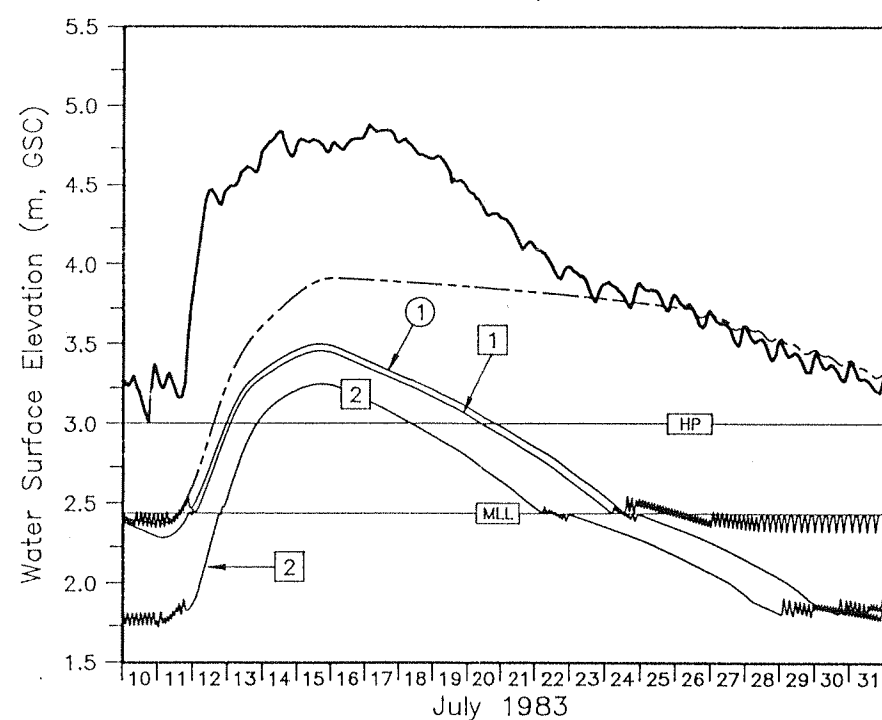
Predicted Water Surface Elevations  
Hatzic Pumpouse

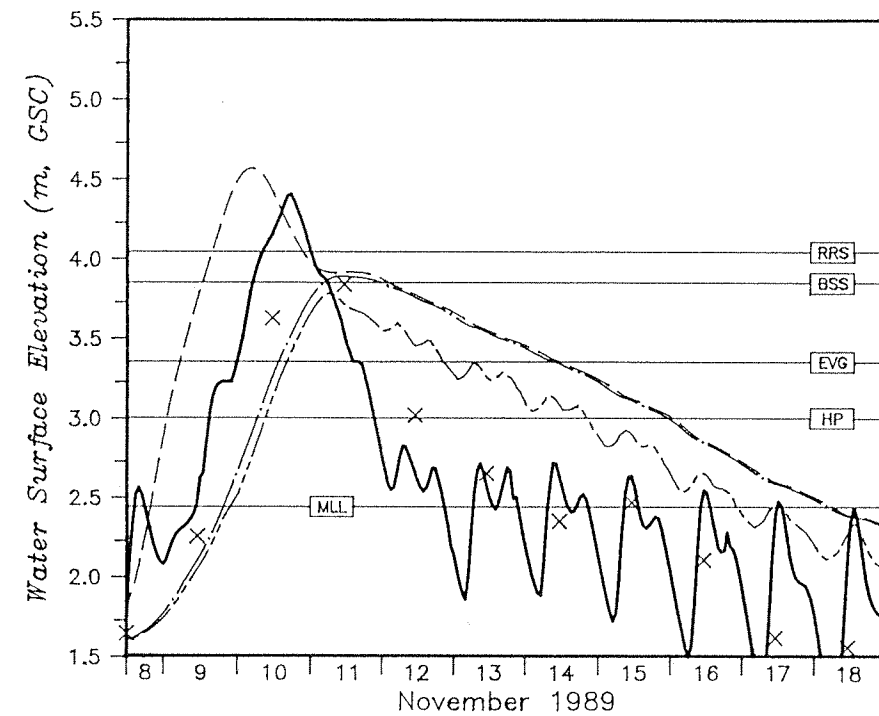
Calculated Water Surface Elevations  
Existing Conditions

- Estimated Fraser River level at Hatzic Pumpphouse
- - - Calculated Water surface elevation of Lagace Creek at Dale Road Bridge for EXISTING CONDITIONS

- ... Calculated water surface elevation of Hatzic Lake for EXISTING CONDITIONS
- . - Calculated water surface elevation at Hatzic Pumpphouse for EXISTING CONDITIONS

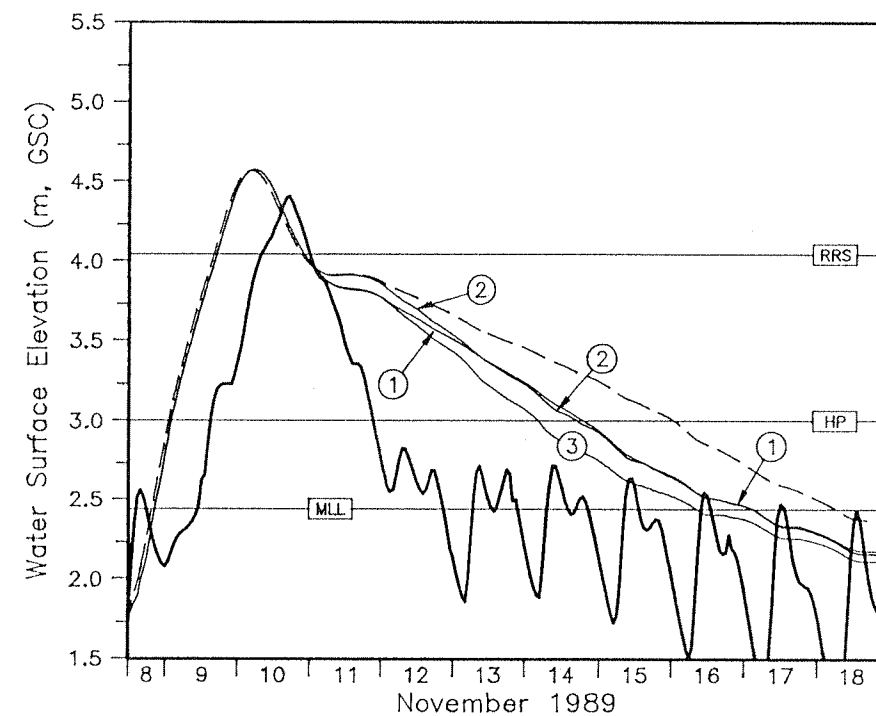
Predicted Water Surface Elevations  
Lagace Creek at Dale Road Bridge

- X Observed water surface elevation at Hatzic Pumpphouse (as recorded in the Pumplogs)
- ① Water surface elevation for EXISTING CONDITIONS with ADDITIONAL PUMPS.

- ② Water surface elevation for EXISTING CONDITIONS with ADDITIONAL FLOODBOXES and ADDITIONAL CPR CULVERTS
- ③ Water surface elevation for EXISTING CONDITIONS with ADDITIONAL FLOODBOXES, ADDITIONAL CPR CULVERTS, and ADDITIONAL PUMPS

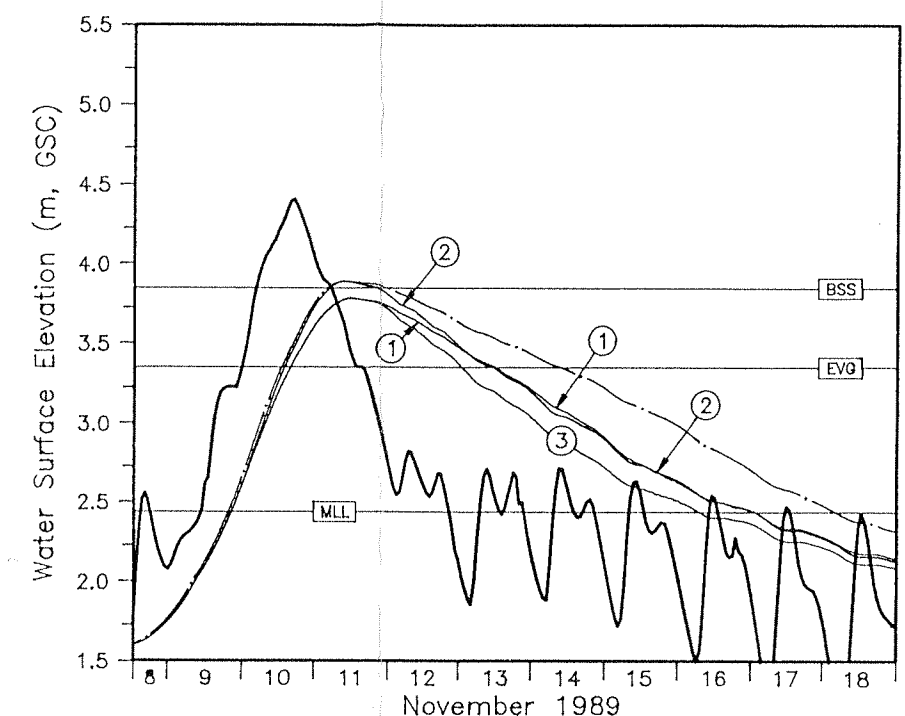
Predicted Water Surface Elevations  
Hatzic Lake

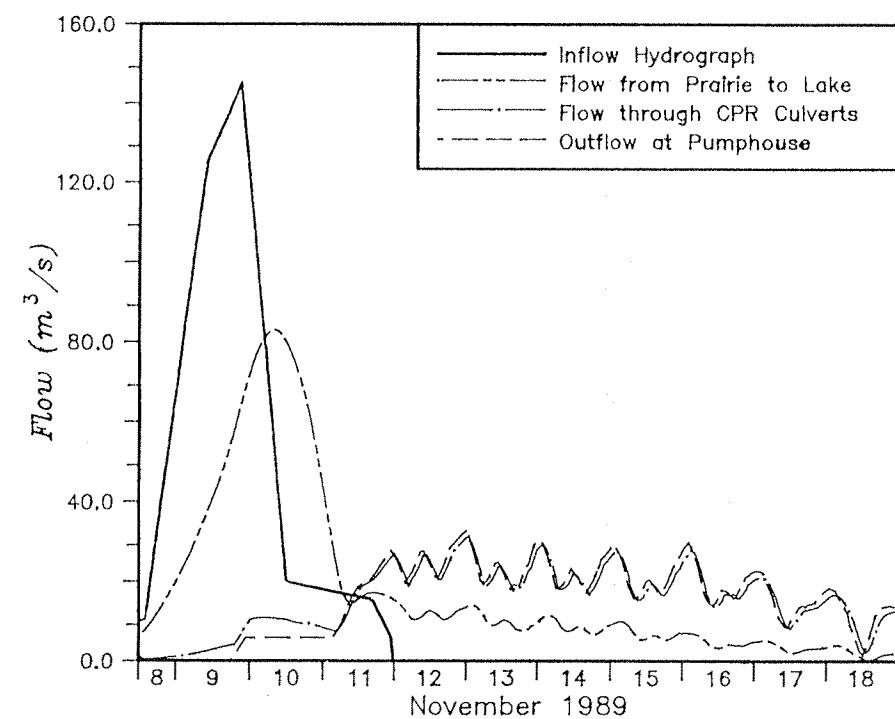
Inflow Hydrograph & Flows  
Existing Conditions

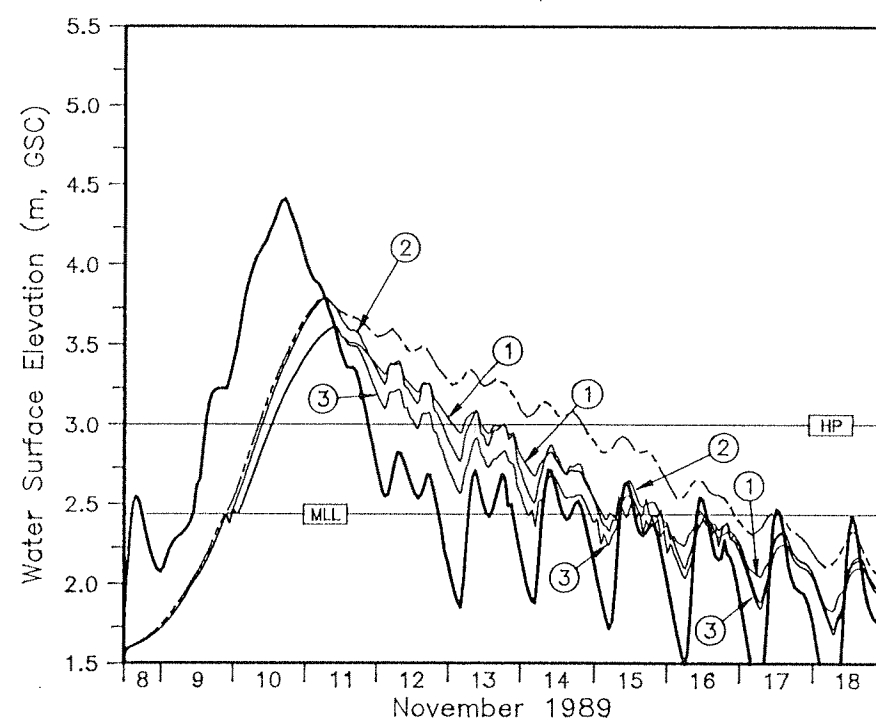
Predicted Water Surface Elevations  
Hatzic Pumpphouse

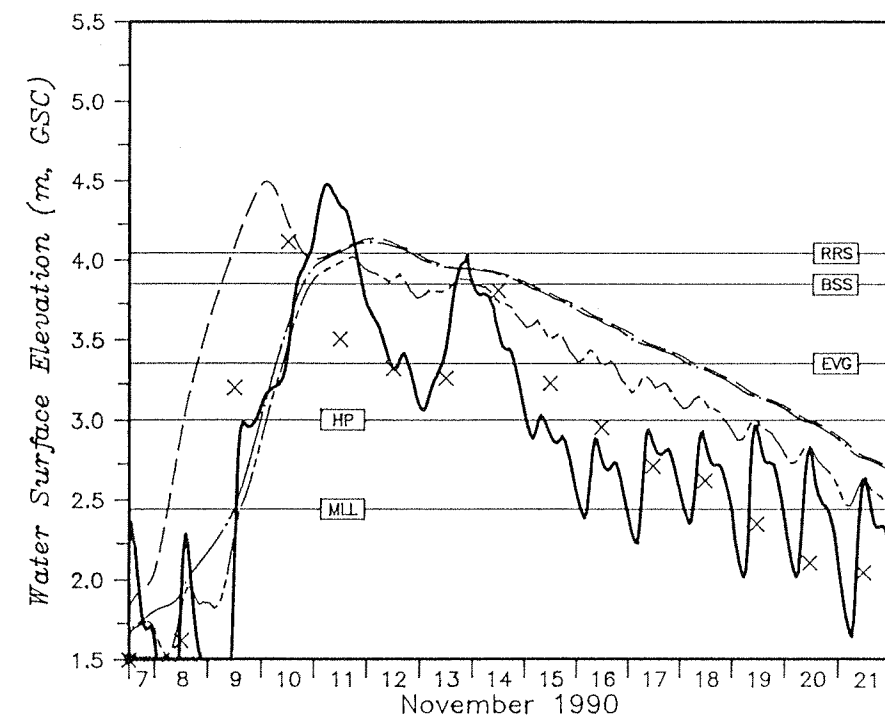
Calculated Water Surface Elevations  
Existing Conditions

- Estimated Fraser River level at Hatzic Pumphouse
- - - Calculated Water surface elevation of Lagace Creek at Dale Road Bridge for EXISTING CONDITIONS
- ... Calculated water surface elevation of Hatzic Lake for EXISTING CONDITIONS

- . - Calculated water surface elevation at Hatzic Pumphouse for EXISTING CONDITIONS
- X Observed water surface elevation at Hatzic Pumphouse (as recorded in the Pumplogs)

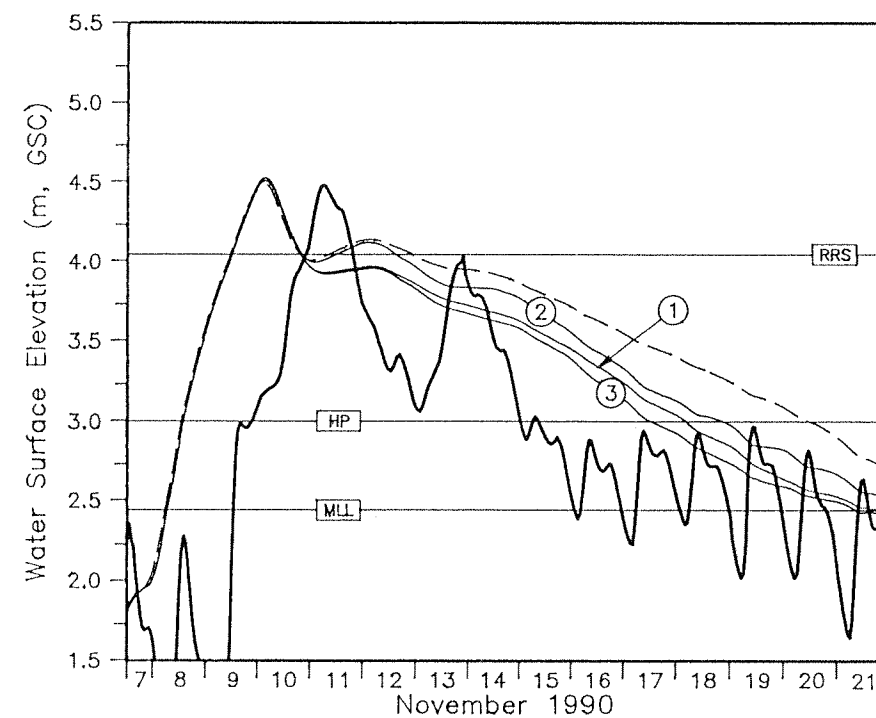
Predicted Water Surface Elevations  
Lagace Creek at Dale Road Bridge

- ① Water surface elevation for EXISTING CONDITIONS with ADDITIONAL PUMPS.
- ② Water surface elevation for EXISTING CONDITIONS with ADDITIONAL FLOODBOXES and ADDITIONAL CPR CULVERTS

- ③ Water surface elevation for EXISTING CONDITIONS with ADDITIONAL FLOODBOXES, ADDITIONAL CPR CULVERTS, and ADDITIONAL PUMPS
- RRS Riverside Rd. Subdivision - Flooding above 4.04 m GSC

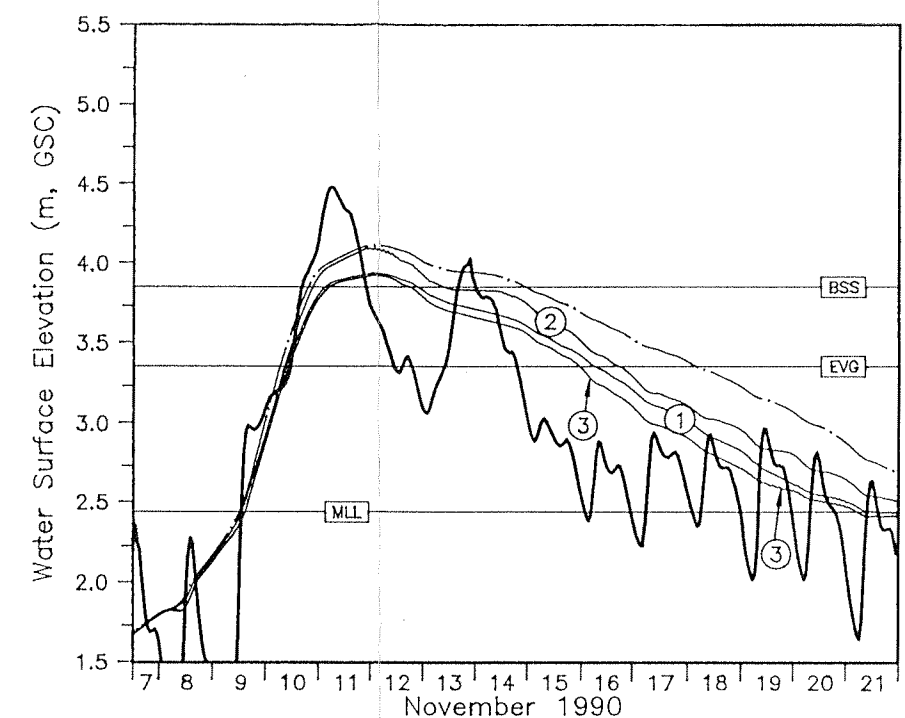
Predicted Water Surface Elevations  
Hatzic Lake

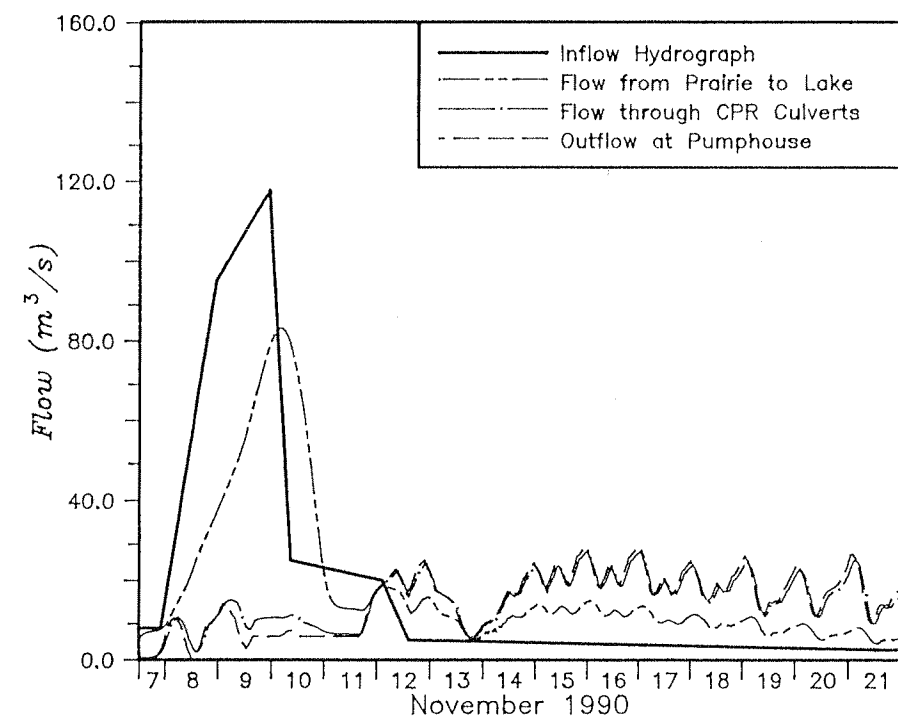
Inflow Hydrograph & Flows  
Existing Conditions

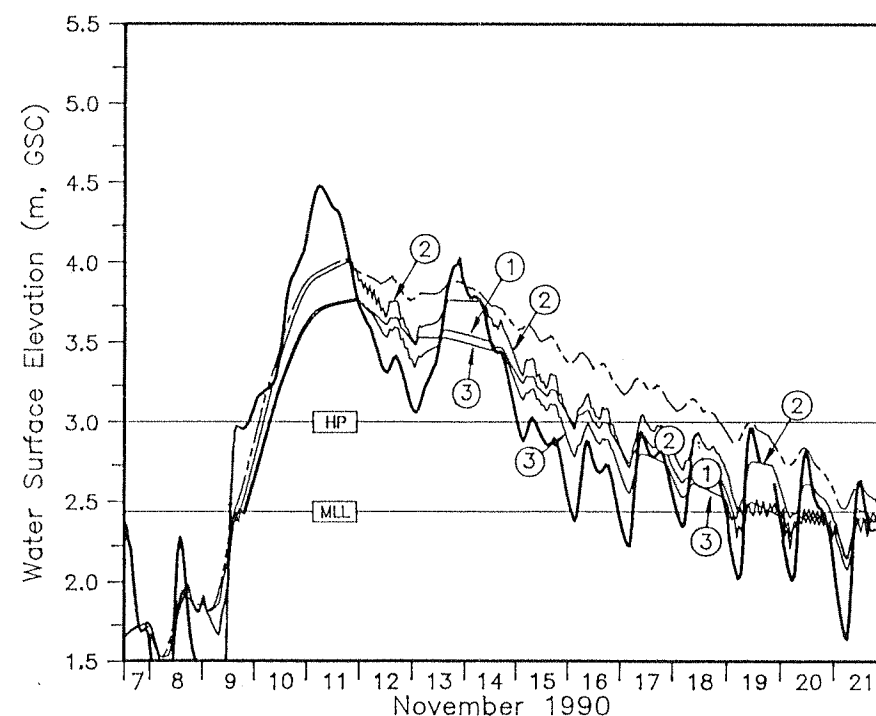
Predicted Water Surface Elevations  
Hatzic Pumphouse

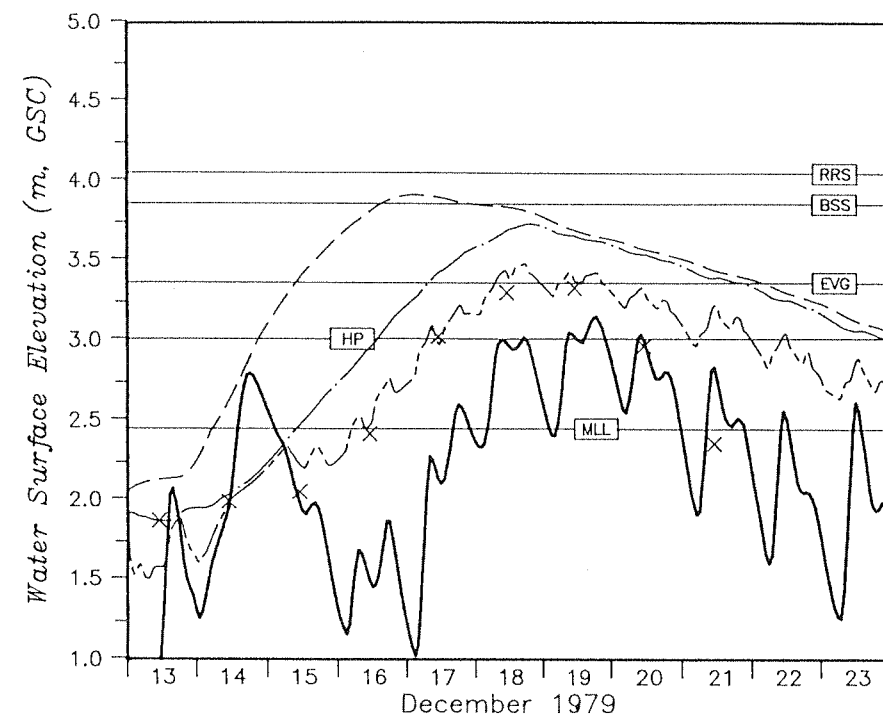
Calculated Water Surface Elevations  
Existing Conditions

- Estimated Fraser River level at Hatzic Pumphouse
- - - Calculated Water surface elevation of Lagace Creek at Dale Road Bridge for EXISTING CONDITIONS
- Calculated water surface elevation of Hatzic Lake for EXISTING CONDITIONS

- - - Calculated water surface elevation at Hatzic Pumphouse for EXISTING CONDITIONS
- × Observed water surface elevation at Hatzic Pumphouse (as recorded in the Pumplogs)

- 1) ADDITIONAL PUMPS - additional pump capacity of 8.34 m³/s.
- 2) ADDITIONAL FLOODBOXES - four additional 1.829 m by 1.829 m (6 ft by 6 ft) floodboxes at Hatzic Pumphouse.

- 3) ADDITIONAL CULVERTS - two additional 3 m culverts at the CPR crossing.
- 4) Mean lake level - 2.438 m GSC (8 ft).
- 5) Historical flood level - 3.353 m GSC (11 ft) - Flooding of the Everglades and 270 hectares (670 acres) on Hatzic Prairie.

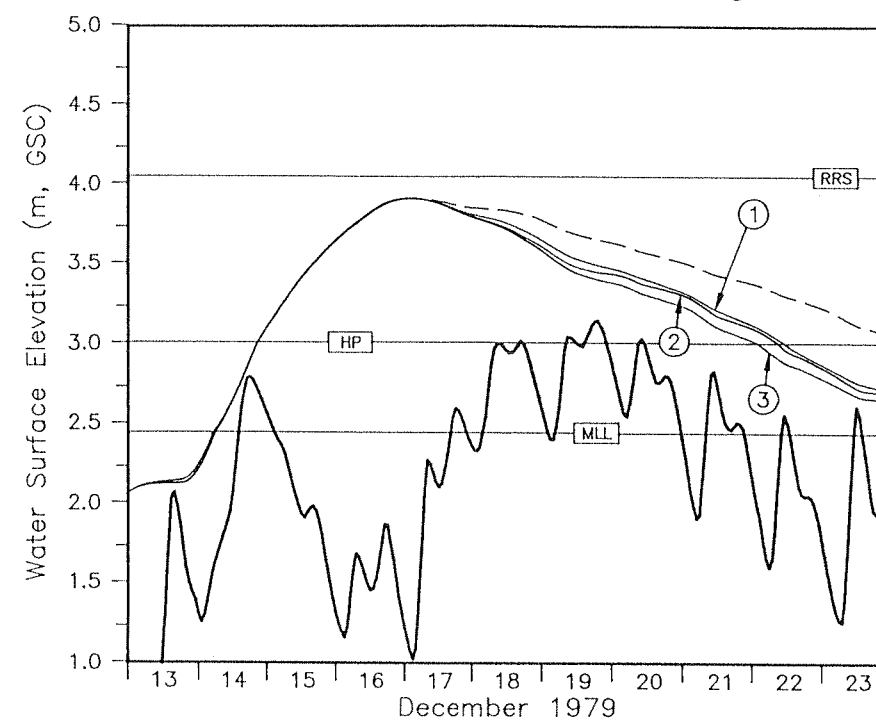
Predicted Water Surface Elevations  
Lagace Creek at Dale Road Bridge

- ① Water surface elevation for EXISTING CONDITIONS with ADDITIONAL PUMPS.
- ② Water surface elevation for EXISTING CONDITIONS with ADDITIONAL FLOODBOXES and ADDITIONAL CPR CULVERTS

- ③ Water surface elevation for EXISTING CONDITIONS with ADDITIONAL FLOODBOXES, ADDITIONAL CPR CULVERTS, and ADDITIONAL PUMPS
- RRS Riverside Rd. Subdivision - Flooding above 4.04 m GSC

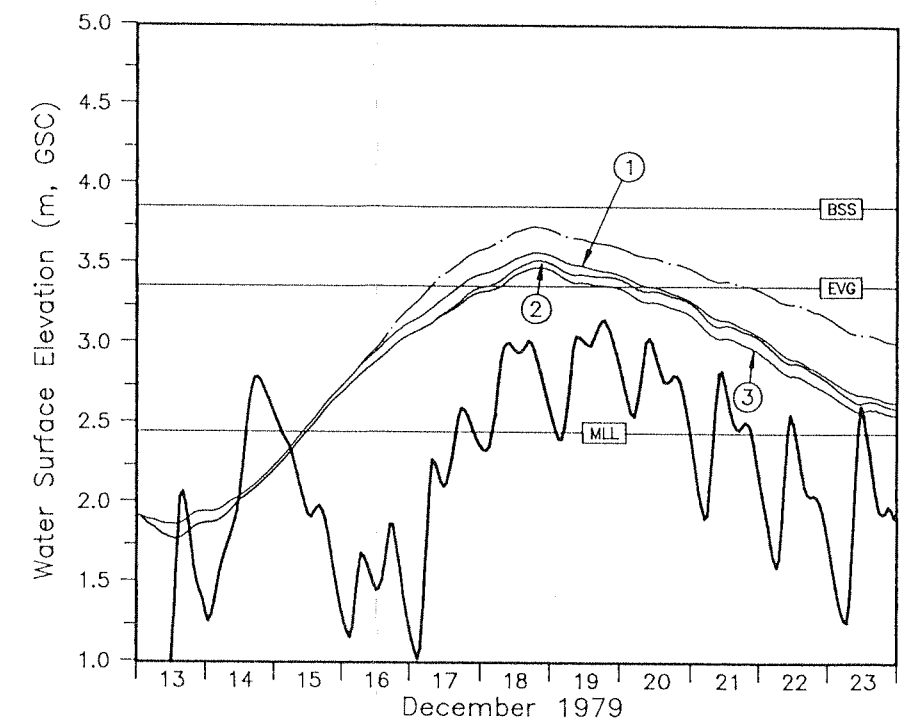
Predicted Water Surface Elevations  
Hatzic Lake

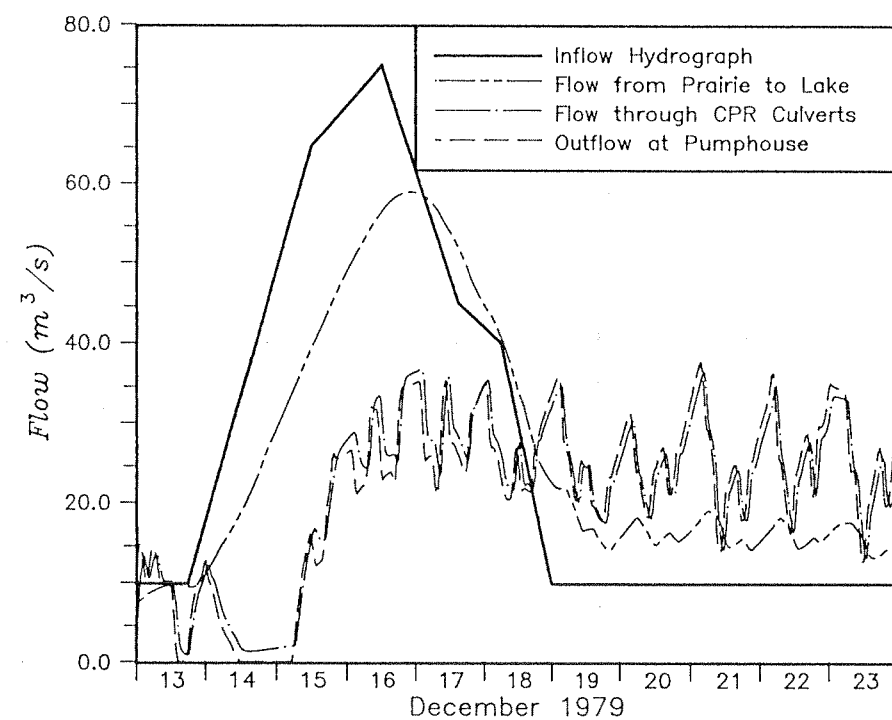
Inflow Hydrograph & Flows  
Existing Conditions

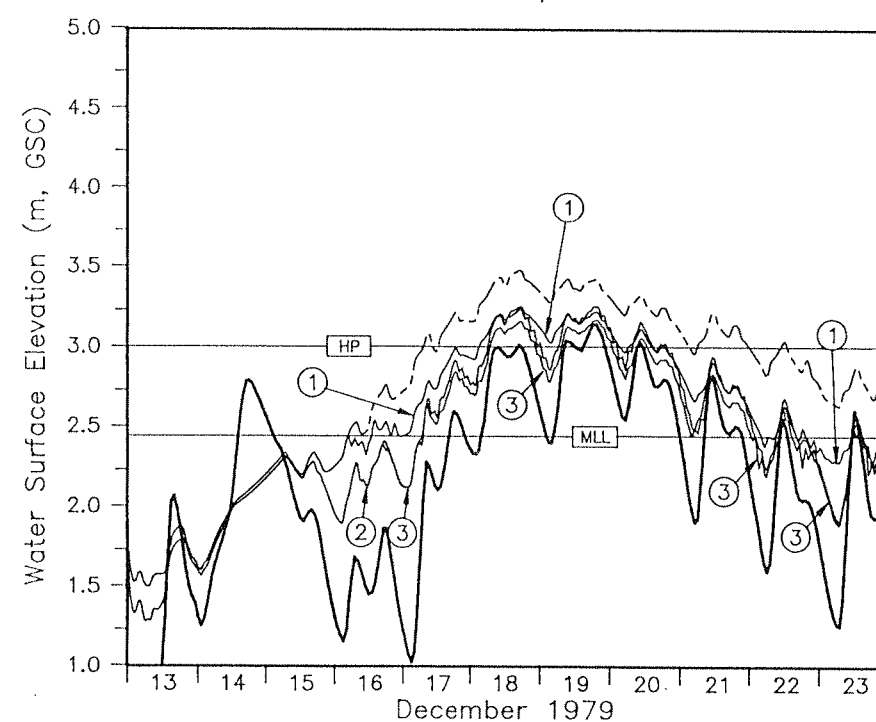
Predicted Water Surface Elevations  
Hatzic Pumphouse

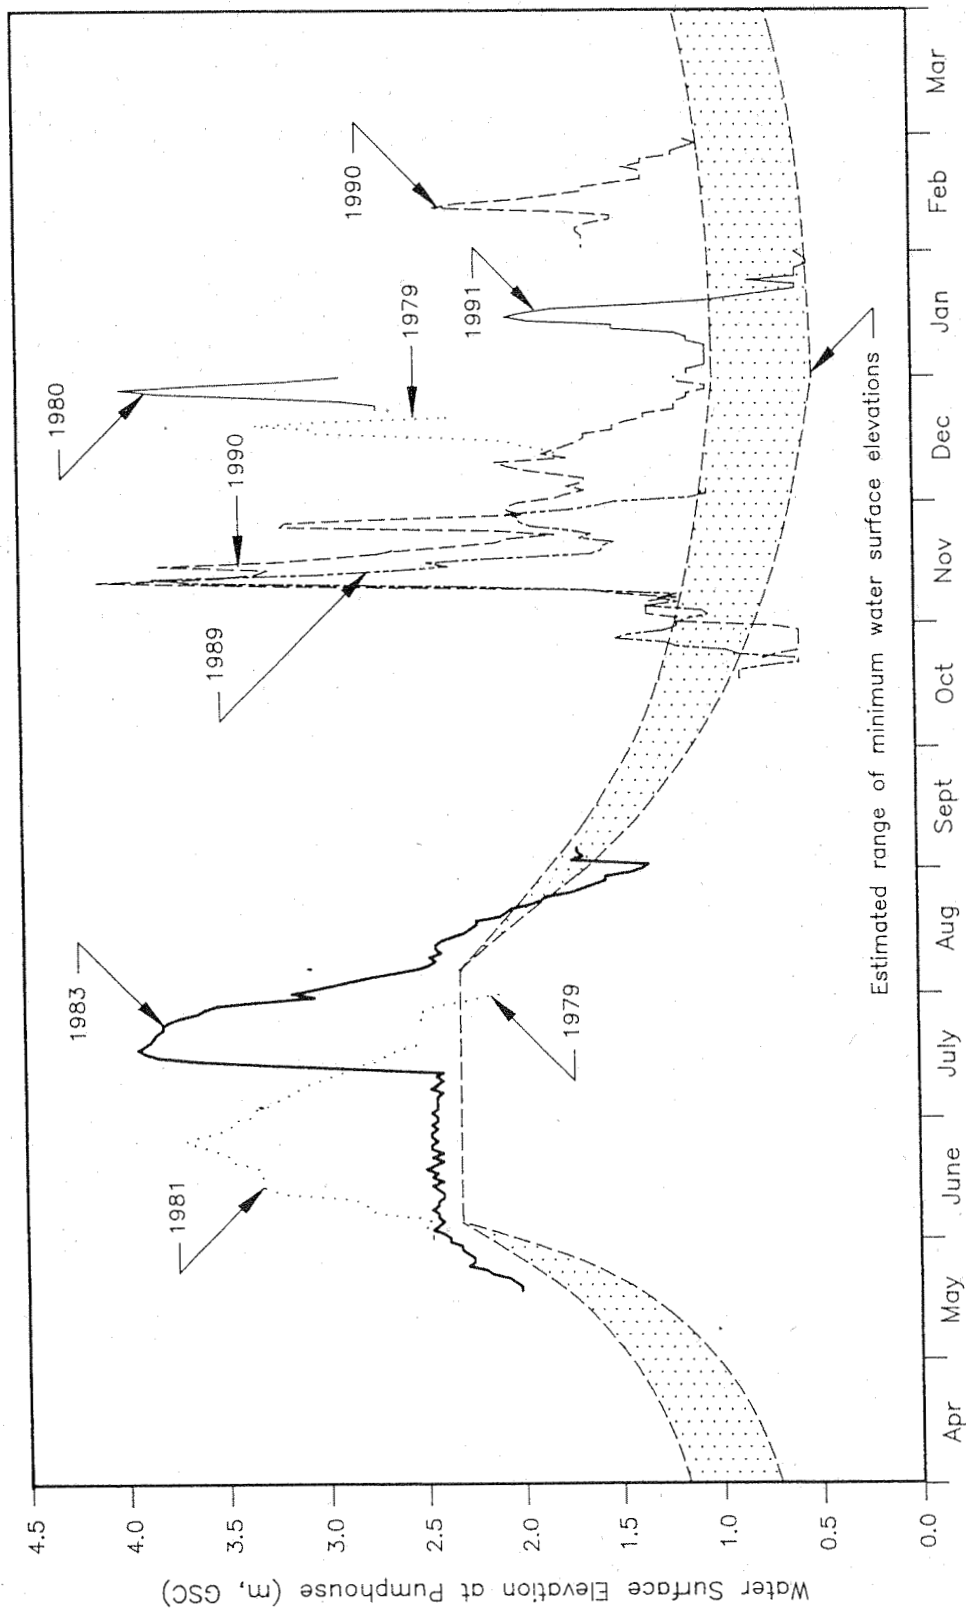
Note: Water levels taken from pumplogs.

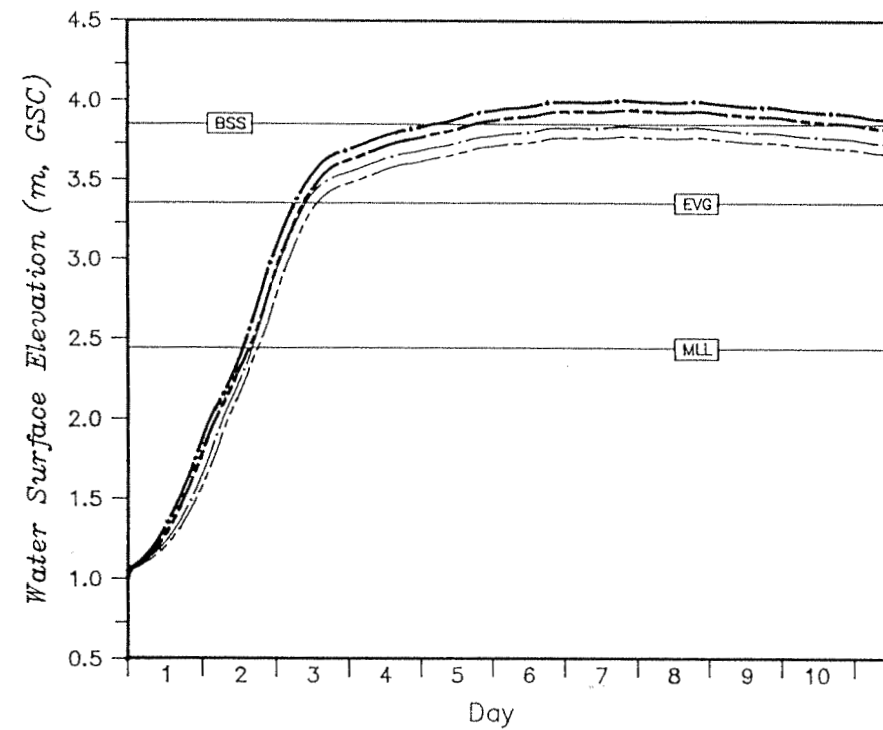
Initial Level at the Pumphouse 1.00 m

Dredging Effects on Peak Water Surface Levels:  
(East side of Hatzic Lake dredged to 0.5 m GSC)

- — — — — Calculated water surface elevation of Hatzic Lake with NO DREDGING and EXISTING CONDITIONS
- — — — — Calculated water surface elevation of Hatzic Lake with DREDGING and EXISTING CONDITIONS
- — — — — Calculated water surface elevation at Hatzic Pumphouse with NO DREDGING and EXISTING CONDITIONS
- — — — — Calculated water surface elevation at Hatzic Pumphouse with DREDGING and EXISTING CONDITIONS
- BSS — Benbow St. Subdivision — Flooding above 3.85 m GSC
- EVG — Everglades — Flooding above 3.353 m GSC (Historical Flood Level)
- HP — Hatzic Prairie — Flooding above 3.00 m GSC near Dale Rd. and Farms Rd.
- MLL — Mean Lake Level

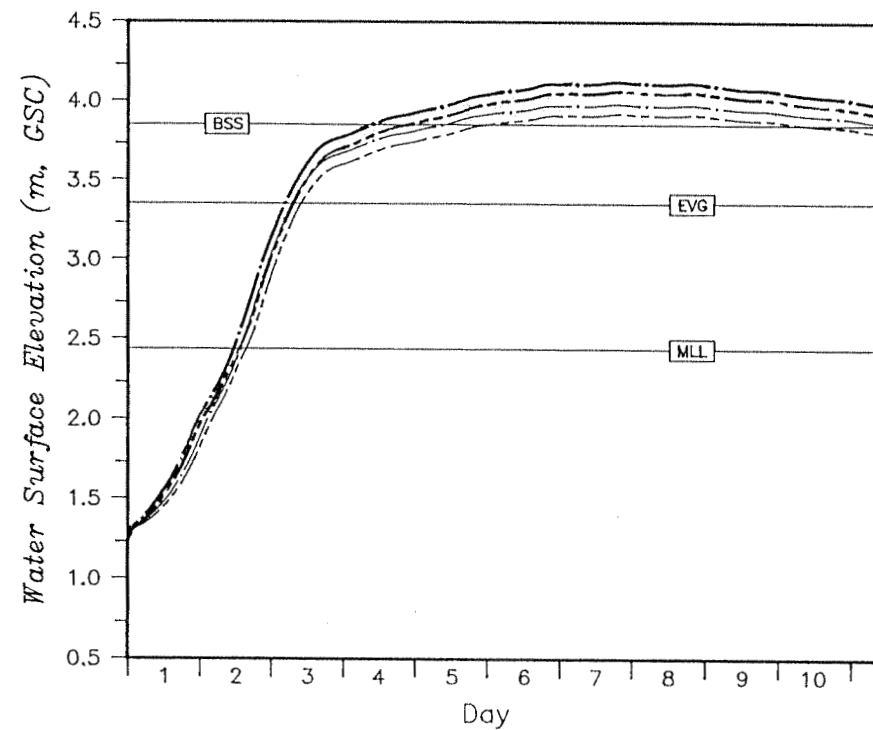
Initial Level at the Pumphouse 1.25 m

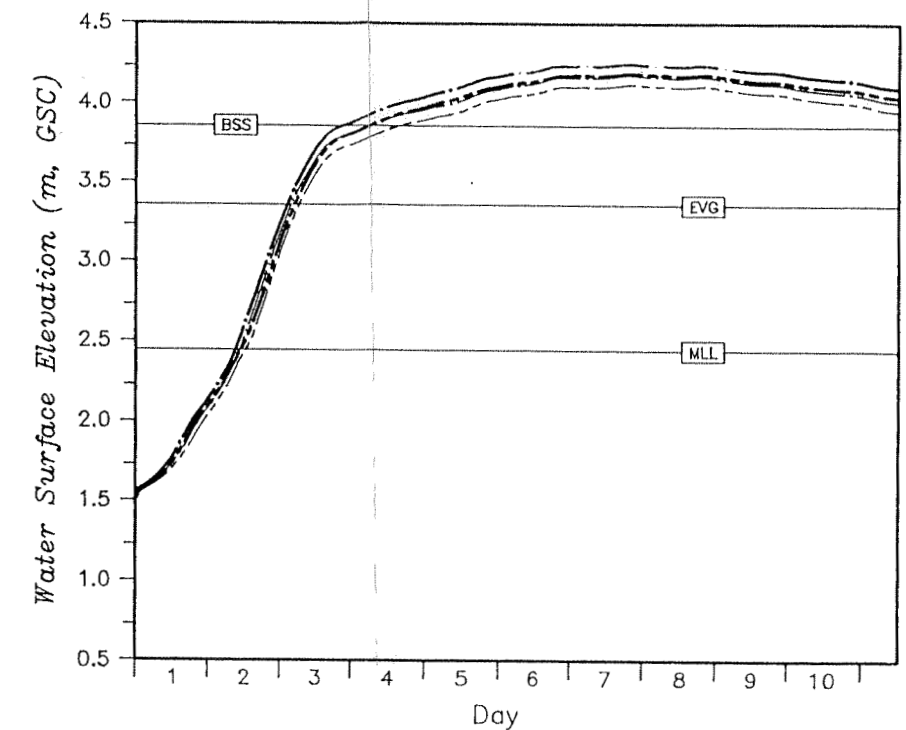
Initial Level at the Pumphouse 1.50 m

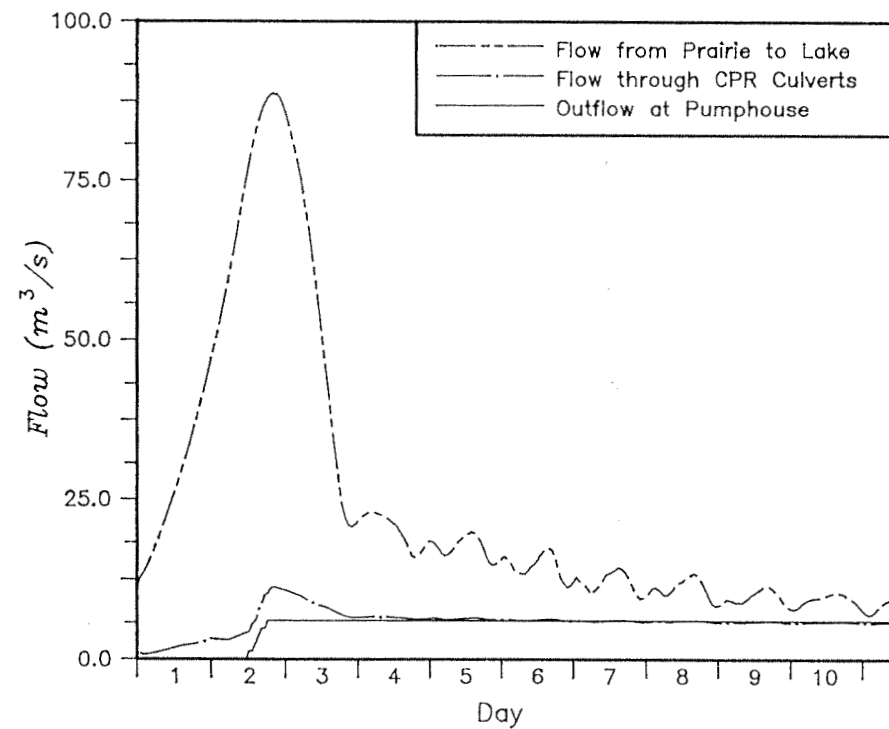
Inflow Hydrograph & Flows  
Existing Conditions

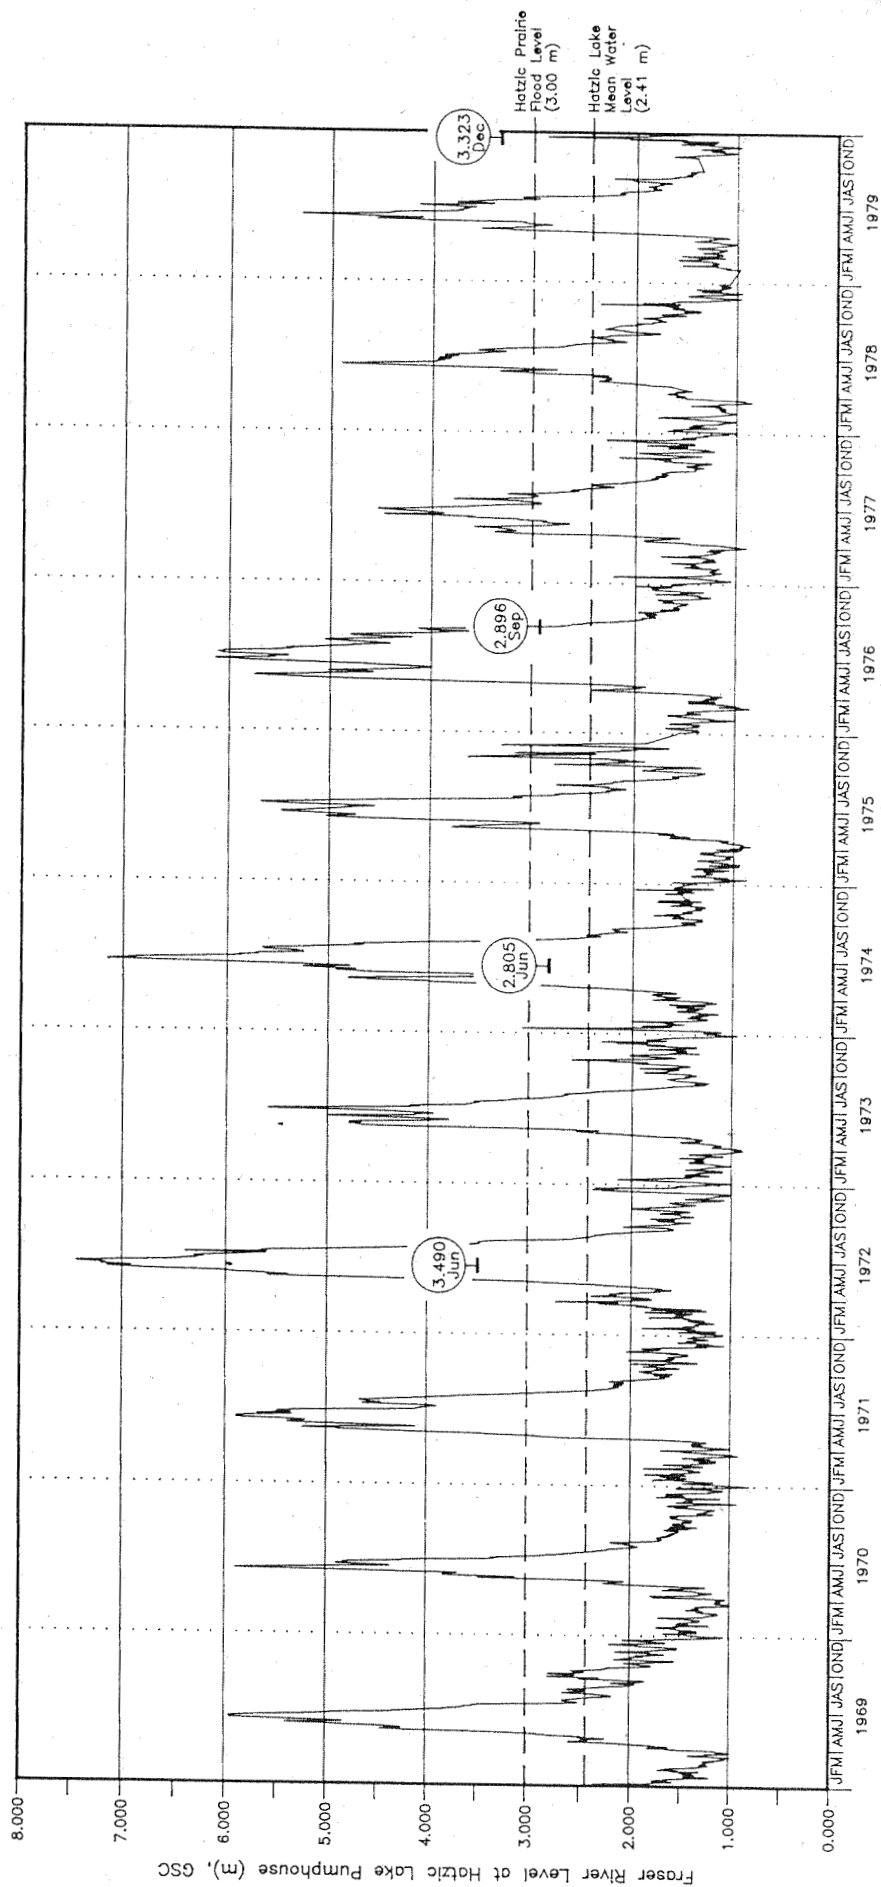
1969 - 1979

## Hatzic Prairie Study

- 1) The river level at the pumphouse was estimated by adding 0.3 m to the level recorded at the Mission. This represents the water level decrease for the 5.0 km reach given a hydraulic gradient of 0.00006 at Mission.
- 2) Maximum lake levels were obtained from Hatzic Lake pumphouse records.

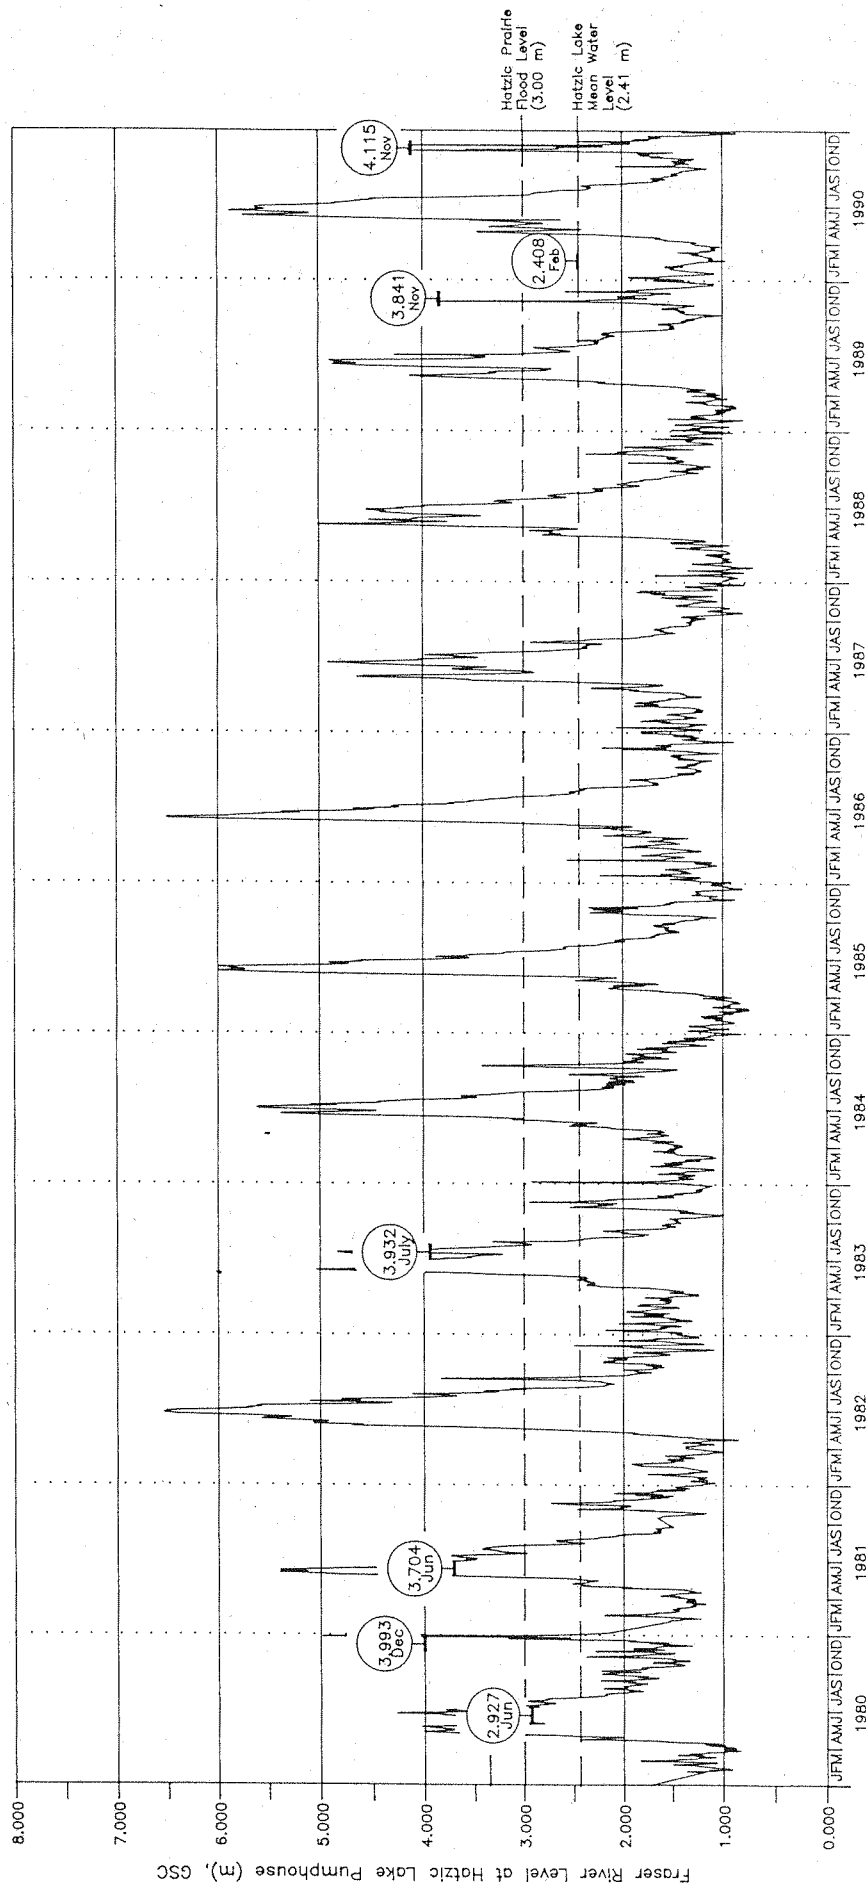
Legend:

Maximum lake level at Hatzic Lake Pumphouse for the indicated month (Elevation given as m GSC).

Notes:

- 1) The river level at the pumphouse was estimated by adding 0.3 m to the level recorded at the Mission. This represents the water level decrease for the 5.0 km reach given a hydraulic gradient of 0.00006 at Mission.
- 2) Maximum lake levels were obtained from Hatzic Lake pumphouse records.

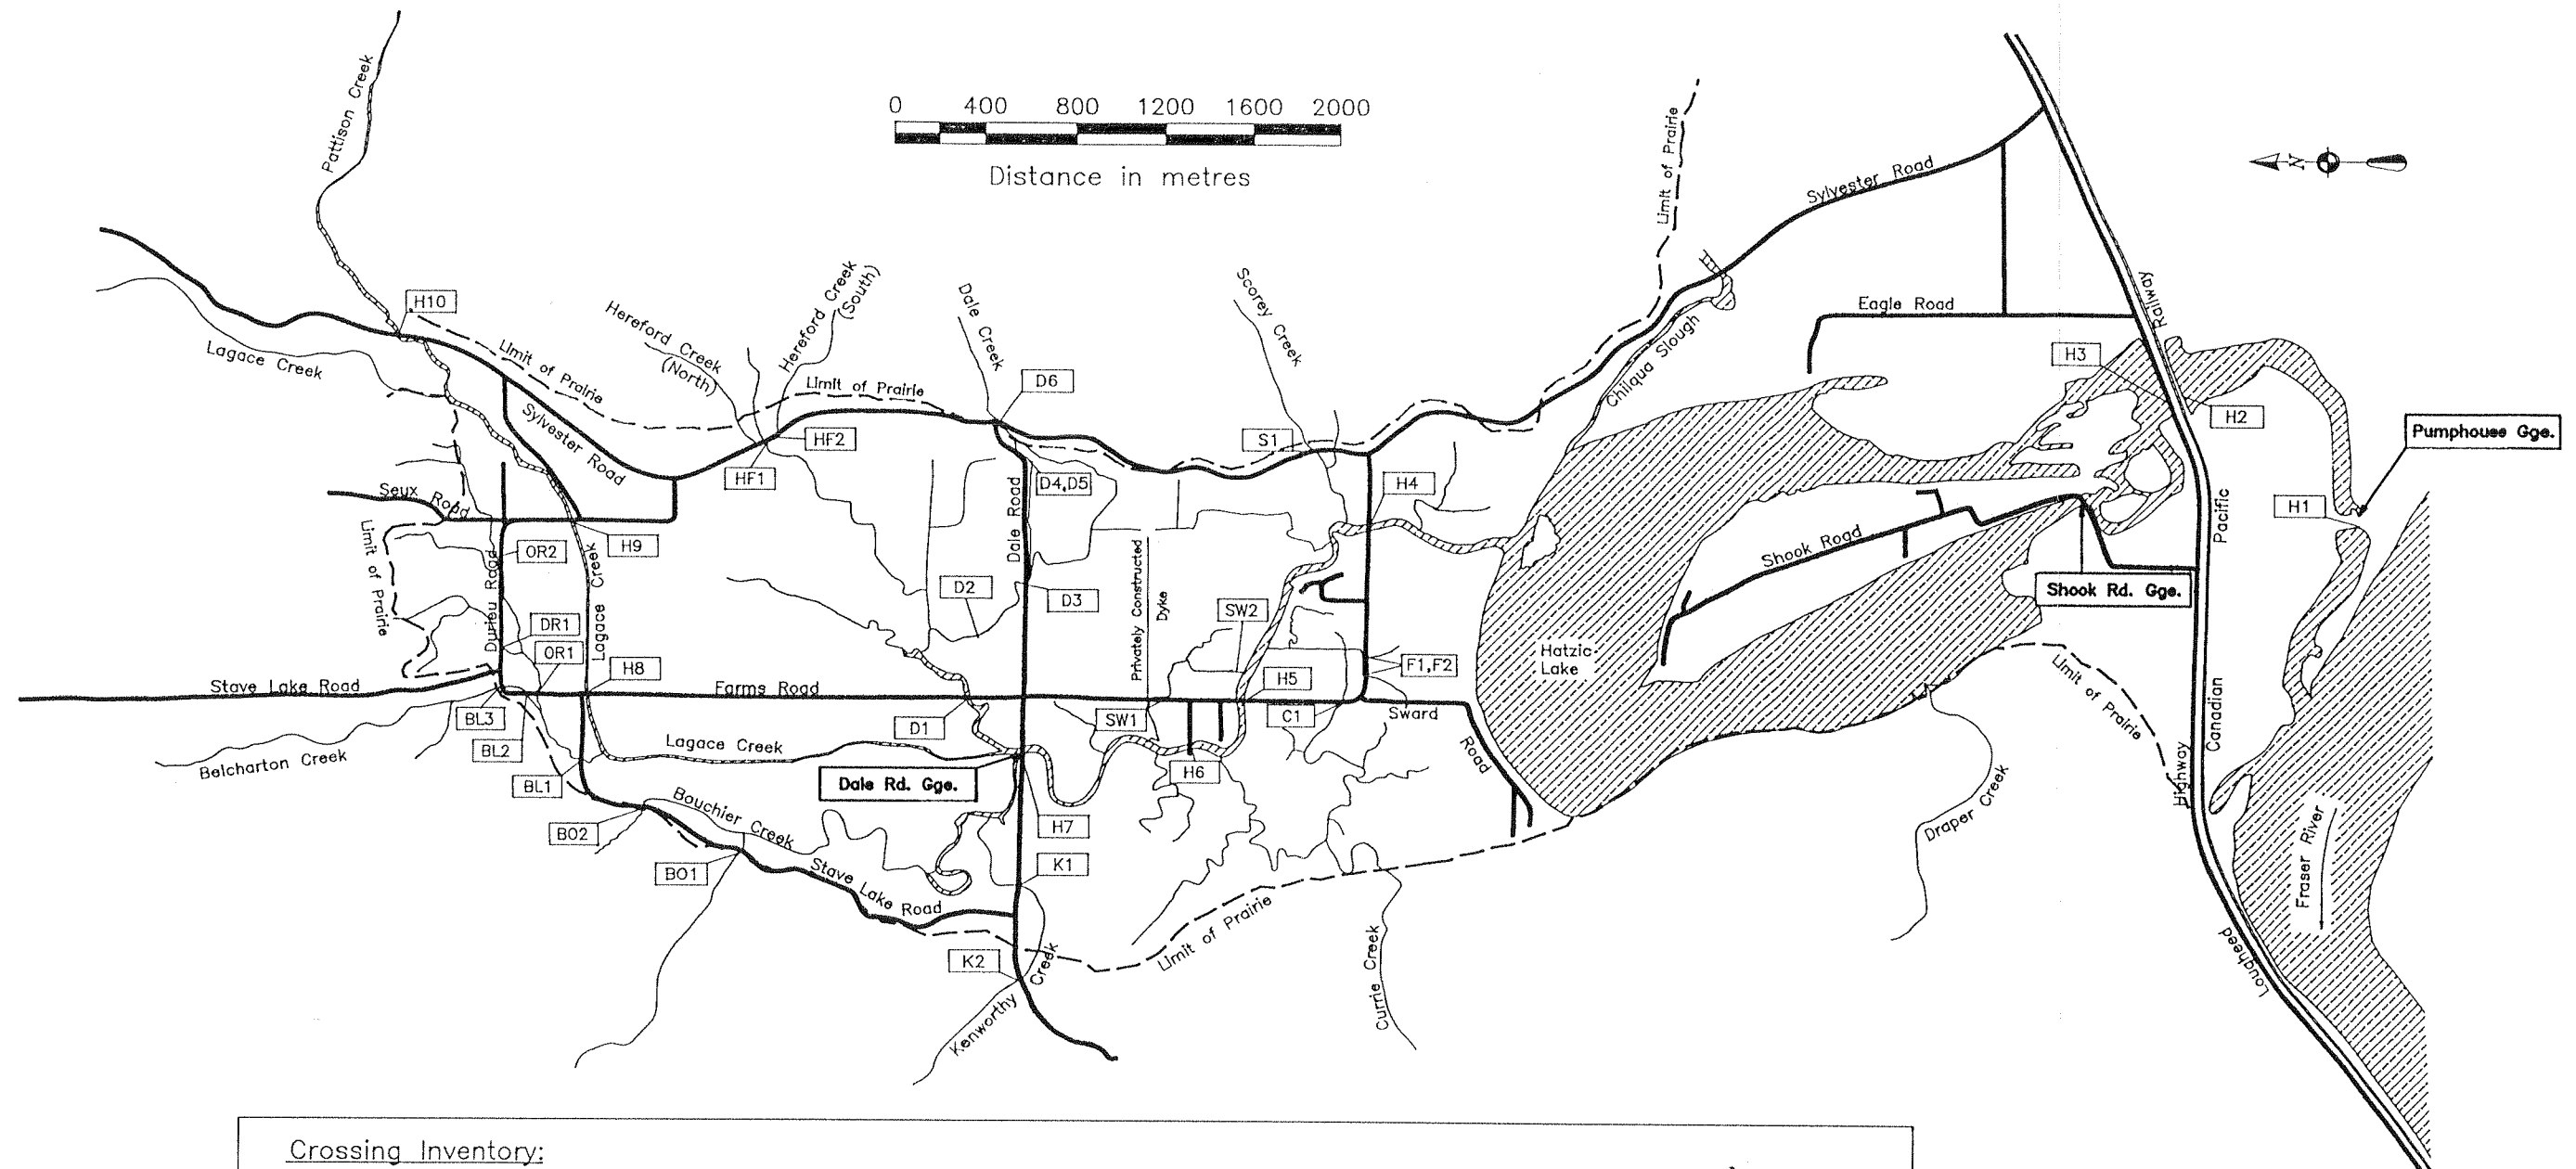
### Drainage Channel Survey Crossing Inventory

### Crossing Inventory:

#### Belcharton Creek

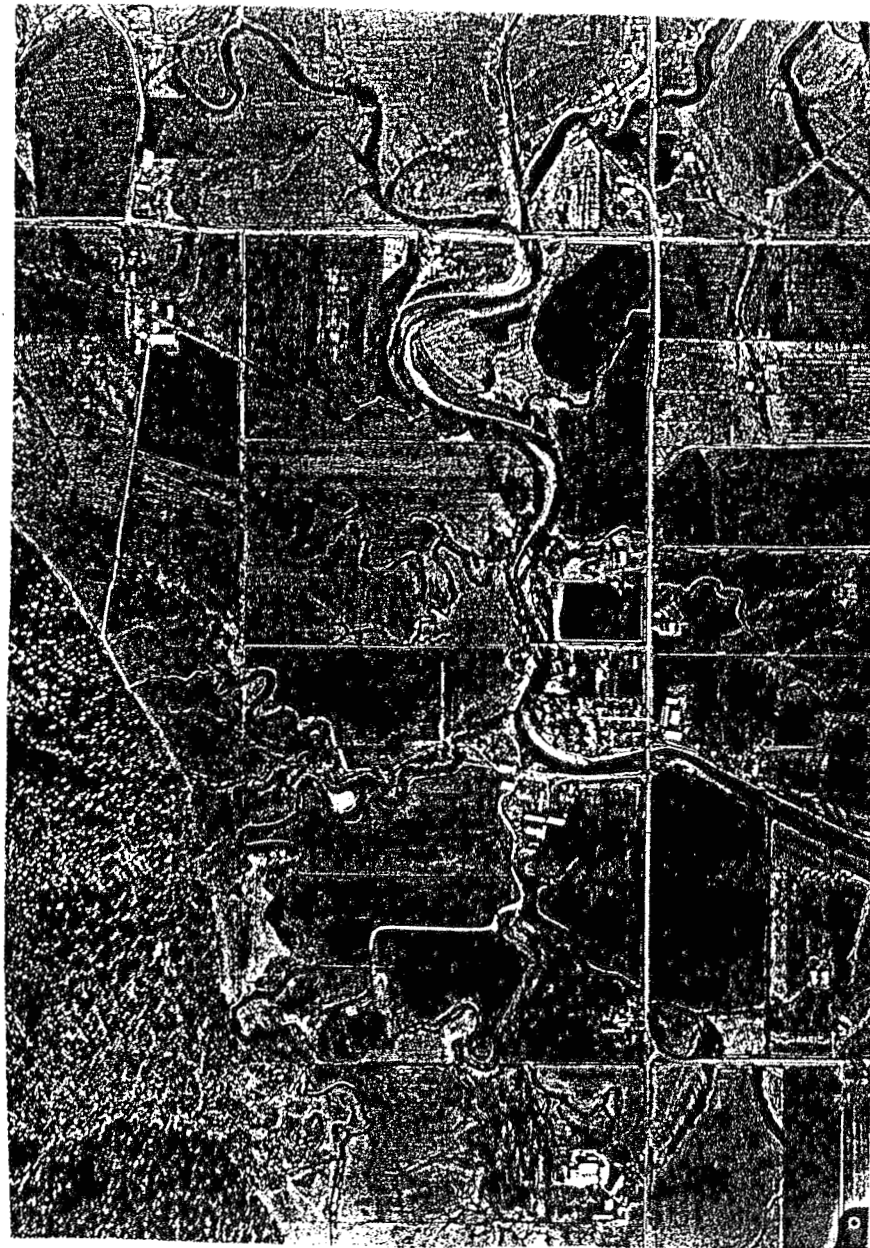
Hatzic Prairie — Drainage channels on Lagace Creek near Dale Road Bridge (1984).

Similarities between Hatzic Prairie  
Drainage Channels and Tidal Channels
