**DEWDNEY-ALOUETTE REGIONAL DISTRICT  
MISSION, B.C.**

**HATZIC PRAIRIE DRAINAGE STUDY  
VOLUME 2**

*August 1992*

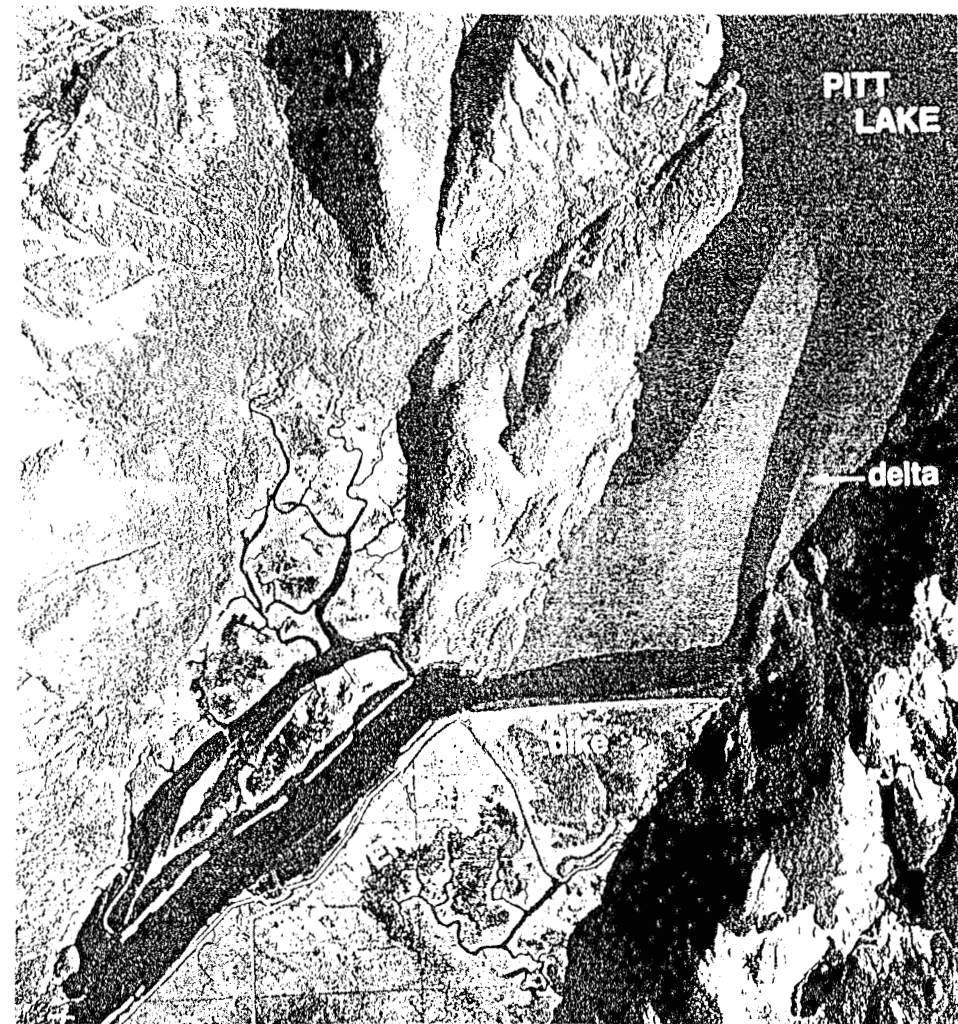
Pitt Lake — Lower Pitt system showing tidal influence on drainage channels (1954).

Similarities between Hatzic Prairie  
Drainage Channels and Tidal Channels

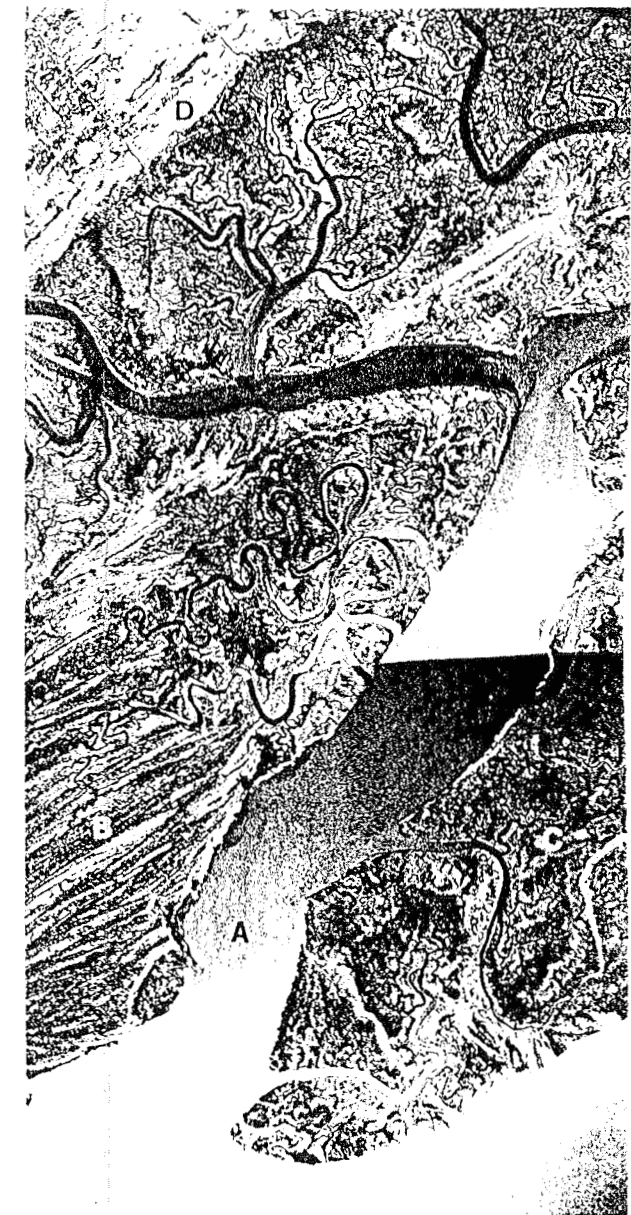
Trenchard Inlet, South Carolina — Typical tidal channel pattern (1951).

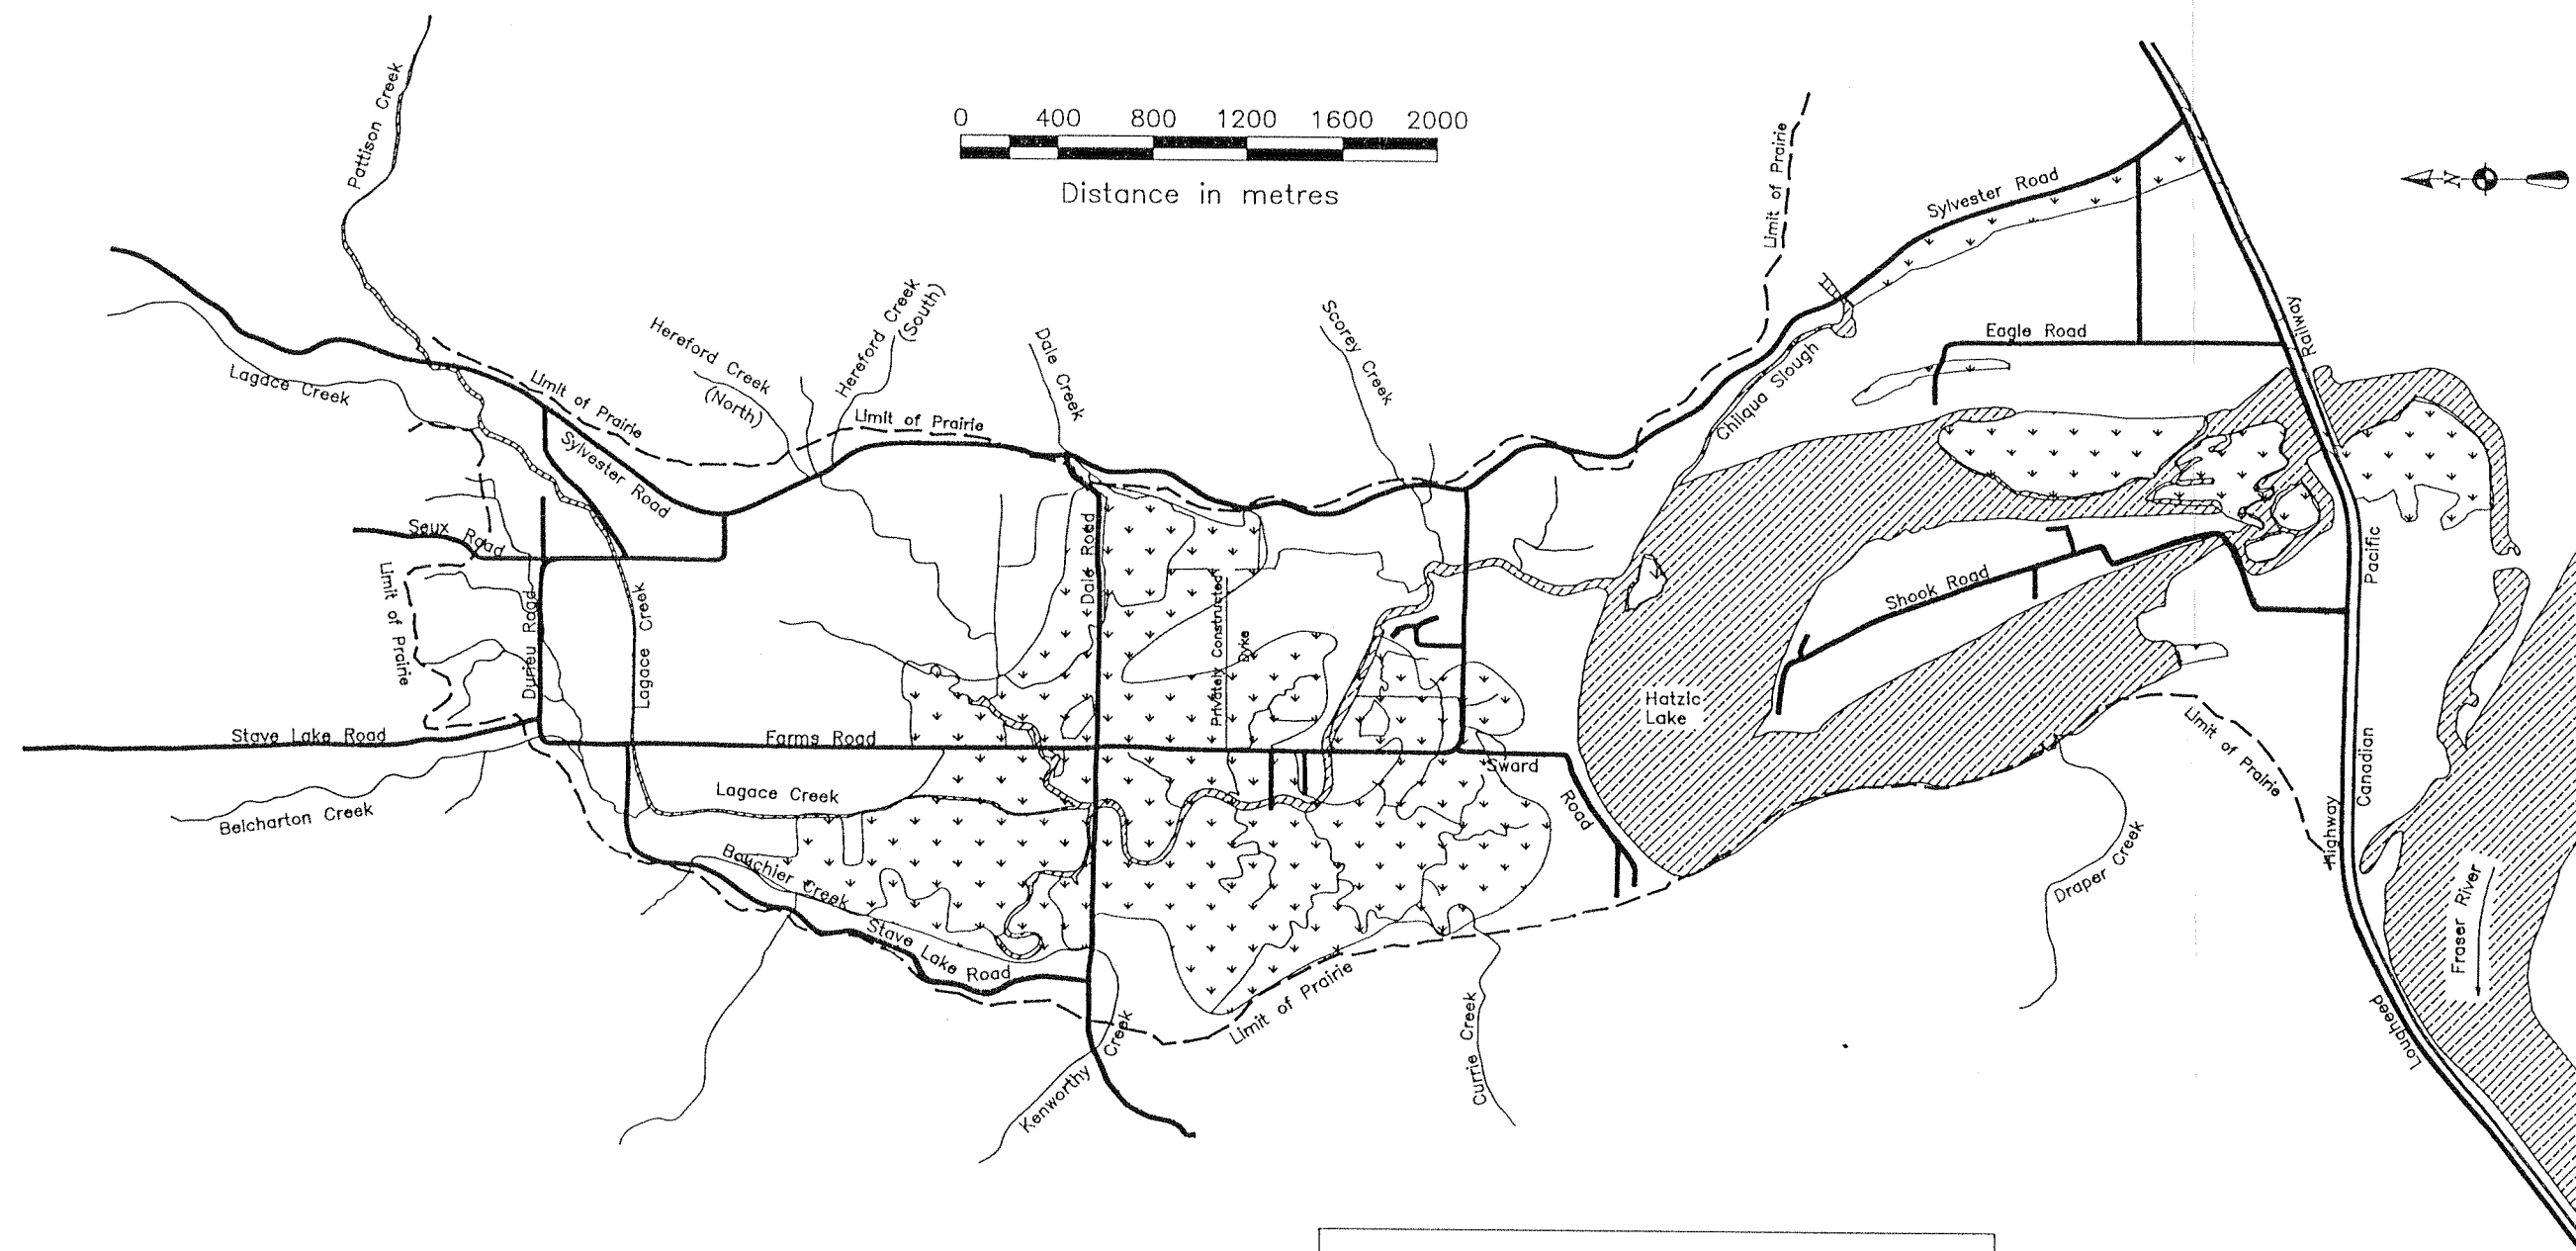
ARDSA Criteria  
Areas Below 3.6 m GSC

Legend:

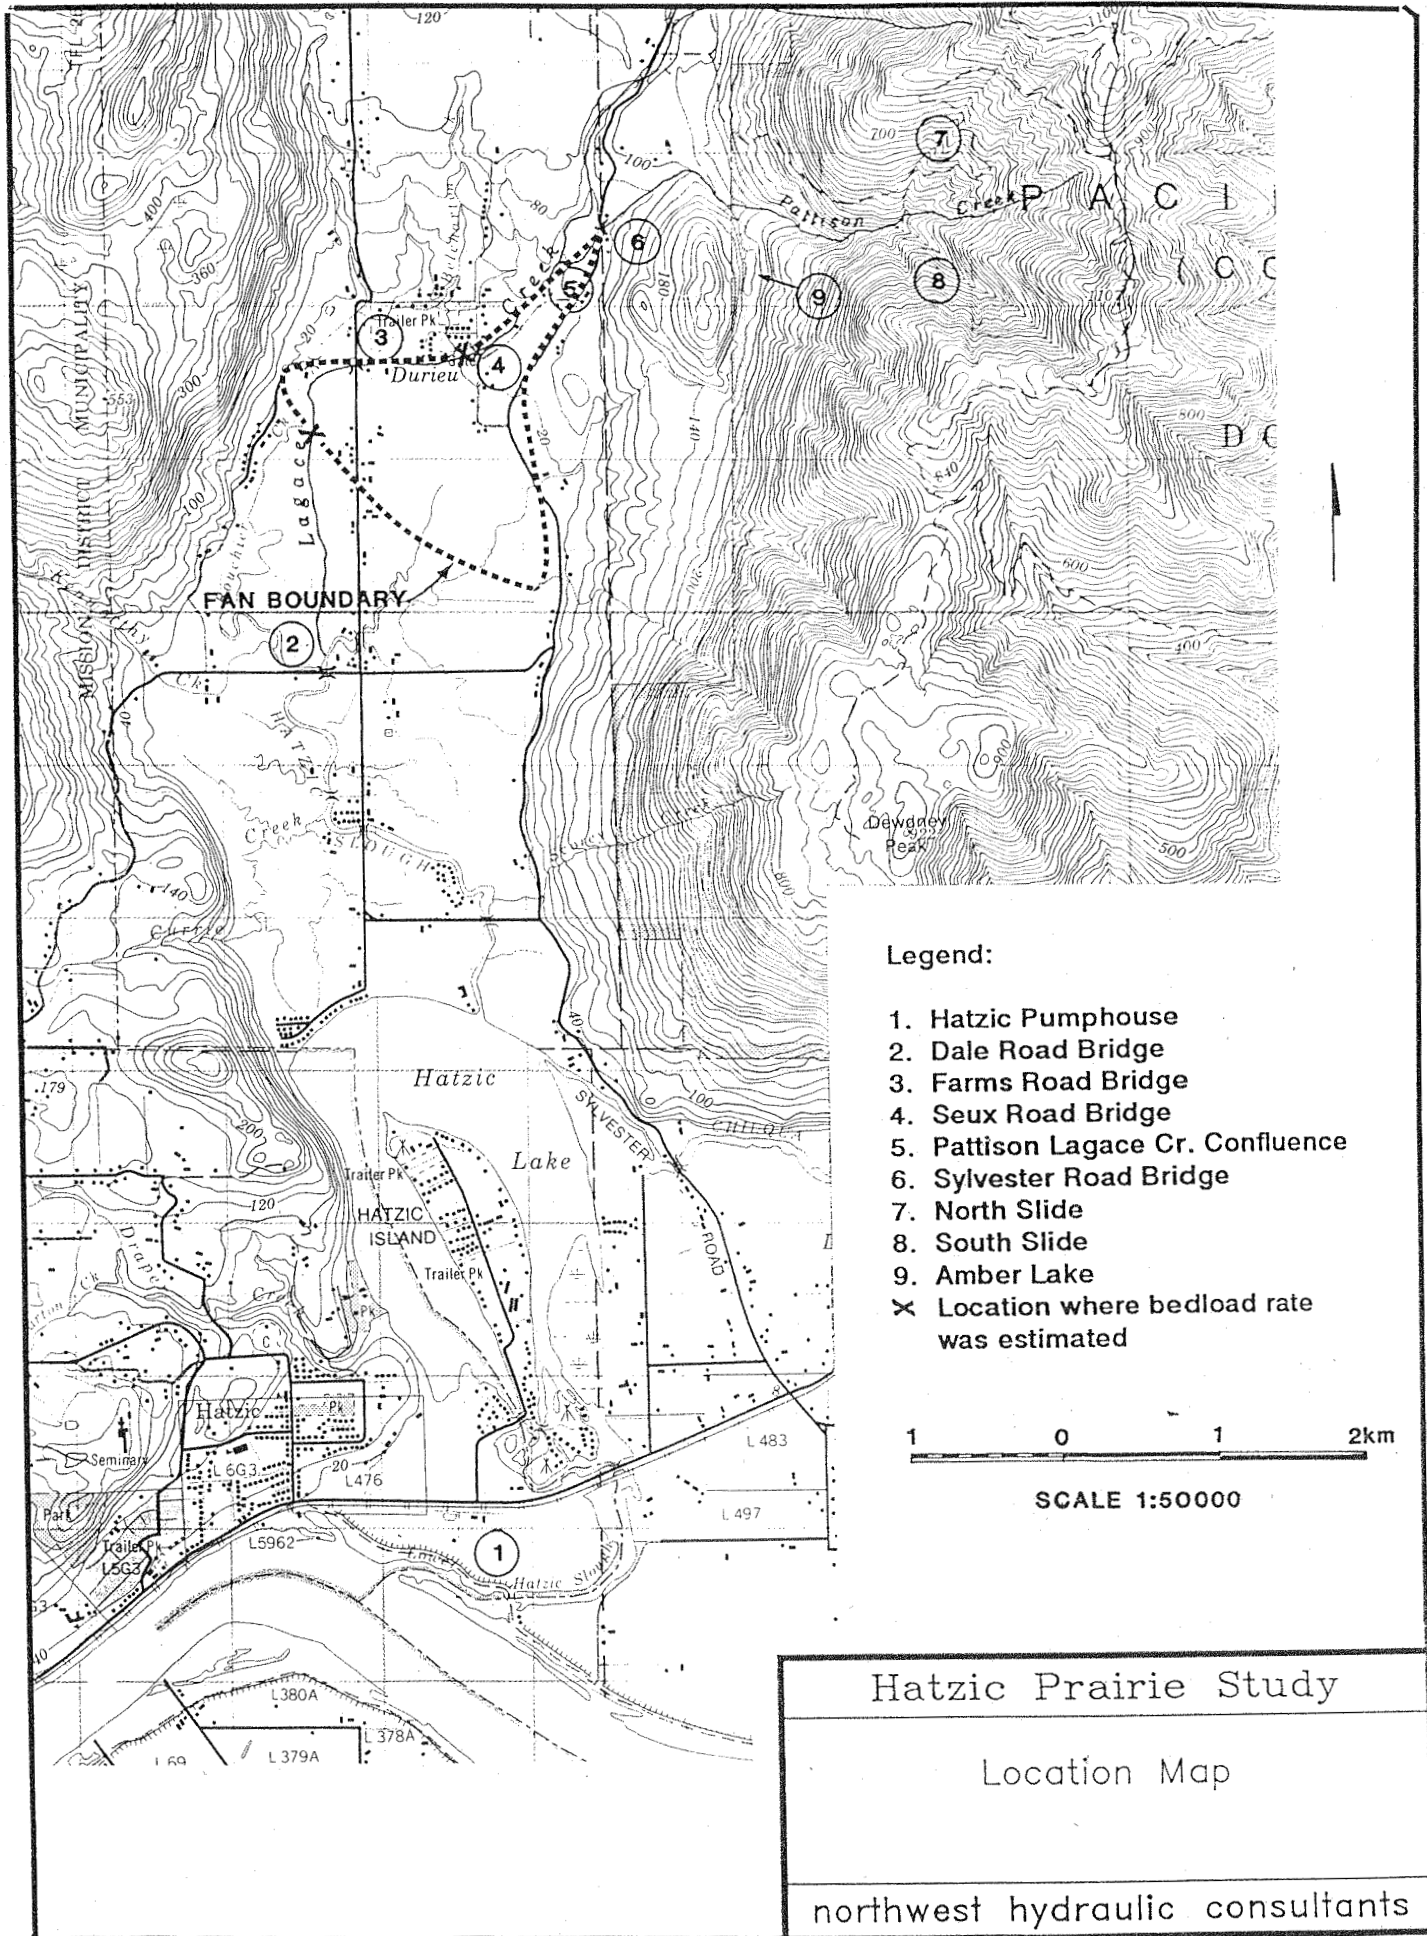
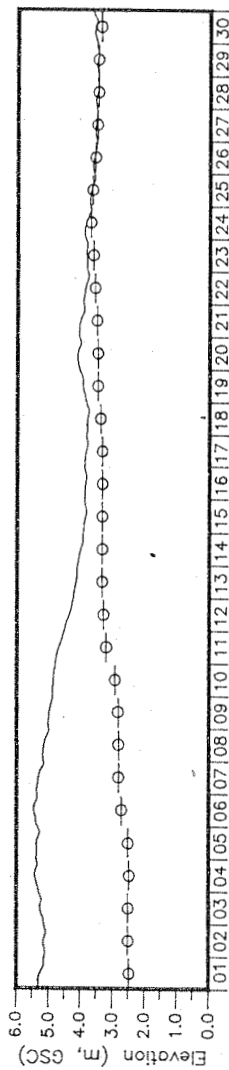
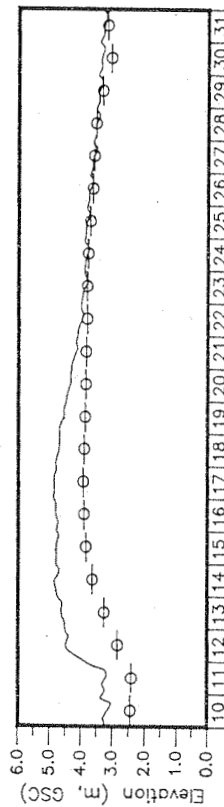
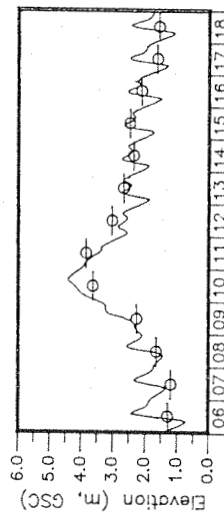
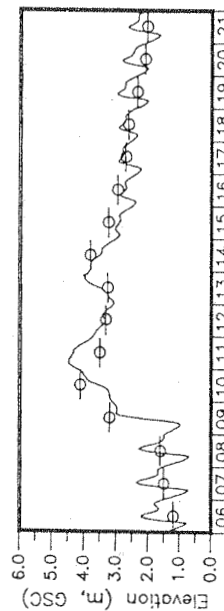
Fraser River and Hatzic Lake  
Levels at Hatzic Pumphouse

June 1981

December 1980

July 1983

November 1989

November 1990

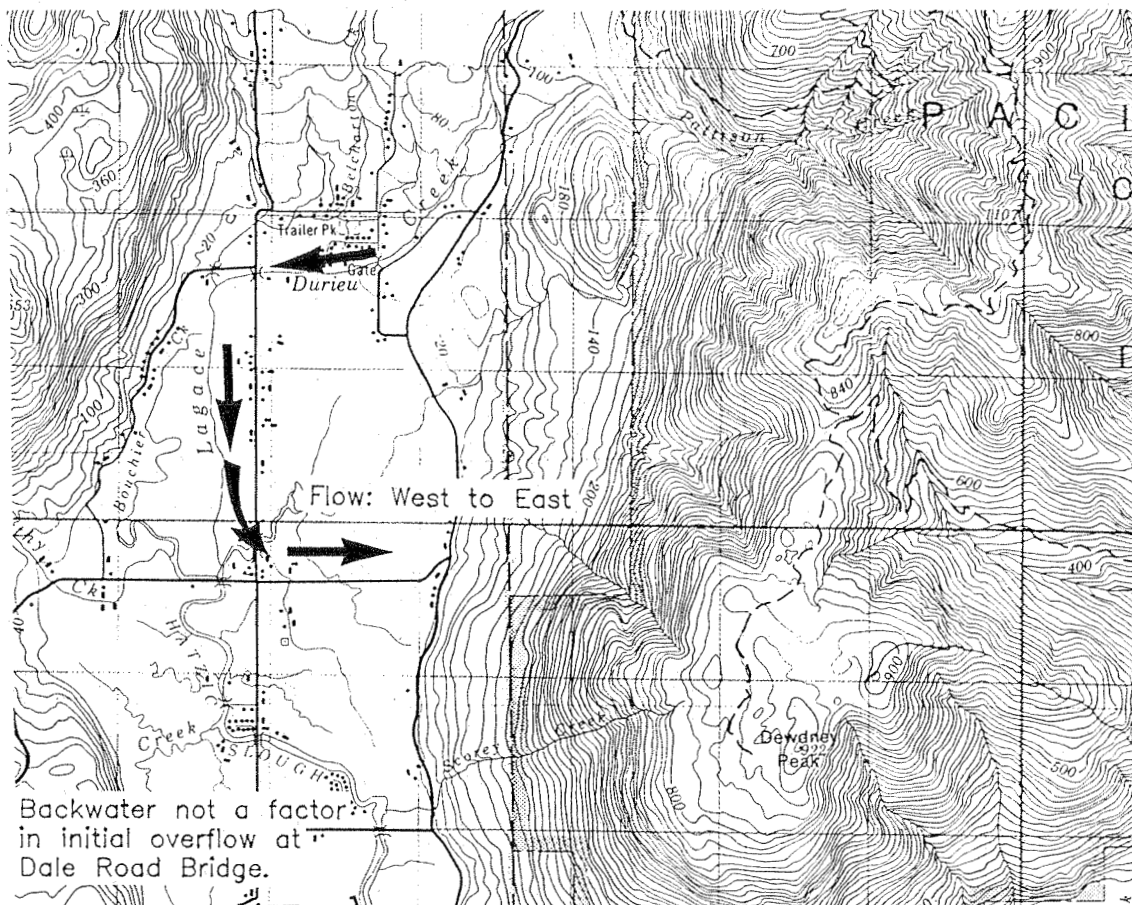
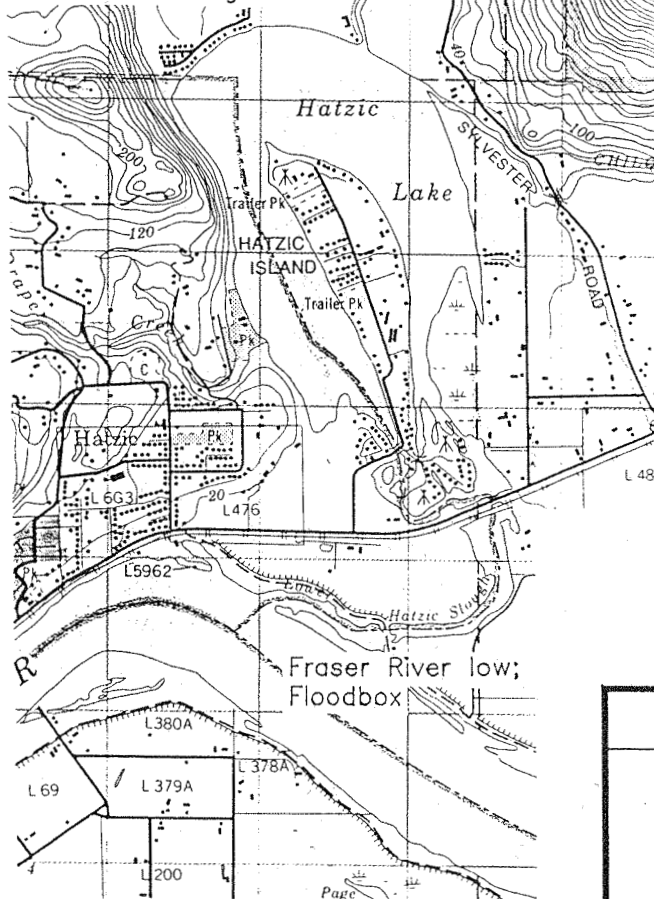
Flooding:  
February 1990

Backwater not a factor in initial overflow at Dale Road Bridge.

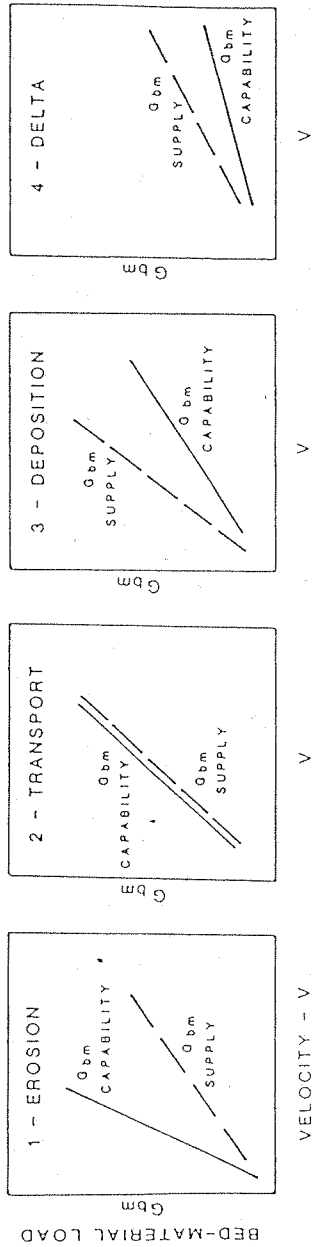
# WATER/SEDIMENT PROCESSES

SEDIMENT ERODED FROM A WATERSHED IS CONVEYED ALONG RIVER CHANNELS. A SIMPLIFIED CLASSIFICATION OF WATER/SEDIMENT PROCESSES WITHIN RIVER CHANNELS CAN BE REDUCED TO FOUR DISTINCT PROCESSES DEPENDING UPON THE CAPABILITY OF THE RIVER CHANNEL TO MOVE SEDIMENT:

1. River can transport more bed-material than watershed can supply. The slope of the river is controlled by bedrock.
2. River transport capability matches supply of sediment. The river is stable.
3. River cannot transport all the bed-material supplied and forms bars and islands. The river is unstable.
4. River capability to transport bed-material is low and distributary channels develop.

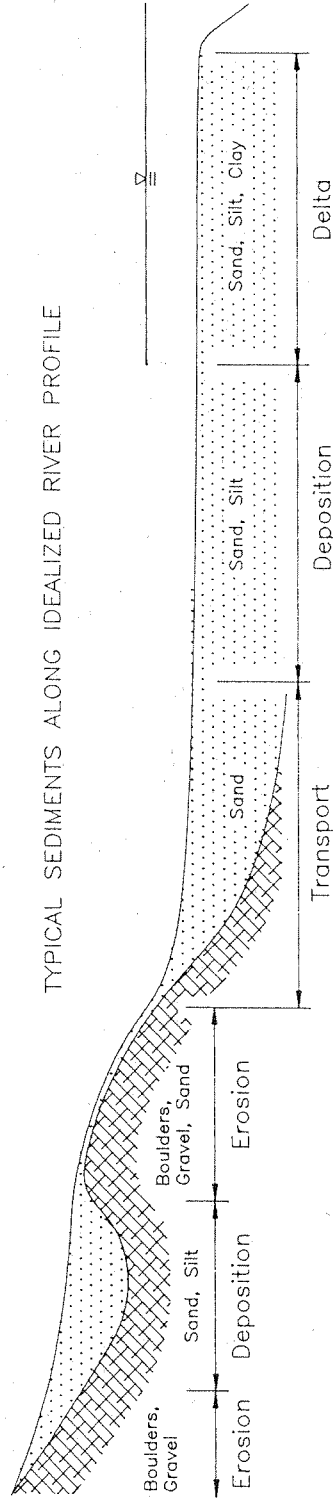
Idealized River Profile

## TYPICAL SEDIMENTS ALONG IDEALIZED RIVER PROFILE

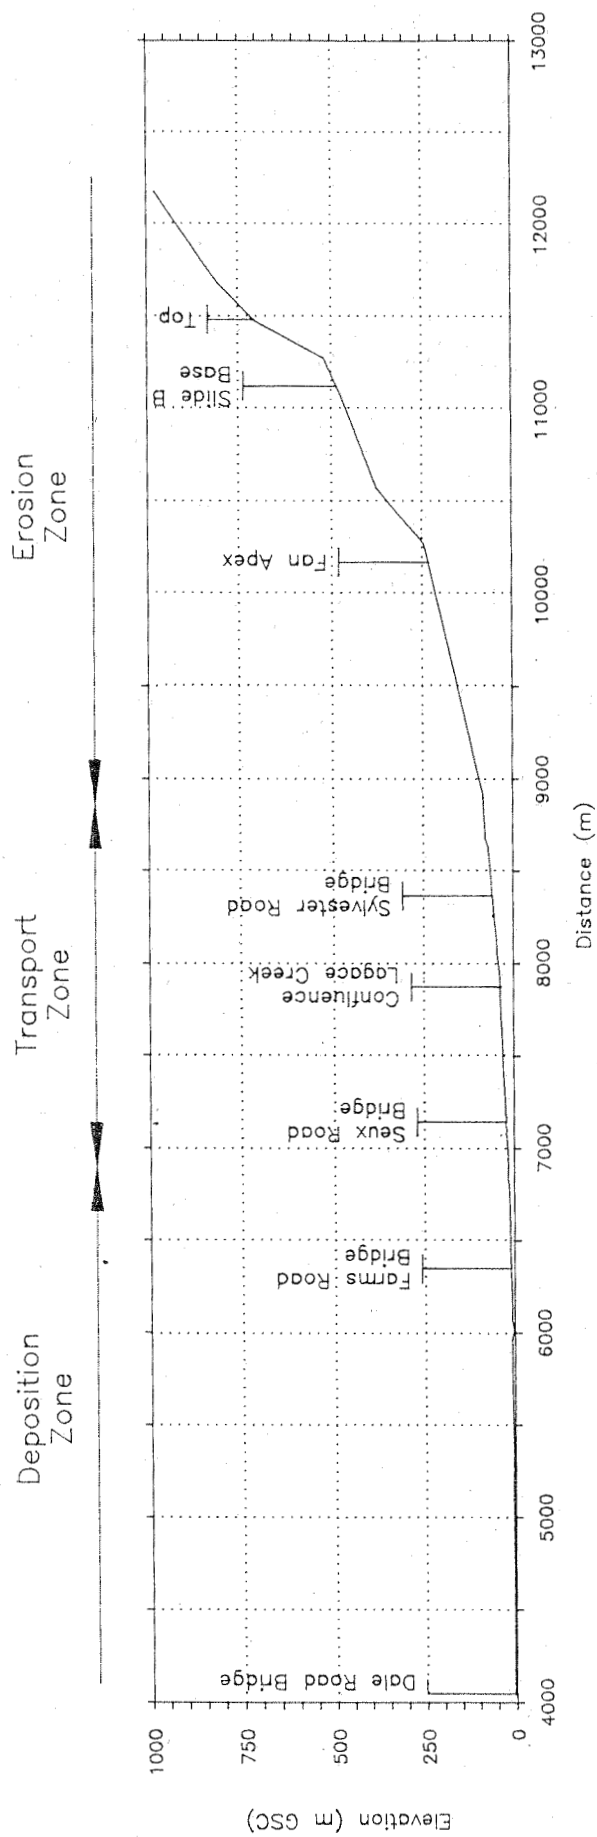
Pattison/Lagace Creek Profile

Erosion, Transport, and Deposition

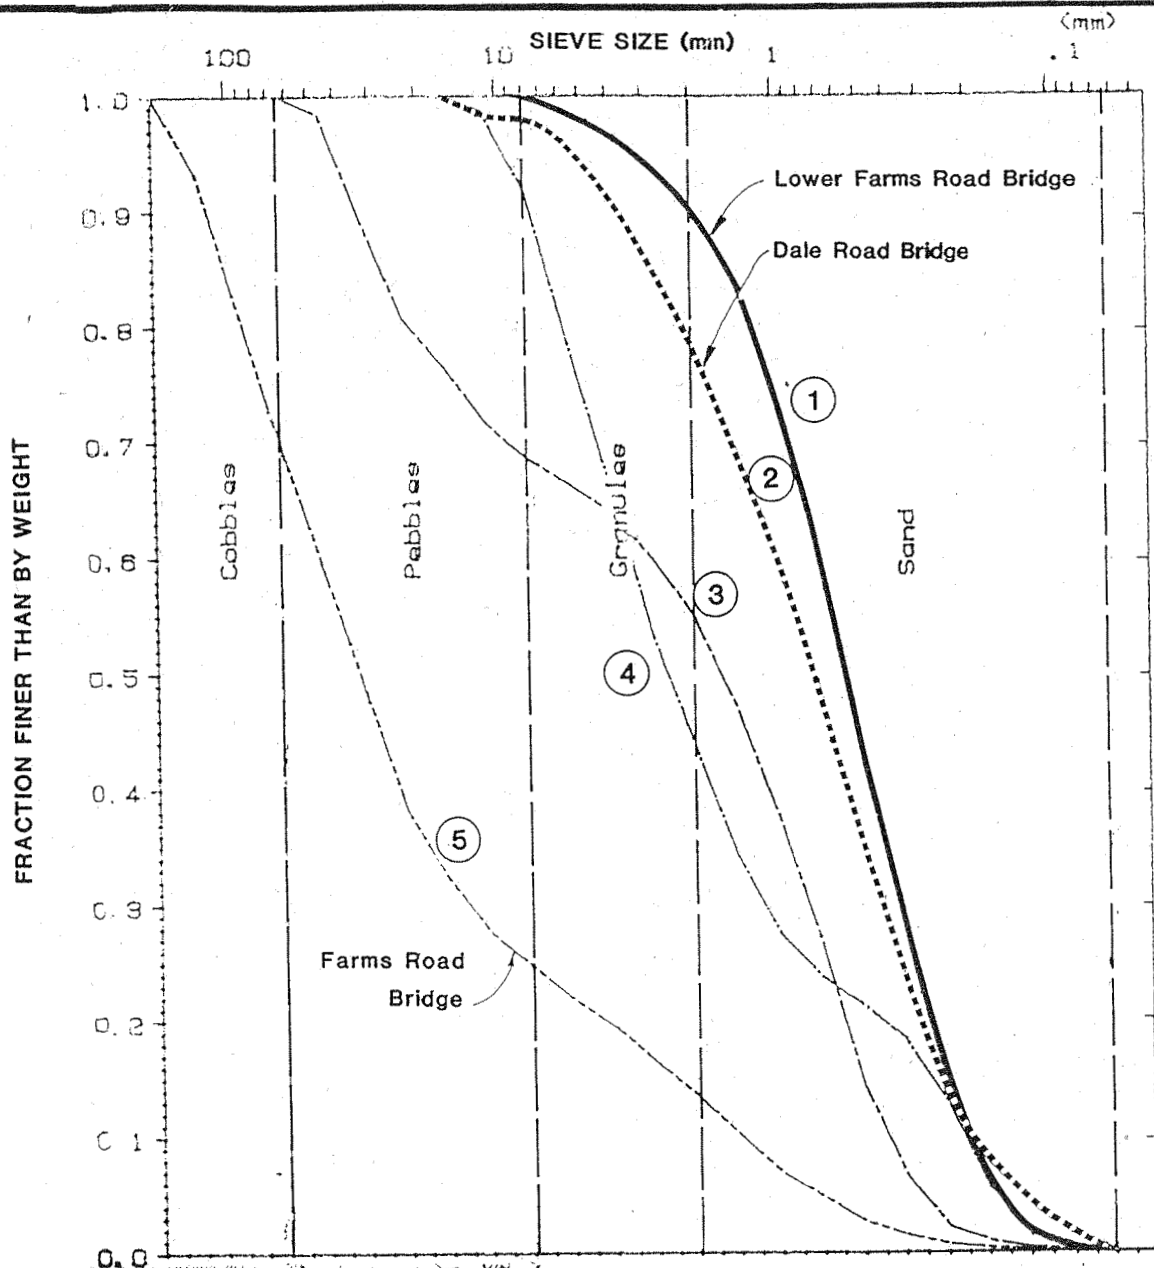
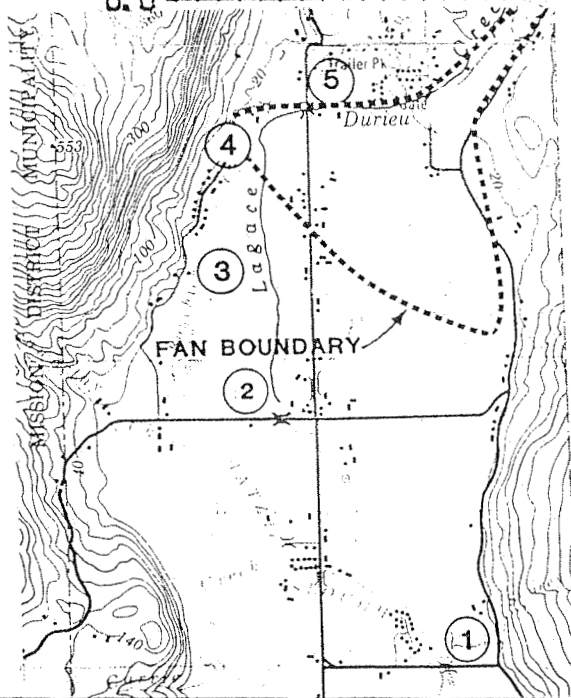
DWG No. 3.9

Grain Size Analyses  
of Bed Material

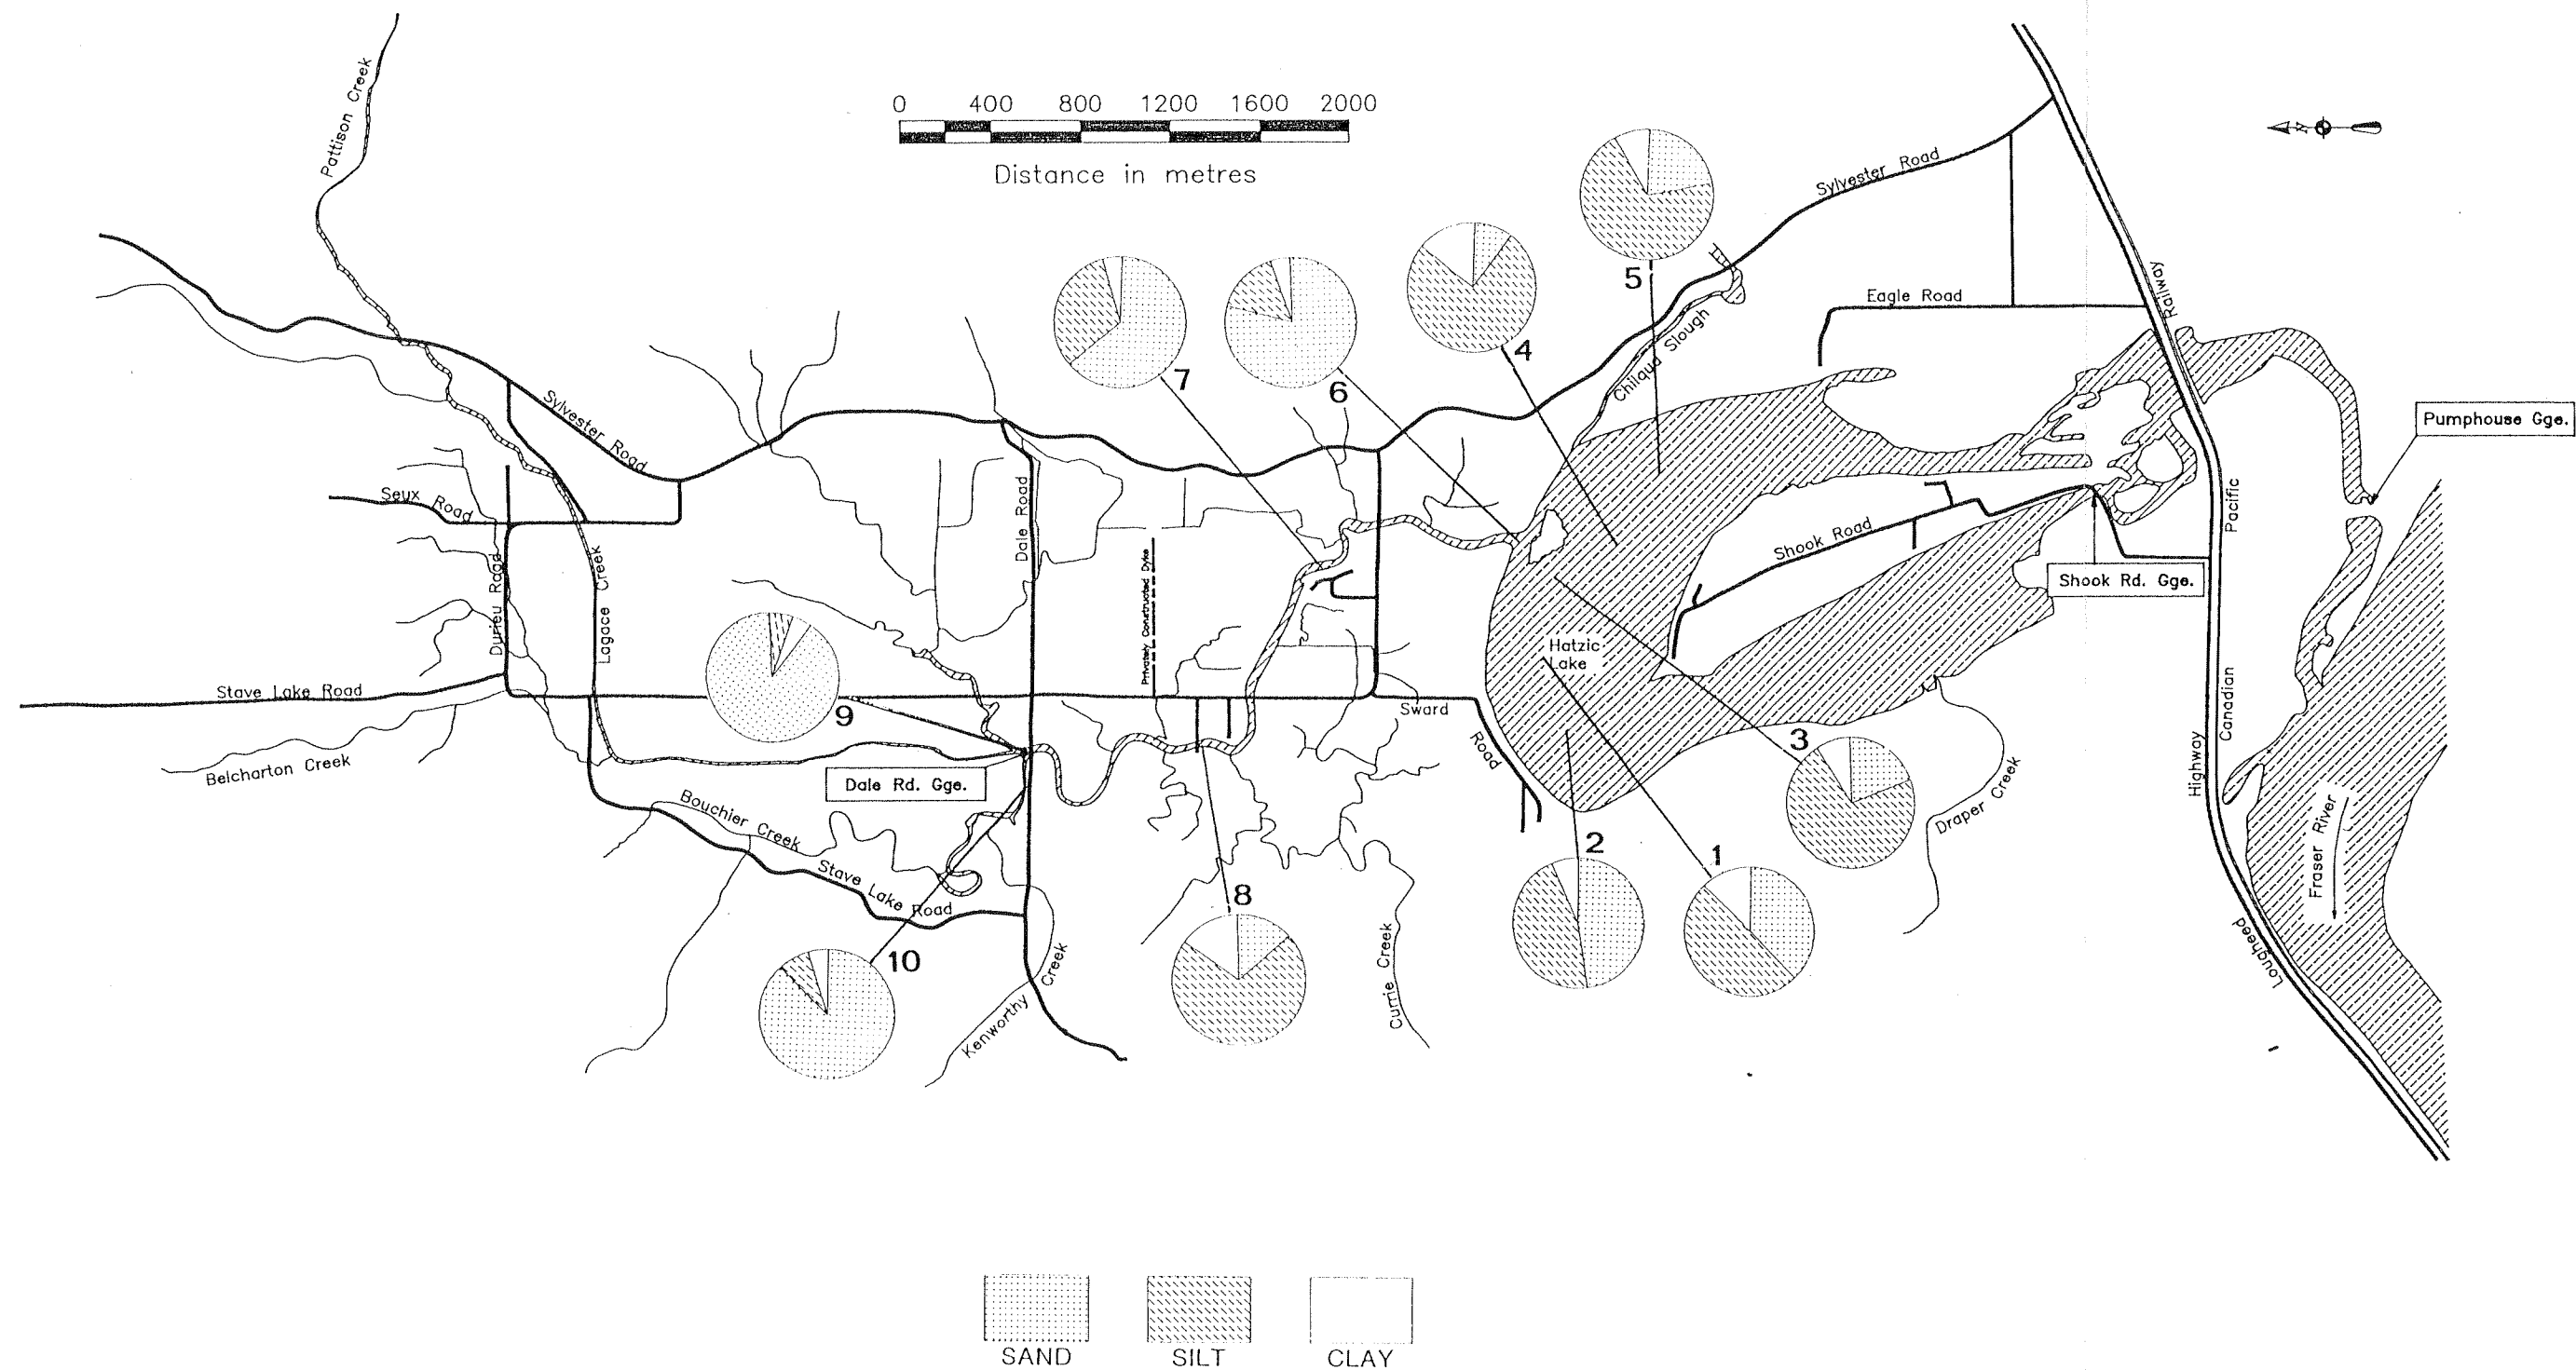
Sediment Sample Locations  
September 1991

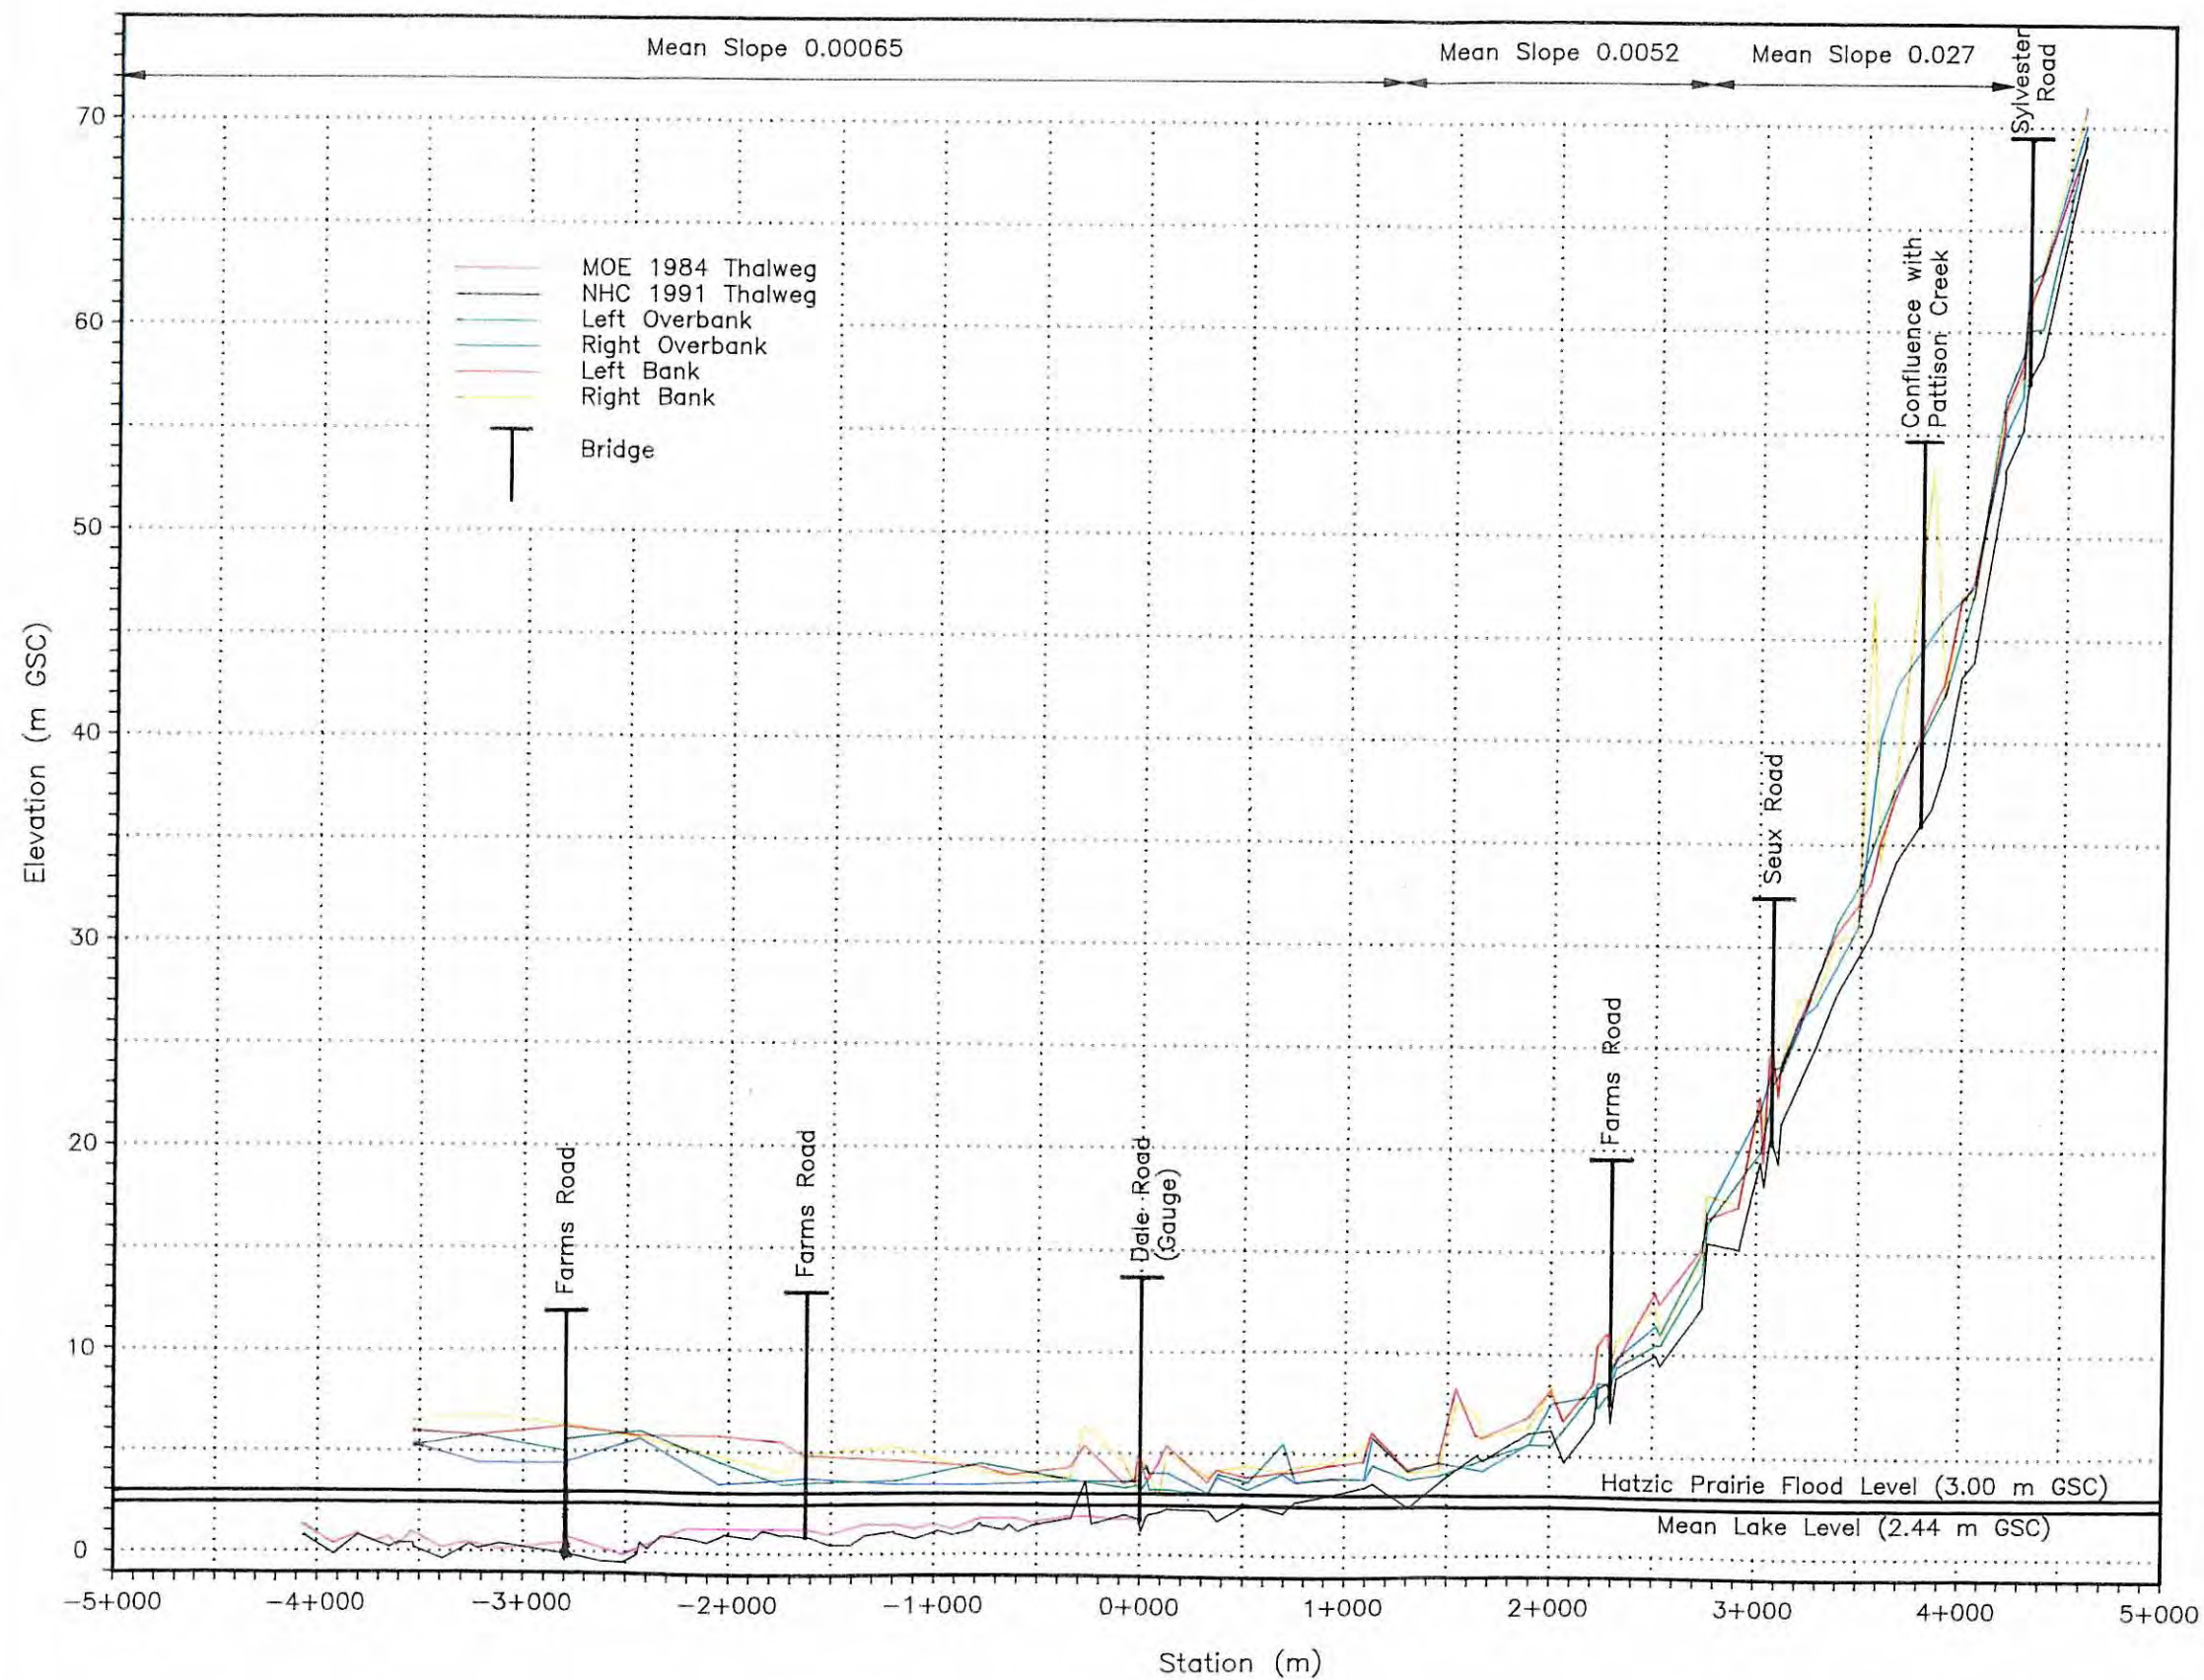
DWG No. 3.11

Lagace Creek  
Thalweg and Bank Profiles

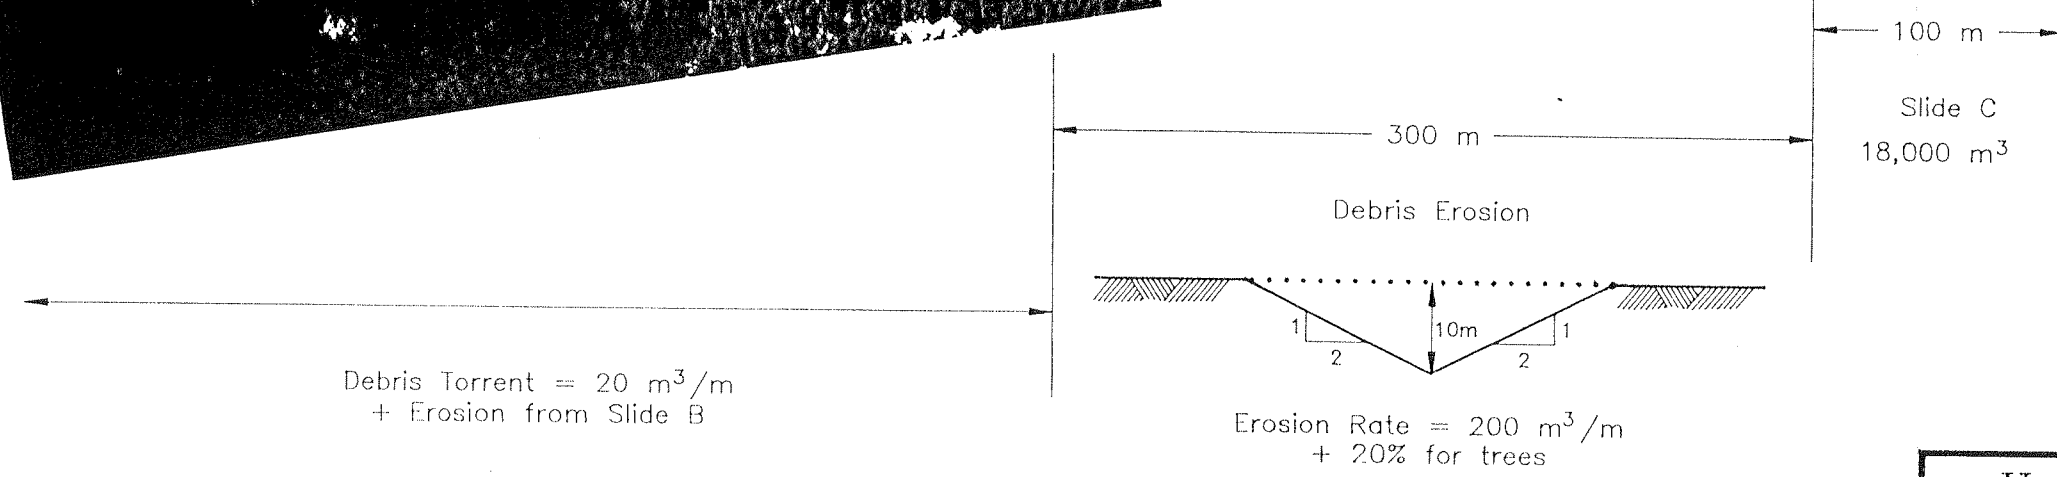
Debris Torrent  
Sediment Budget
