**DEWDNEY-ALOUETTE REGIONAL DISTRICT  
MISSION, B.C.**

**HATZIC PRAIRIE DRAINAGE STUDY  
VOLUME 2**

*August 1992*

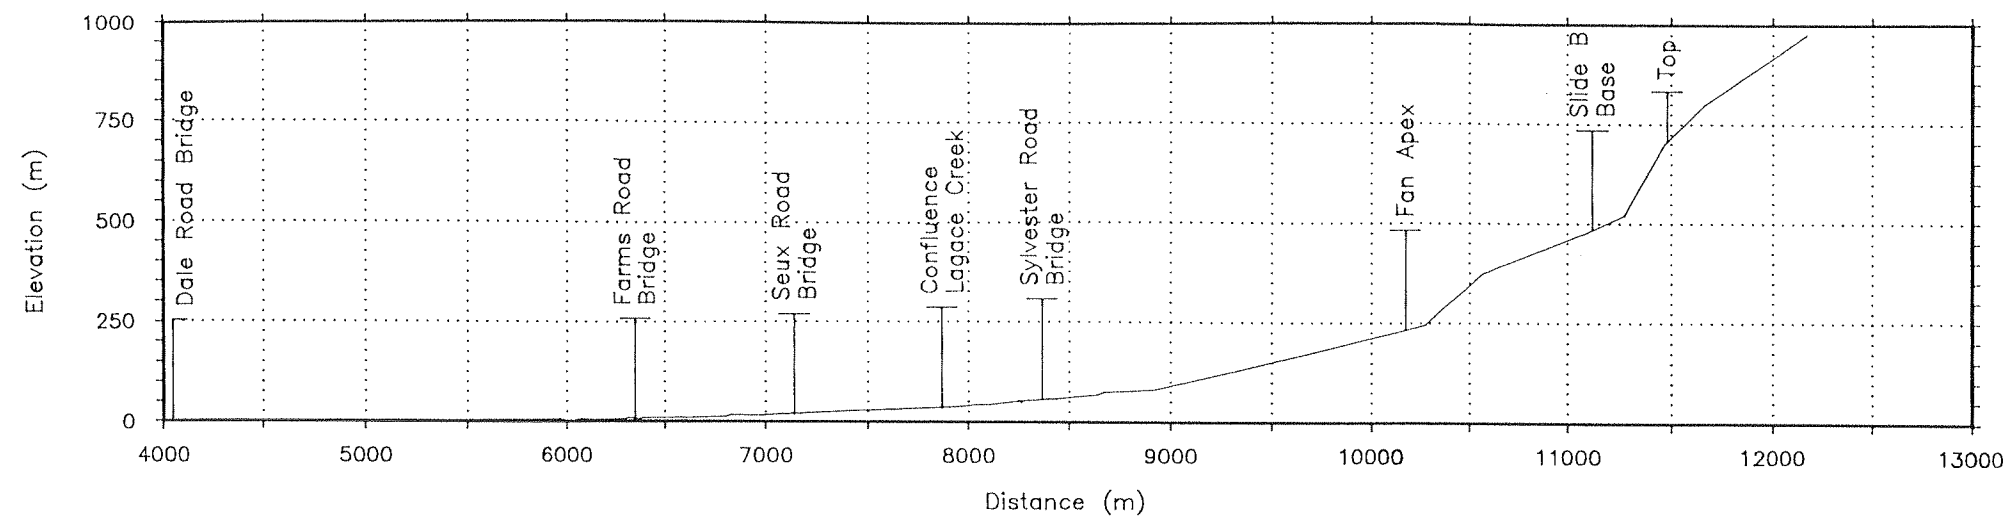
a) Profile of Pattison - Lagace Creeks.

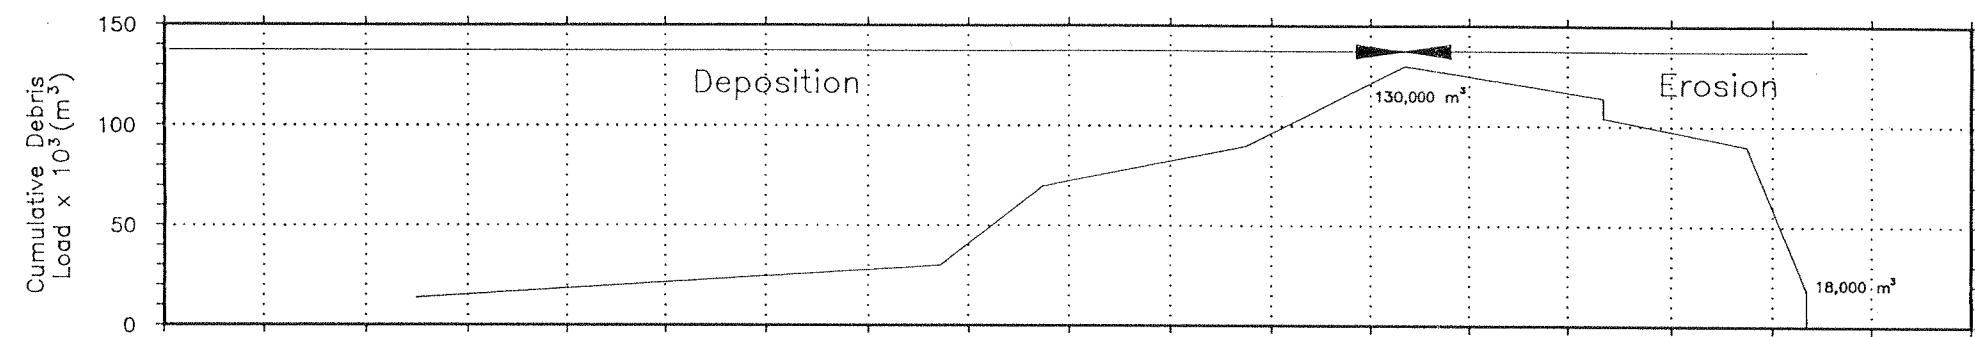
b) Sediment budget for debris flow event (about one hour).

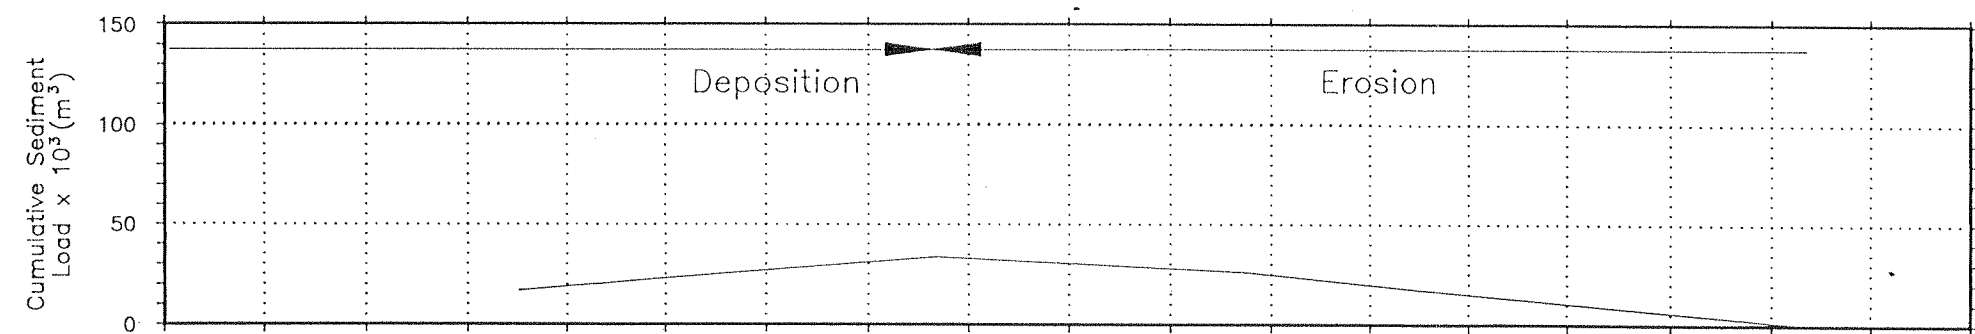
c) Post-debris torrent sediment budget (about one day).

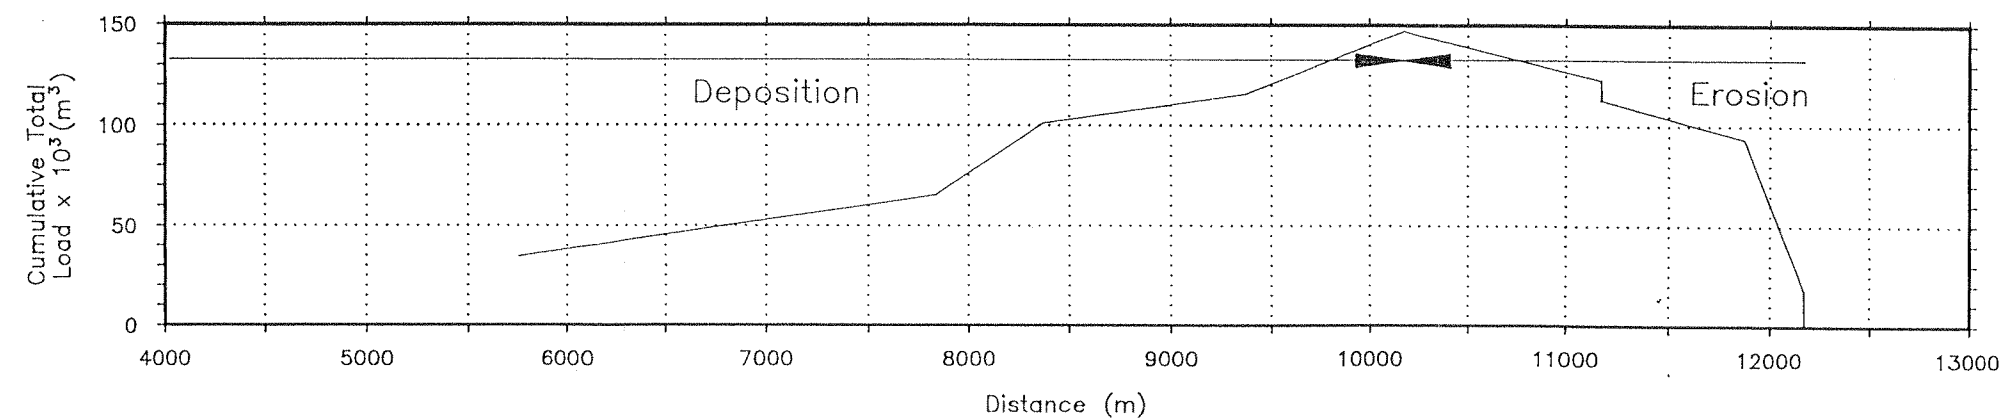
d) Total sediment budget (about one day).

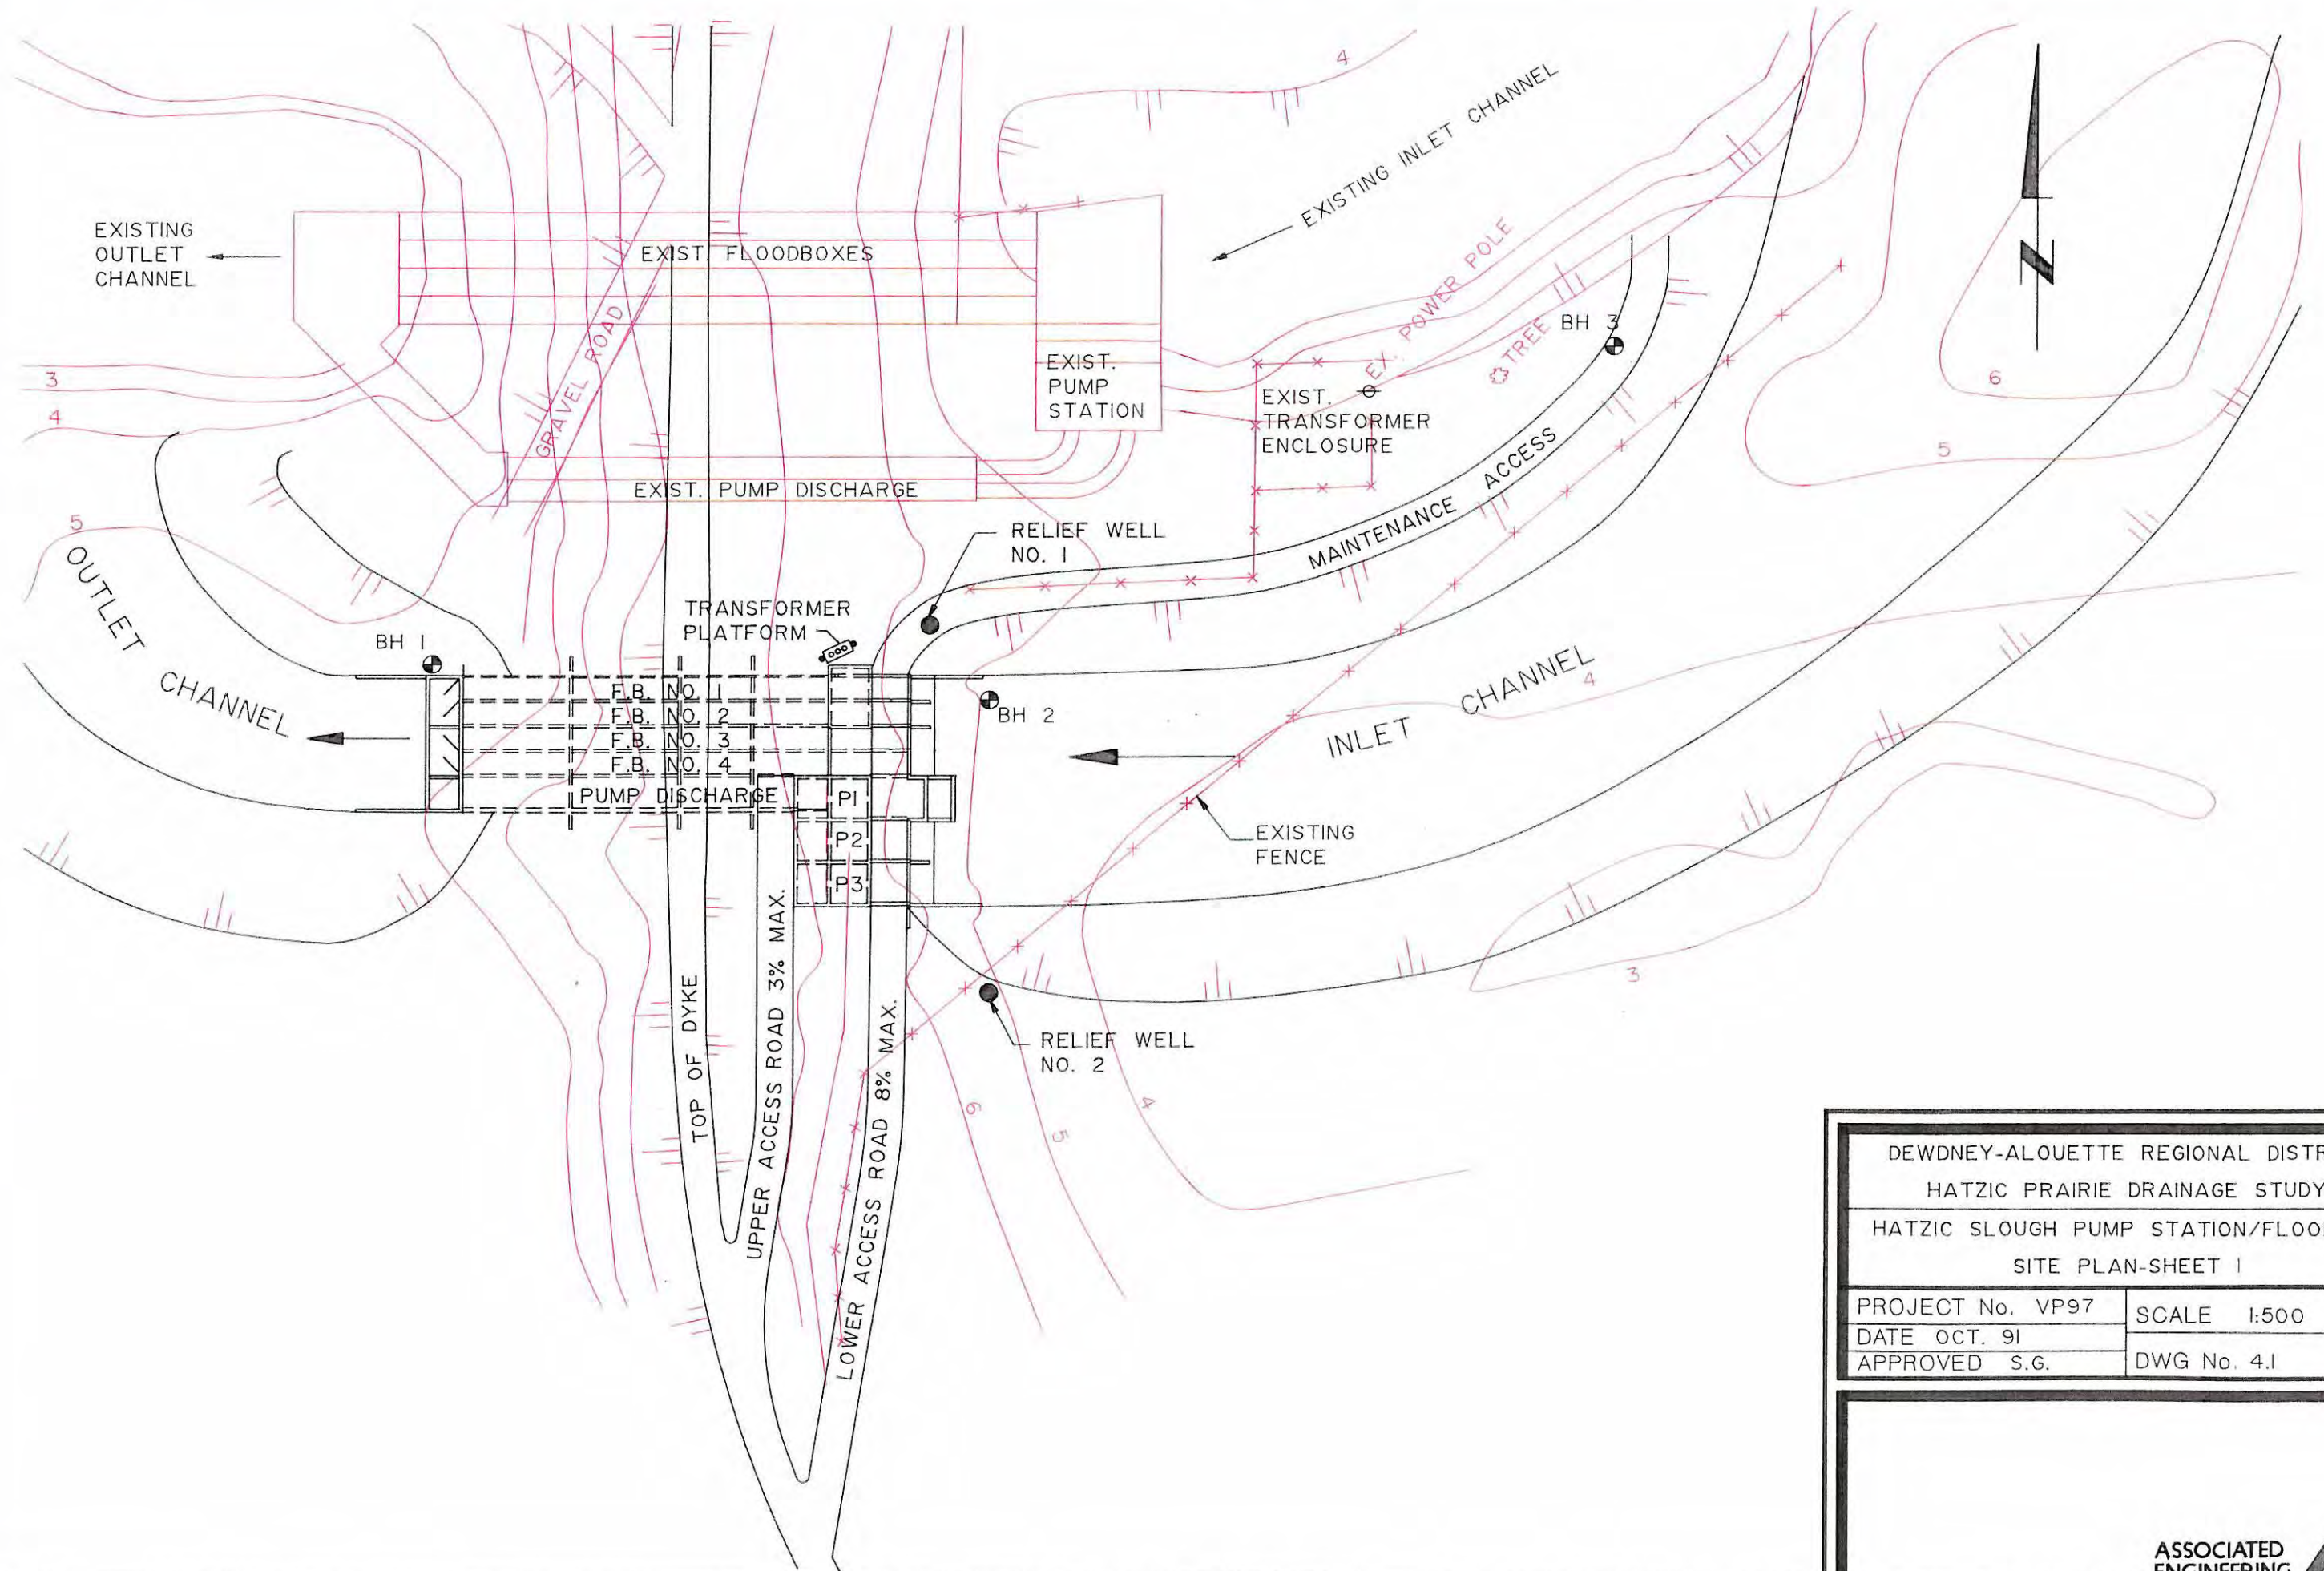
DEWDNEY-ALOUETTE REGIONAL DISTRICT  
 HATZIC PRAIRIE DRAINAGE STUDY  
 HATZIC SLOUGH PUMP STATION/FLOODBOX  
 SITE PLAN-SHEET 1

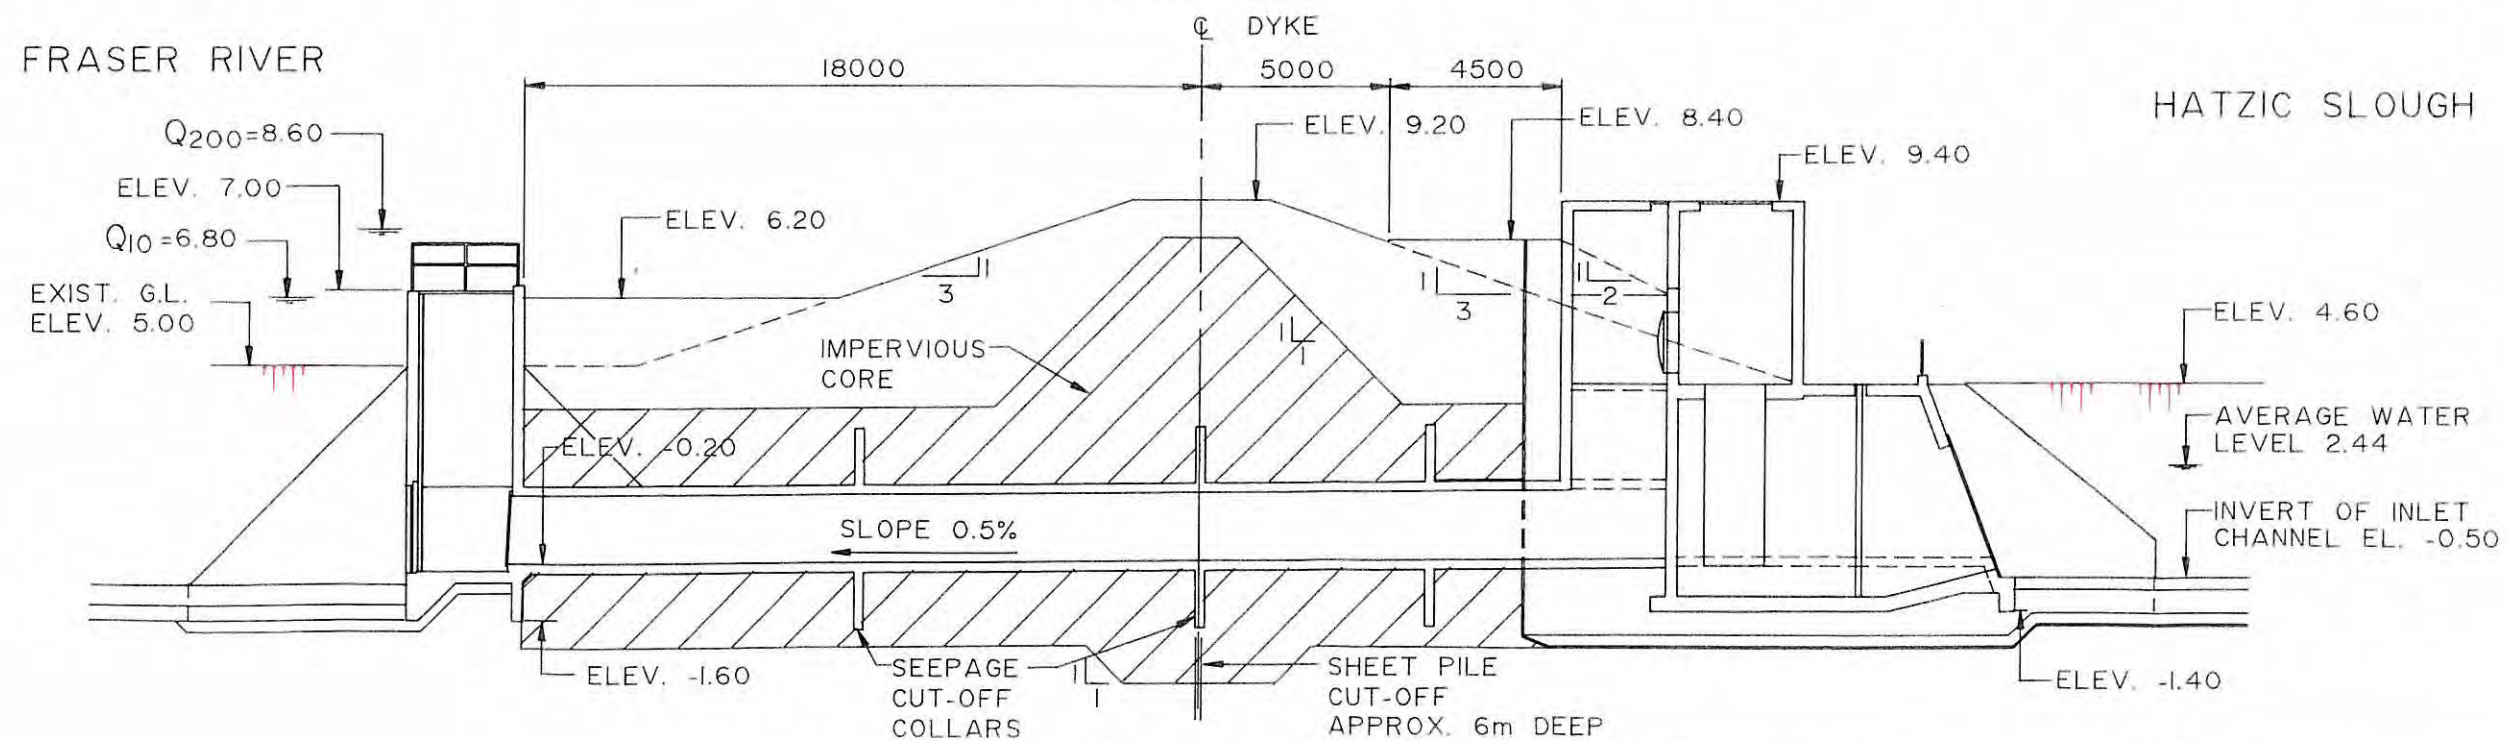
PROJECT No. VP97  
 DATE OCT. 91  
 APPROVED S.G.  
 SCALE 1:200  
 DWG No. 4.2

DEWDNEY-ALOUETTE REGIONAL DISTRICT  
 HATZIC PRAIRIE DRAINAGE STUDY  
 HATZIC SLOUGH PUMP STATION/FLOODBOX  
 PLAN AND SECTION-SHEET 2

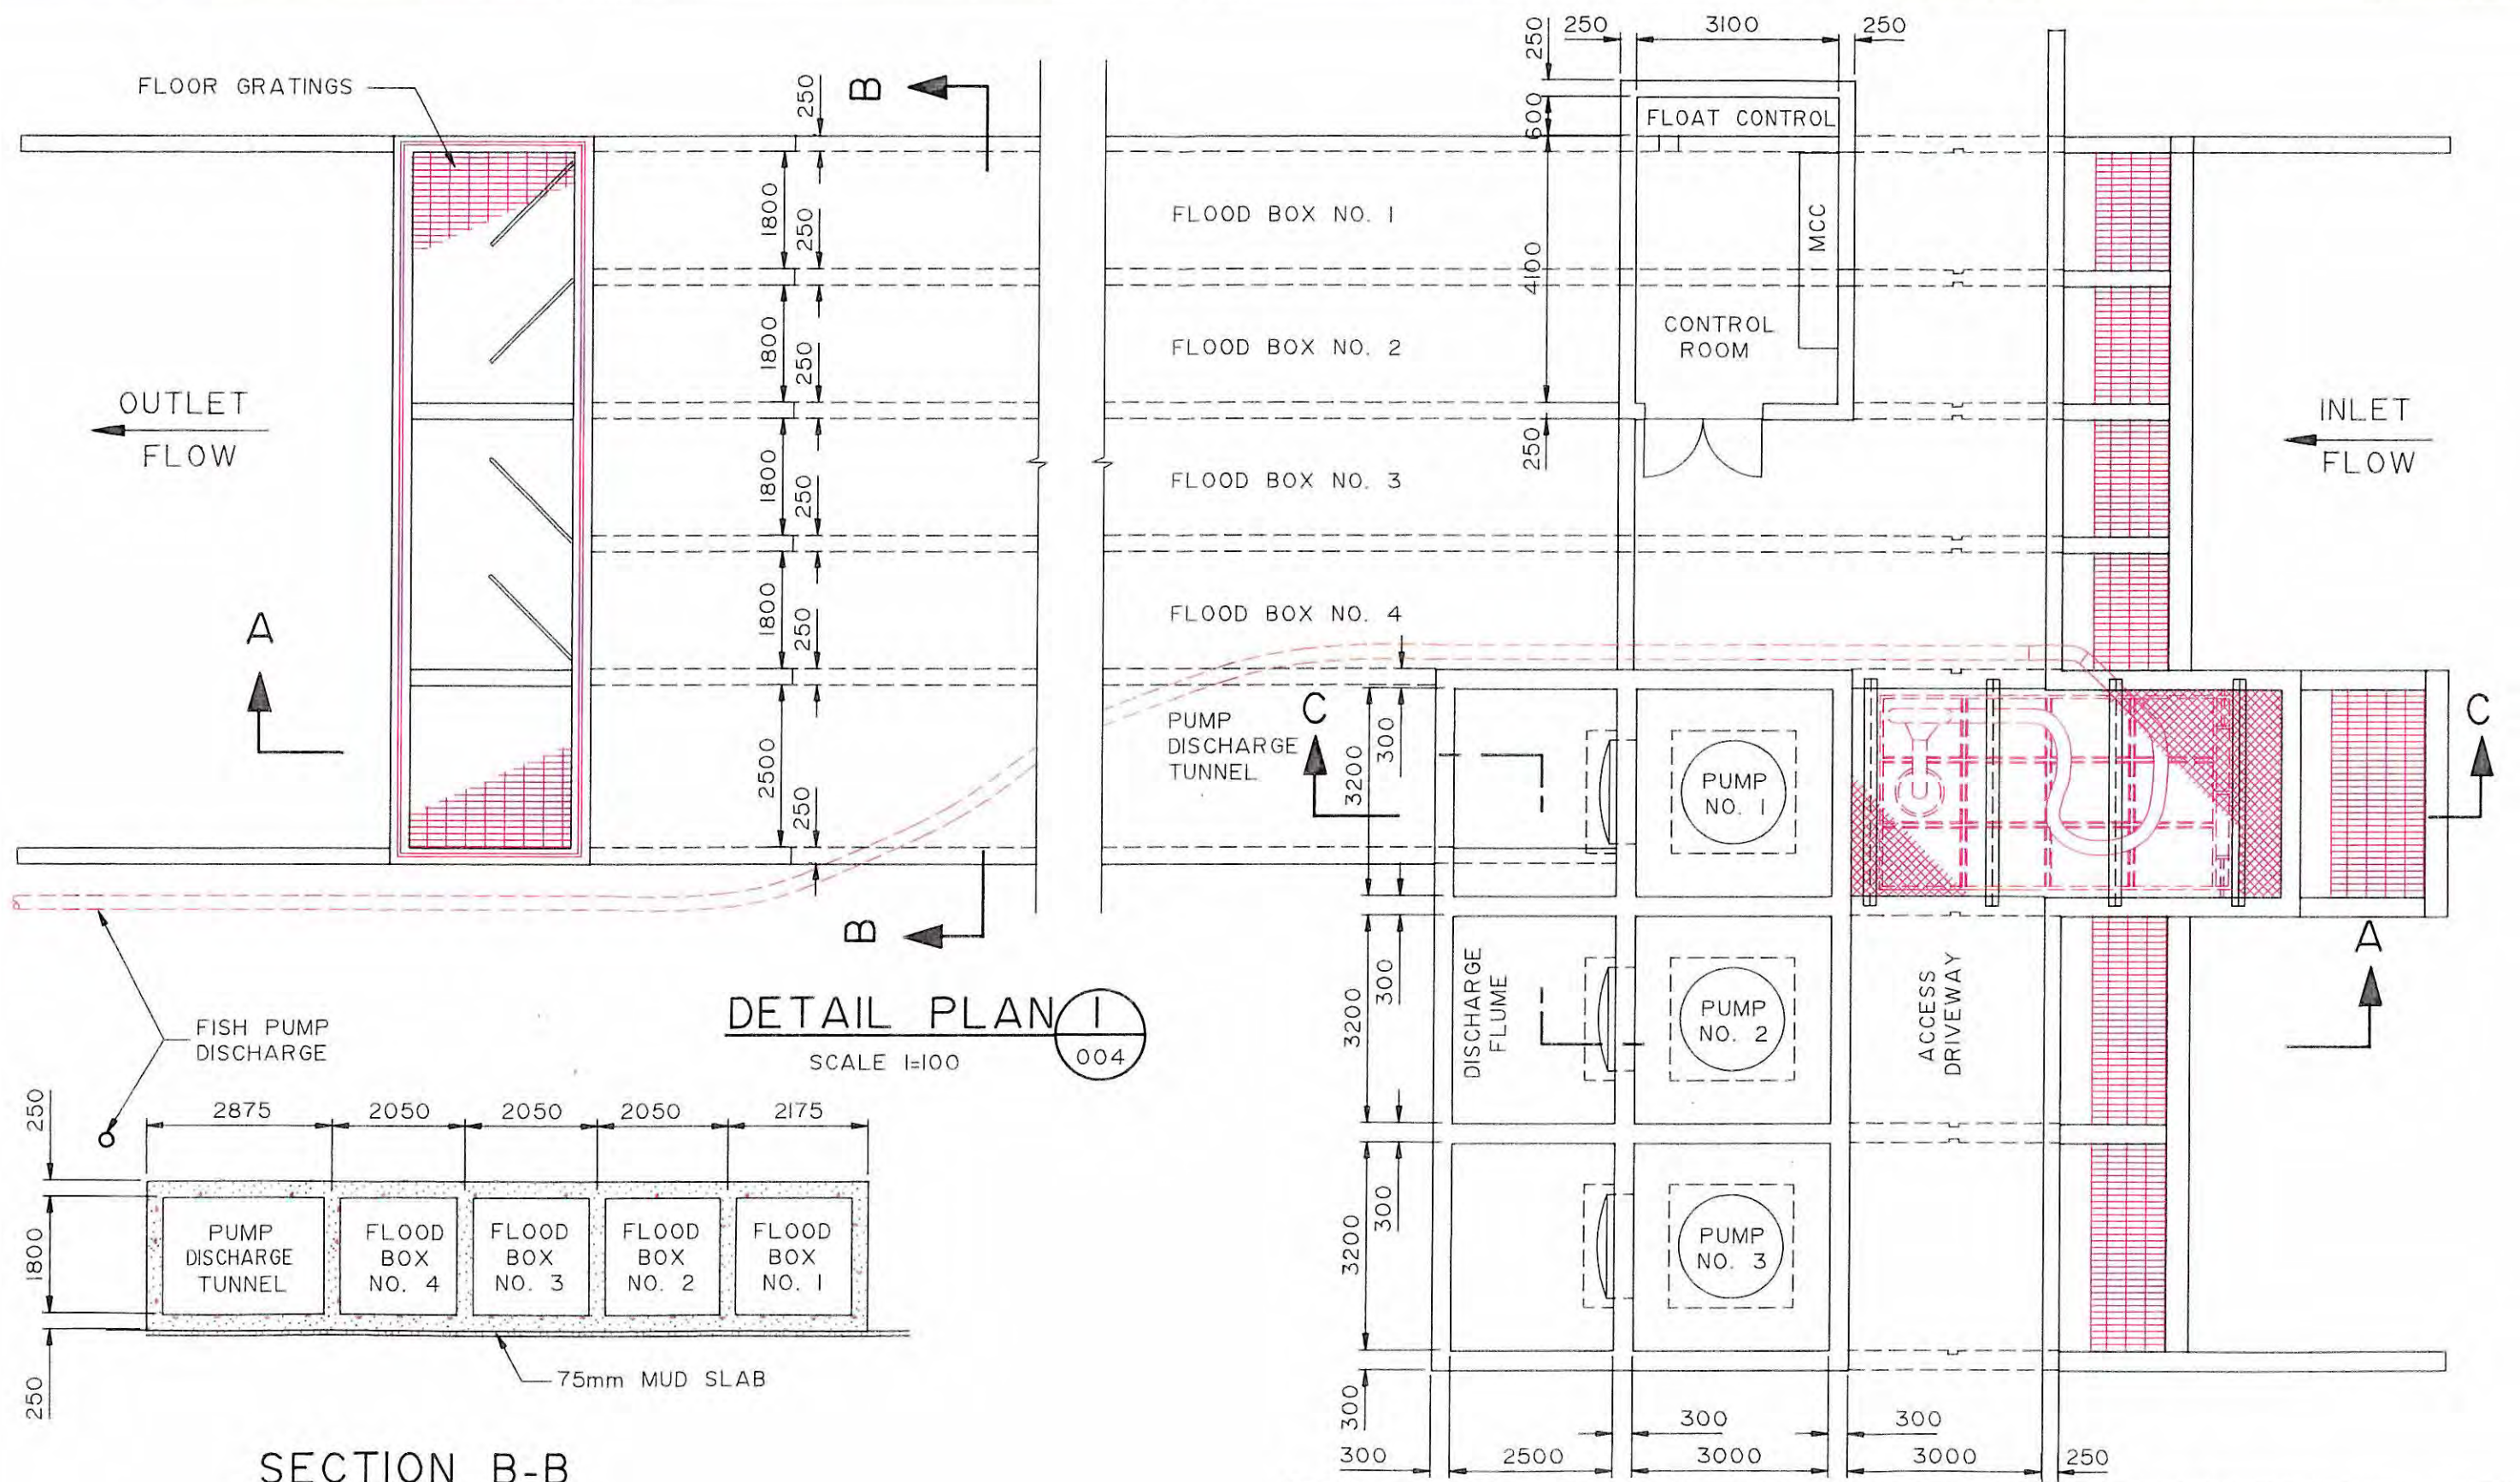
PROJECT No. VP97  
 DATE OCT. 91  
 APPROVED S.G.  
 SCALE 1:100  
 DWG No. 4.3

DEWDNEY-ALOUETTE REGIONAL DISTRICT  
 HATZIC PRAIRIE DRAINAGE STUDY  
 HATZIC SLOUGH PUMP STATION/FLOODBOX  
 DETAIL PLAN-SHEET 3

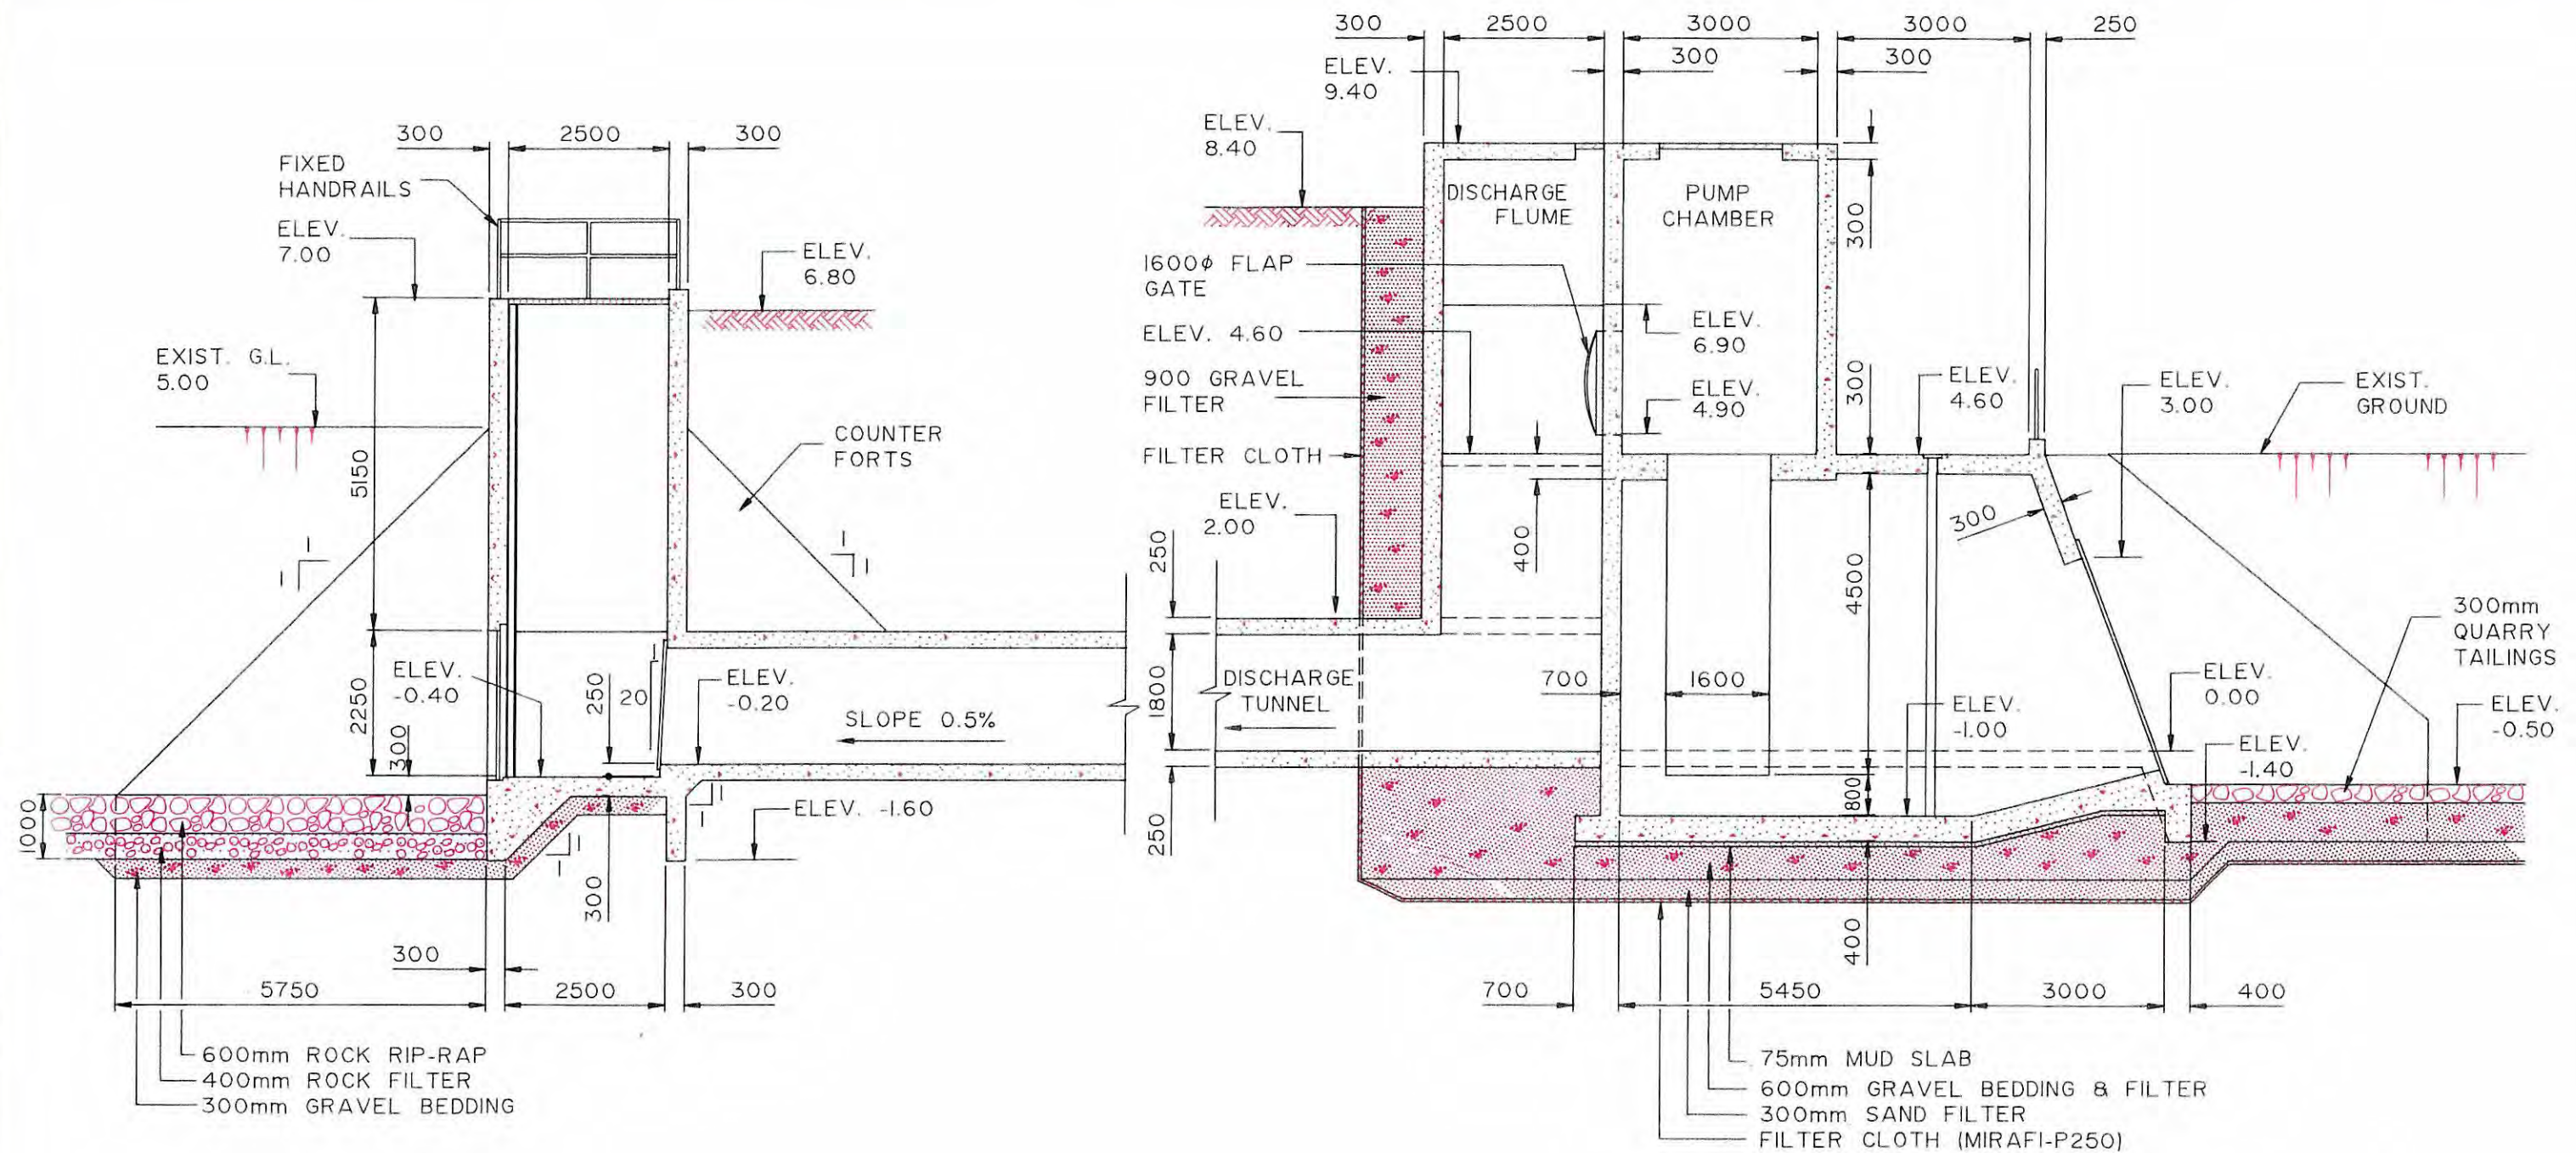
| DATE OCT. 91 | DWG No. 4.4 |

DETAIL SECTION A-A  
(DYKE DELETED)  
SCALE 1:100

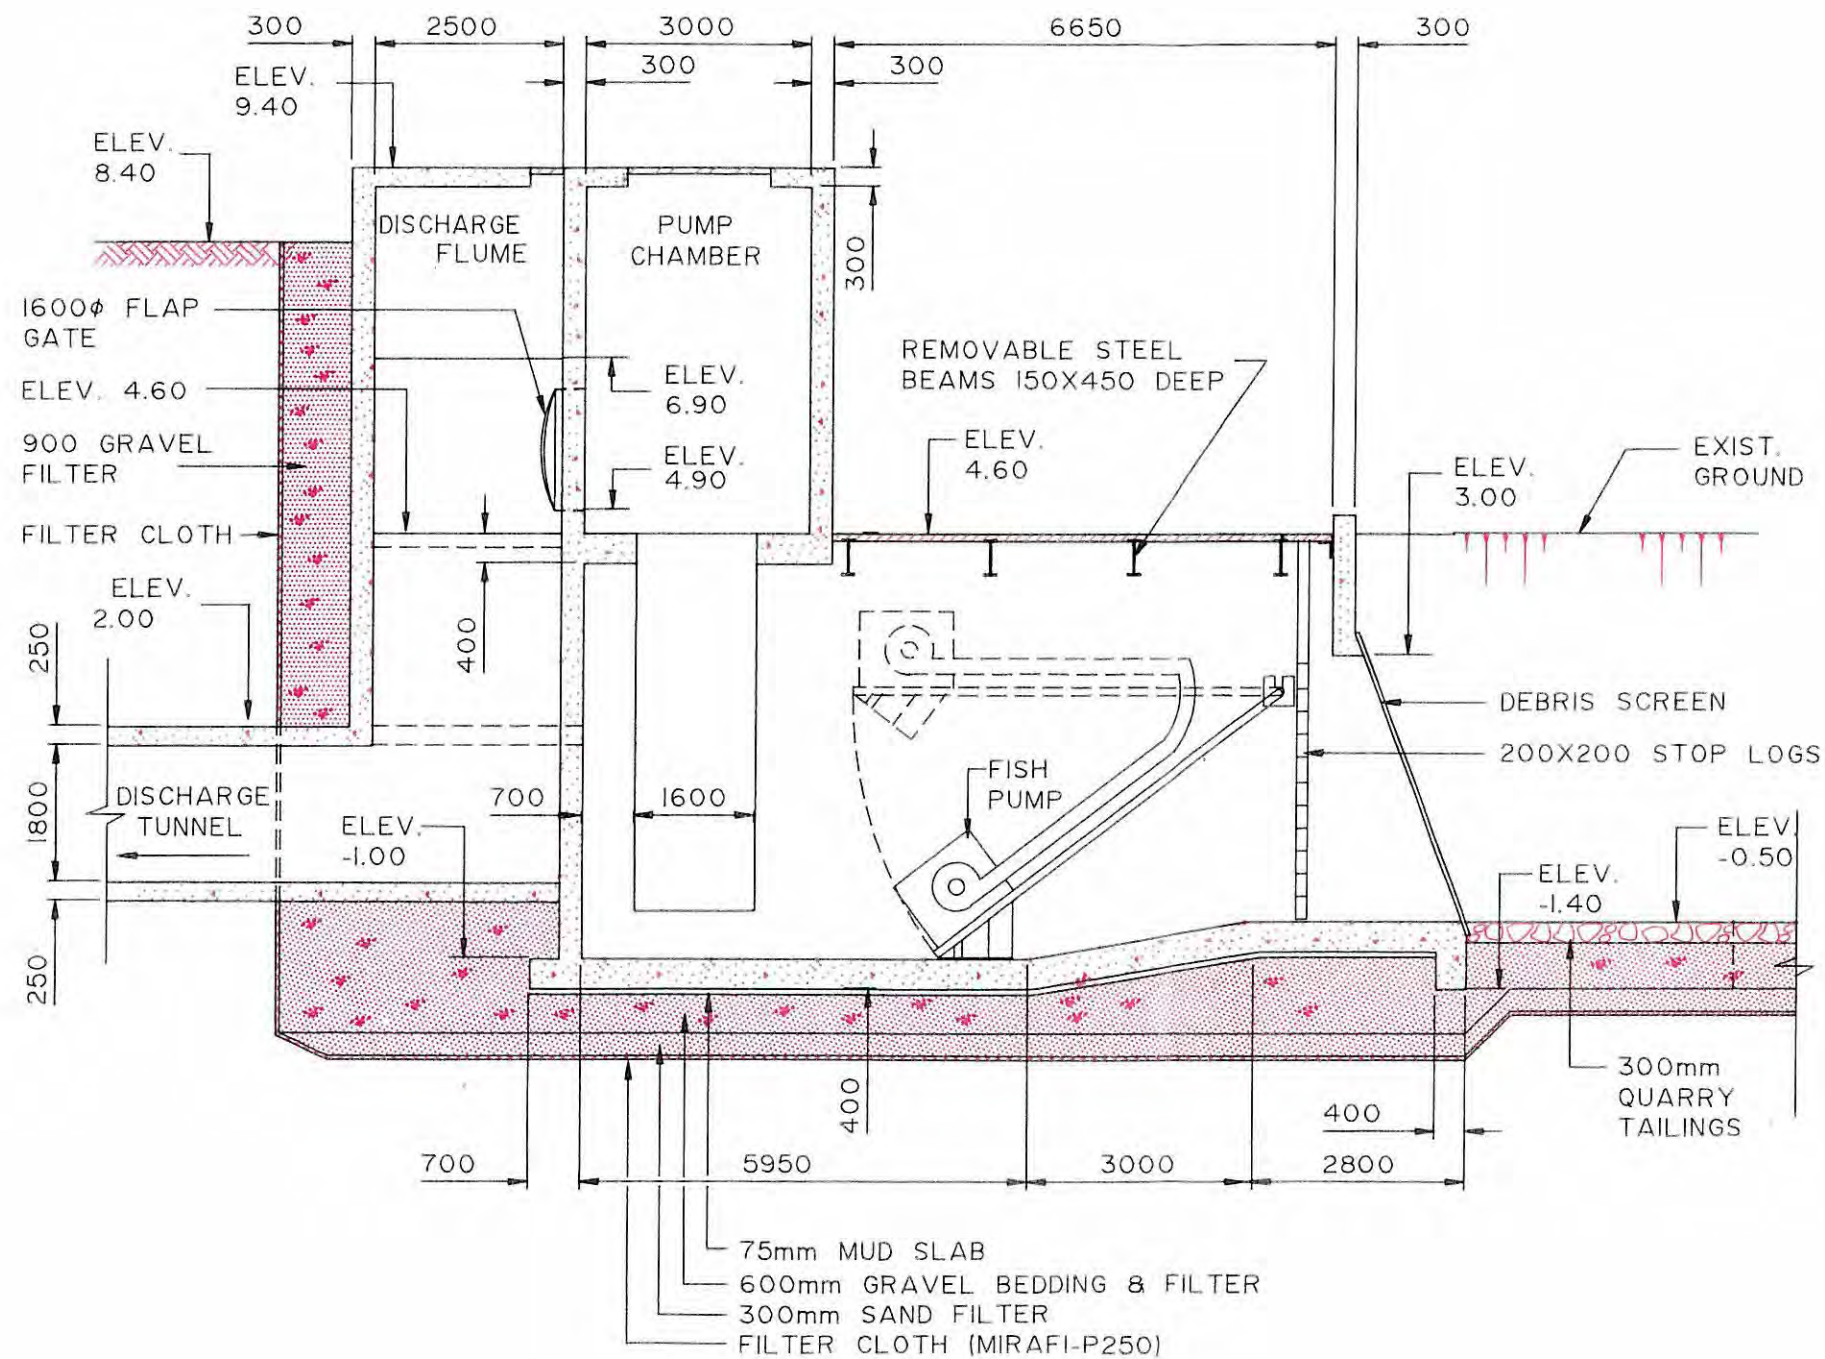
| APPROVED S.G. | DWG No. 4.5 |

**SECTION C-C**  
**PUMP CHAMBER NO. 1**  
 SCALE 1:100

DEWDNEY-ALOUETTE REGIONAL DISTRICT  
 HATZIC PRAIRIE DRAINAGE STUDY  
 HATZIC SLOUGH PUMP STATION/FLOODBOX  
 DETAIL SECTION-SHEET 5

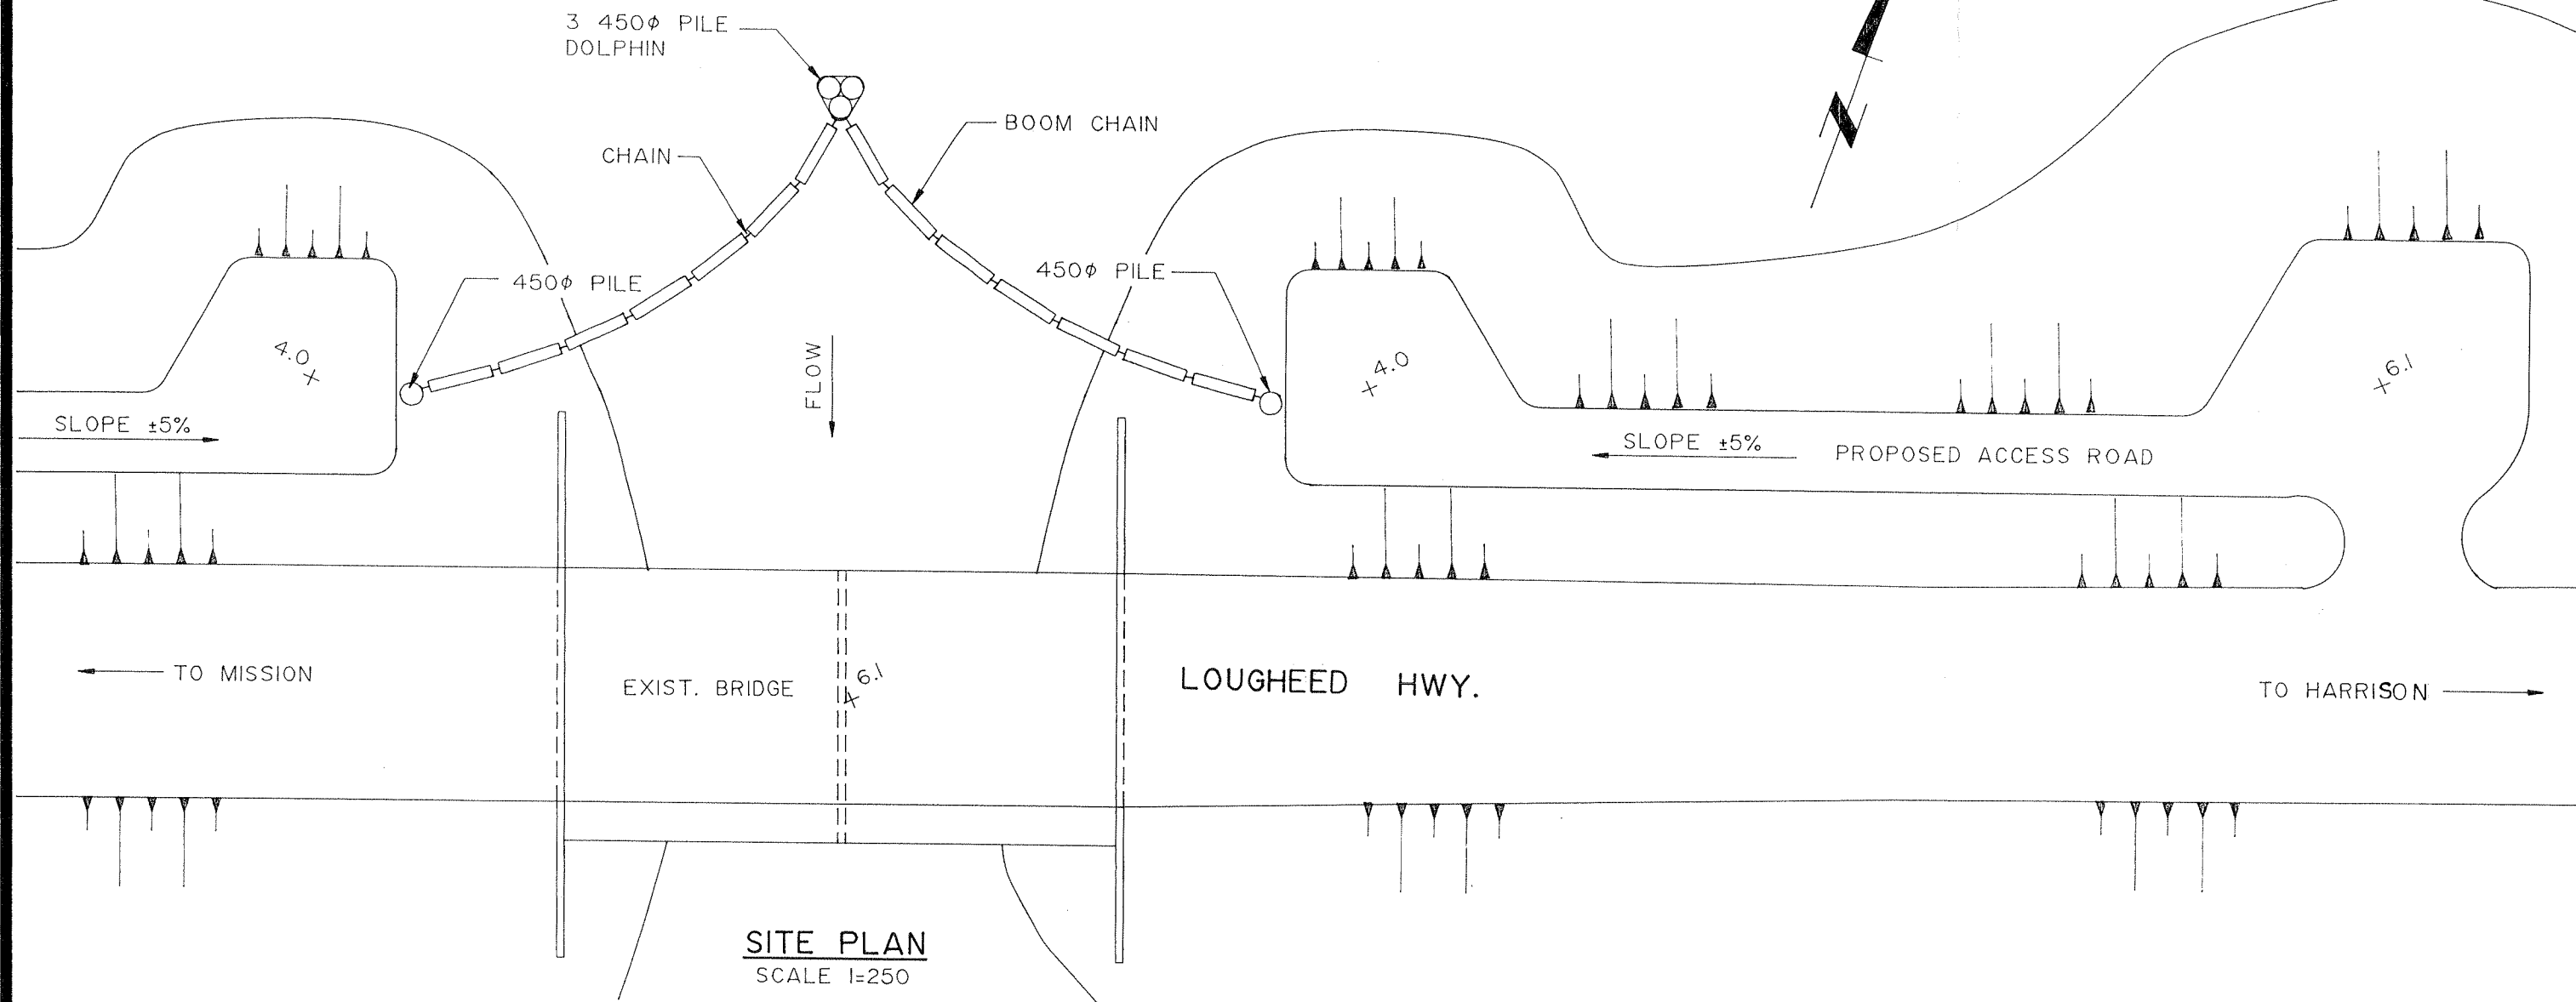
DWG No. 4.8

HATZIC LAKE  
DEBRIS CONTROL STRUCTURE
