**DEWDNEY-ALOUETTE REGIONAL DISTRICT  
MISSION, B.C.**

**HATZIC PRAIRIE DRAINAGE STUDY  
VOLUME 2**

*August 1992*

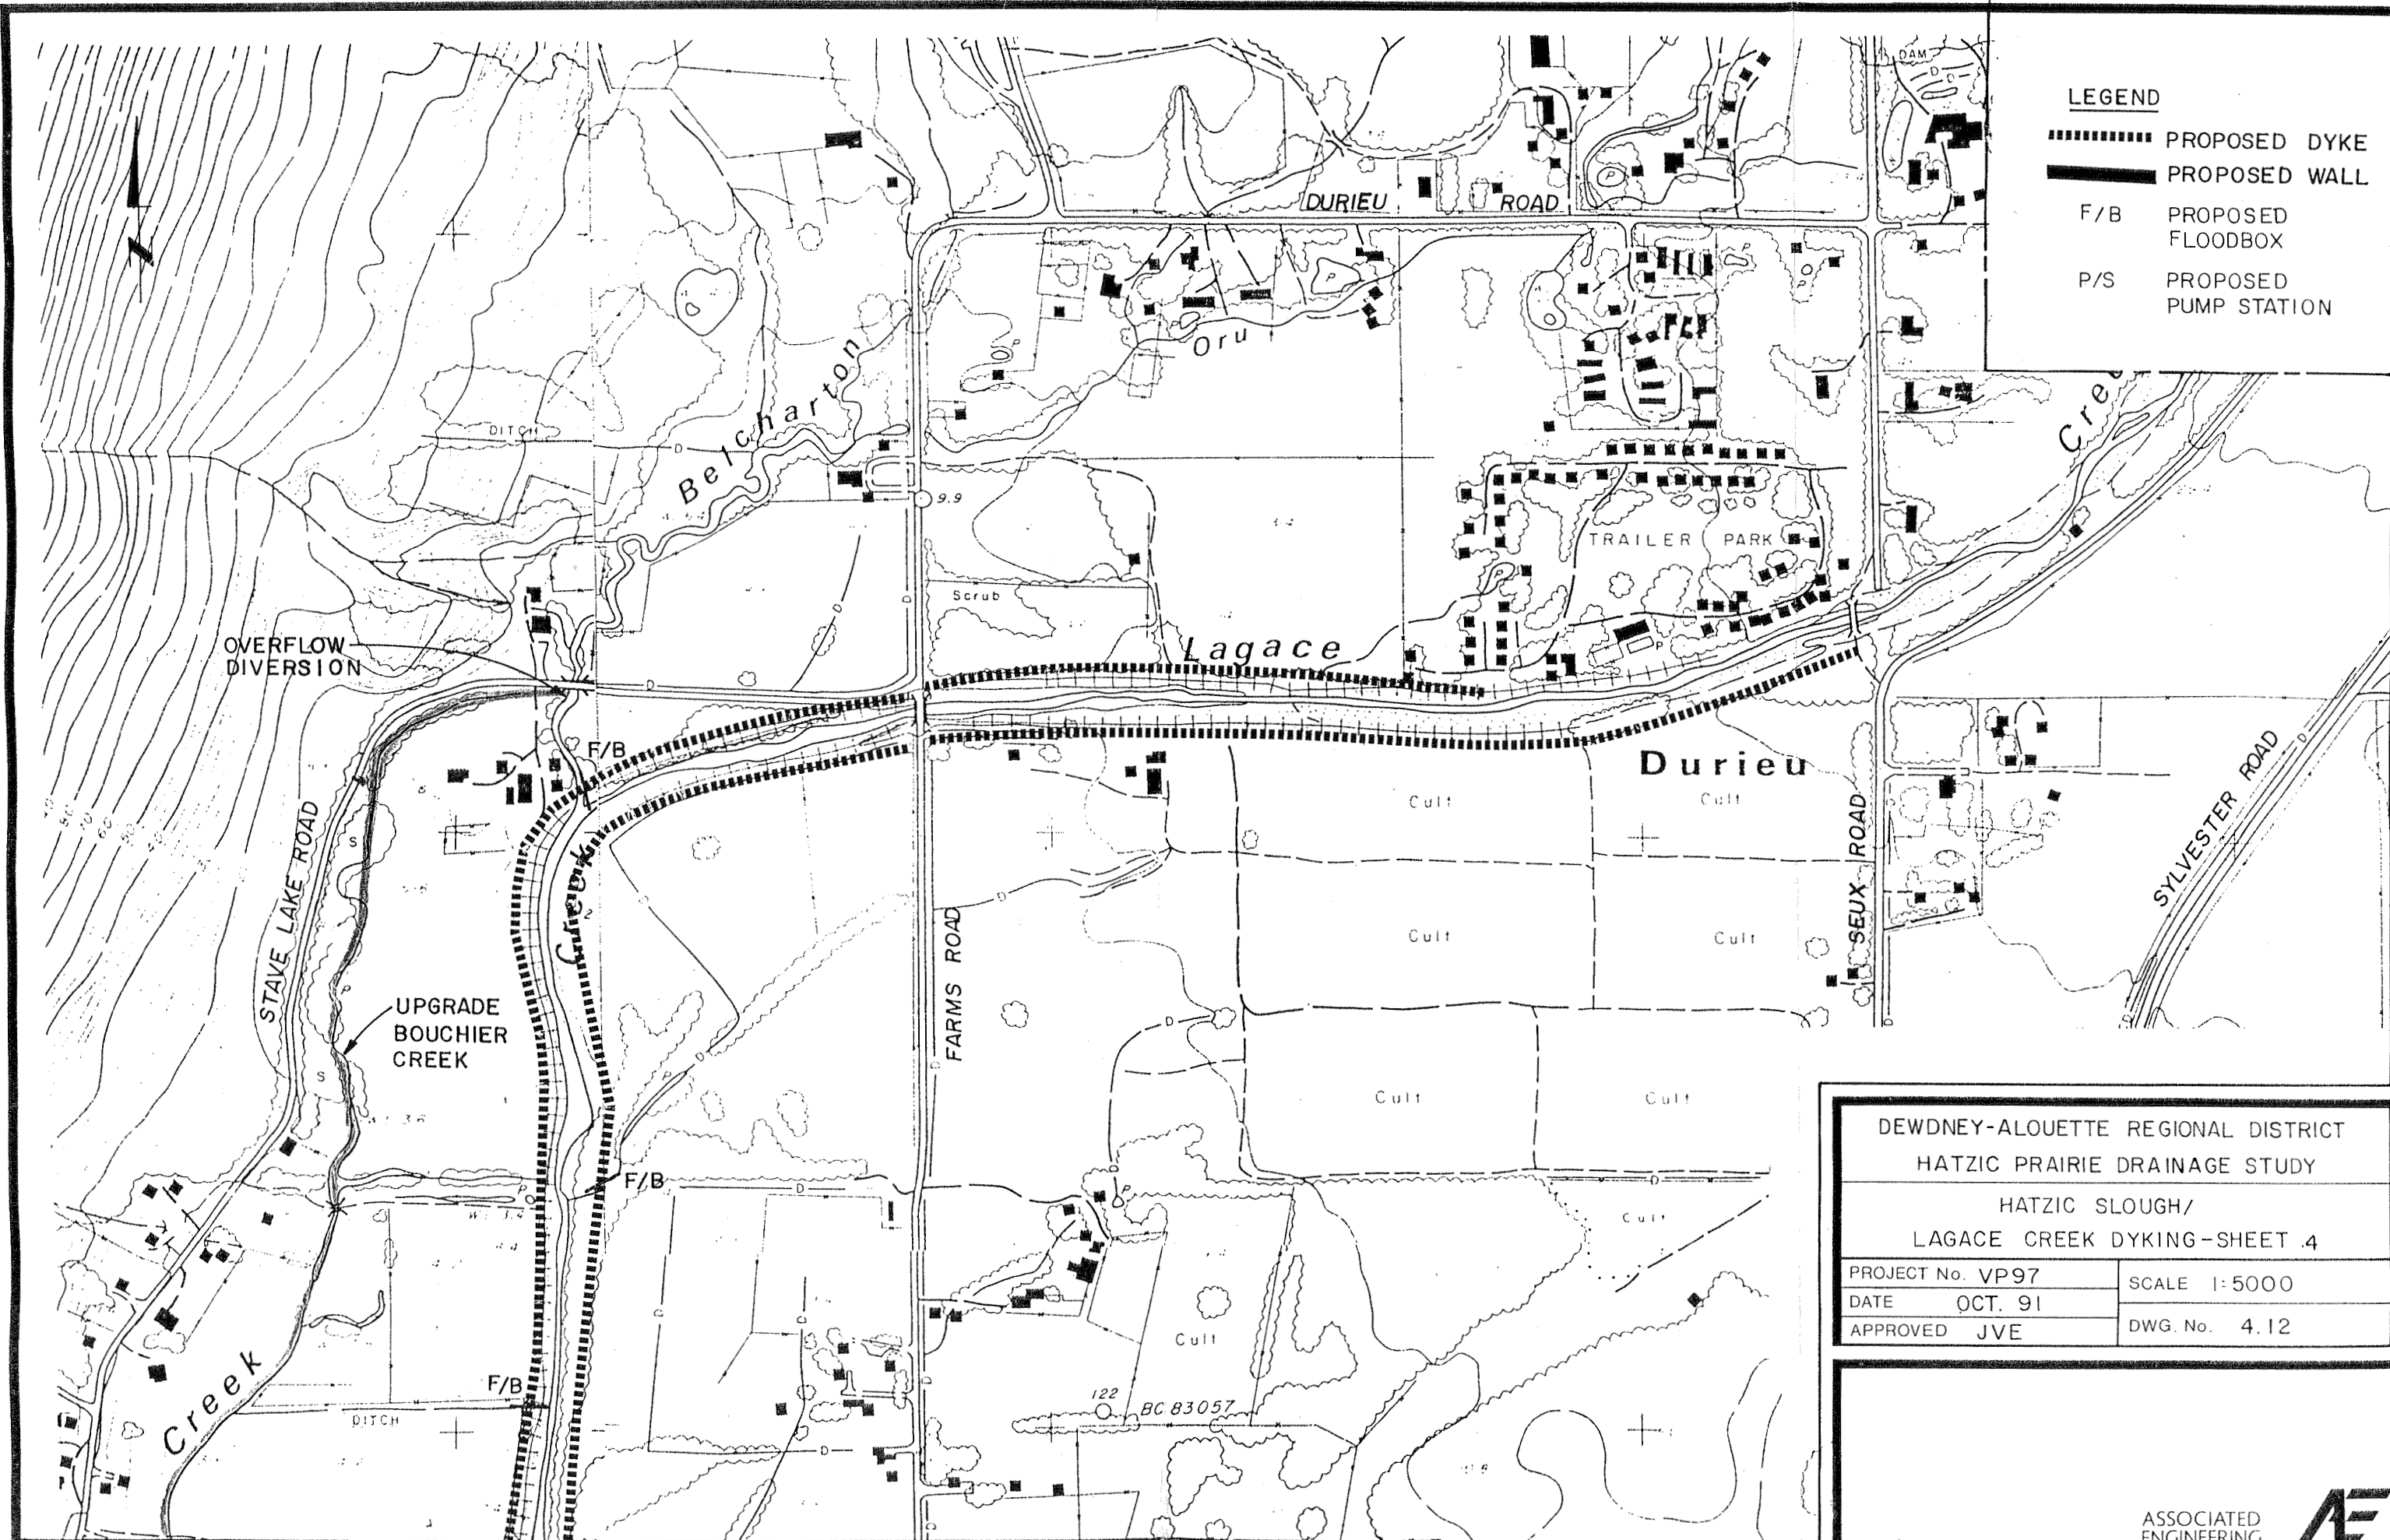
| DATE OCT. 91 | DWG. No. 4.12 |

- LEGEND**
- PROPOSED DYKE
  - PROPOSED WALL
  - F/B PROPOSED FLOODBOX
  - P/S PROPOSED PUMP STATION

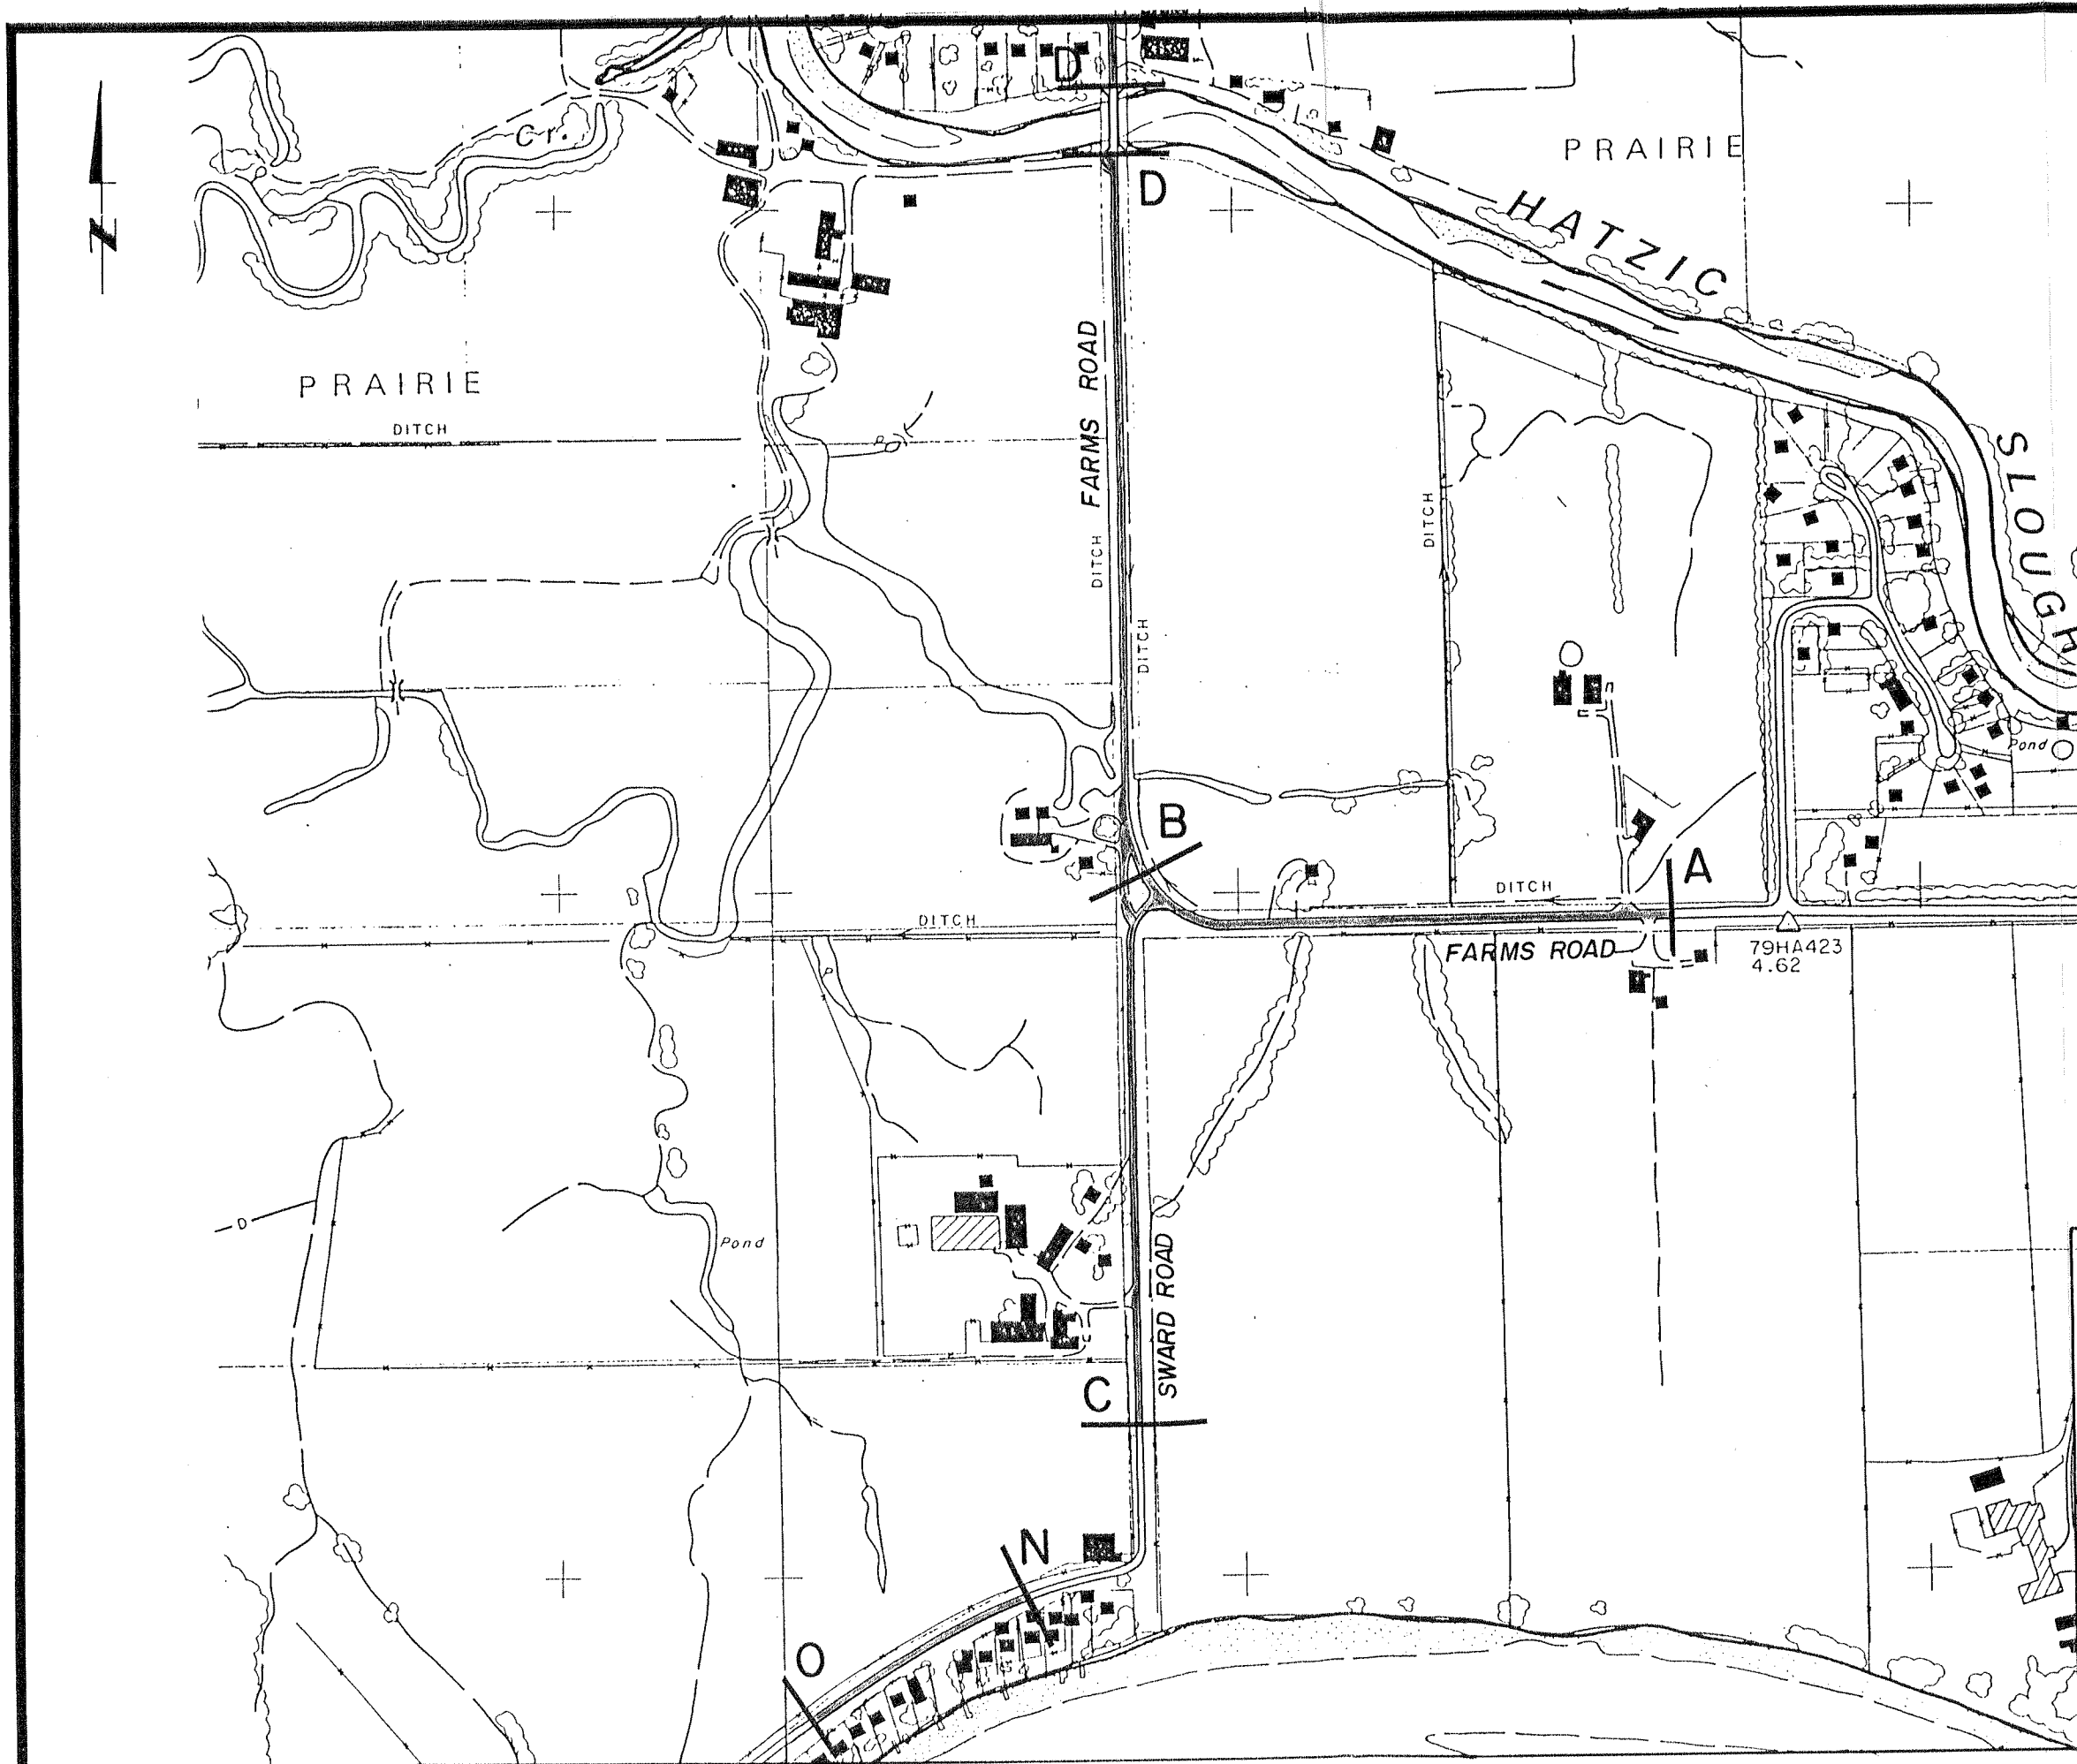
| RAISING ROAD - SHEET 1 | |

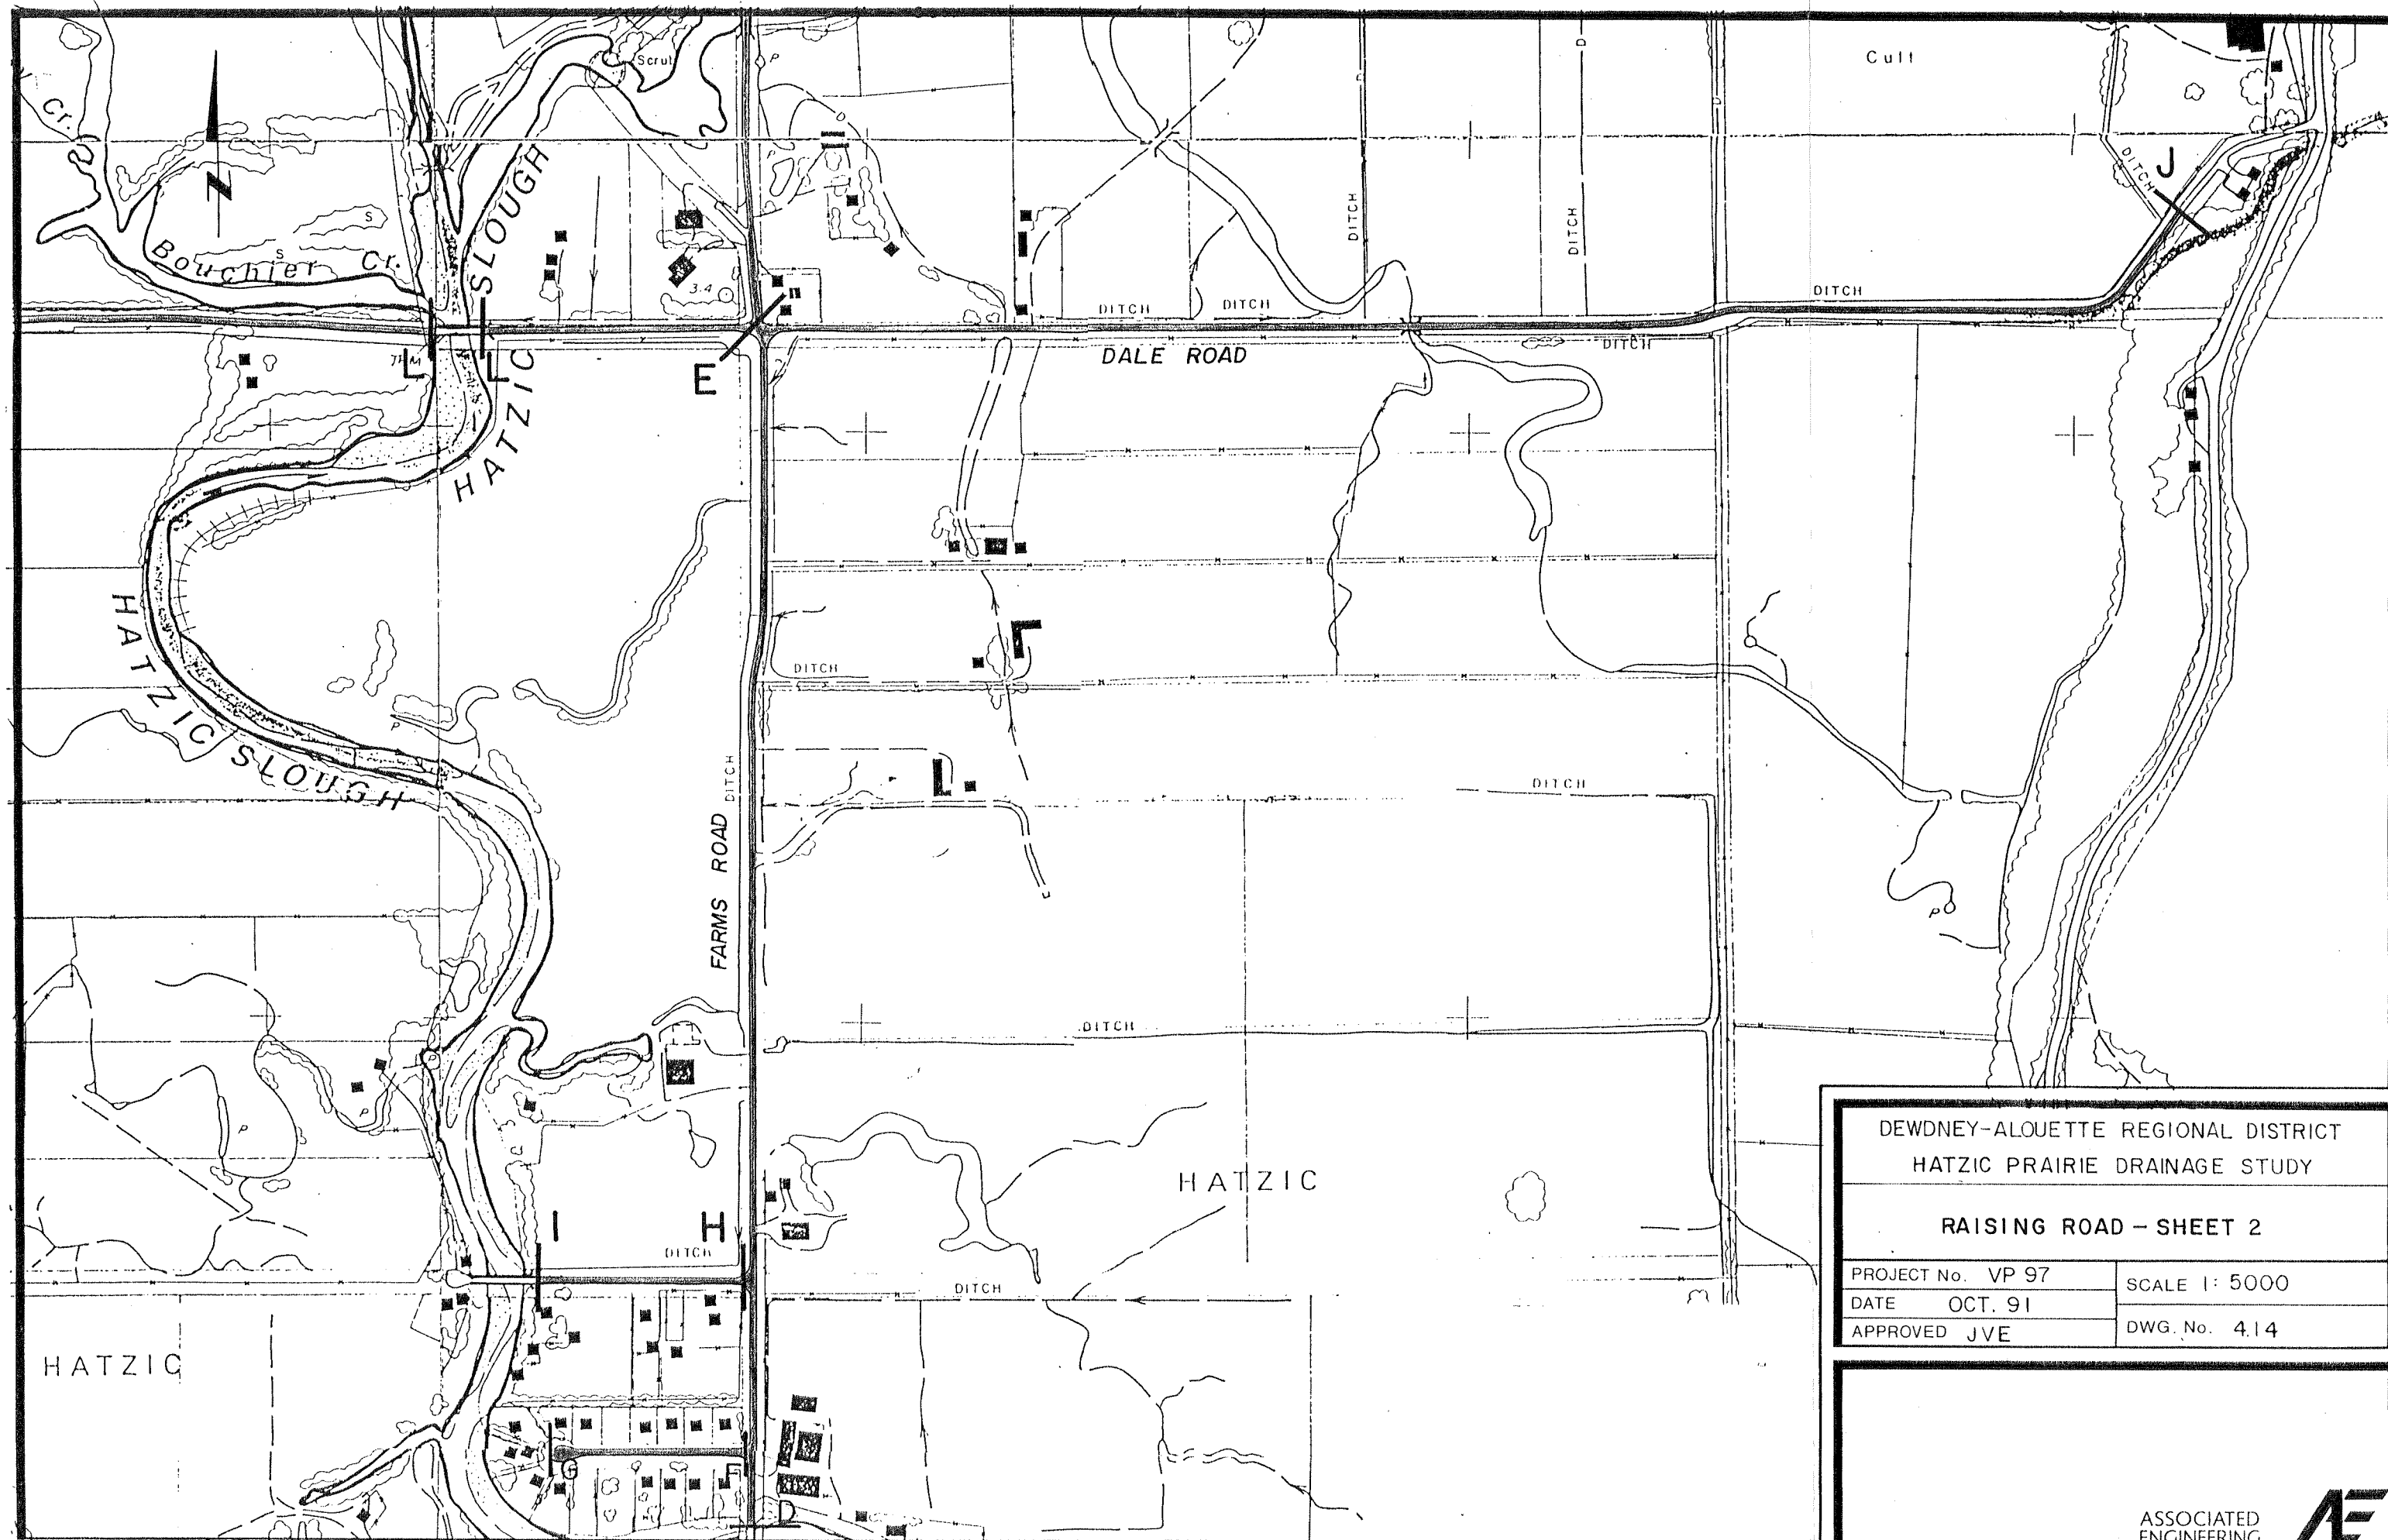
RAISING ROAD - SHEET 2

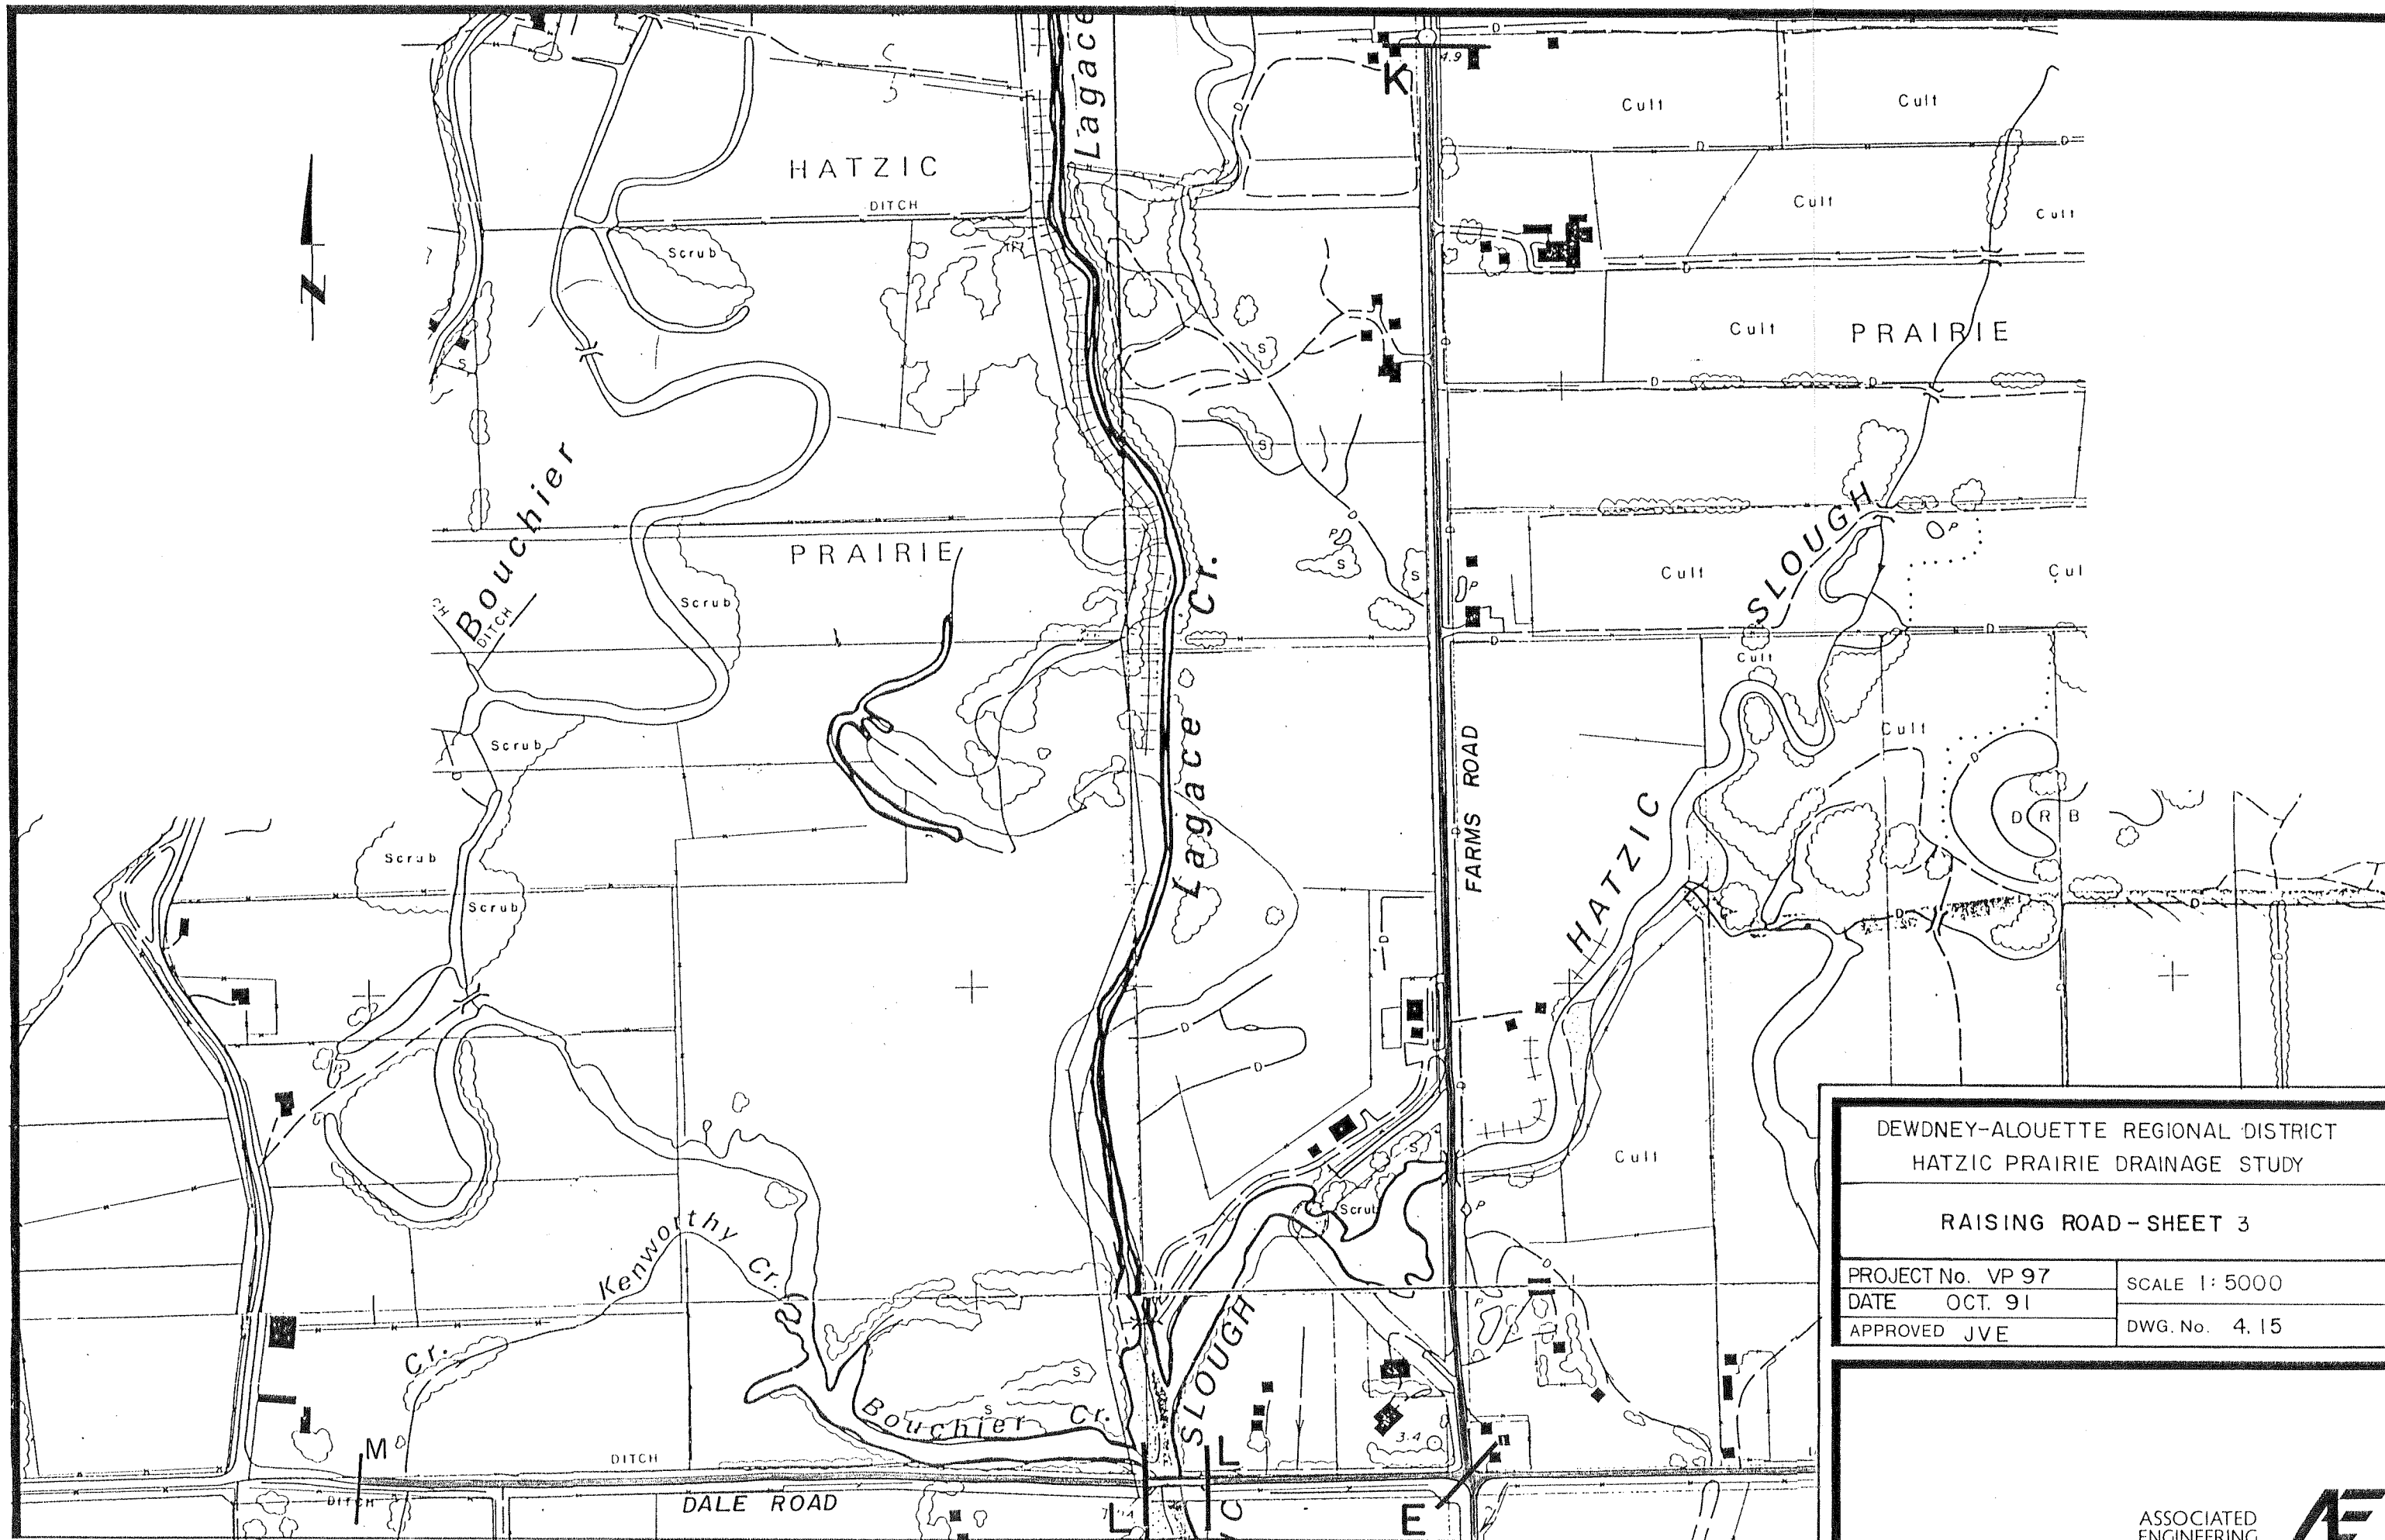
RAISING ROAD - SHEET 3

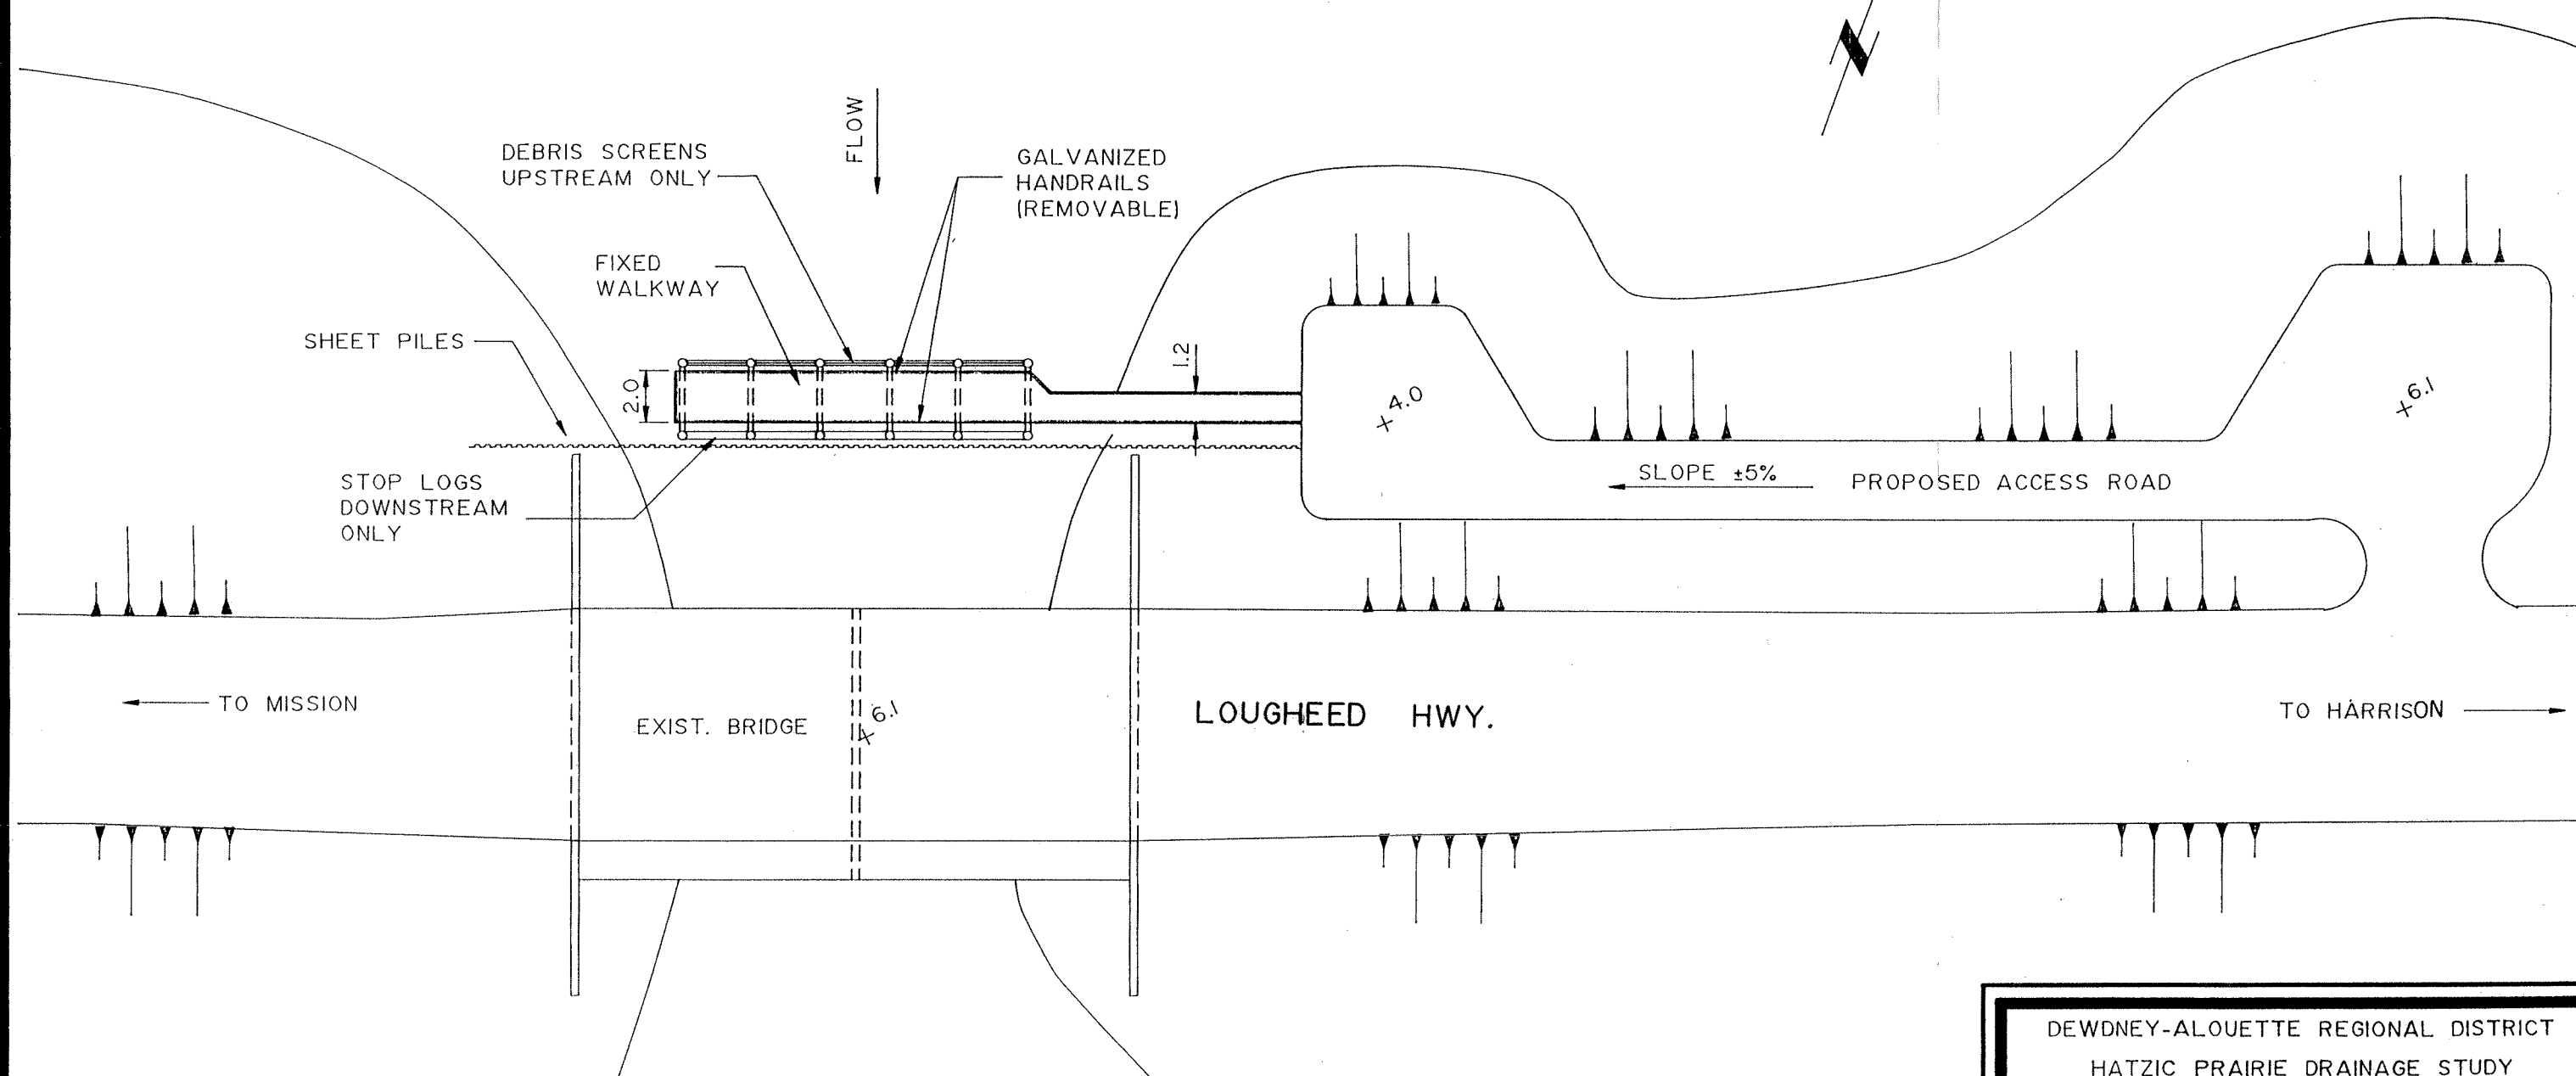
| DATE OCT. 91 | DWG No. 4.17 |

**SITE PLAN**  
SCALE 1:250

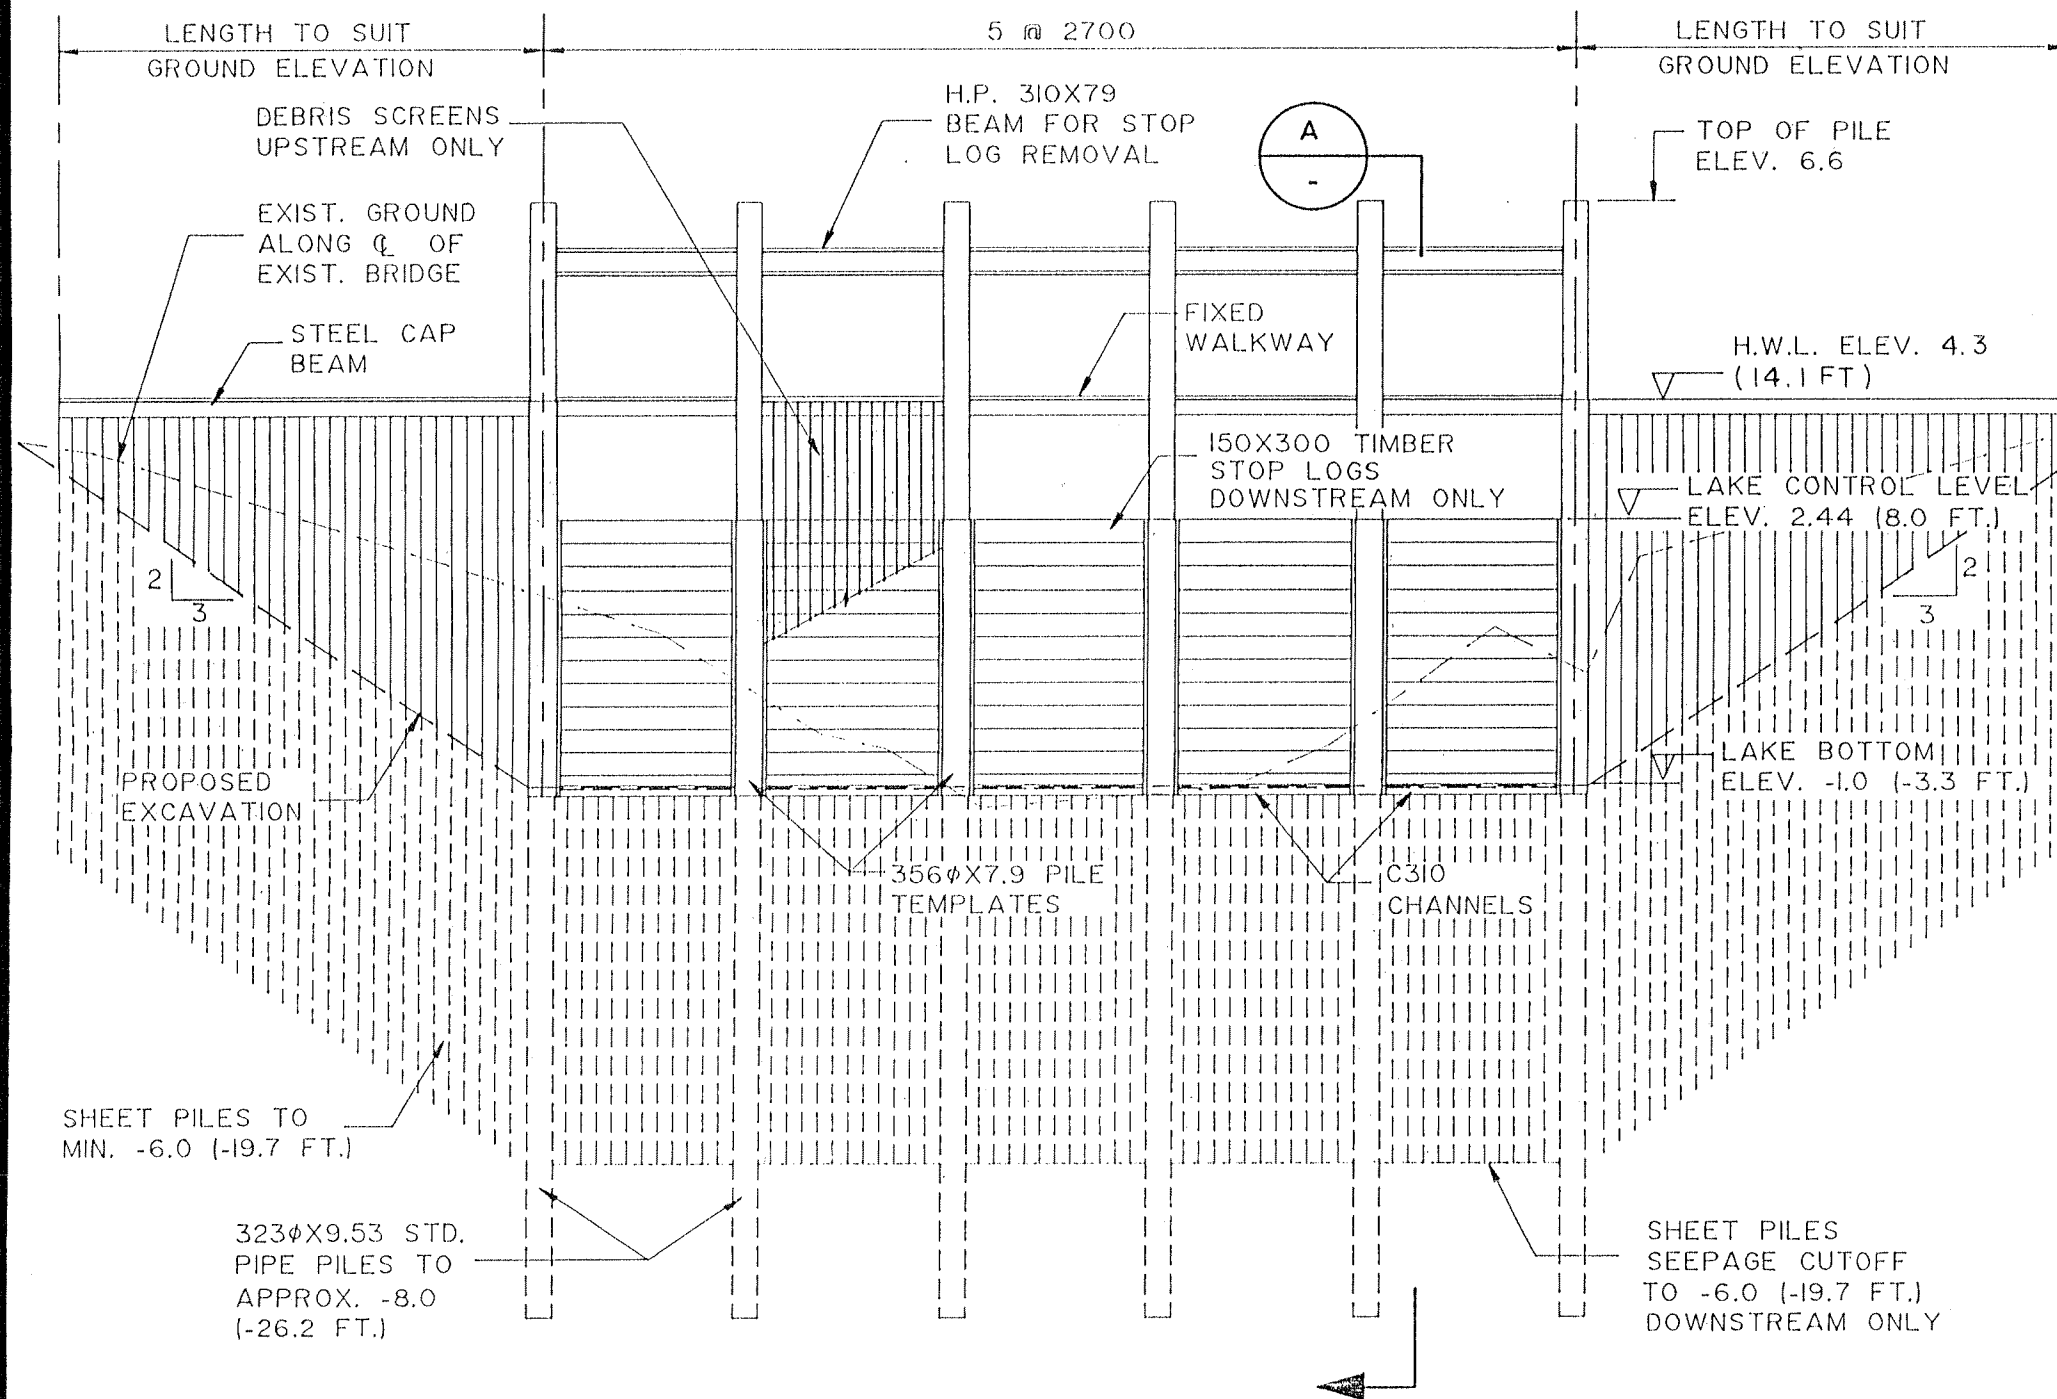
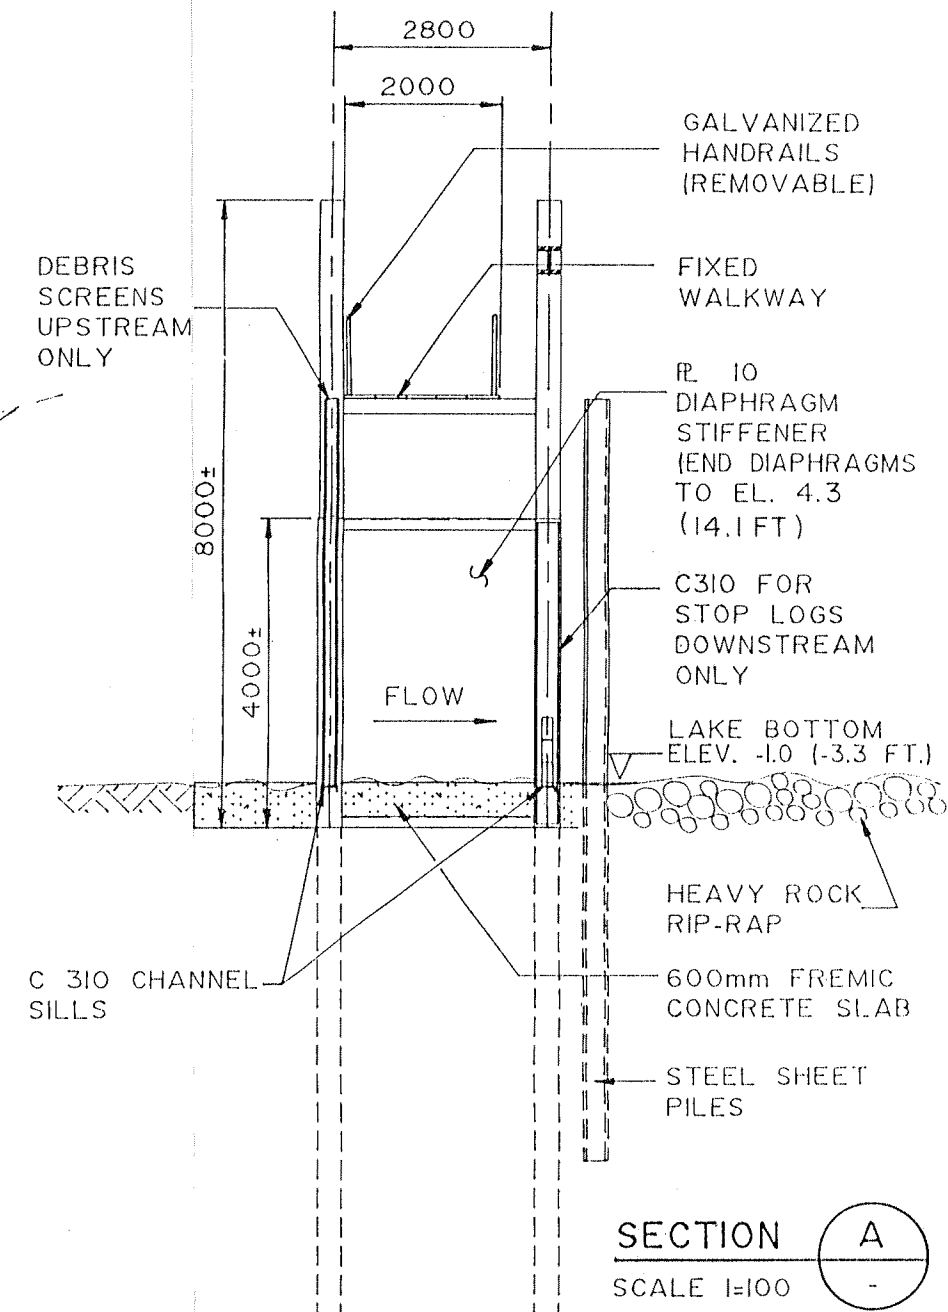
| DATE OCT. 91 | DWG No. 4.18 |

UPSTREAM ELEVATION  
SCALE 1:100

SECTION A  
SCALE 1:100
