**DEWDNEY-ALOUETTE REGIONAL DISTRICT  
MISSION, B.C.**

**HATZIC PRAIRIE DRAINAGE STUDY  
VOLUME 2**

*August 1992*

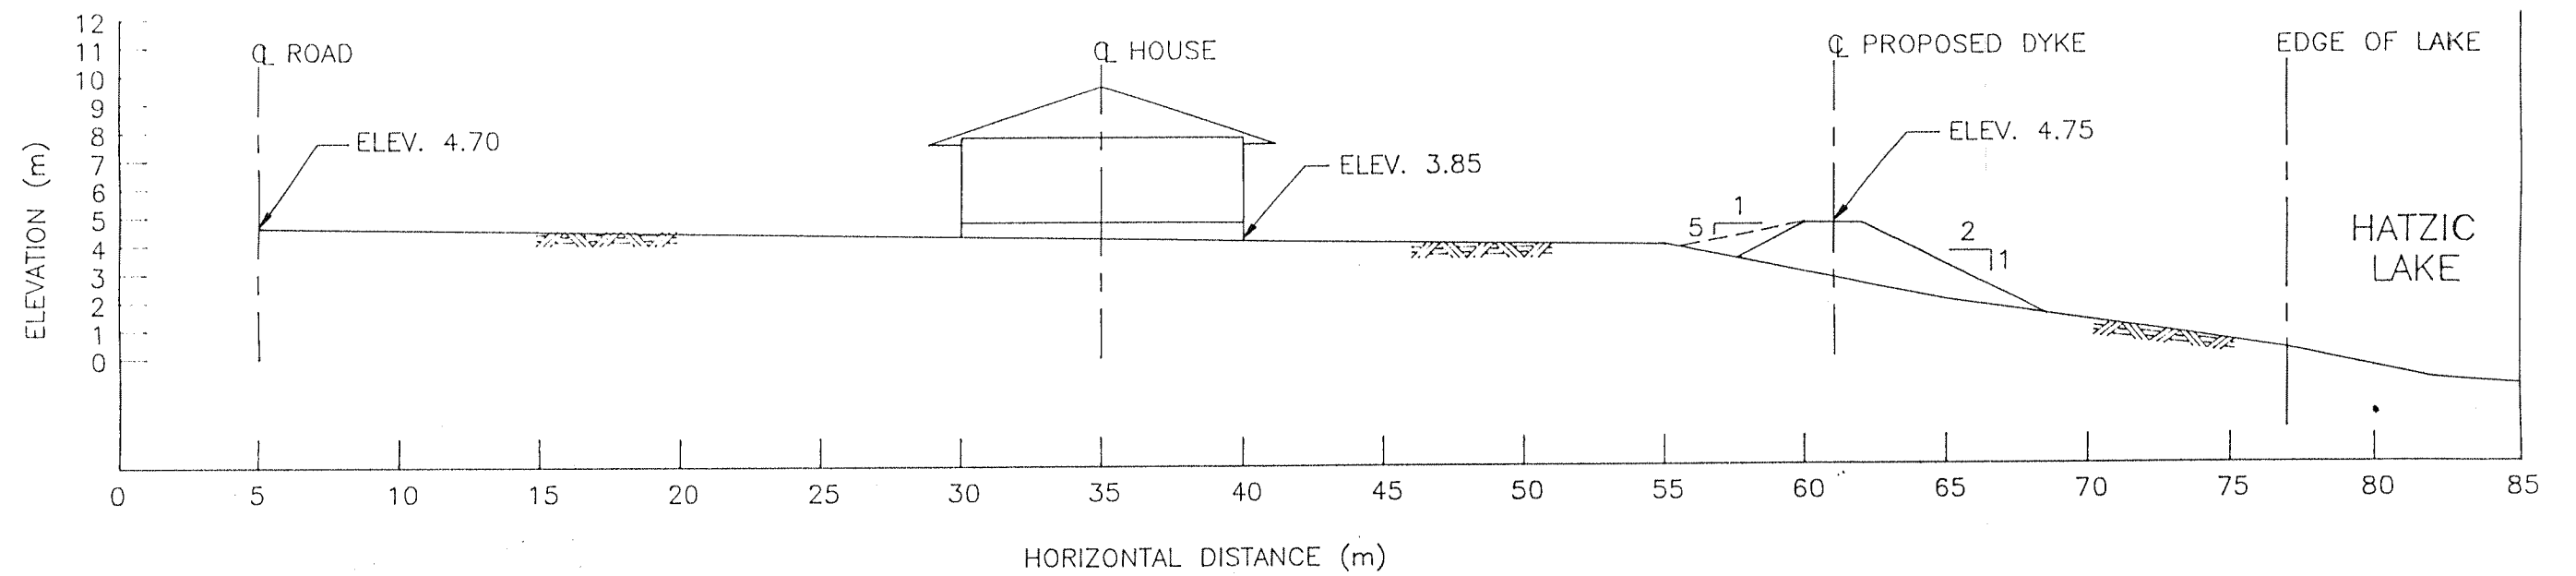
| DATE OCT. 91 | DWG No. 4.20 |

SECTION A-A  
SCALE 1:250

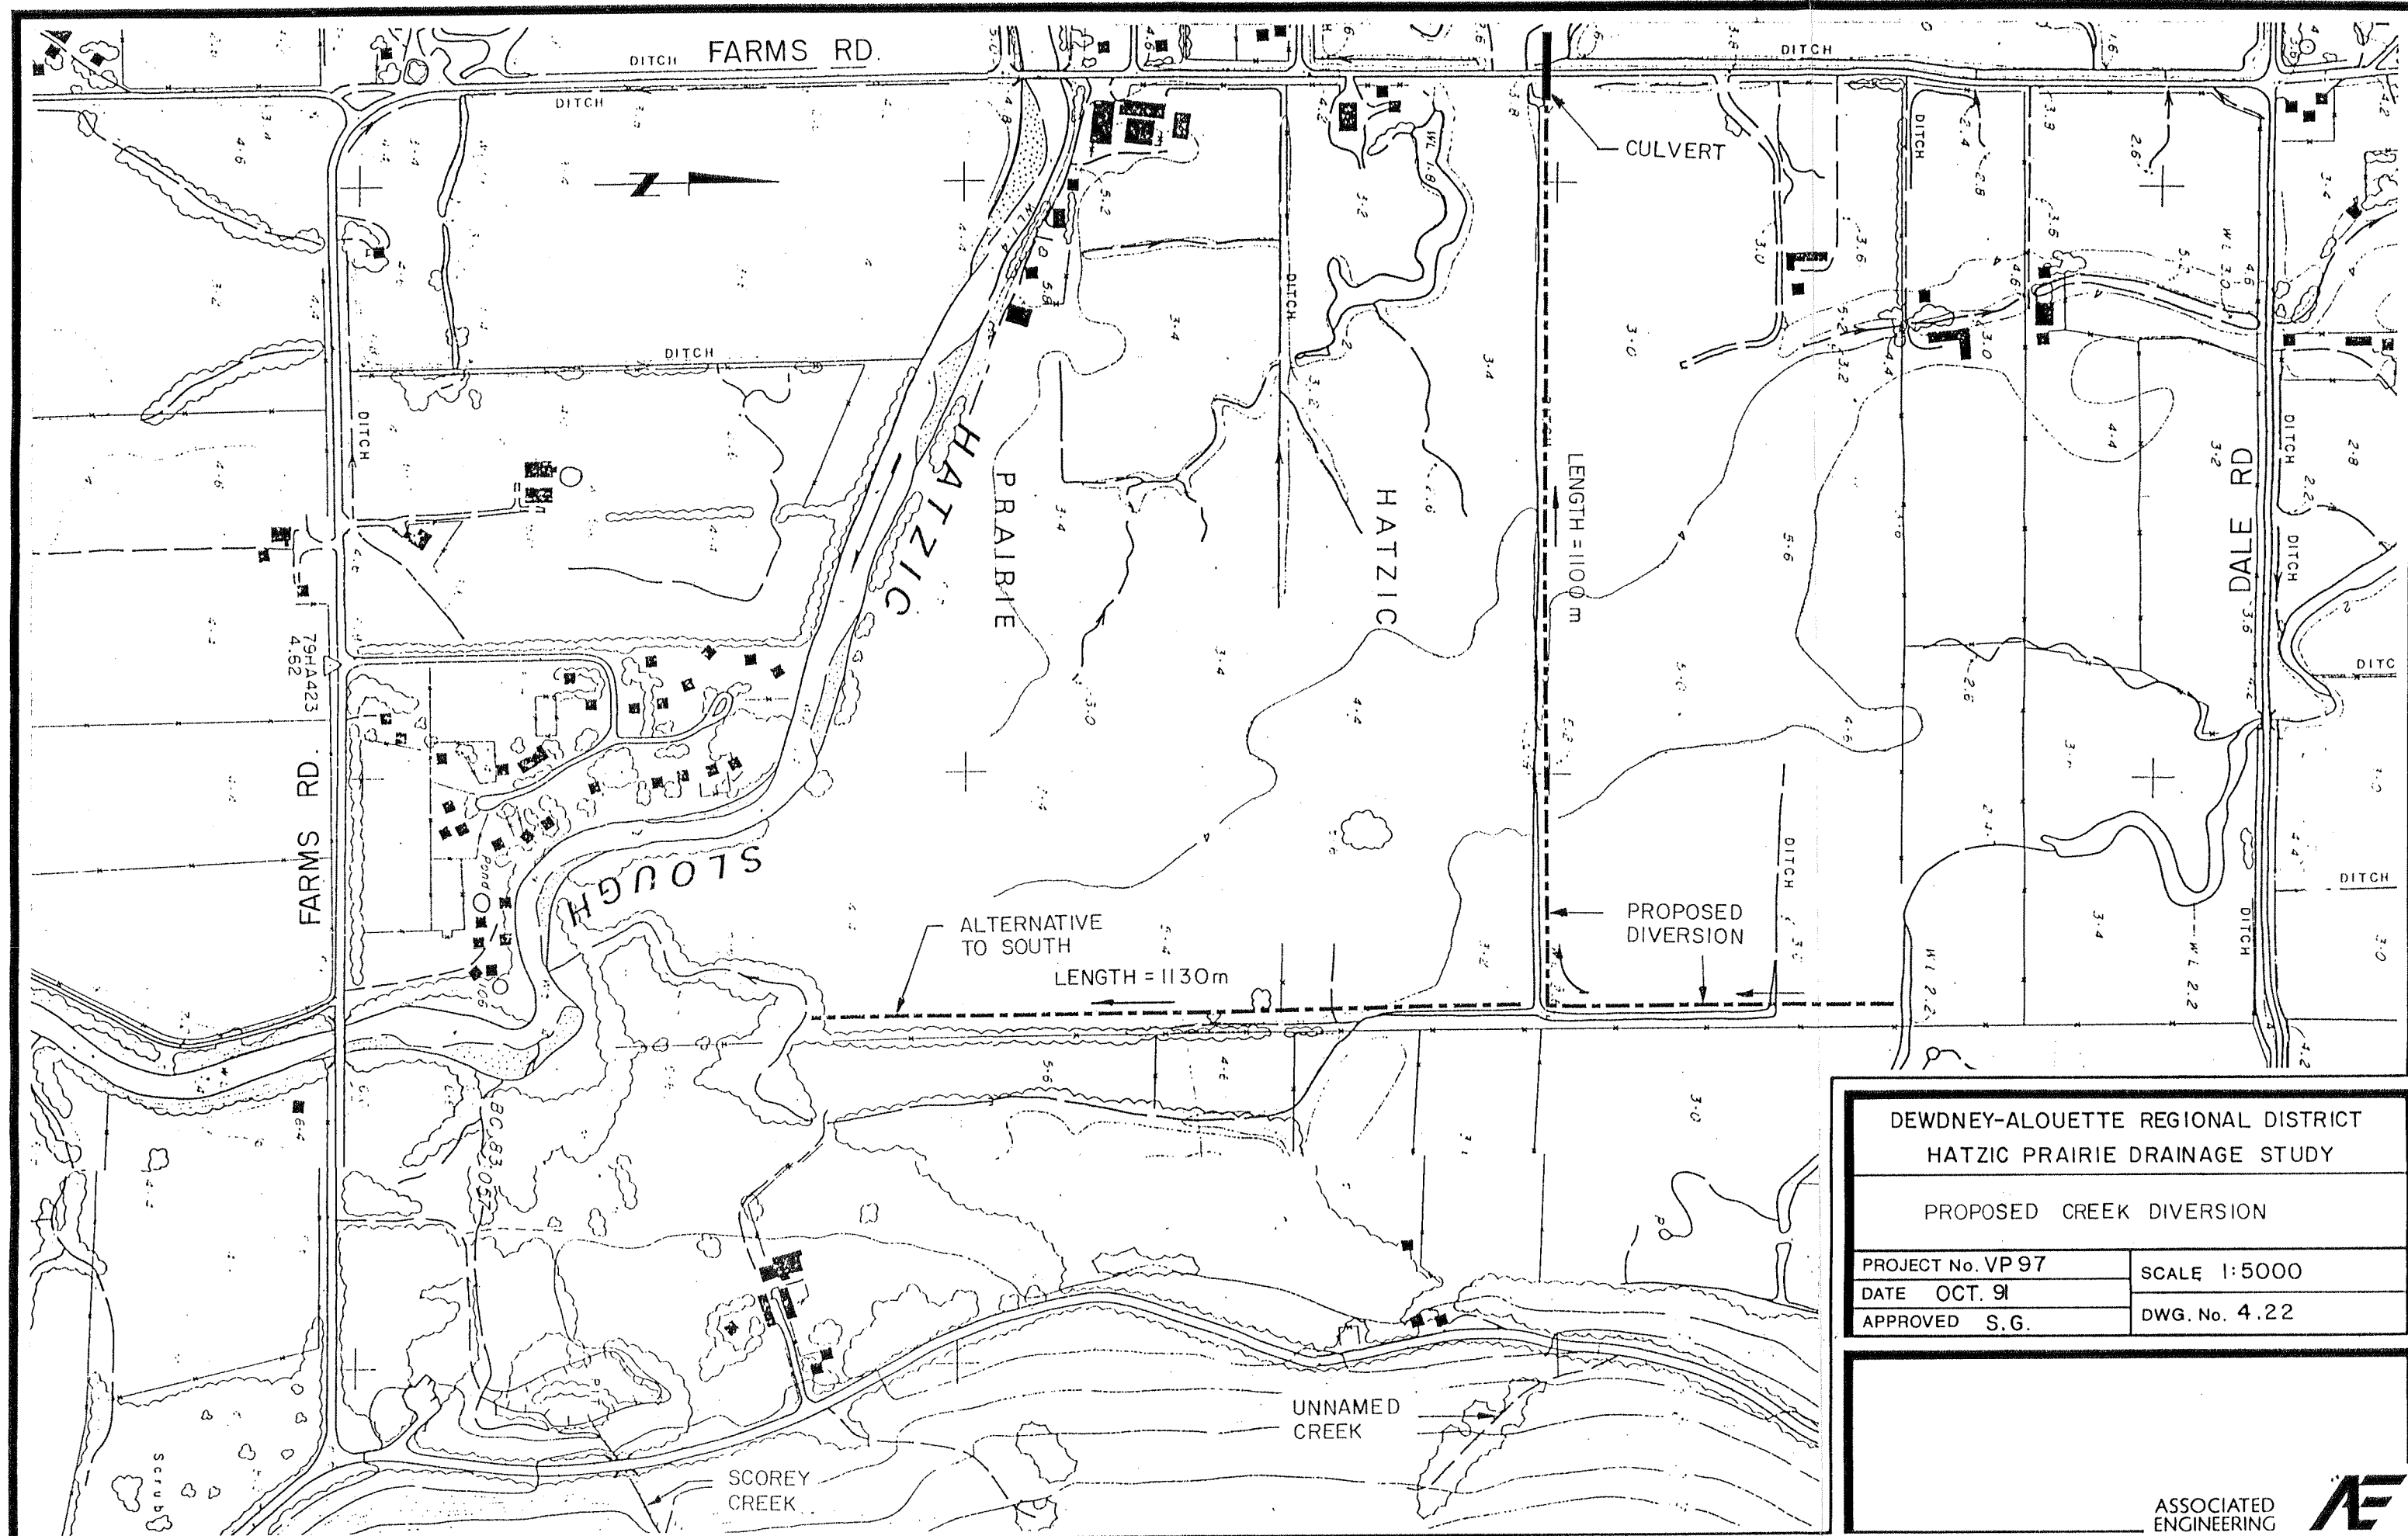
PROPOSED CREEK DIVERSION

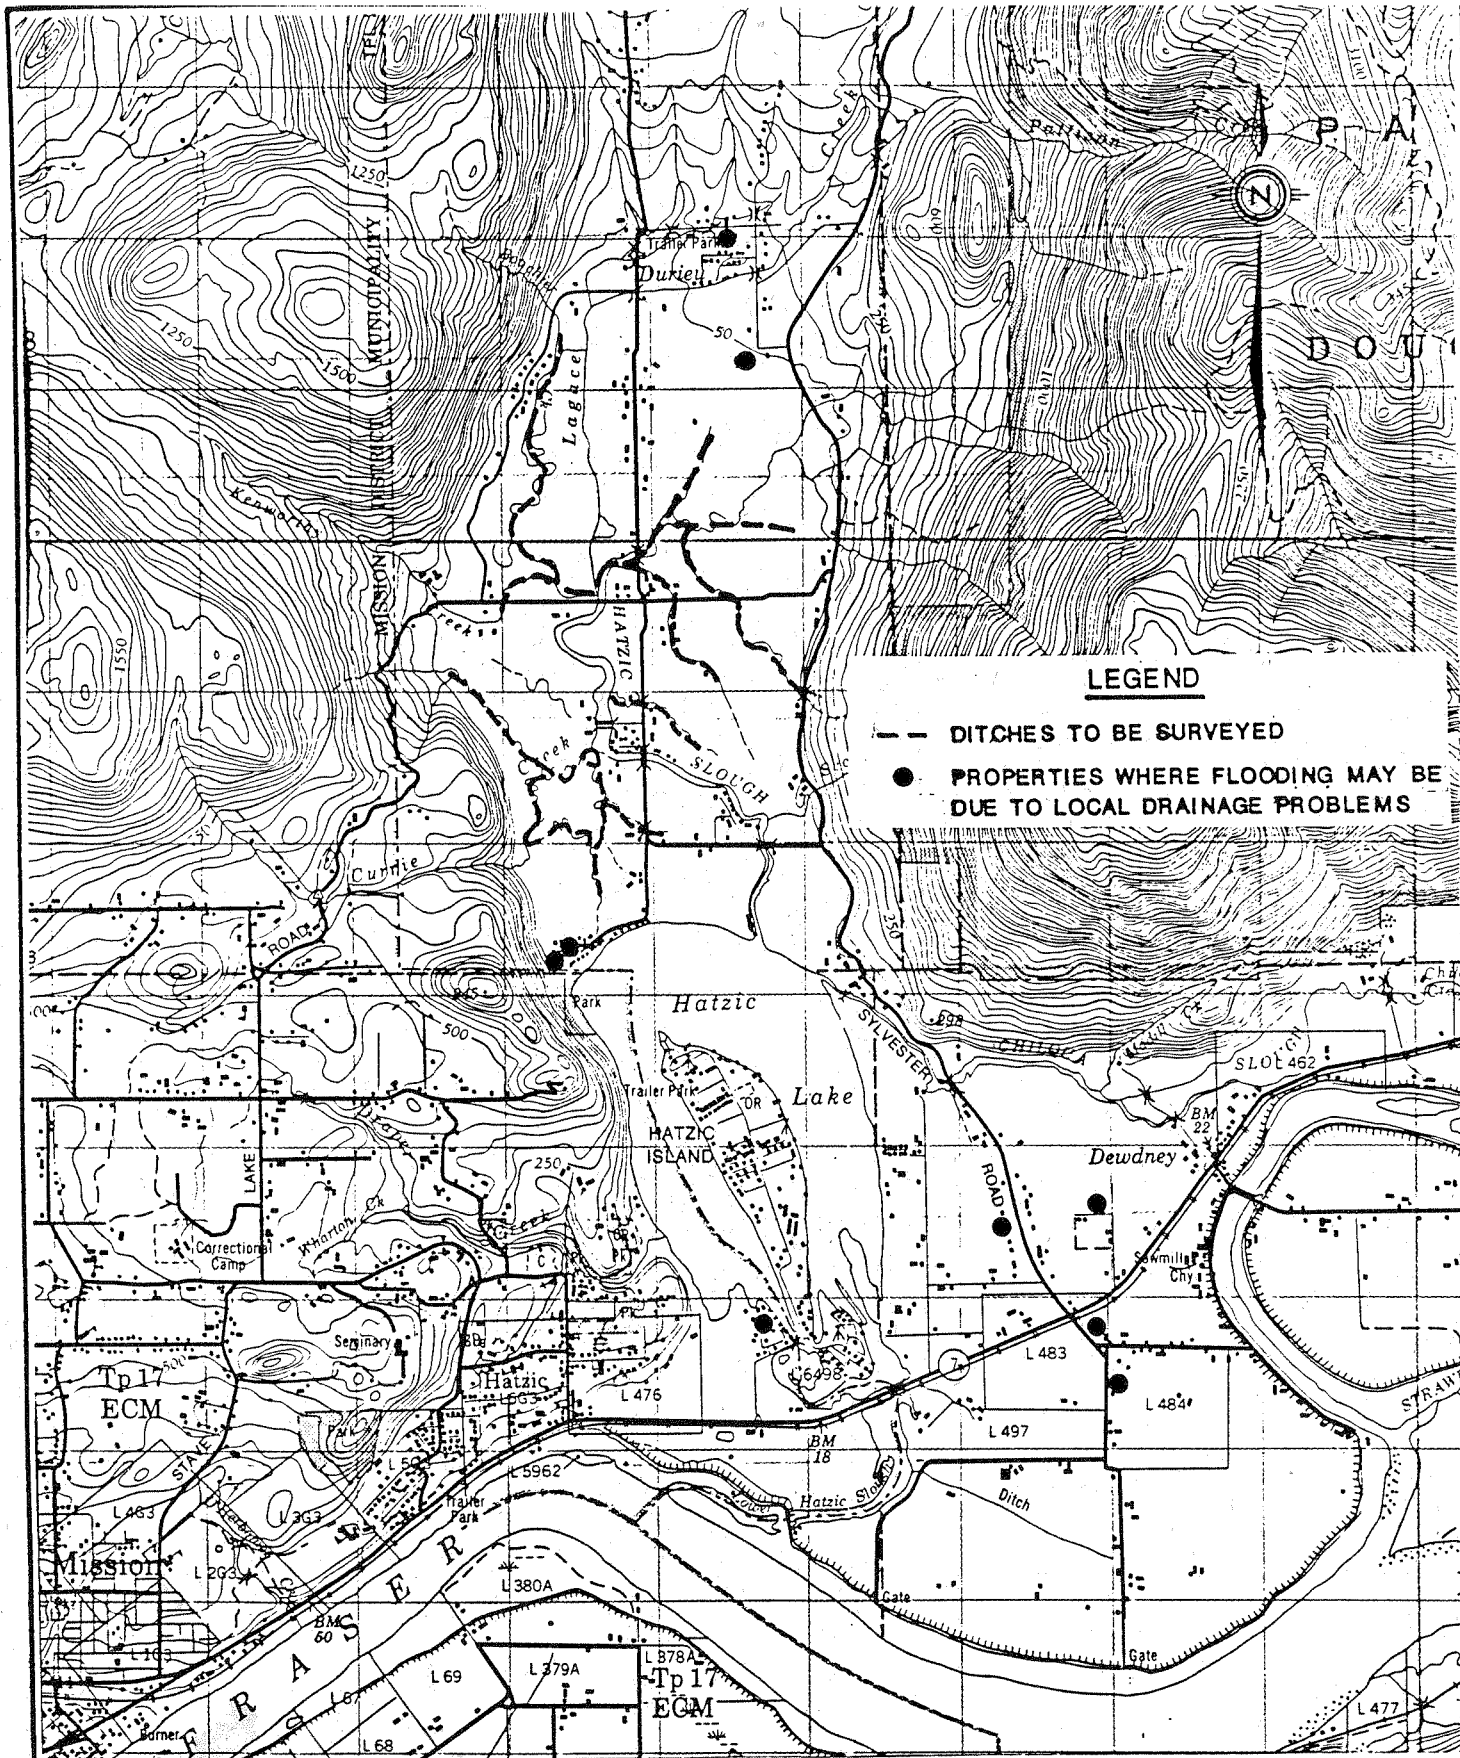
TO ACCOMPANY REPORT ON  
**LOCATION OF DITCH SURVEYS AND  
POSSIBLE DRAINAGE PROBLEMS**

Suggestions have been made in earlier reports and by landowners that Hatzic Slough is silting up. Given the aggradation occurring on Legace Creek this would be a reasonable thing to expect. However, a comparison of cross sections surveyed at the three bridges between Dale Road and Hatzic Lake show little difference in cross section between surveys carried out by MOE in July 1984 and March 1991. This is quite surprising. The consultant will pick up the thalweg of the channel between Dale Road and Hatzic Lake and compare it with the thalweg surveyed in 1984. The consultant will also survey cross sections at approximately 500 m intervals and at any obvious constrictions or shallower points. If the channel appears to have been stable over time, the consultant

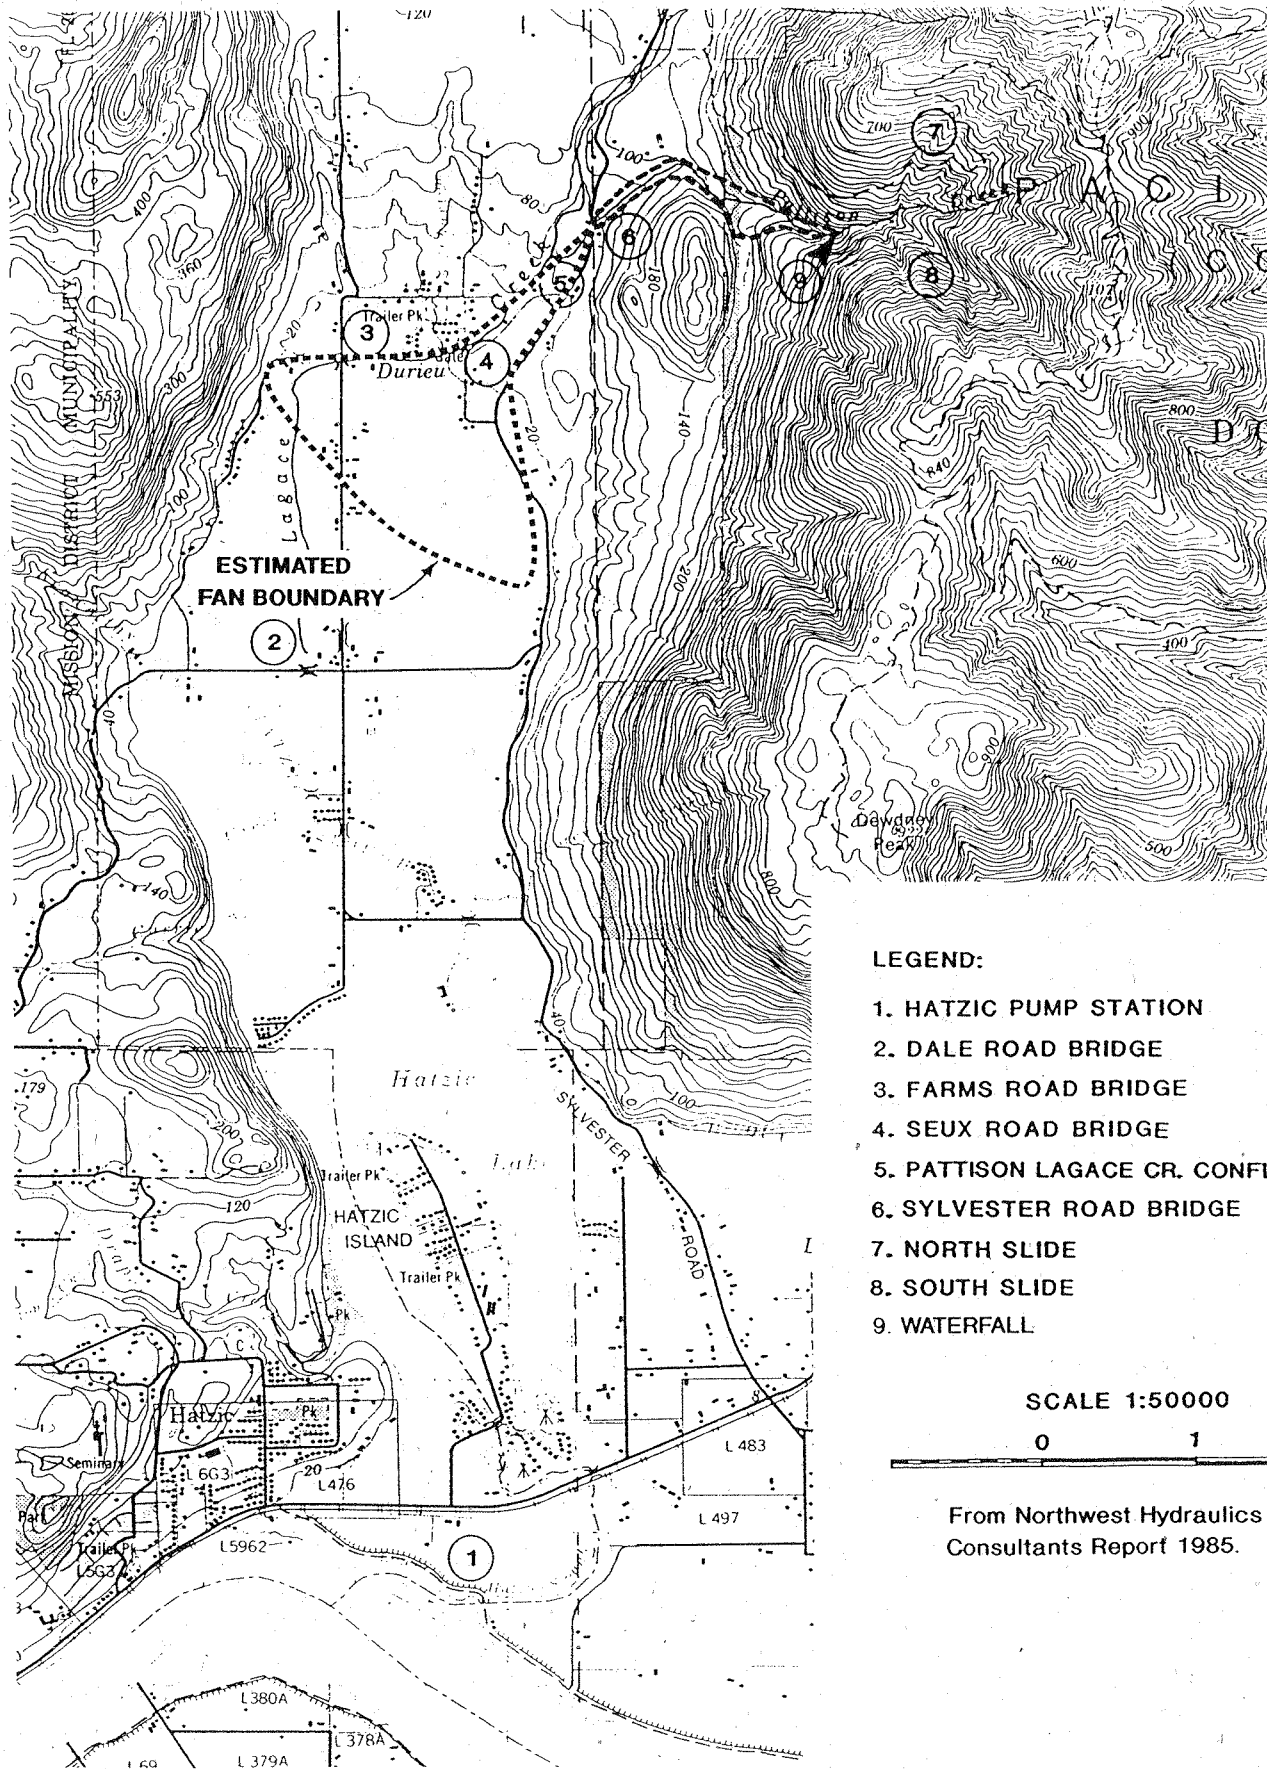
Figure 1

# LOCATION PLAN

1. HATZIC PUMP STATION
2. DALE ROAD BRIDGE
3. FARMS ROAD BRIDGE
4. SEUX ROAD BRIDGE
5. PATTISON LAGACE CR. CONFLUENCE
6. SYLVESTER ROAD BRIDGE
7. NORTH SLIDE
8. SOUTH SLIDE
9. WATERFALL

Pattison Creek is a small west-facing catchment of some 6 km<sup>2</sup> which drains towards the flat floodplain of Hatzic Prairie on the north side of the Fraser River. The elevation of the watershed ranges from EL. 1,200 m down to approximately EL. 20 m on the floodplain. The creek has formed a large fan below EL. 260 m which has spilled out across the floodplain and disrupted the local drainage which flows predominantly southwards towards Hatzic Lake and the Fraser River (Figure 1). The fan is estimated to have a surface area of 2.1 km<sup>2</sup> (TEL, 1990).

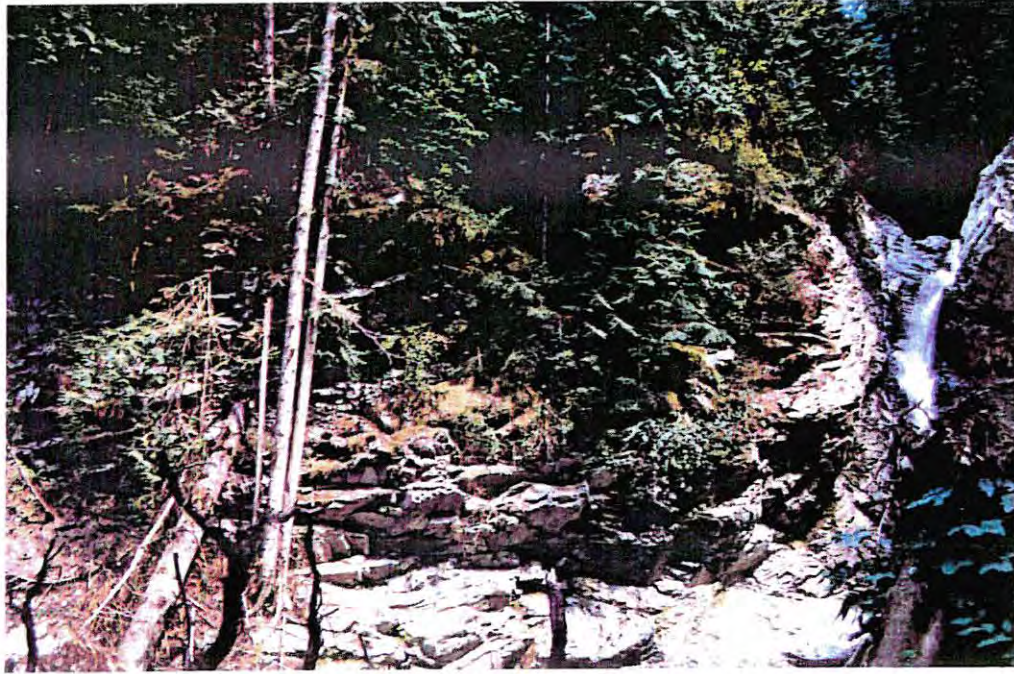
**Plate 1 – Waterfall at apex of fan**

part of the fan above the Sylvester Road Bridge and to 3 - 4° downstream. The main branch of the creek is incised into bedrock from El. 600 m down to a waterfall at El. 260 m at the apex of the fan (see Plate 1). Elsewhere, creek channels are developed in colluvial and glacial soils.

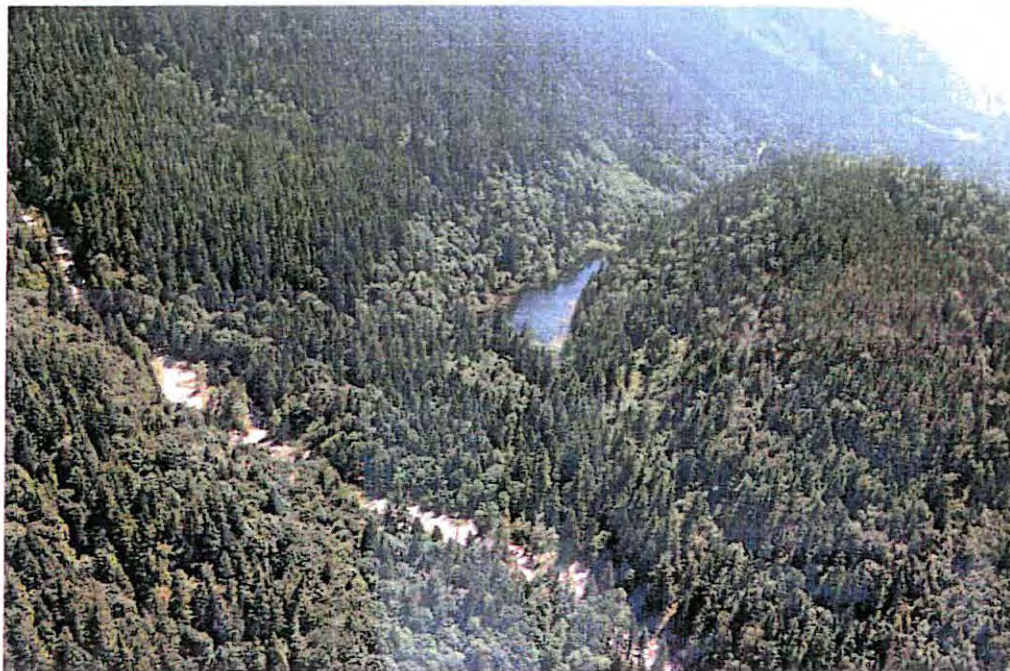
**Plate 2 – Relationship of Pattison Creek  
and Amber Lake**

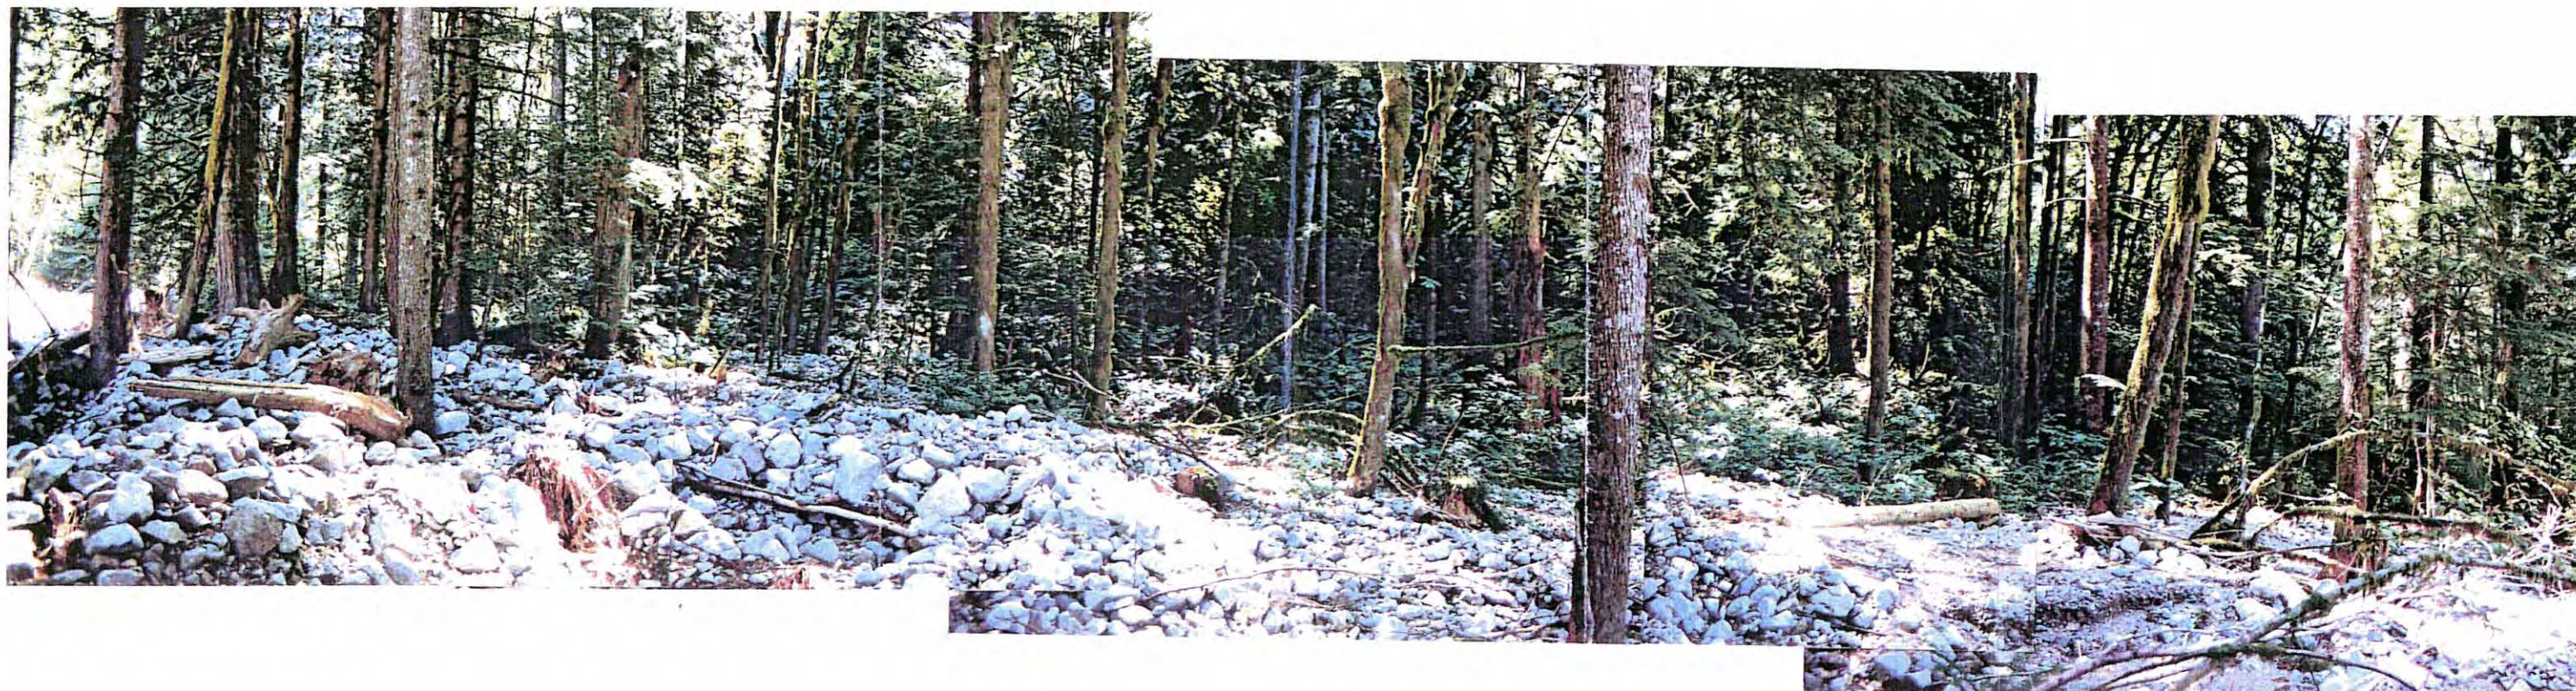
Note: Existing channel at left.

**Plate 3 – Extension of fan towards Amber Lake**

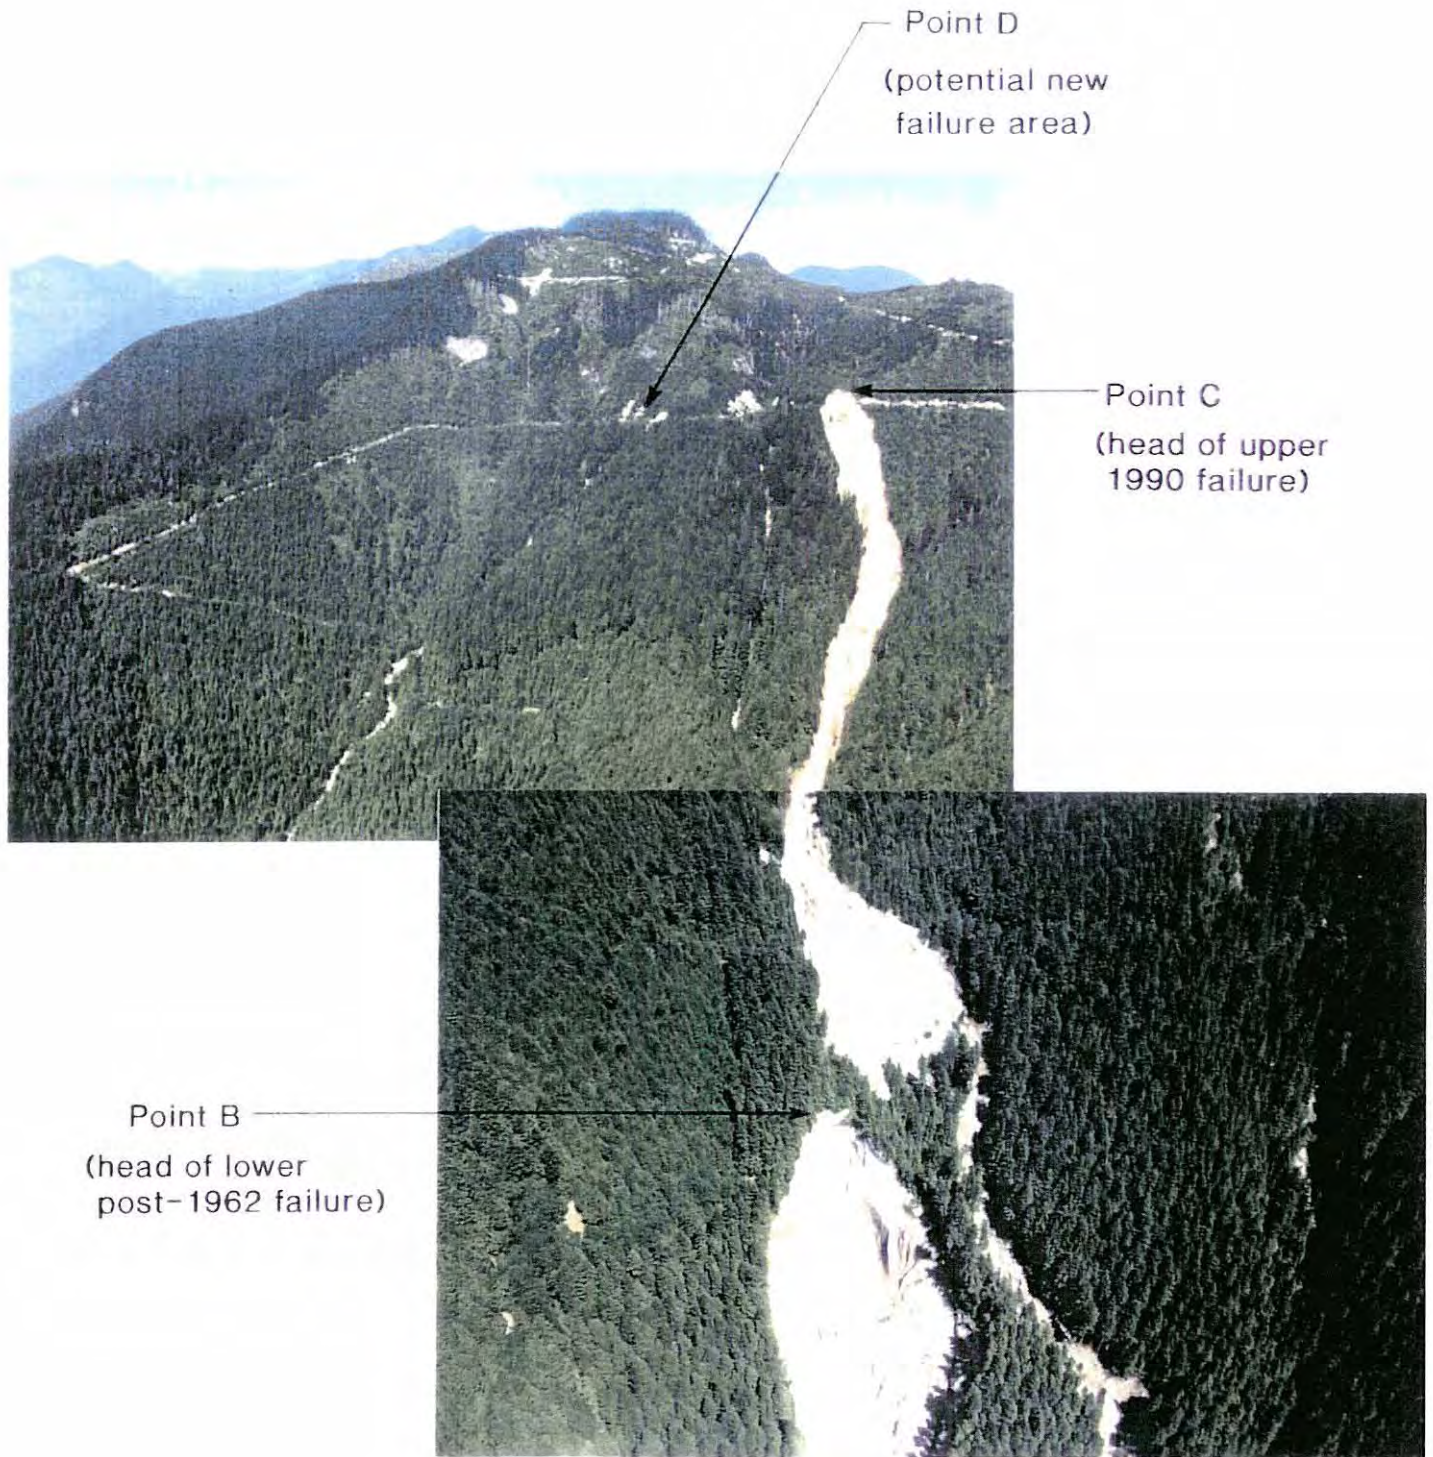
**Plate 4 – Debris failures on North side of catchment**

By contrast, there is a progressively increasing level of activity from the north side of the catchment where failures in largely glacio-fluvial materials (possibly with some tills) have precipitated debris flows (Plate 4). The event of November, 1990 has been described in detail by TEL. Initial activity at Point A (Figure 2) prior to 1962 was followed by a progressively deteriorating situation at Point B over the subsequent period, and latterly the failure at Point C in 1990. Recent advice from NHC shows that  $300,000 \text{ m}^3$  of material has been removed below point B and that up to  $130,000 \text{ m}^3$  has been removed below point C over a 30-year period. Other incipient failures have been recognized. Most existing failures are intimately related to the presence of the Forest Access Road where the sidecast material below the road, or steep unprotected cuts in soil, have caused triggering events precipitating debris flows. The failures are seen to be initiated at the access road, but to fail retrogressively to affect the slopes above the road and to create debris flows with significant destructive power downstream.

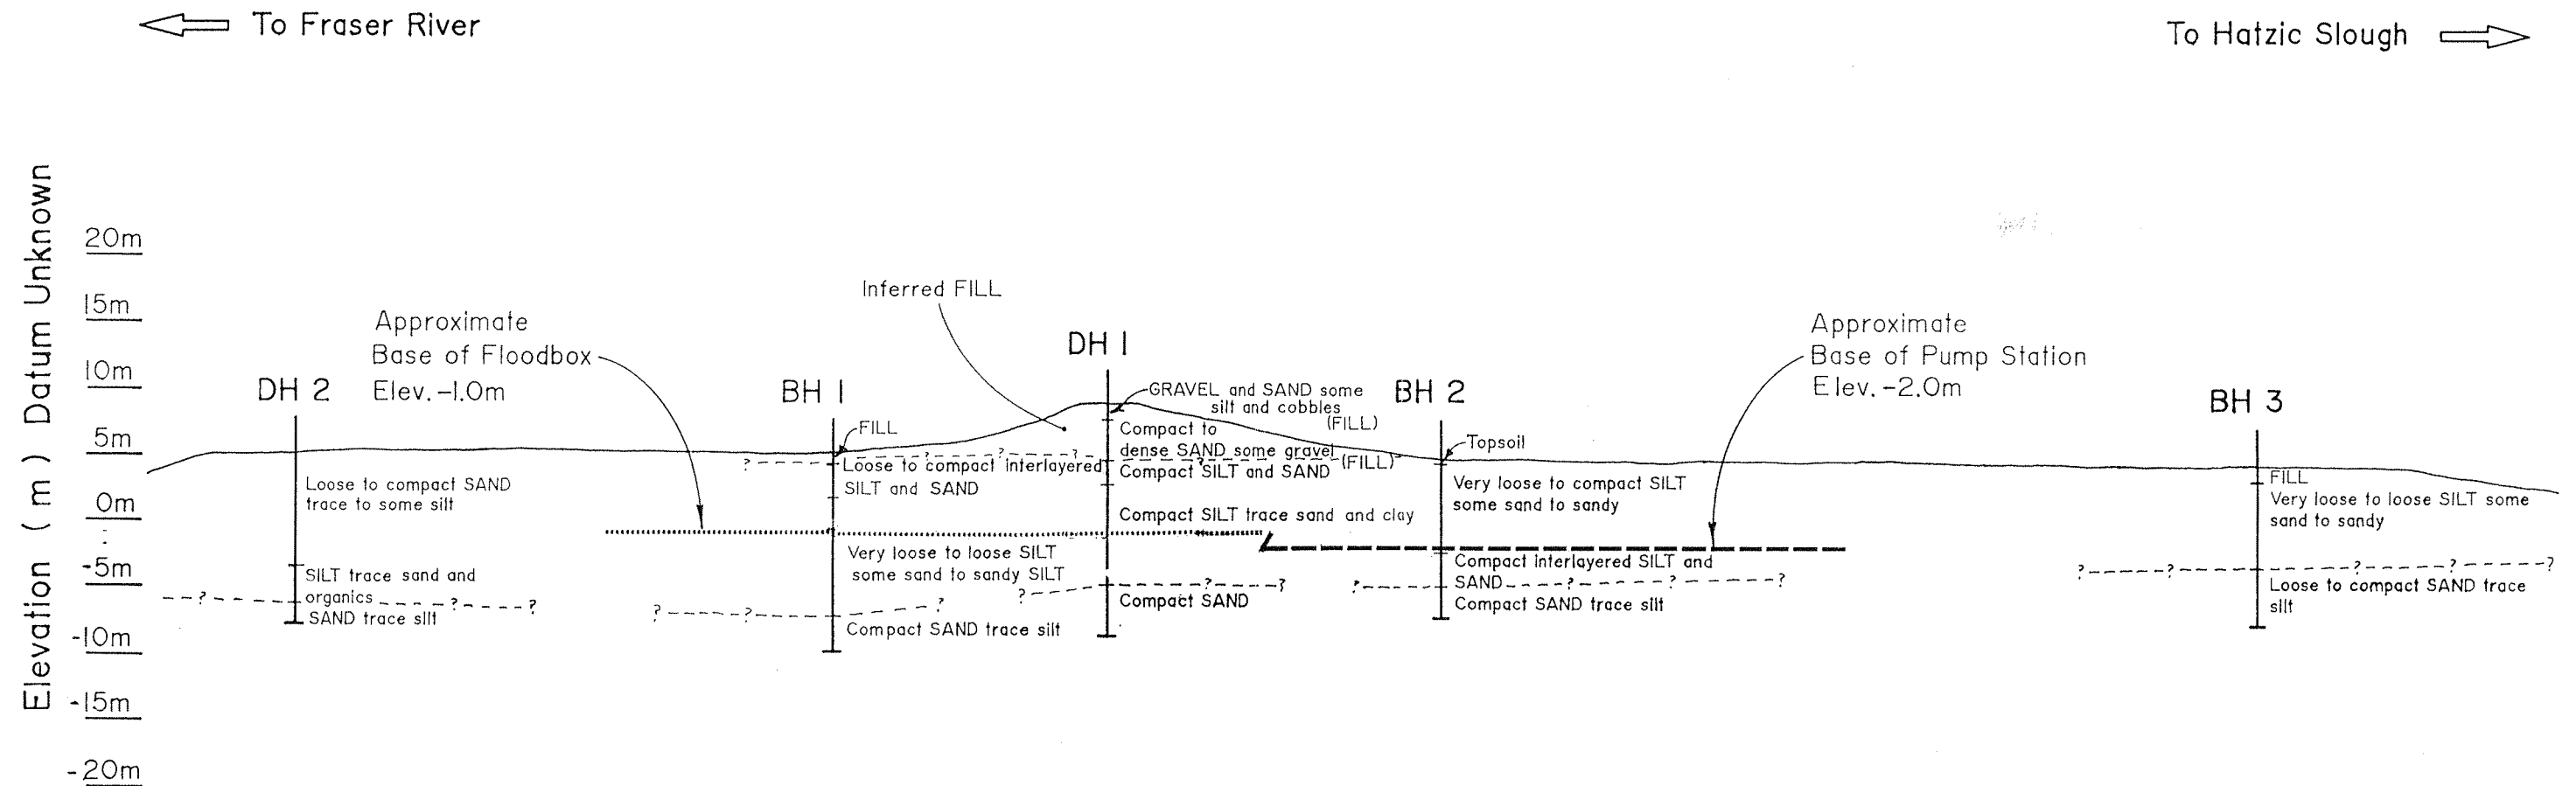
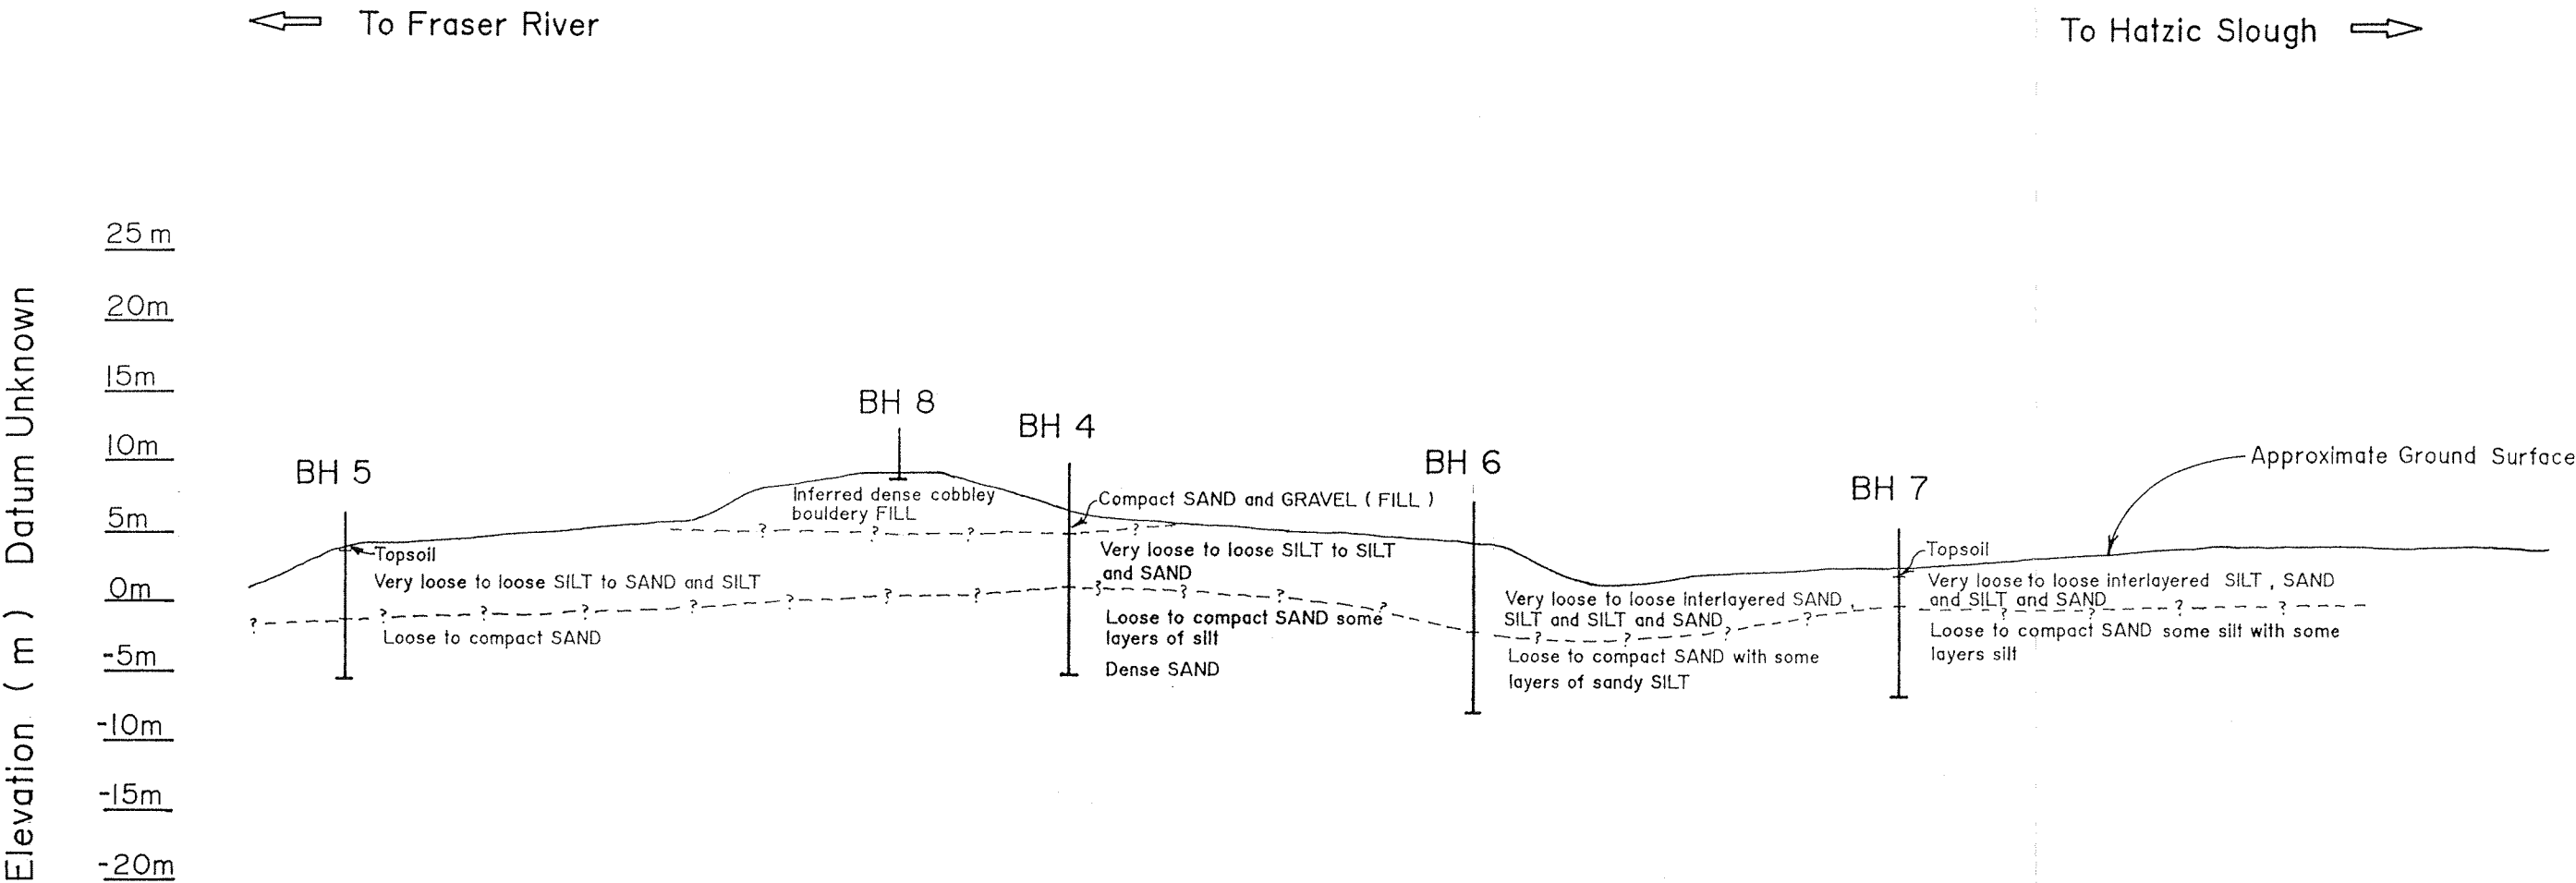
Note: DH 1 and 2 drilled in 1963 by Dept. of Highways for the Water Resources Branch

Reference Drawing ; Associated Engineering drawing number VP97 24 001 titled, Hatzic Slough Pump Station and Floodboxes

Detailed descriptions of the soils encountered in the boreholes are presented in the Record of Boreholes in Appendix II. Inferred soil profiles are shown in cross-sections plotted along the proposed southern and northern alignments shown in Figures 3 and 4, respectively.

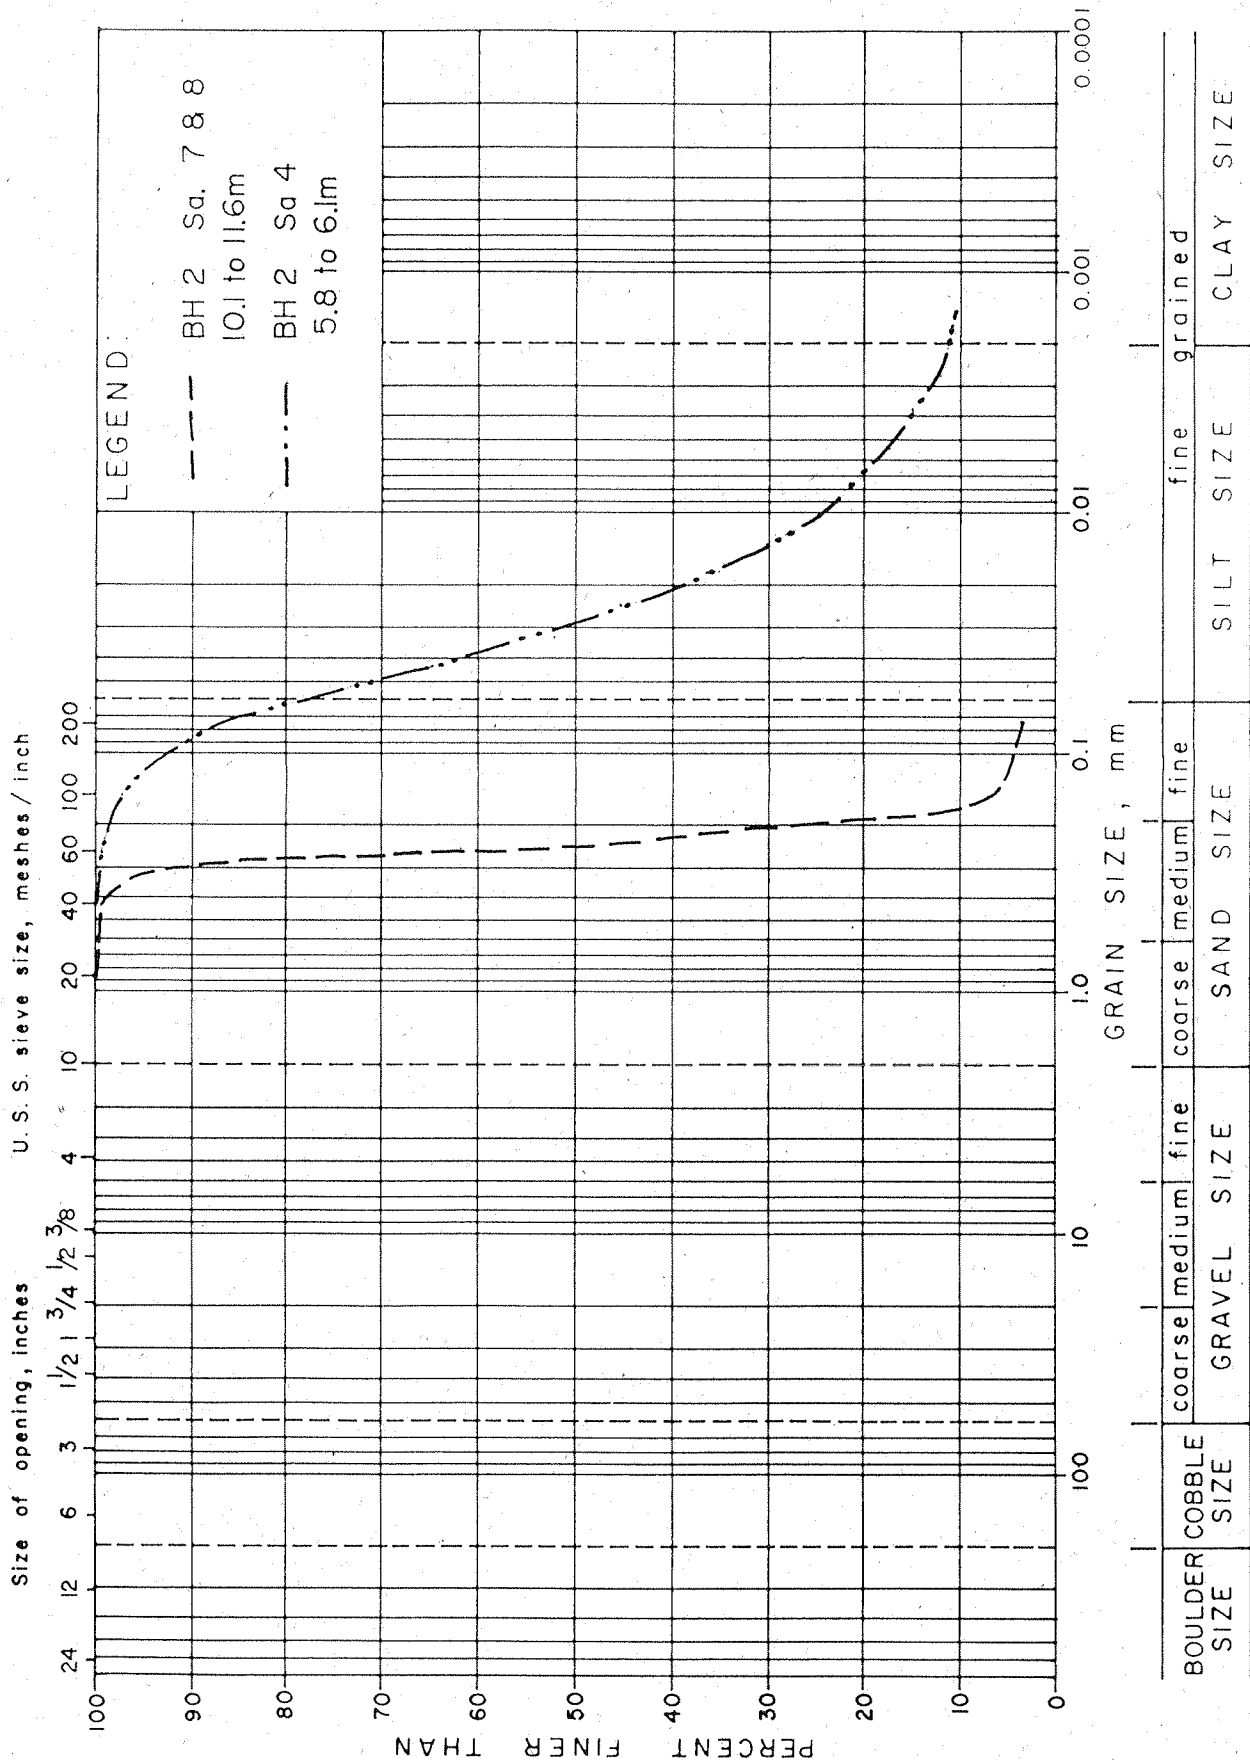
Figure 5

M.I.T. GRAIN SIZE SCALE

The grain size distribution of a sample obtained from a silt layer within this stratum is shown in Figure 5. It should be noted, however, that significant variation in grain size distribution was encountered within individual boreholes and between adjacent boreholes.

The grain size distribution of a sample of the sand stratum is shown in Figure 5.
