**DEWDNEY-ALOUETTE REGIONAL DISTRICT  
MISSION, B.C.**

**HATZIC PRAIRIE DRAINAGE STUDY  
VOLUME 2**

*August 1992*

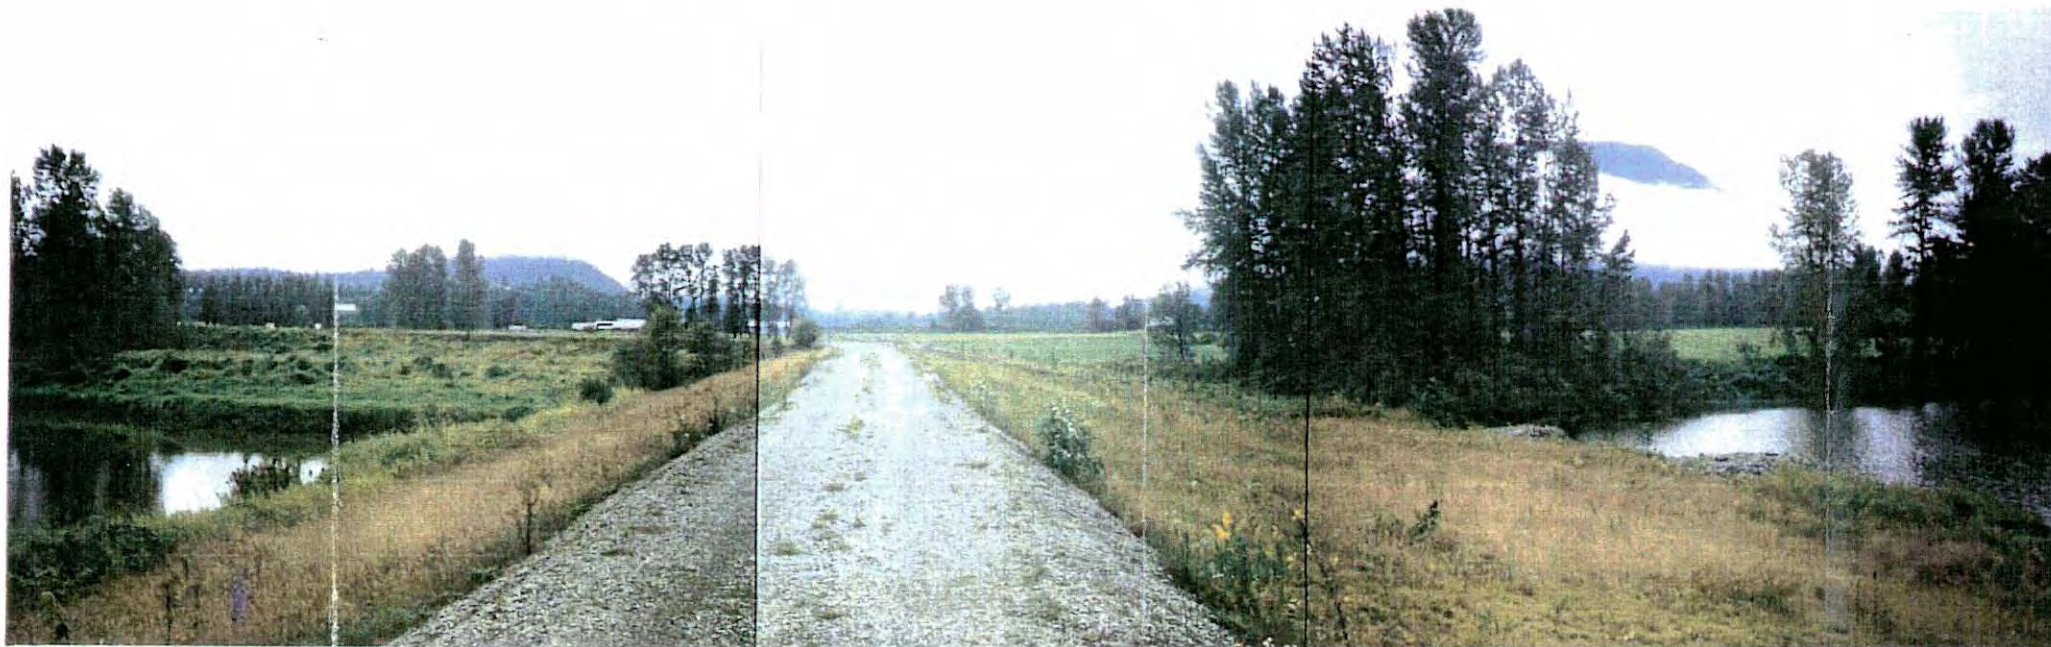
**PHOTOGRAPH 1**

Photo-mosaic looking northward along the centerline of the Hatzic Slough dam.

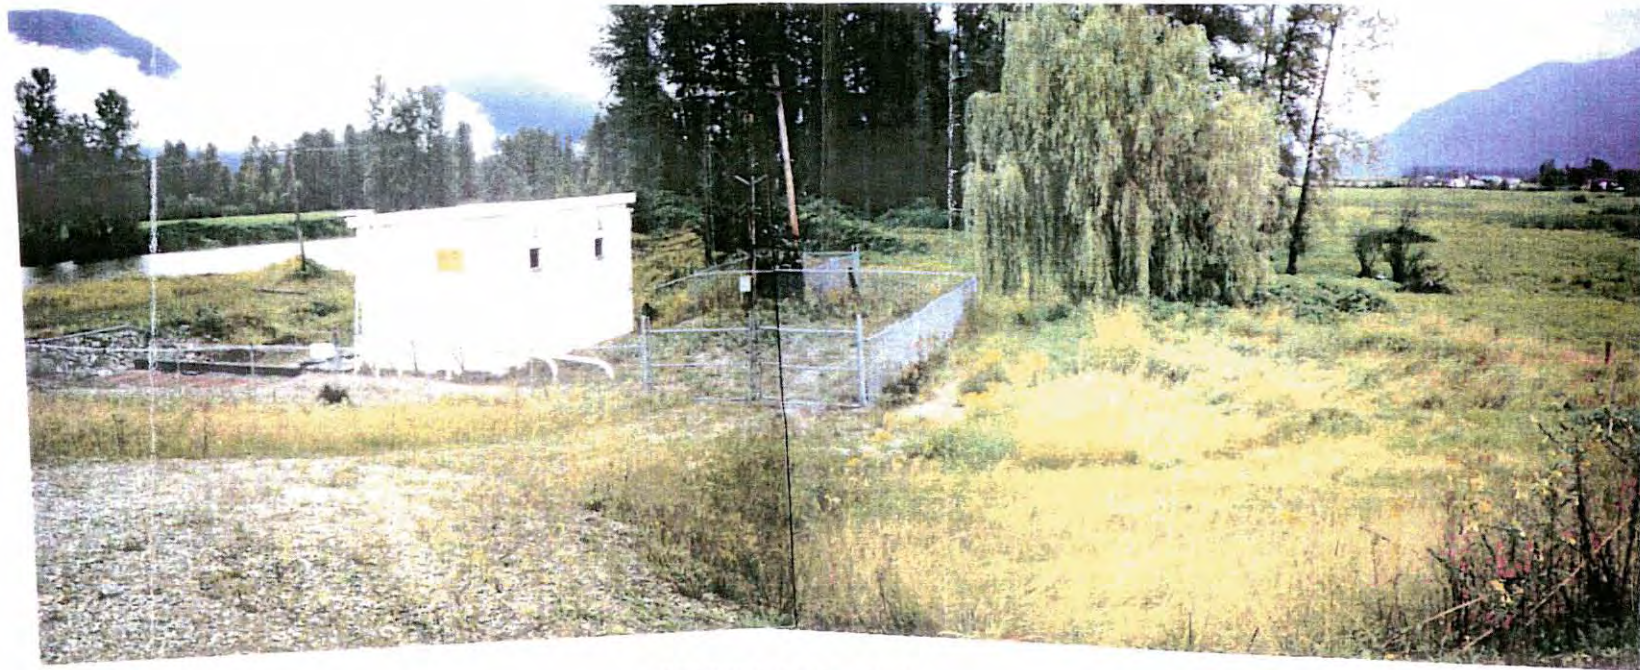
**PHOTOGRAPH 2**

Photograph looking eastward from the edge of the dyke towards the existing pump station. Hatzic Slough Channel appears in the upper left-hand side of the photograph.

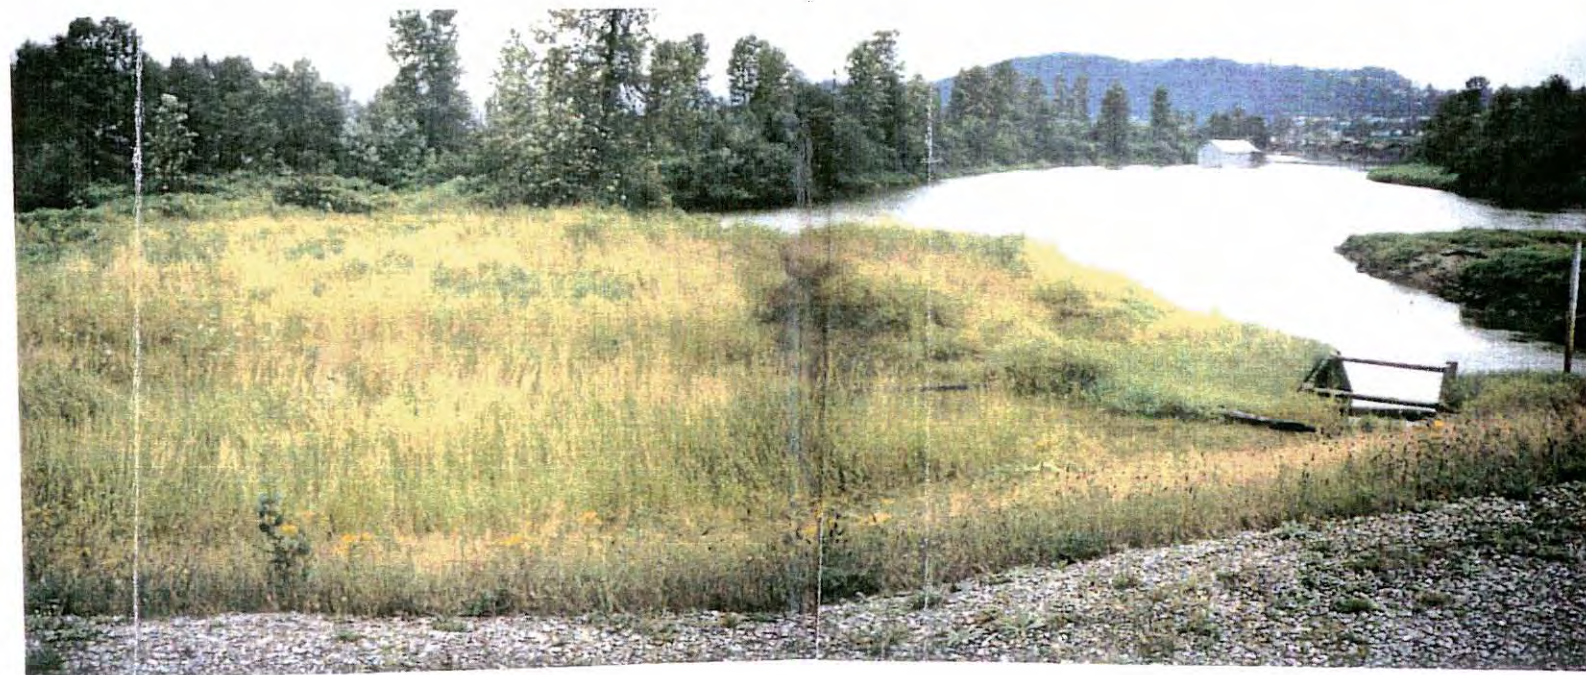
**PHOTOGRAPH 3**

Photograph looking westward from the edge of the dyke in the downstream flow direction of Hatzic Slough. The outfall structure for the existing pump station appears at the right-hand side of the photograph.

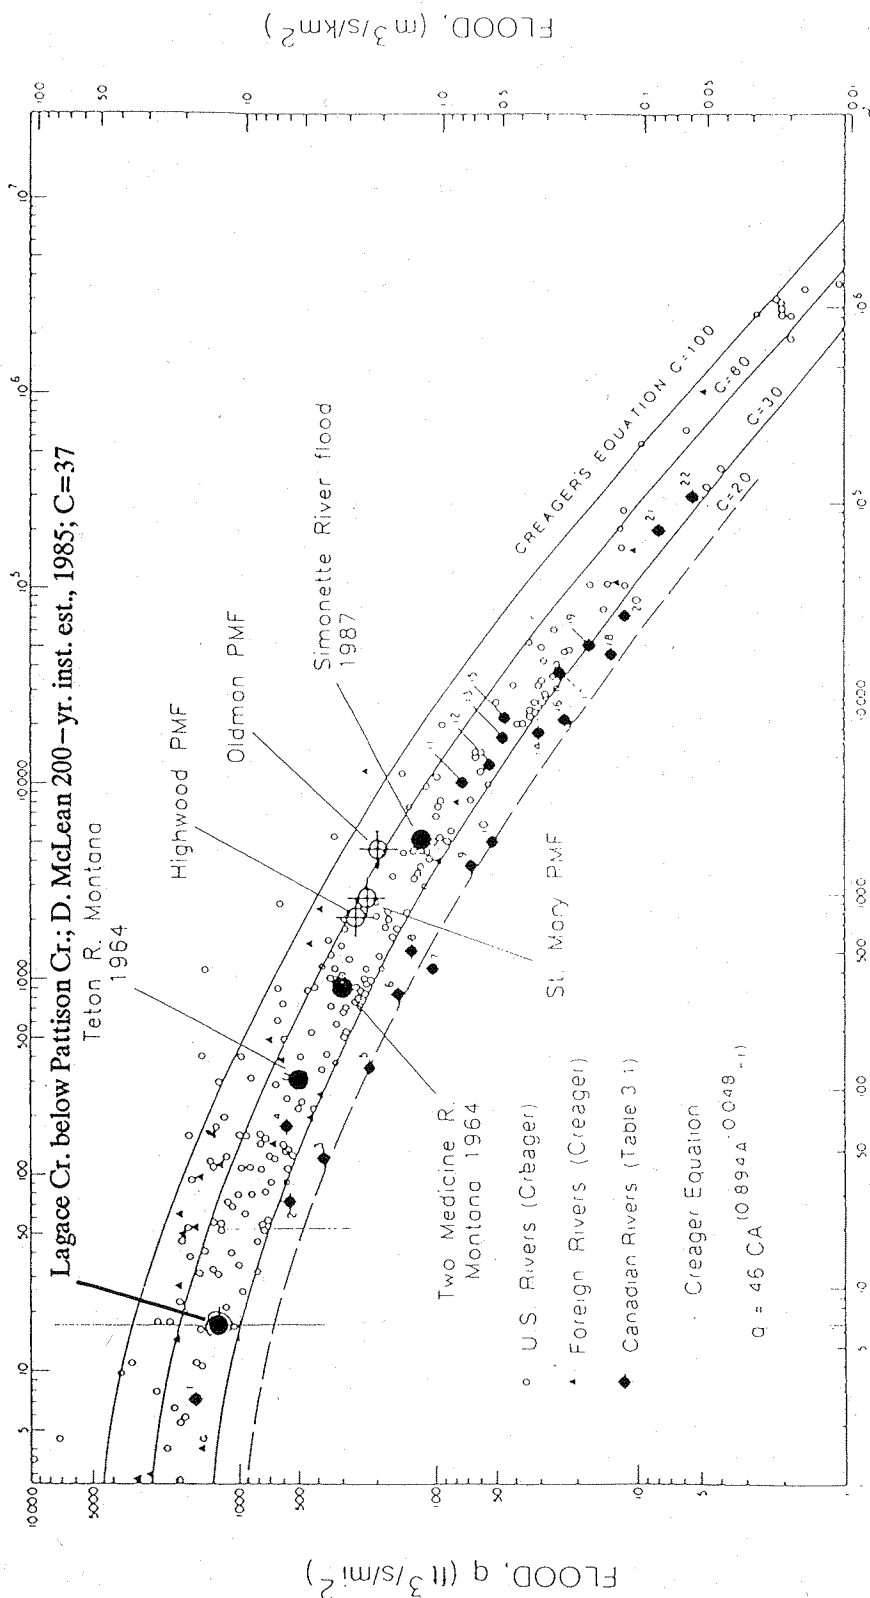
Creager's diagram with added Canadian and Montana flood data and recent PMF estimates for western Alberta.

Adapted from Watt et al (1989)

For very small areas, the unit discharge  $q$  for a given  $C$  is virtually independent of area, that is, peak discharge increases almost proportionally to area: this reflects the physical condition that small basins are blanketed by the critical storms. For very large areas, the unit discharge for a given  $C$  is almost inversely proportional to area, that is, the peak discharge is almost constant: this reflects the physical condition that the areal coverage of a single storm is limited.

The value of  $C$  for a given basin accounts implicitly for climatic, abstraction-from-rainfall and routing factors. It should be higher for regions of higher storm rainfall intensities, and for basins of lower infiltration capacities and steeper slopes.

The limited plotting of unusual Canadian flood data (which were drawn from most provinces and territories) indicates that the highest gauged events in Canada generally have  $C$  values in the range of 20 to 40, with an upper limit of about 45 to date. In contrast, many of Creager's data from USA and elsewhere reached  $C$  values of 100 or more. Recent PMF determinations in western Alberta correspond to  $C$  values in the range of 55 to 70.

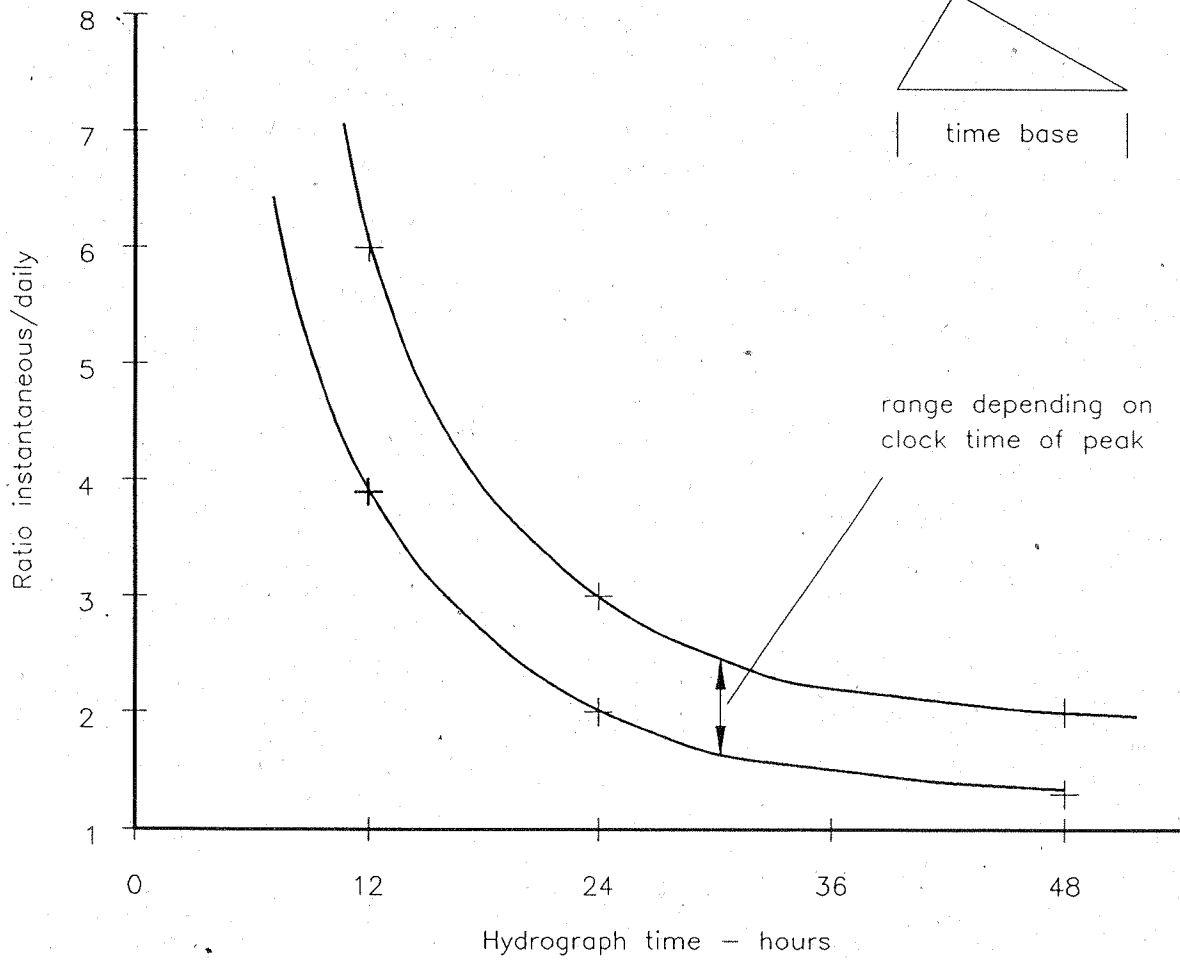
Hatzic Prairie Study

Variability of Inst./Daily  
Maximum Flow Ratios

Unit hydrograph theory postulates that the time base of the direct runoff hydrograph for a given basin is more or less independent of the rainfall, but that the ordinates are proportional to the effective rainfall. It can therefore be reasoned that the peak-to-daily ratio for a given basin should not depend significantly on the frequency of the event. If the reported instantaneous and daily annual maxima for a given station are examined, the ratios usually found to vary more or less randomly and not to depend on the size of the event.

It follows that for small basins with hydrograph time bases of one day or less, flood frequency analyses based on daily maxima are not of much value for inferring instantaneous maxima, and that the application of a constant multiplying factor to daily data is difficult to justify.

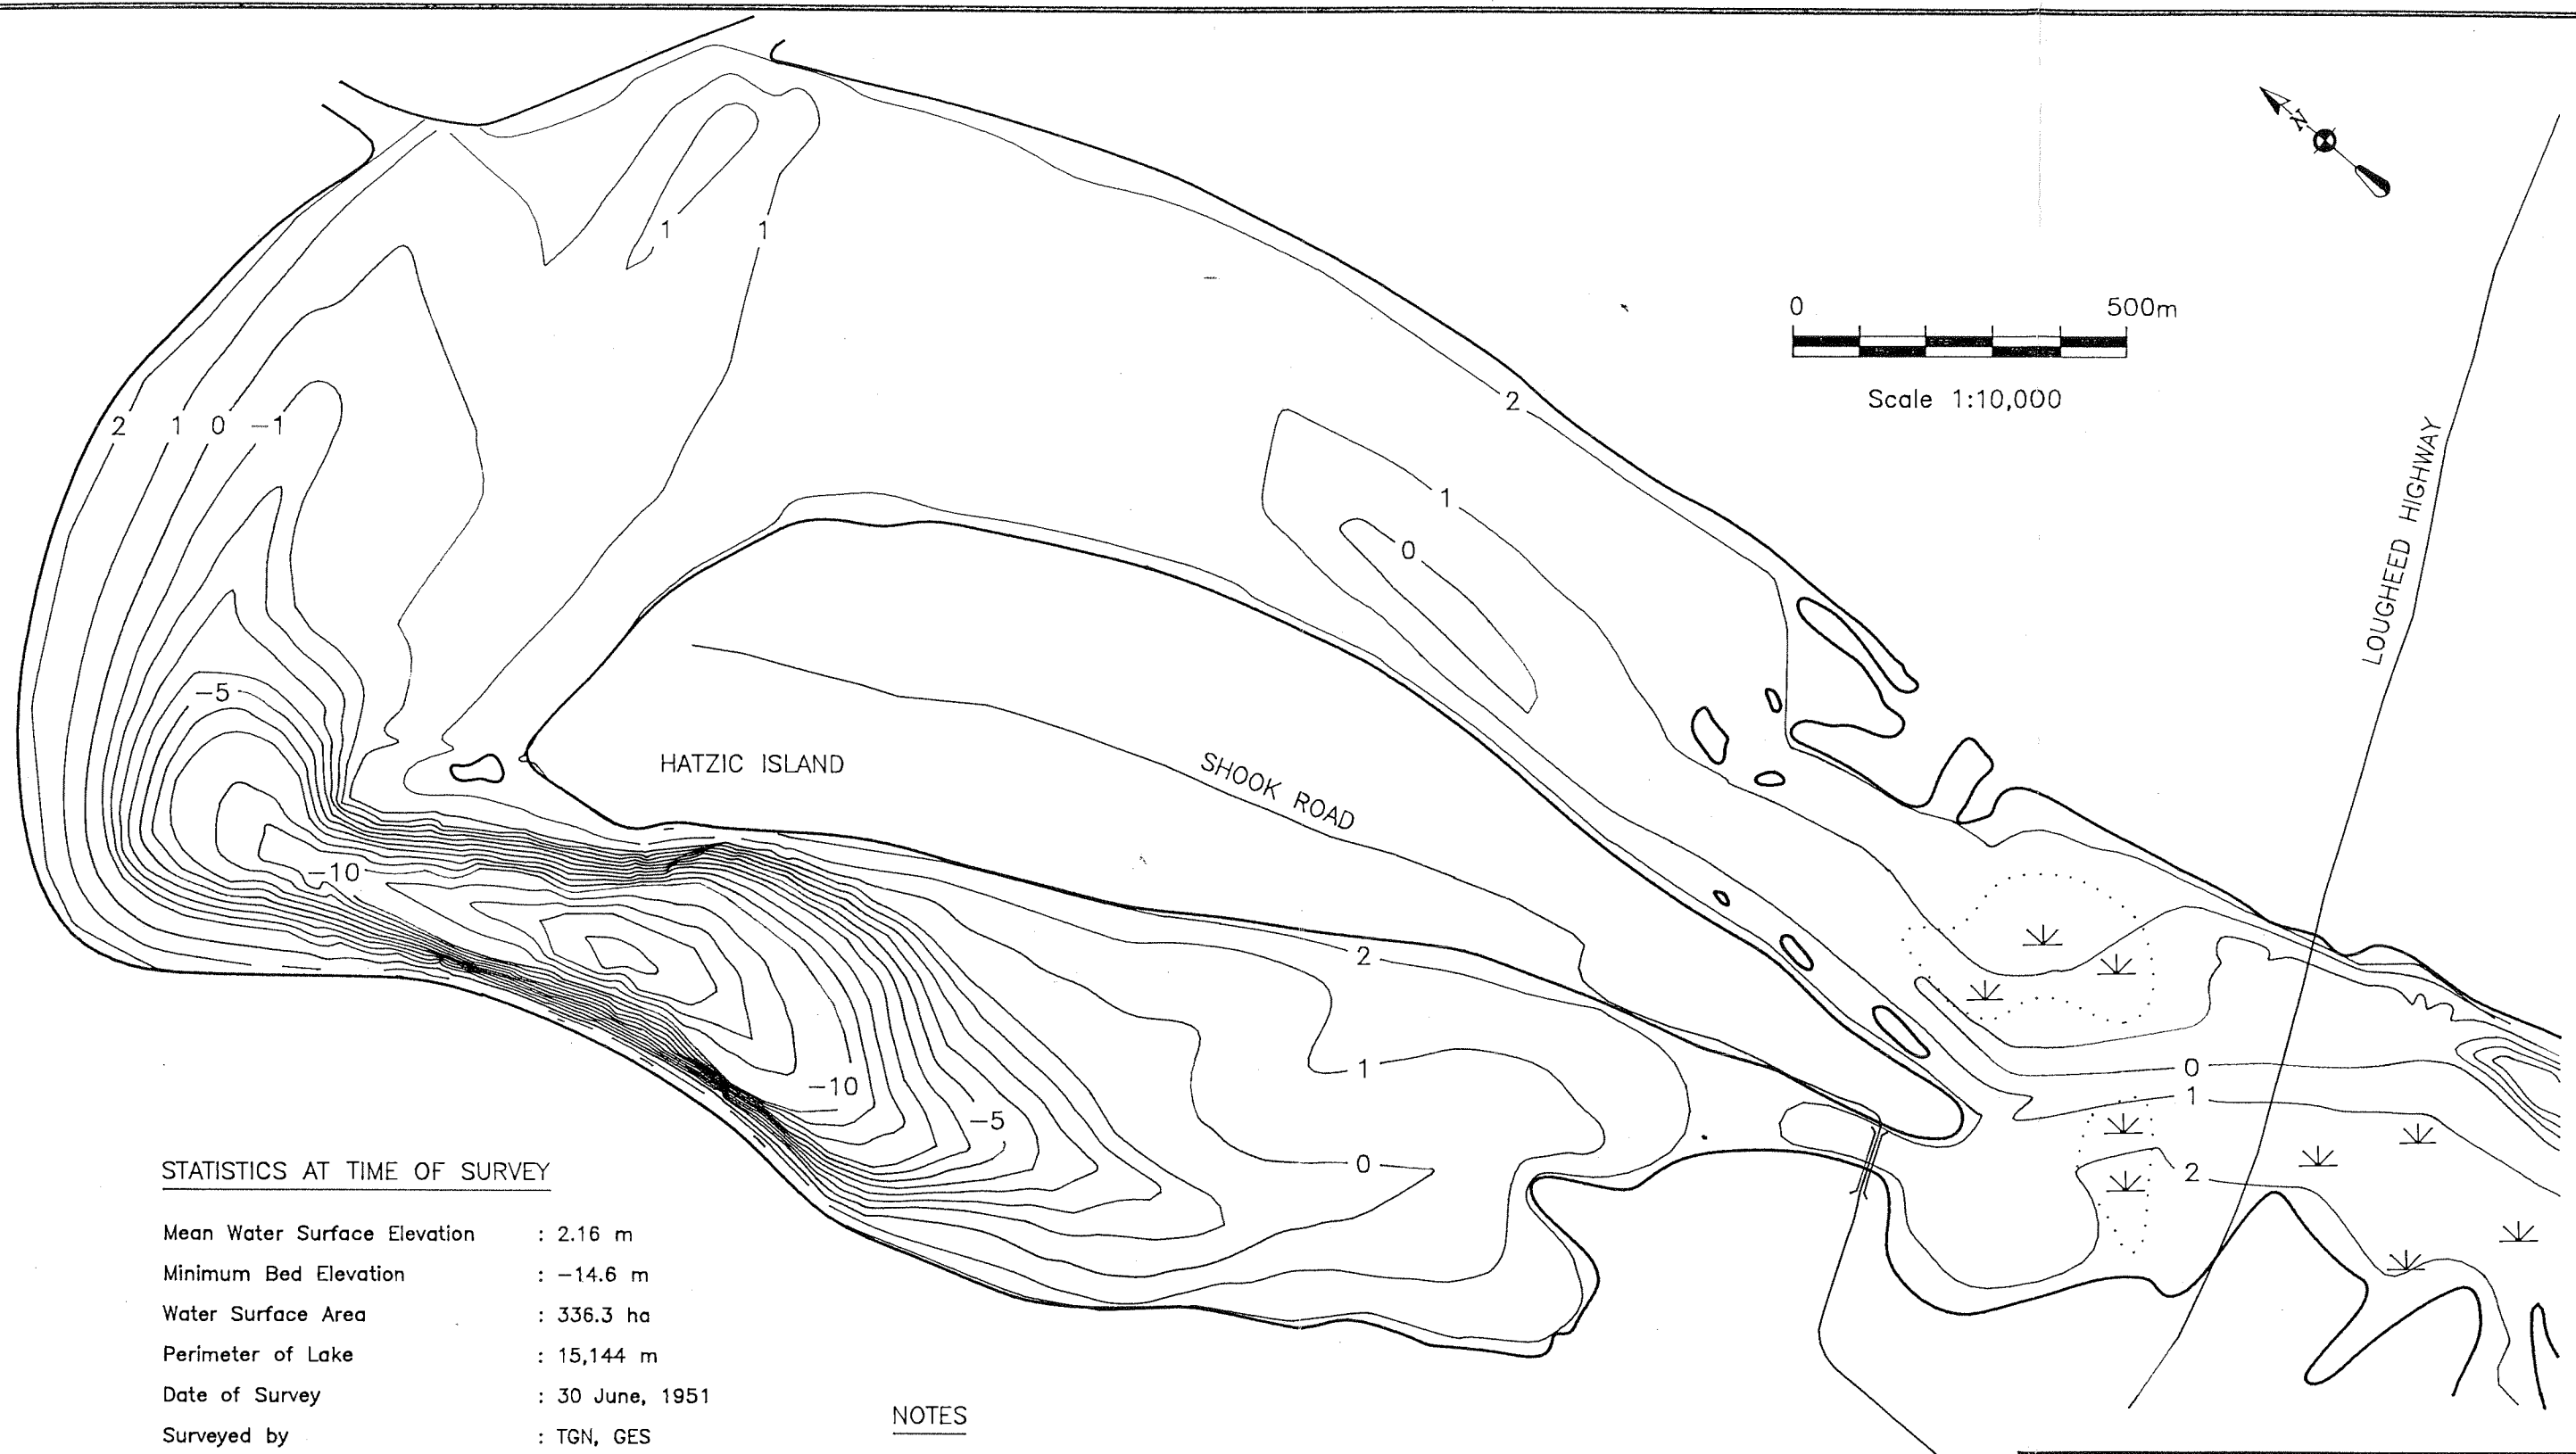
| Hatzic Lake Bathymetry<br>June 1951 |

STATISTICS AT TIME OF SURVEY

| Mean Water Surface Elevation | : 2.16 m |

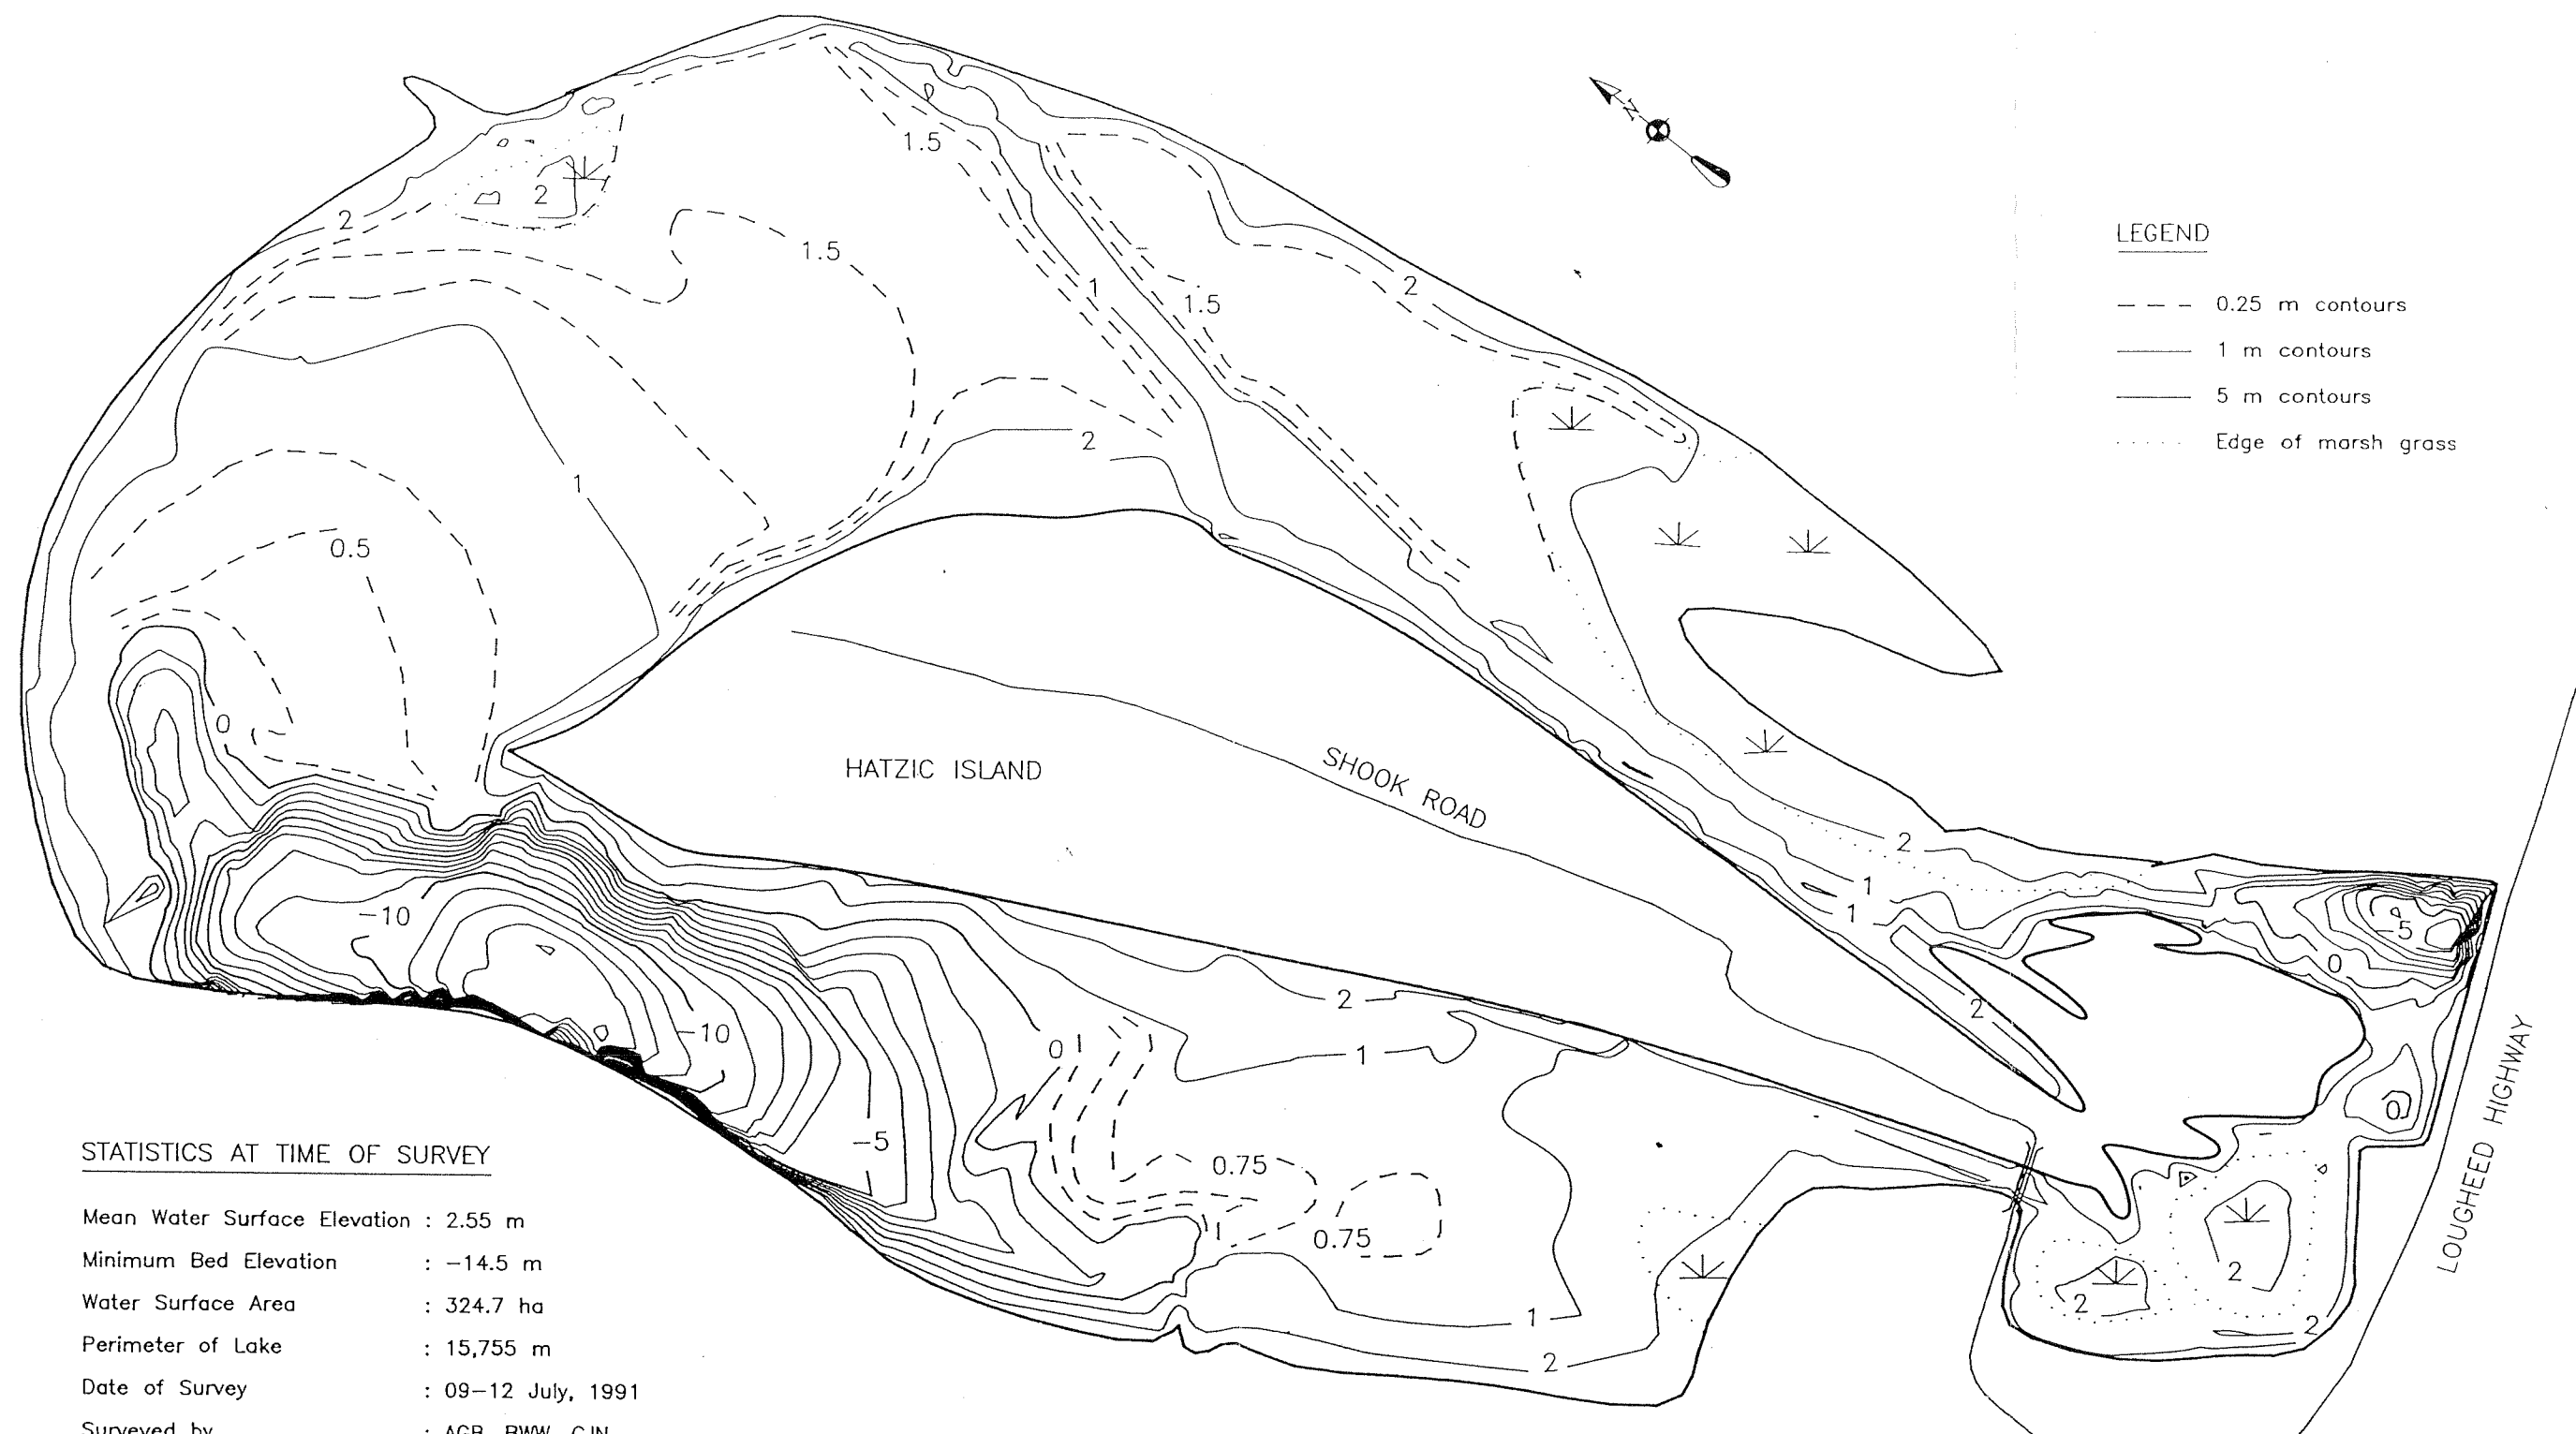
Hatzic Lake Bathymetry  
July 1991

#### STATISTICS AT TIME OF SURVEY

Mean Water Surface Elevation : 2.55 m  
 Minimum Bed Elevation : -14.5 m  
 Water Surface Area : 324.7 ha  
 Perimeter of Lake : 15,755 m  
 Date of Survey : 09-12 July, 1991  
 Surveyed by : AGB, BWW, CJN  
 Contour Interval : 1 m

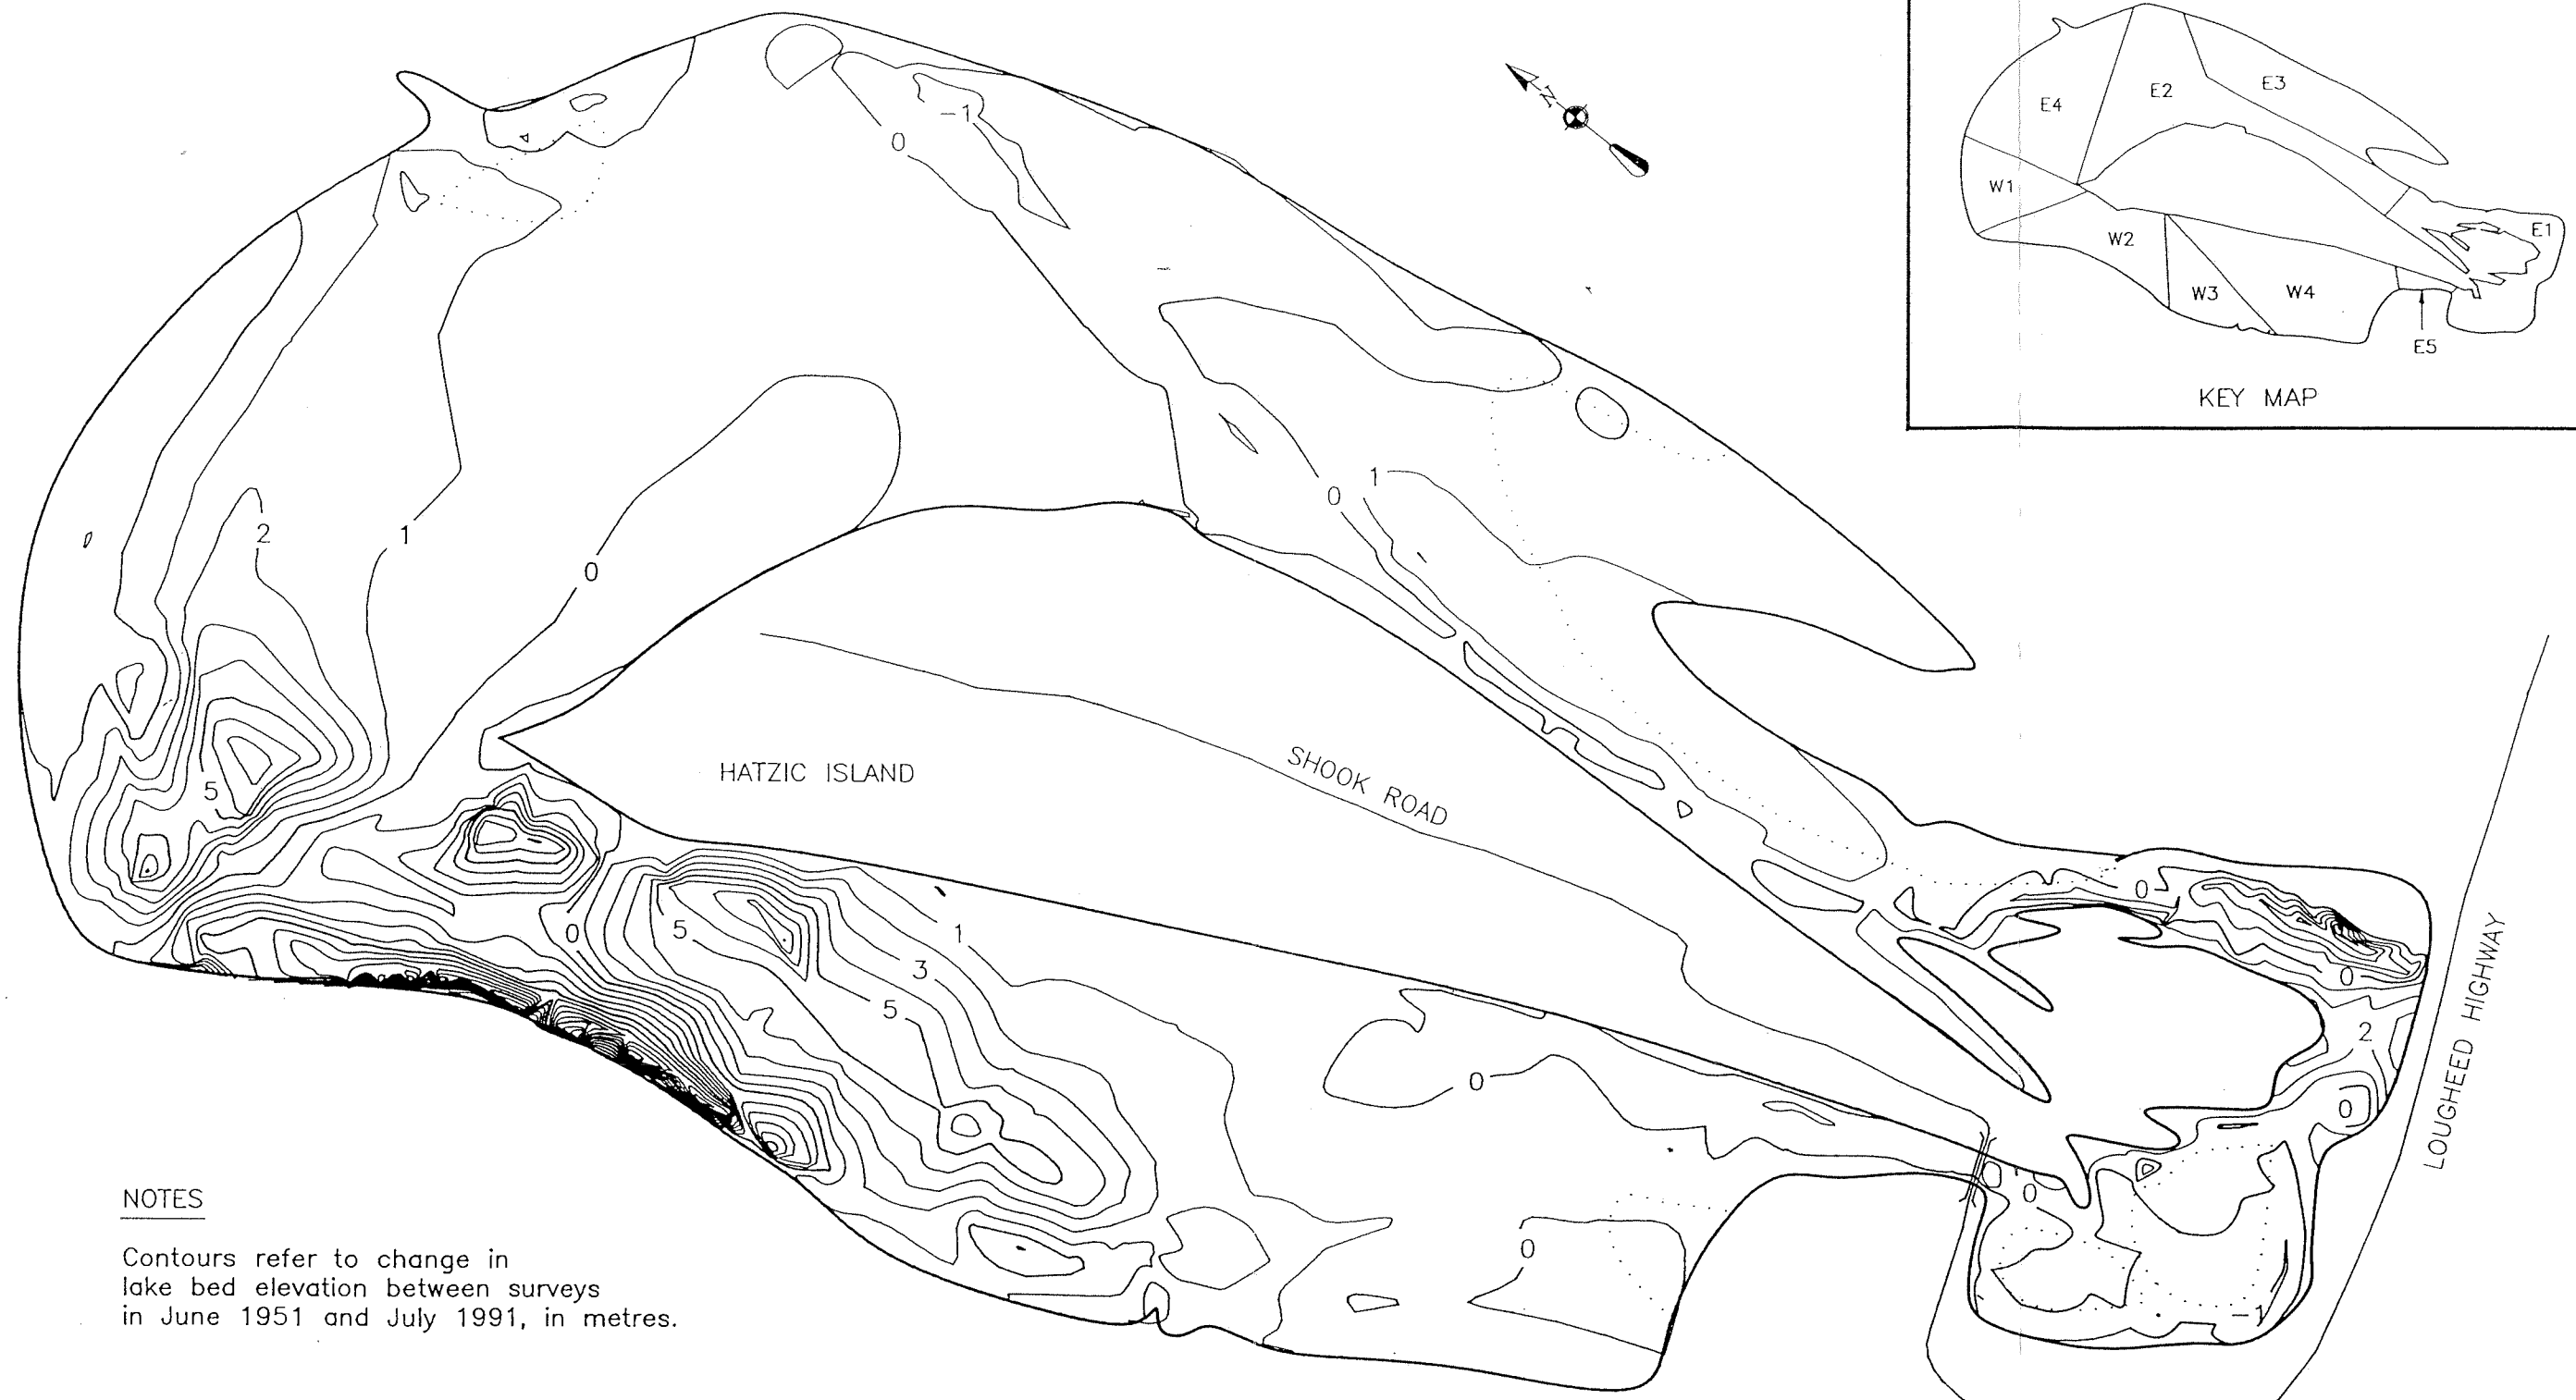
Contours refer to change in lake bed elevation between surveys in June 1951 and July 1991, in metres.

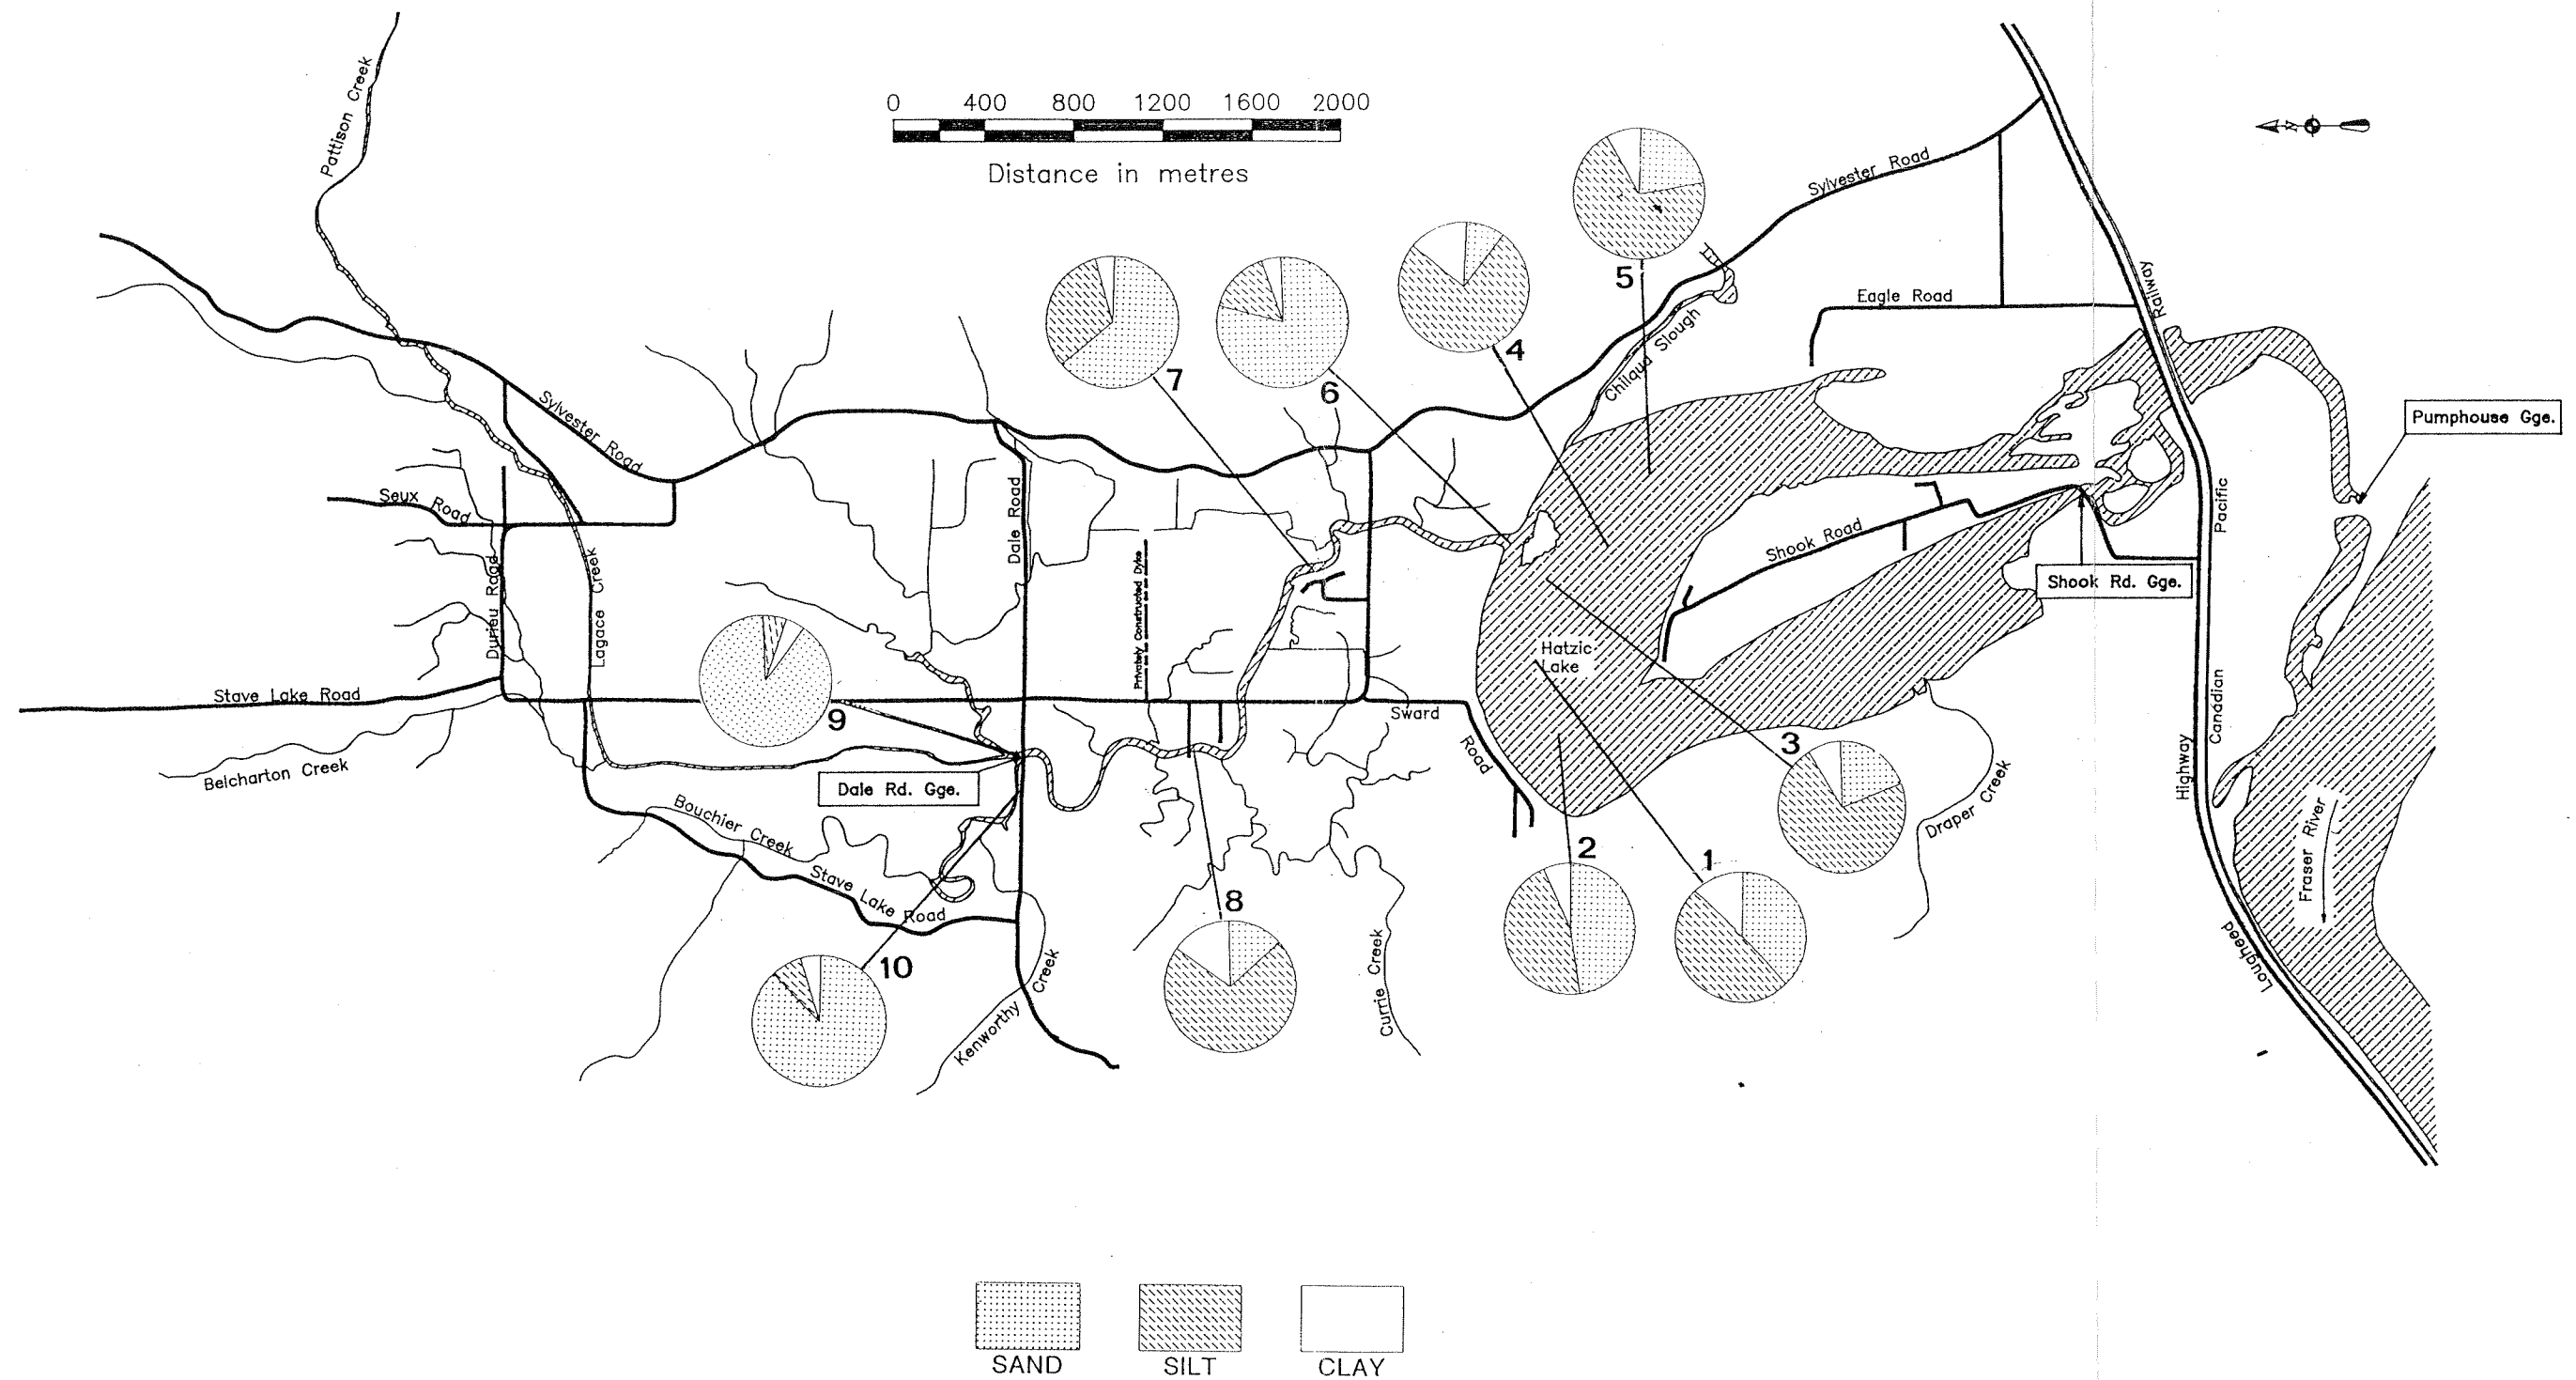
# Hatzic Prairie Study

Sediment Sample Locations  
September 1991
