**DEWDNEY-ALOUETTE REGIONAL DISTRICT  
MISSION, B.C.**

**HATZIC PRAIRIE DRAINAGE STUDY  
VOLUME 2**

*August 1992*

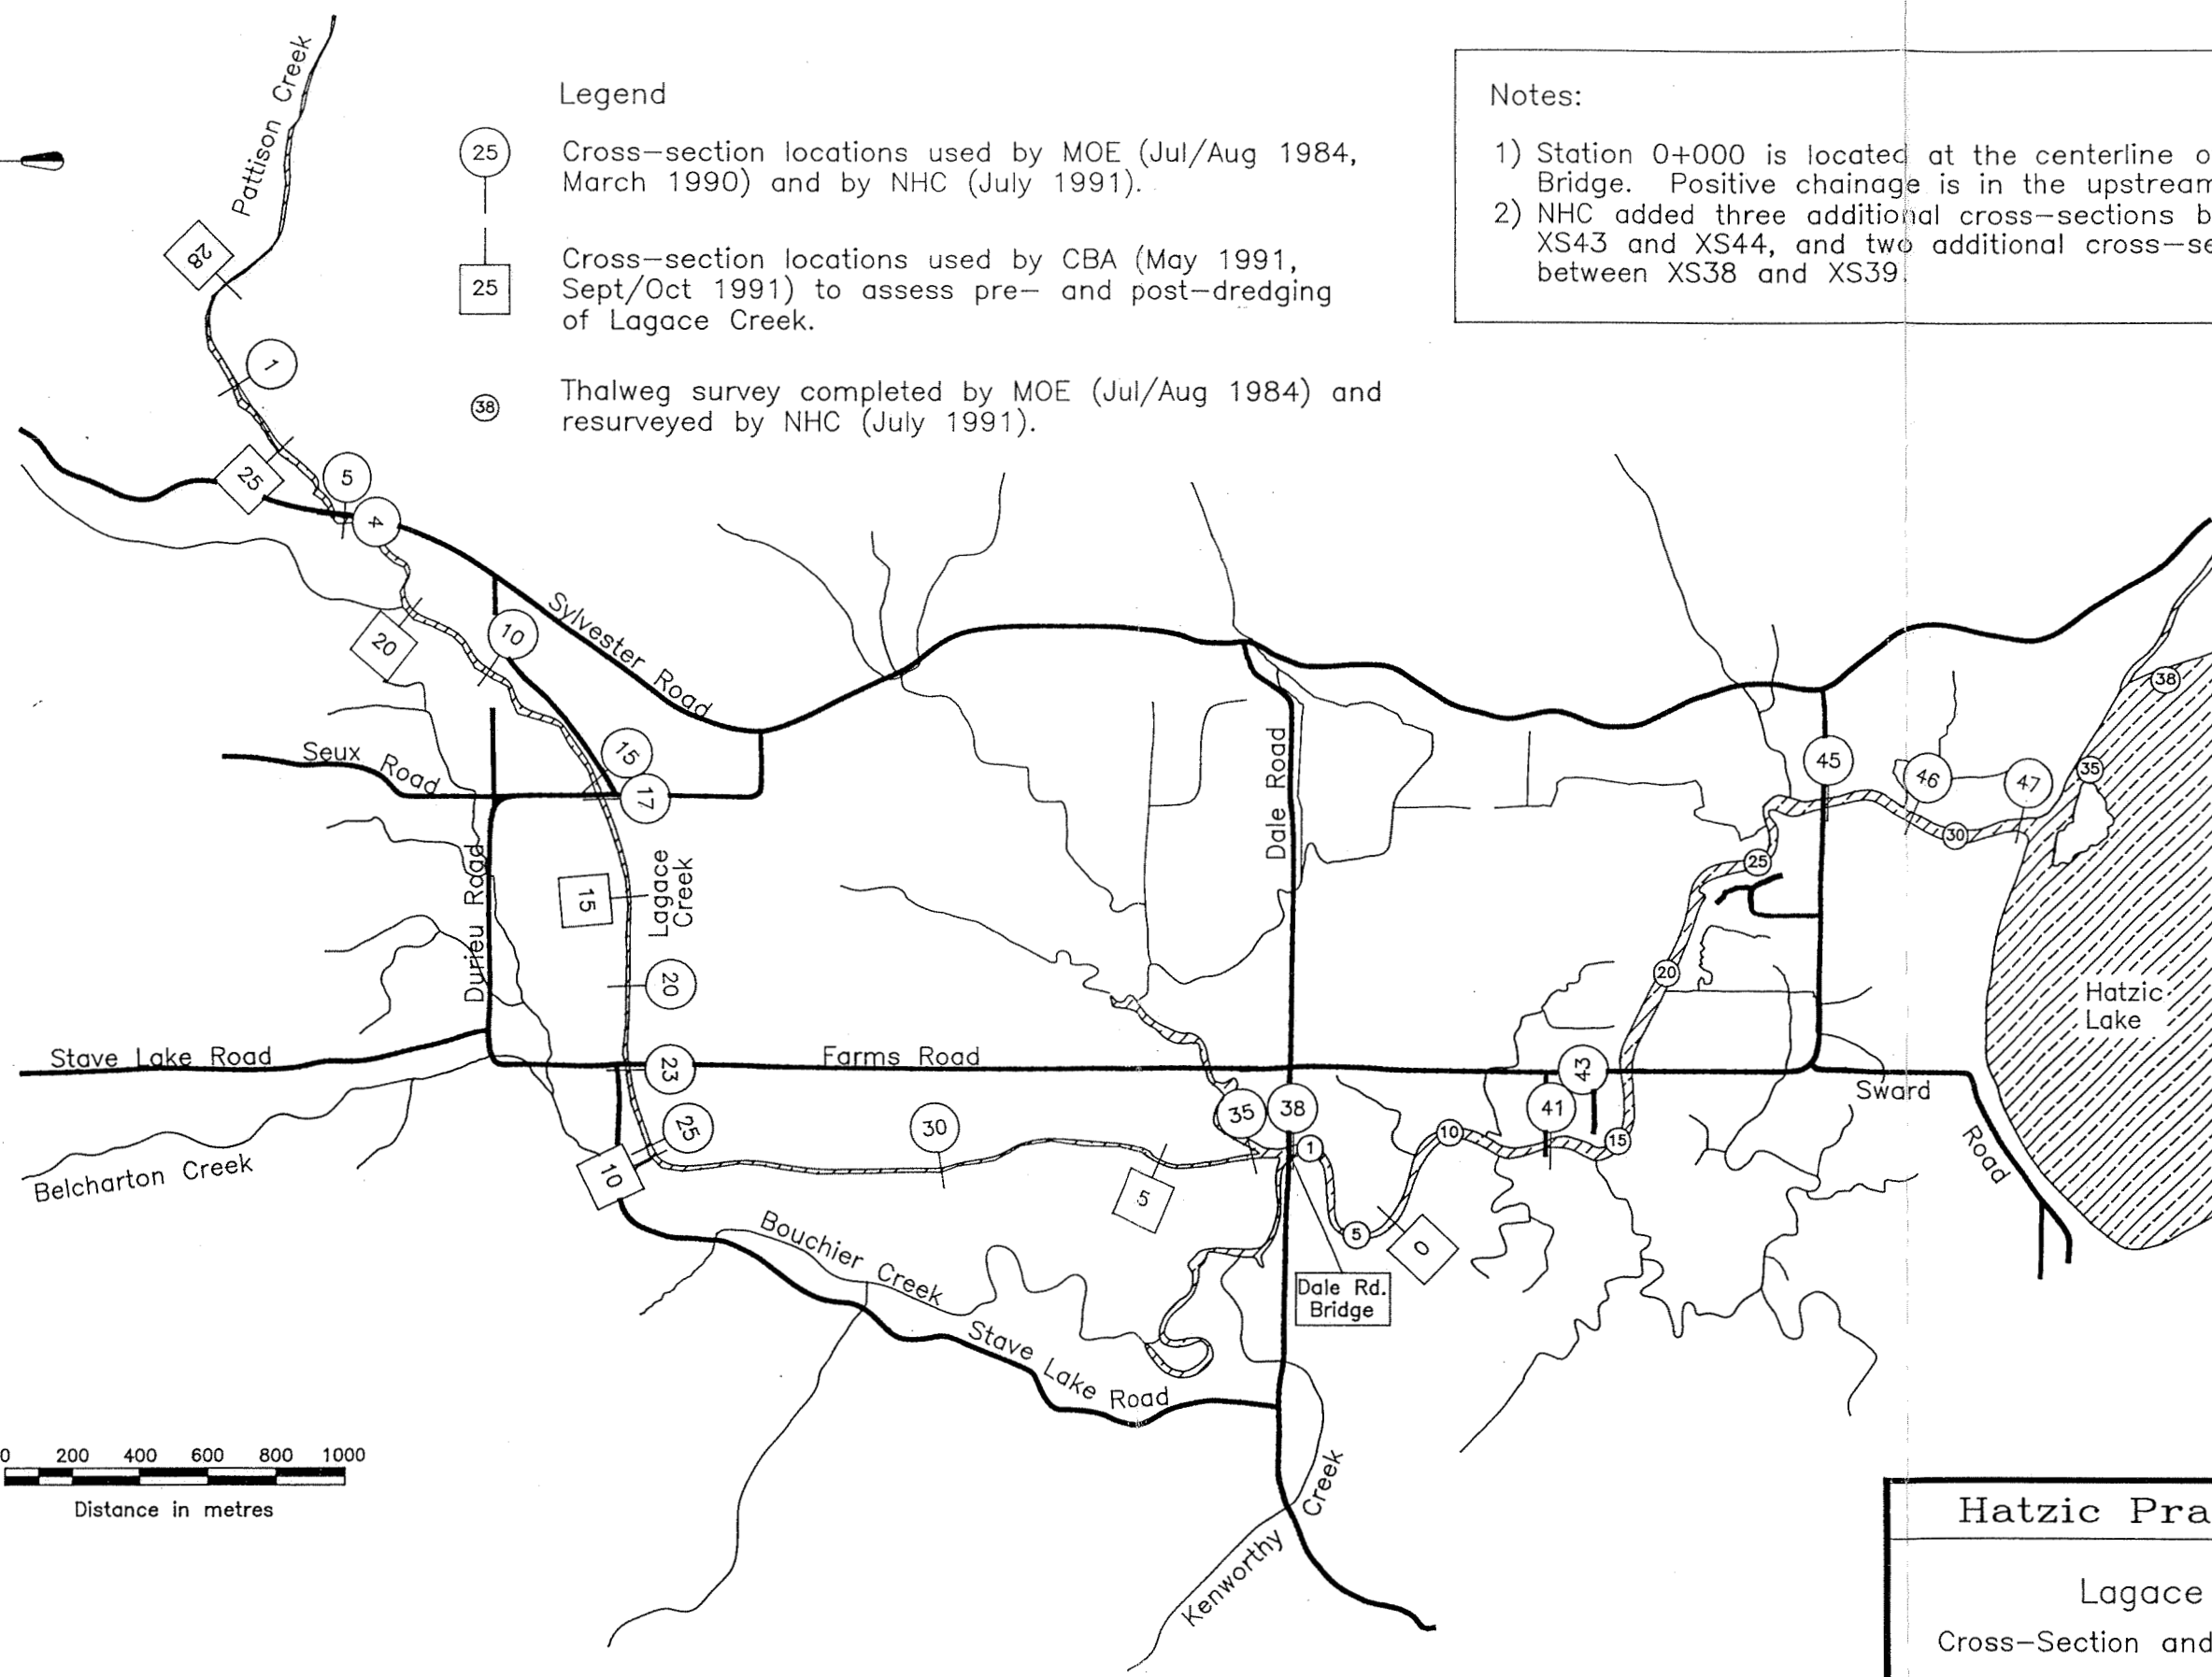
- Cross-section locations used by MOE (Jul/Aug 1984, March 1990) and by NHC (July 1991).
- Cross-section locations used by CBA (May 1991, Sept/Oct 1991) to assess pre- and post-dredging of Lagace Creek.
- Thalweg survey completed by MOE (Jul/Aug 1984) and resurveyed by NHC (July 1991).

- .1 The MOE 1984 cross-sections are very similar to those surveyed by CBA-(pre-PEP), and were used for the computations. The high bed levels were assumed to be representative of post debris torrent events and the dykes would be designed to hold back water under this condition.
- .2 The dykes on each side of the creek were set back 15 m (bank edge to toe).
- .3 For supercritical flows, mostly near and upstream from the Sylvester Road bridge, the flow depths were assumed to be close to critical depth.
- .4 The dykes are to be designed for the 50-year peak discharges.
