# Corporate Bridge Register (CBR) Structure Inventory Data Form "BRIDGES"

**Routine Condition Bridge Inspection Form**  
(except for log stringer or timber stringer bridges)

| GENERAL INFORMATION | | | | (enter either long/lat or UTM - not both) | | |
|---|---|---|---|---|---|---|
| Site # <u>CK2175</u> | | Structure # | | | | |
| FSR Name <u>LAST MUKDO</u> | | User km <u>1.2</u> | Project File ID <u>84#6</u> | Branch <u>02</u> | | |

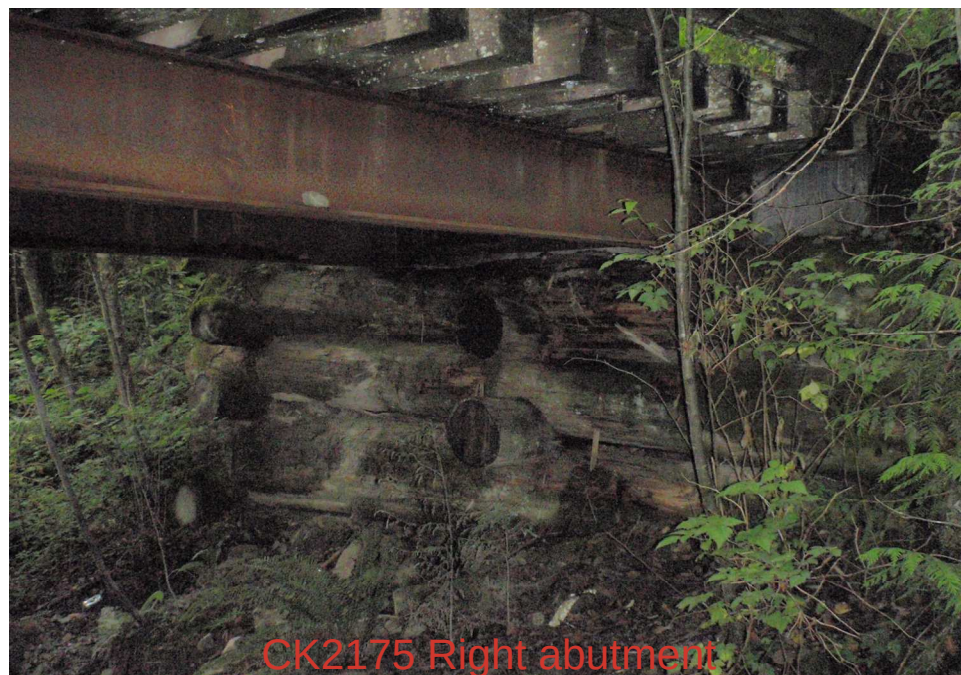
CK2175 Right abutment

| GENERAL INFORMATION | | | | (enter either long/lat or UTM - not both) | | |
|---|---|---|---|---|---|---|
| Log/Timber Crib | E G (F) P N/A | OLD CRIB. 3x CLOSED FACED | | | | |
| Tie-backs | E G (F) P N/A | 3x TIEBACKS OLD & SOME ROT | | | | |
| Riprap | E G F (P) N/A | ABUTMENTS ARE BEING HEAVILY SCARPED | | | | |

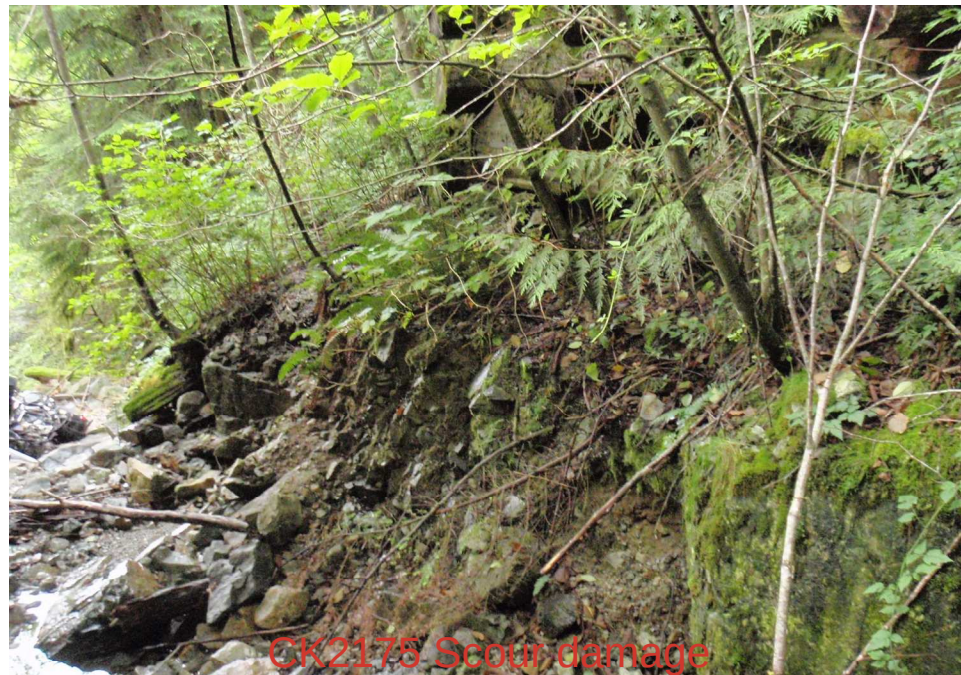
CK2175 Scour damage

| GENERAL INFORMATION | | | |
|---|---|---|---|
| Comments <u>Scour Damage to both abutments</u> | | | |

| GENERAL INFORMATION | | | |
|---|---|---|---|
| 1 | MONITOR SCOUR DAMAGE ANNUALLY TO ENSURE CRIB IS NOT DAMAGED. | | |
