# Corporate Bridge Register (CBR) Structure Inventory Data Form "BRIDGES"

| *Forest Service Road: Stave-Winslow | Kilometres: 4.2 |

**Routine Condition Bridge Inspection Form**  
(for log stringer or timber stringer bridges)

| GENERAL INFORMATION | | | | | | | |
|---|---|---|---|---|---|---|---|
| *Date of Inspection (yyyy/mm/dd)<br><u>2010-09-07</u> | | *Inspection Company Name<br>Onsite Engineering LTD. | | *Inspector's Name (print)<br>Ali Sadehghi | | Inspector's Signature<br> | |

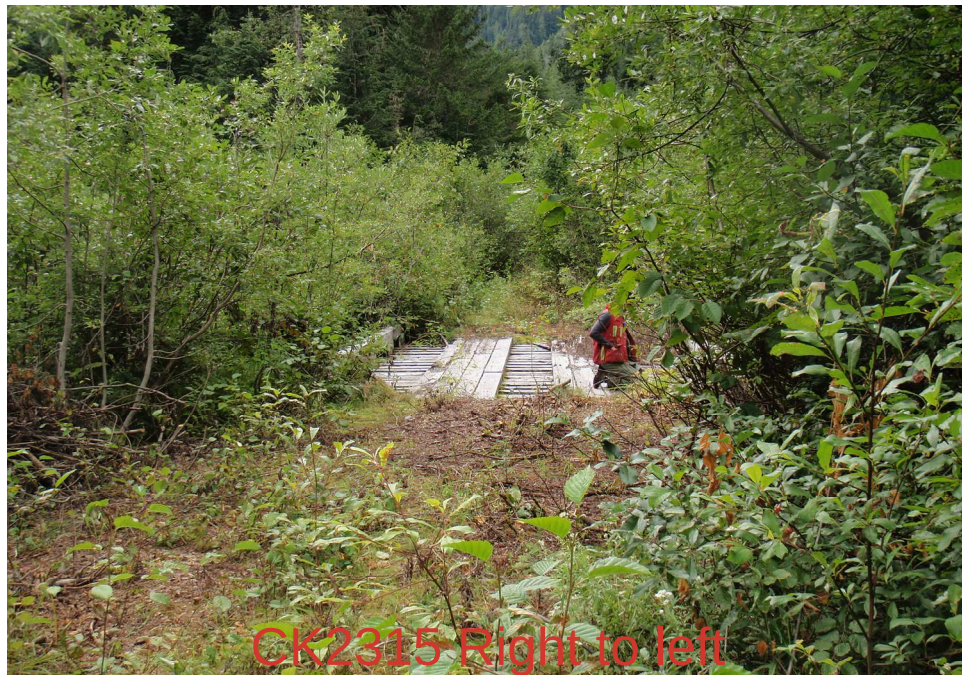
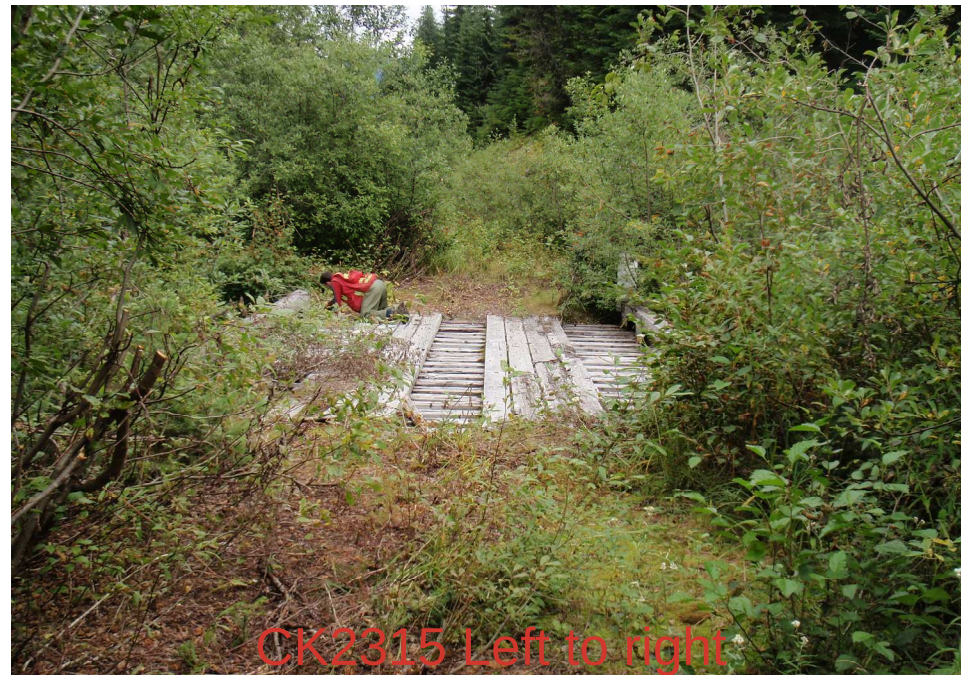
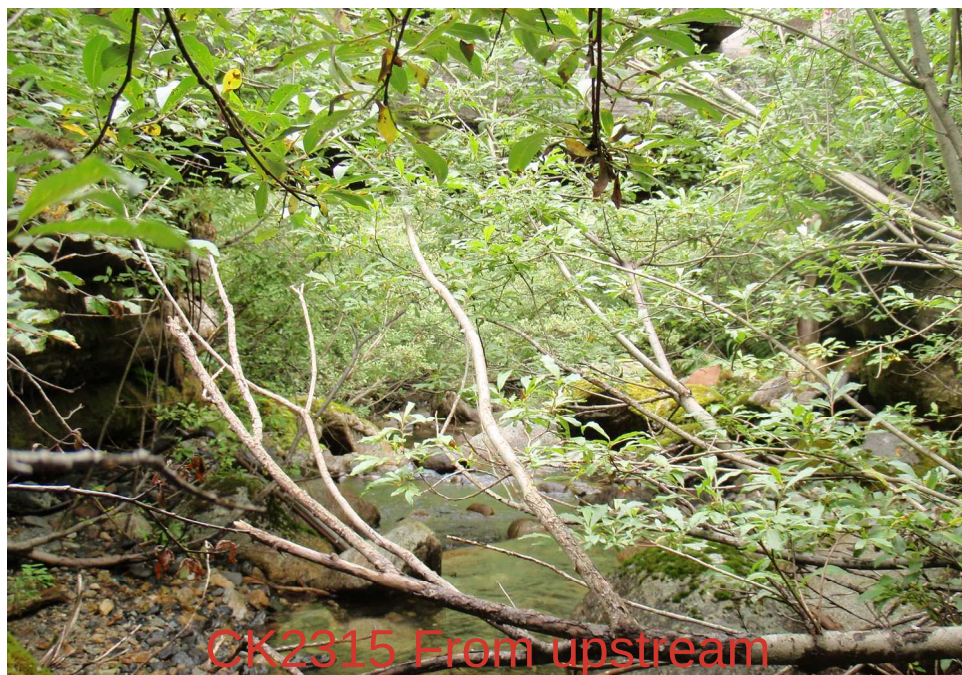
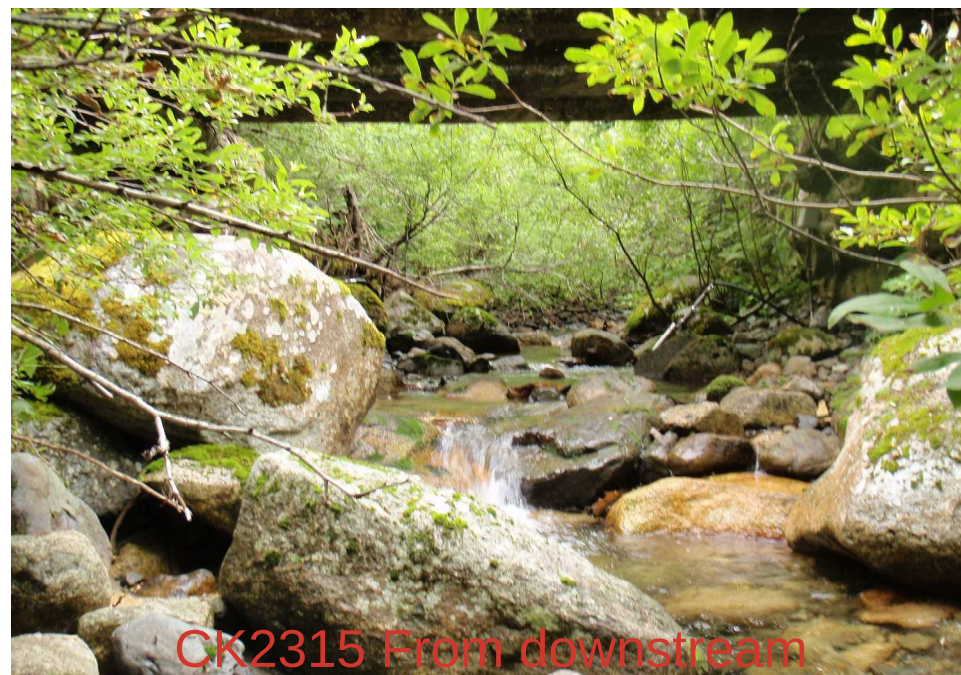
| GENERAL INFORMATION | | | | | | | |
|---|---|---|---|---|---|---|---|
| | Right to Left | | RIGHT ABUT | | | | |
| | Left to Right | | LEFT ABUT | | | | |
| | UPSTREAM | | UNDERWEATH | | | | |
| | DOWNSTREAM | | CONK IN STRINGER #5 | | | | |

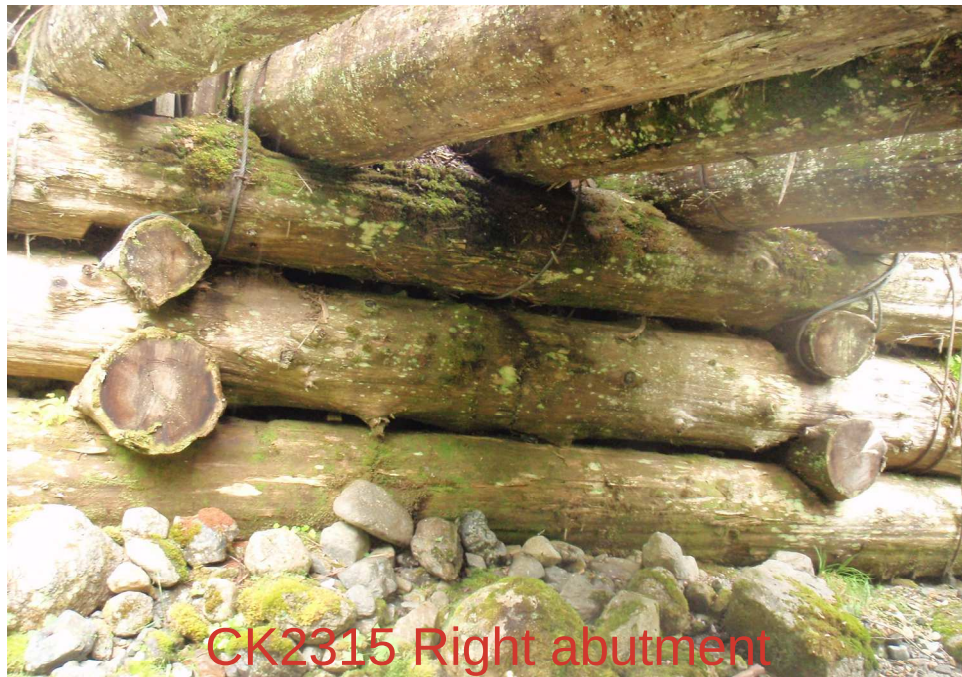
CK2315 Right abutment

| GENERAL INFORMATION | | | | (enter either long/lat or UTM below - not both) | | | |
|---|---|---|---|---|---|--|--|
| Log/Timber Crib | E G <u>P</u> P N/A UR | | 3 high CW closed face - 50mm sep rot. | | | | |
| Riprap | E G F P <u>(N/A)</u> UR | | loft slightly undermined. → No riprap. | | | | |

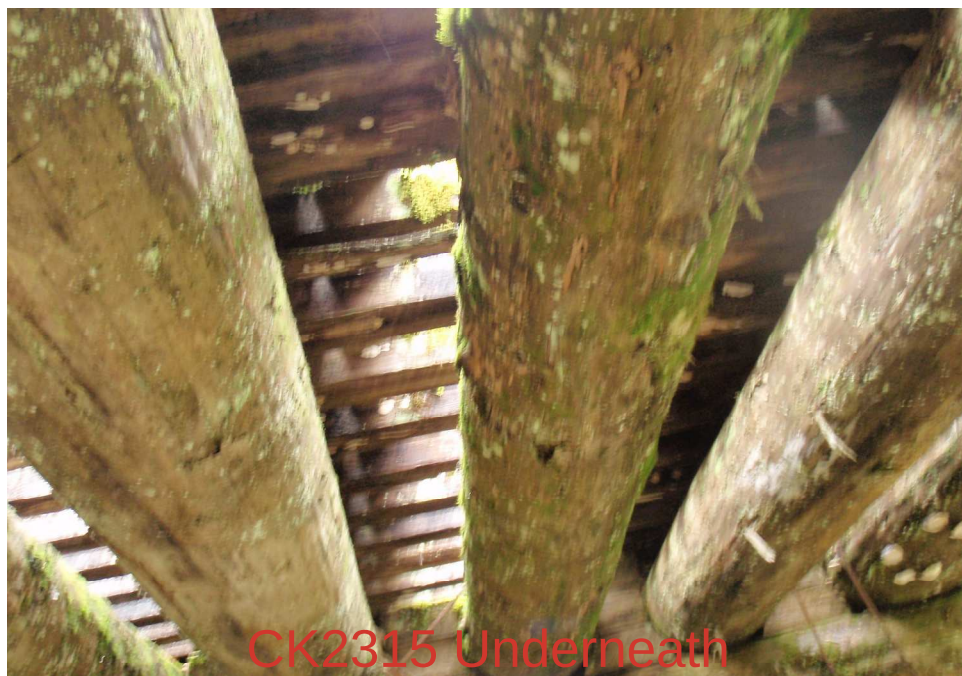
CK2315 Underneath

| GENERAL INFORMATION | | | | (enter either long/lat or UTM below - not both) | | | |
|---|---|---|---|---|---|--|--|
| Sub-deck | E G F P <u>(N/A)</u> UR | | ROTEN CROSS TIES 8" x 8" = LONG CROSS TIES (5.5m) | | | | |
| Ties | E G F <u>P</u> N/A UR | | | | | | |

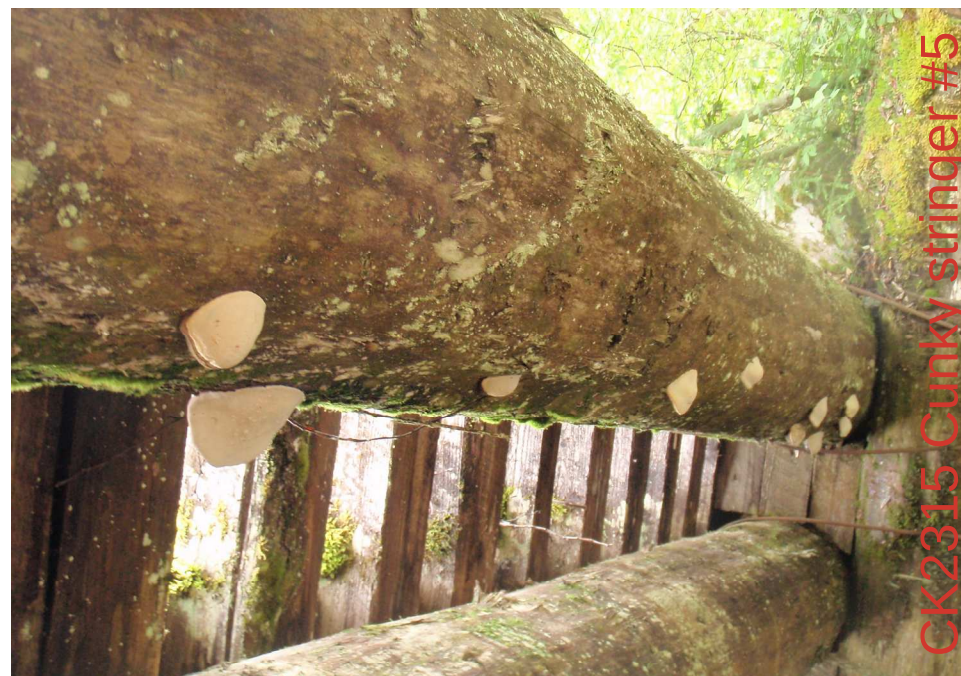
CK2315 Cunky stringer #5

| GENERAL INFORMATION | | | | | | | |
|---|---|---|---|---|---|---|---|
| 5 | V | N | 750 | 750 | | | ROTTEN - VERY CONCERN |
| Inspector's Comments<br>Stringers in fair condition except #5 which is rotten. RUNNING SURFACE IN POOR CONDITION | | | | | | | |

| GENERAL INFORMATION | | | | | | | |
|---|---|---|---|---|---|---|---|
| 1 | H M L | | REPLACE RUNNING SURFACE & REASSESS | | | | |
| 2 | H M L | | STRINGERS PRIOR TO INDUSTRIAL HAULING | | | | |
| P Eng Reviewer's Comments<br>Downrate to 2 tonnes. Please post or barricade bridge. | | | | | | | |
