## Corporate Bridge Register (CBR) Structure Inventory Data Form "BRIDGES"

| *Forest Service Road: HARRISON EAST | Kilometres: 16.8 |

# Routine Condition Bridge Inspection Form (except for log stringer or timber stringer bridges)

| GENERAL INFORMATION | | | | (enter either longlat or UTM below - not both) | | | |
|---|---|---|---|---|---|--|--|
| *Site #: <u>CK-2354</u> | *Crossing Name: | *Type/Class: <input type="checkbox"/> Temporary bridge<br><input checked="" type="checkbox"/> Permanent bridge | *Project File ID# <u>5748</u> | | *Br. <u>01</u> | | |

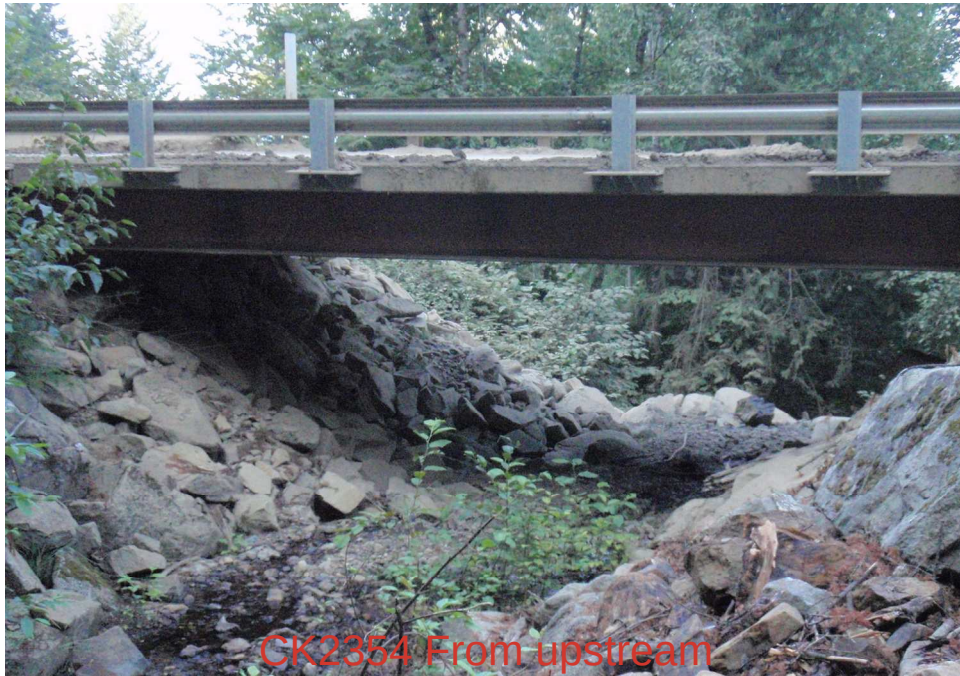
CK2354 From upstream

W/ EACH OTHER,  
THE TWO UPSTREAM  
I-BEAMS WERE INSTALLED  
N 4" HIGHER THAN THE  
TWO I-BEAMS ON THE  
DOWNSTREAM.

IN TERMS OF DSPIN.  
THE ONES INSTALLED  
AT UPSTREAM ARE  
4" SHORTER IN DEPTH

| GENERAL INFORMATION | | | |
|---|---|---|---|
| Girders | E <u>(G)</u> F P UR | 4 X STEEL I-BEAM (TWO SETS OF TWO) | |

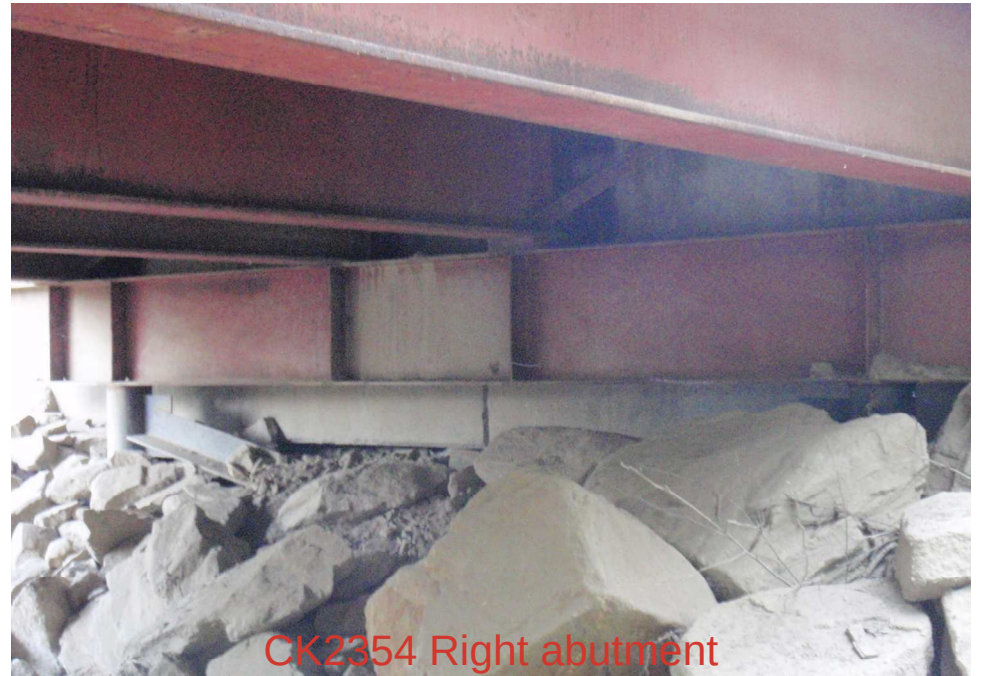
CK2354 Right abutment

| GENERAL INFORMATION | | | | (enter either longlat or UTM below - not both) | | | |
|---|---|---|---|---|---|--|--|
| Caps or Sills | E | <u>G</u> F P N/A UR | STEEL I-BEAM CAPS | | | | |
| Piles or Posts | E | <u>G</u> F P N/A UR | PILE-PIERS | | | | |
| Ballast Wall | E | <u>G</u> F P N/A UR | PRECAST CONCR. | | | | |
