CK-2467

SILVERHOPE 8.4km

2018 Inspection

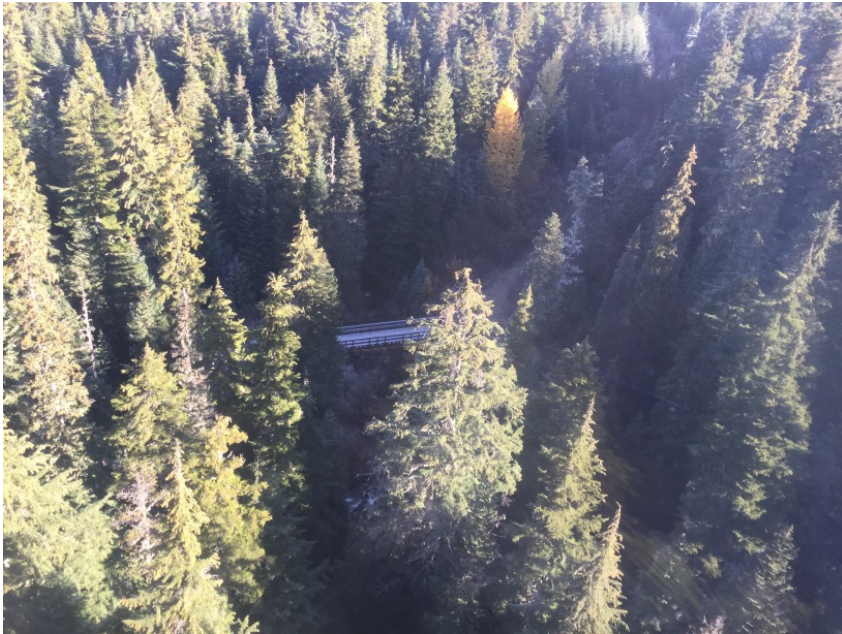
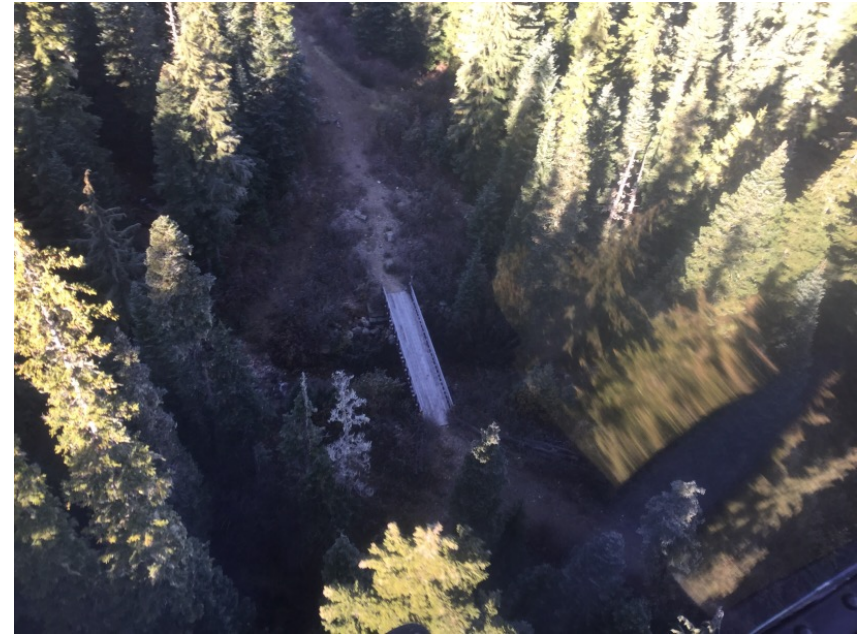
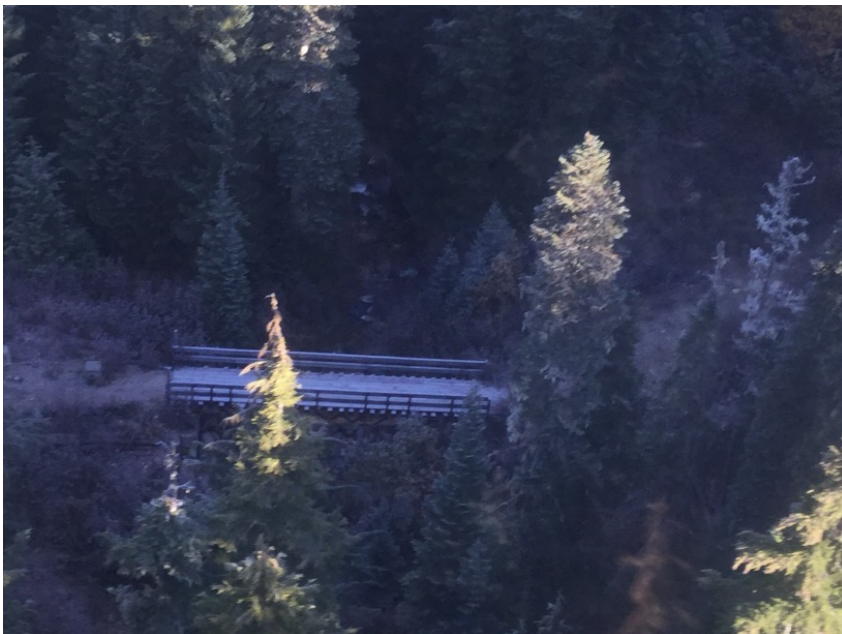
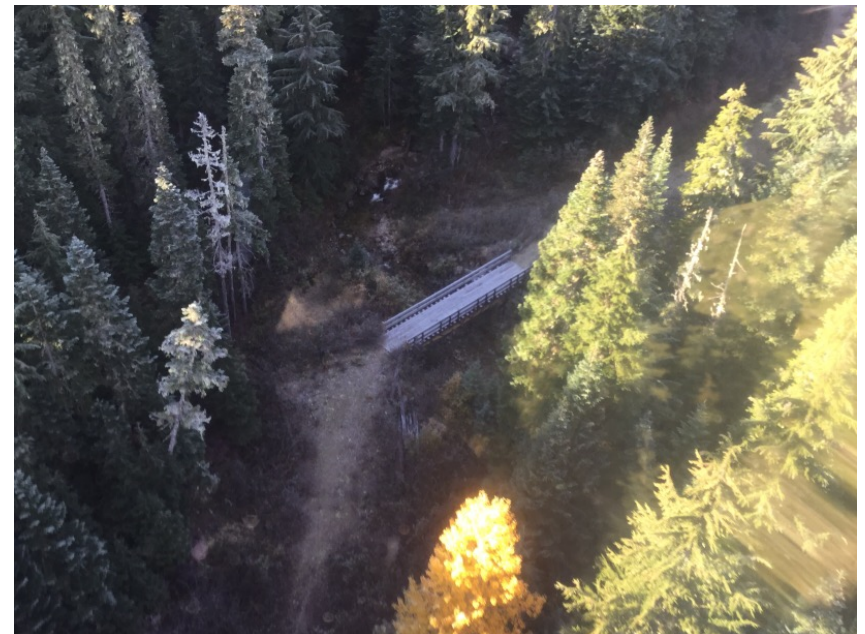
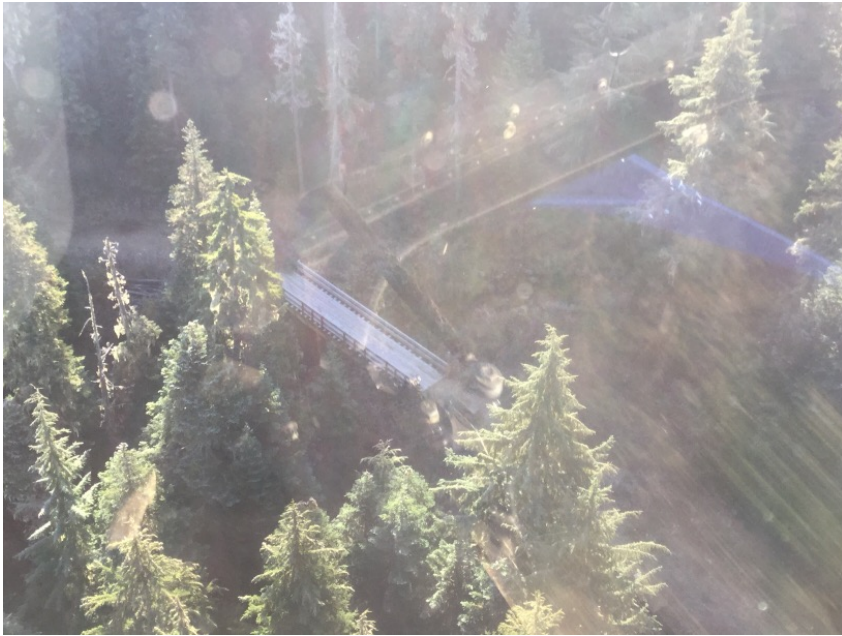
No vehicle access to structure as road is blocked by slide  
 No heli access nearby as road grown over  
 Sub structure and superstructure appear in fair condition  
 Continue with current rating as only pedestrian traffic access

The structure appears in fair condition. As the bridge is only accessible by foot the design load rating of 4.5kN/m2 can continue (pedestrian use only). As the timber components are 11 years old ensure the next inspection includes a complete assessment of the timber components
