# 2012 Nadina District FREP Summary: Riparian

This report summarizes key findings within the Nadina District and provides recommendations to improve on-the-ground resource management practices and decision making.

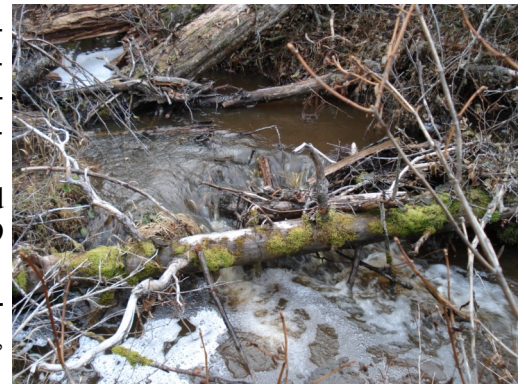
- 79% of RMA vegetation was sufficiently protected from windthrow (ie. windthrow <5%).
- 4% of streams assessed were characterized as “not properly functioning”, and 25% “properly functioning with impact”.

- The “properly functioning” streams had an average of 22.9 m treed RMA, with the “not properly functioning” streams an average of 7.9 m treed RMA (3 streams in sample).

- Place 10 m wide riparian buffers on all S4 streams and perennial S6 streams that deliver water, alluvial sediments, organic materials, nutrients, invertebrates and (or) large woody debris downstream to fish-bearing areas (reduced treed buffer widths contributed to streams not properly functioning, as shown above)
