# STEEL / TIMBER DECK

**ALLNORTH CONSULTANTS LIMITED**  
 301-1777 THIRD AVE. PRINCE GEORGE B.C. PH. 562-7291  
 FOREST SERVICE ROAD CHELASELIE F.S.R.  
 CROSSING CHELASELIE RIVER  
 DISTRICT LAKES

km 18  
 SPAN 28.9m  
 JOB# 99-C-188

DATE INSPECTED: 03/06/99

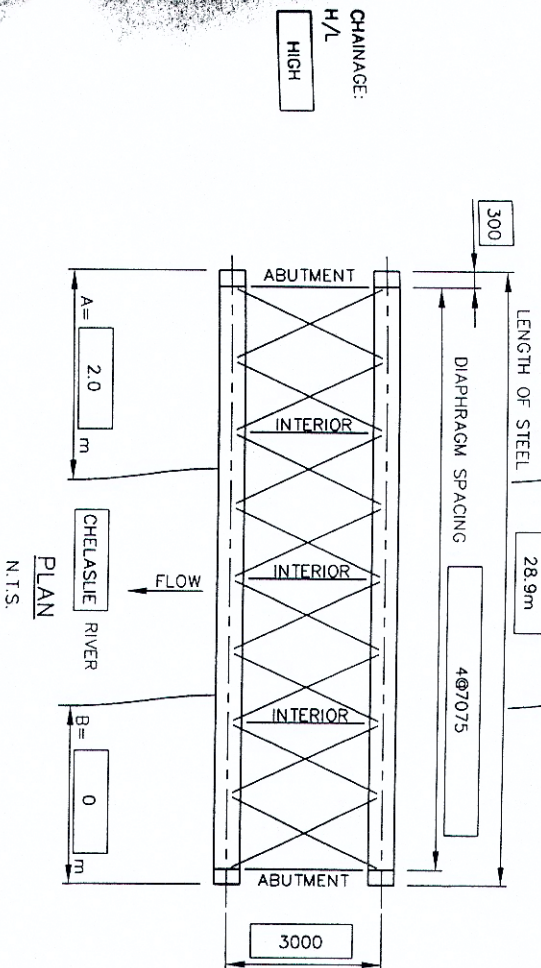
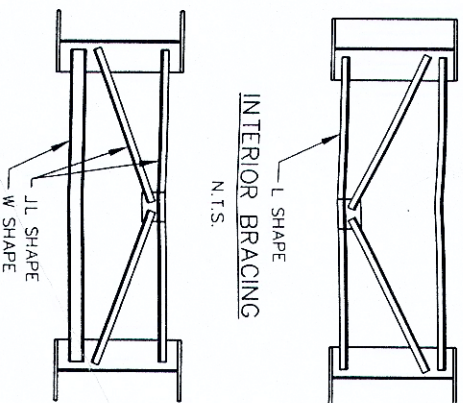
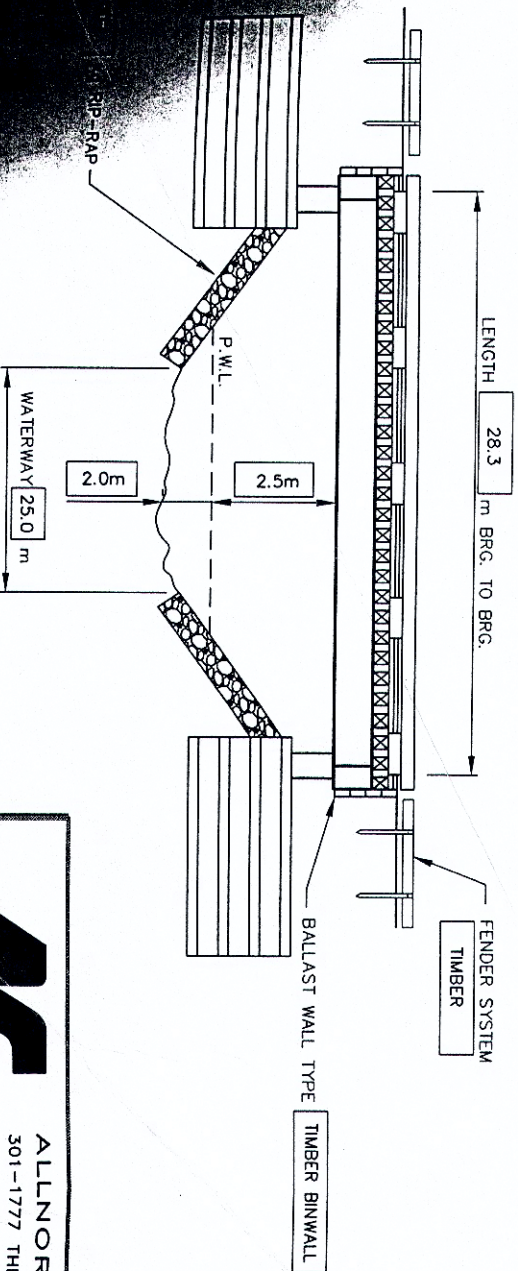
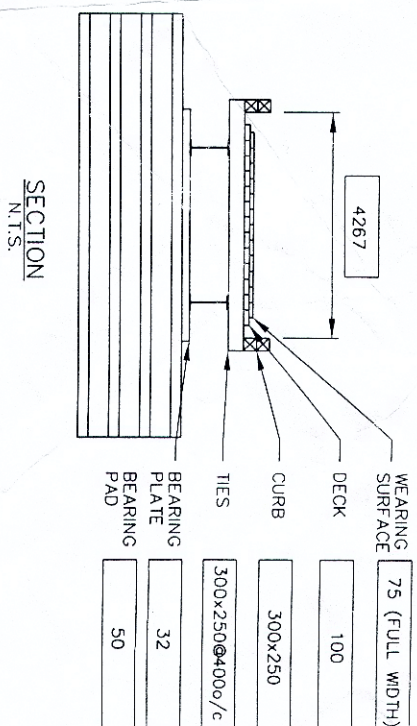
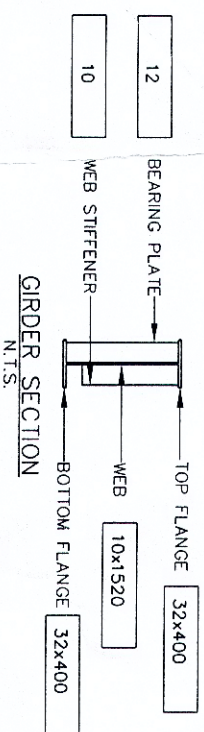
ALL BRACING APPEARS TO BE GALVANIZED

- TREATED TIMBER BINWALL FOUNDATION IN GOOD CONDITION
- TREATED TIMBER BINWALL BALLAST WALL IN GOOD CONDITION
