BC Ministry of  
Forests and Range

## Corporate Bridge Register (CBR) Structure Inventory Data Form "BRIDGES"

| *Structure # | *Site #: CK-2177 |
| *Forest Service Road: Lost-South | Kilometres: 4.9 |

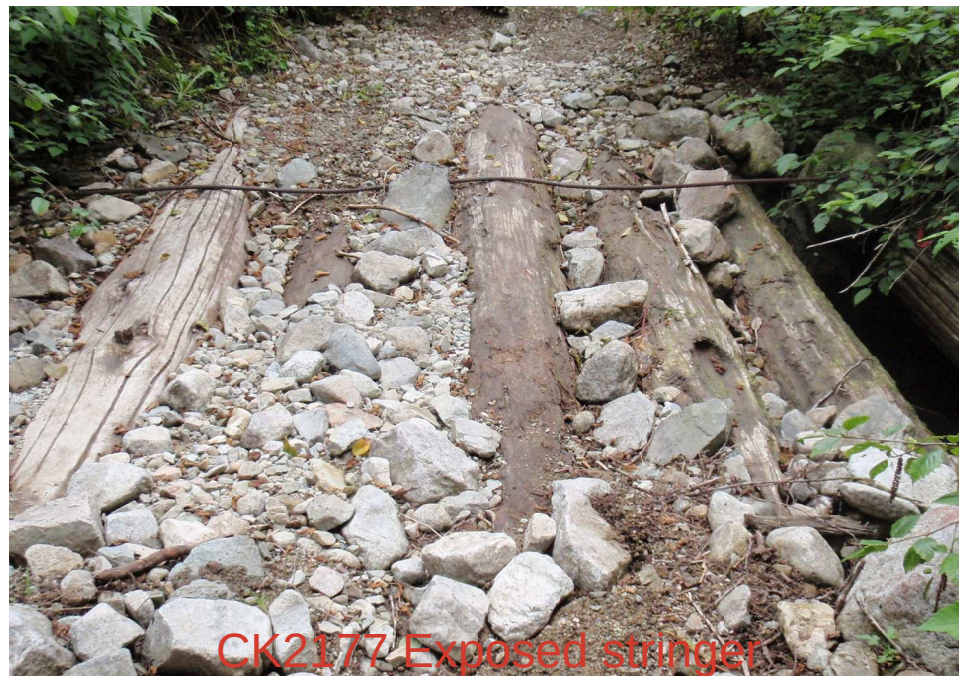
CK2177 Exposed stringer

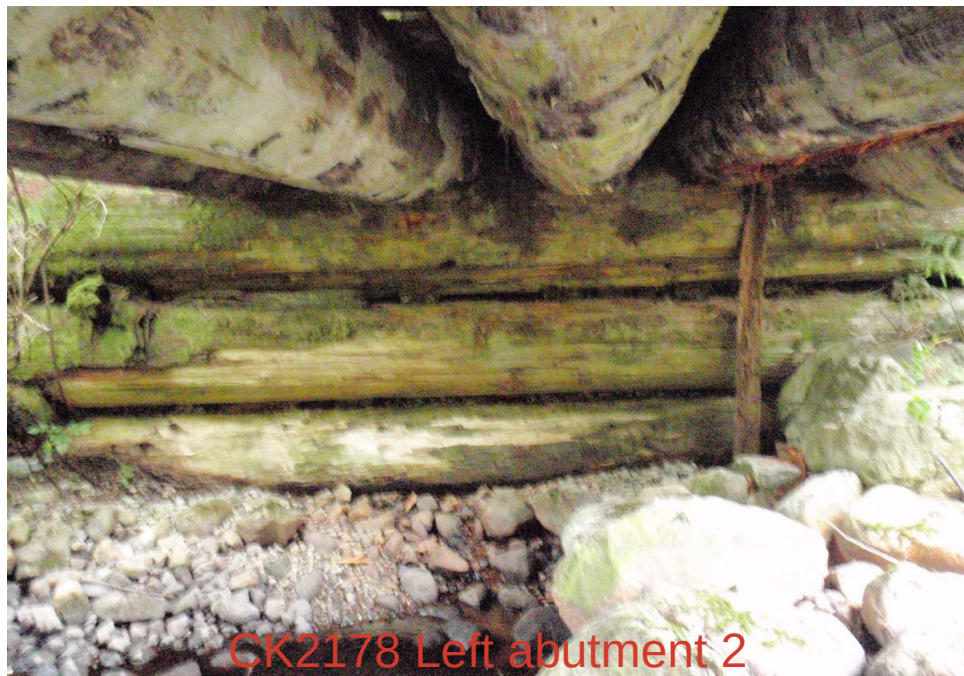
CK2178 Left abutment 2

| Item | Present Condition (circle) | Comments (a comment is mandatory if condition "Poor" is selected) |
|---|---|---|
| Log/Timber Cribbs | E G (F) P N/A | ALTHOUGH OLD & SOME OF CRIB LOGS (POWEN), NO SIGNS OF FAILURE. 3x CRIB |

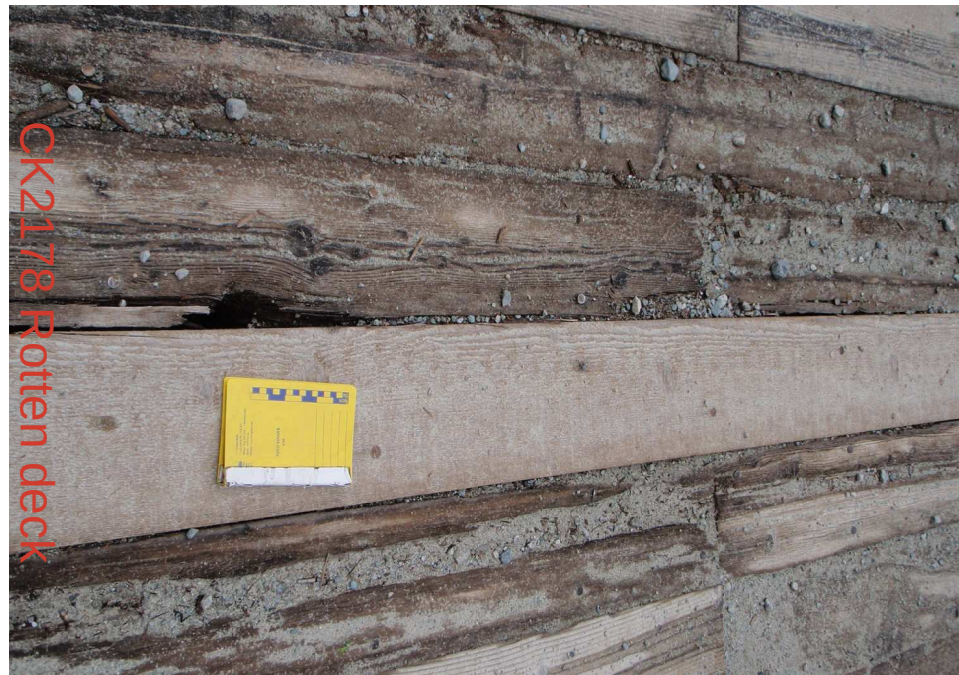
| Item | Present Condition (circle) | Comments (a comment is mandatory if condition "Poor" is selected) |
|---|---|---|
| Overall Deck Condition | E G F (P) | DUE TO ROTTEN CROSS TIES. |

CK2178 Rotten deck

| GENERAL INFORMATION | | | |
|---|---|---|---|
| Comments <b>Downrate to 5 tonnes. Please post. Recommend planning to replace deck.</b> | | | |

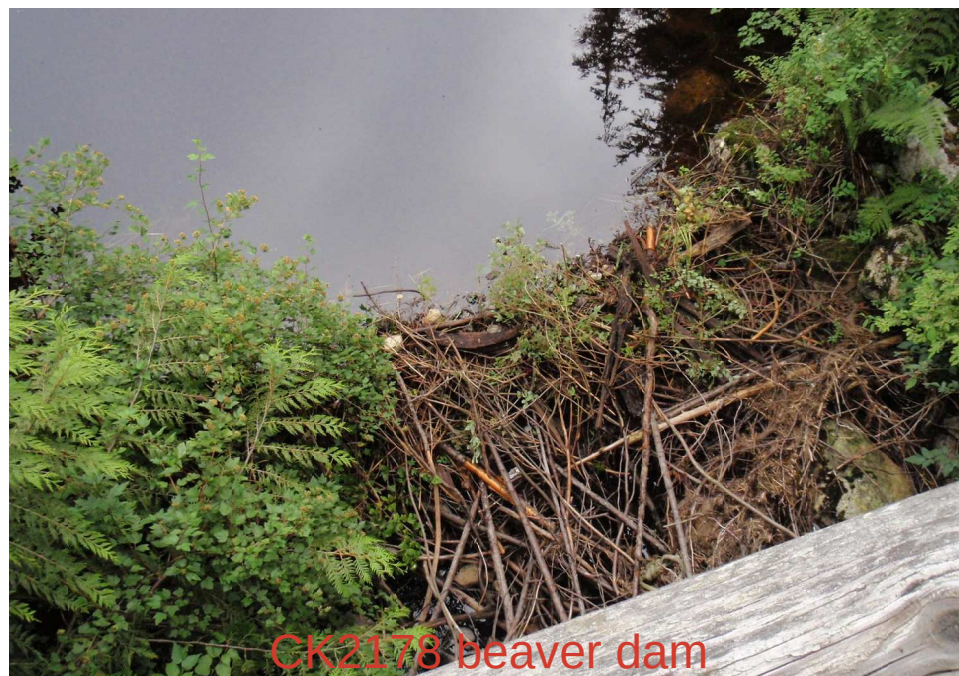
CK2178 beaver dam

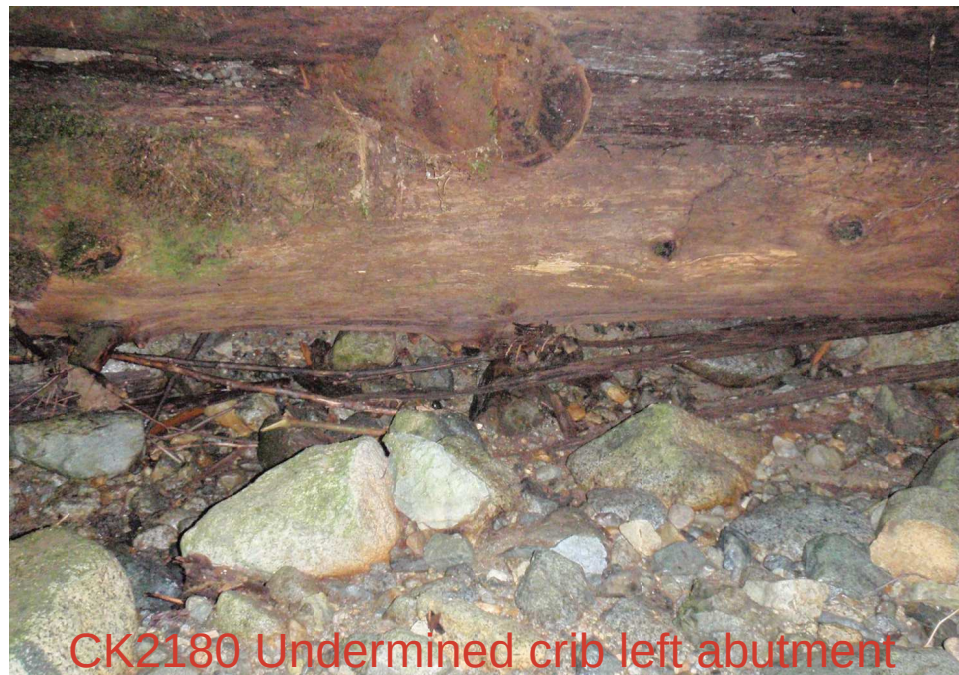
CK2180 Undermined crib left abutment

| GENERAL INFORMATION | | | | | | | |
|---|---|---|---|---|---|---|---|
| Comments <b>Close bridge by barricades or remove bridge.</b> | | | | | | | |

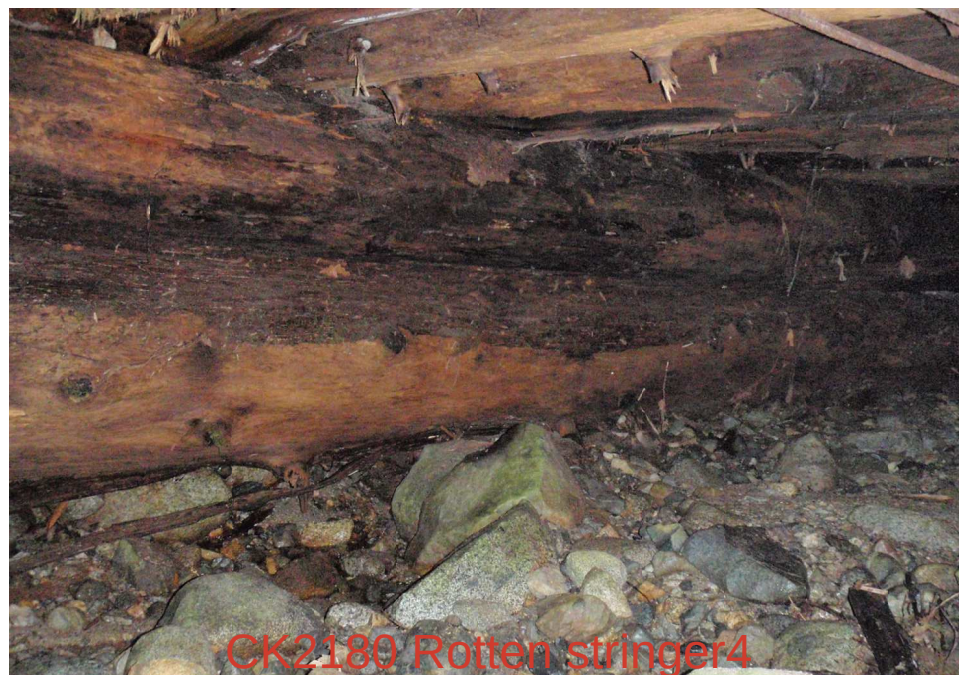
LOG STRINGERS IN A VERY POOR CONDITION. CRIB IS ALSO ROTTEN

CK2180 Rotten stringer4

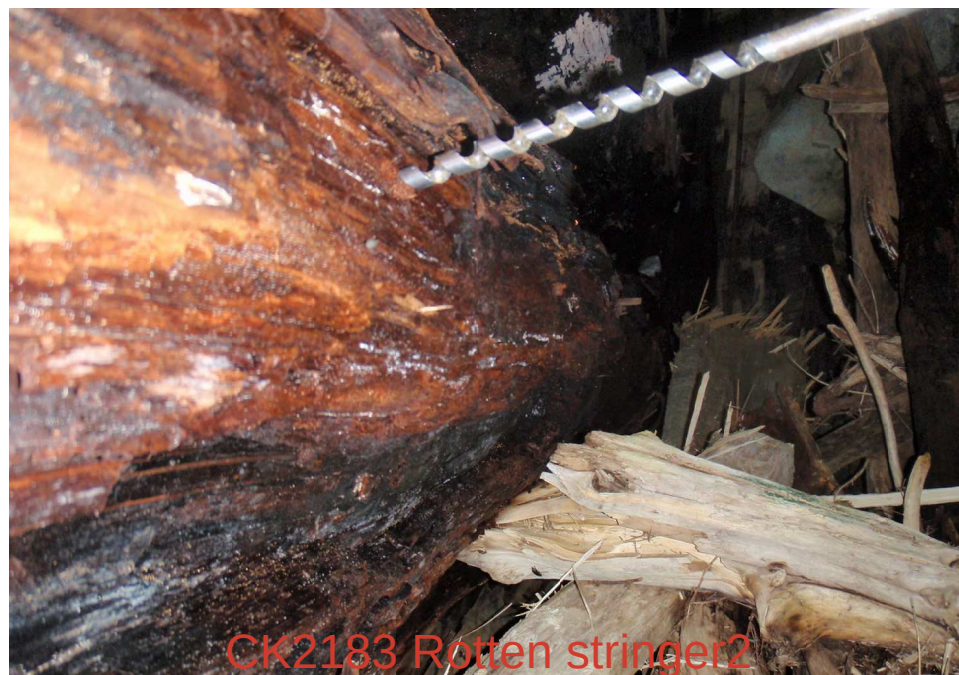
CK2183 Rotten stringer2

| GENERAL INFORMATION | | | | | | | |
|---|---|---|---|---|---|---|---|
| Comments <u>Close bridge by barricades or remove bridge.</u> | | | | | | | |

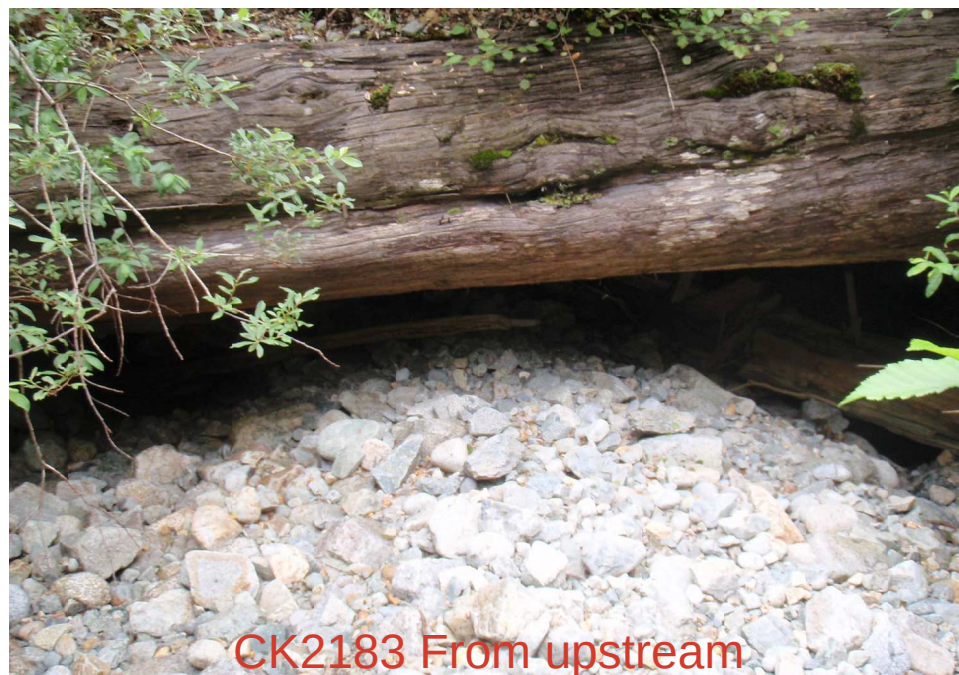
CK2183 From upstream

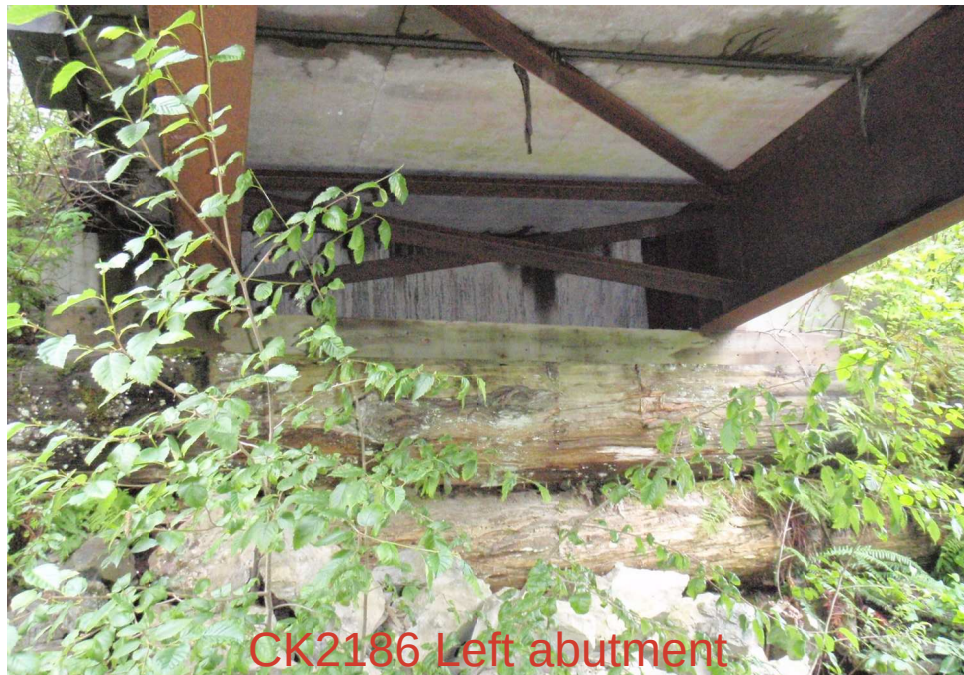
CK2186 Left abutment

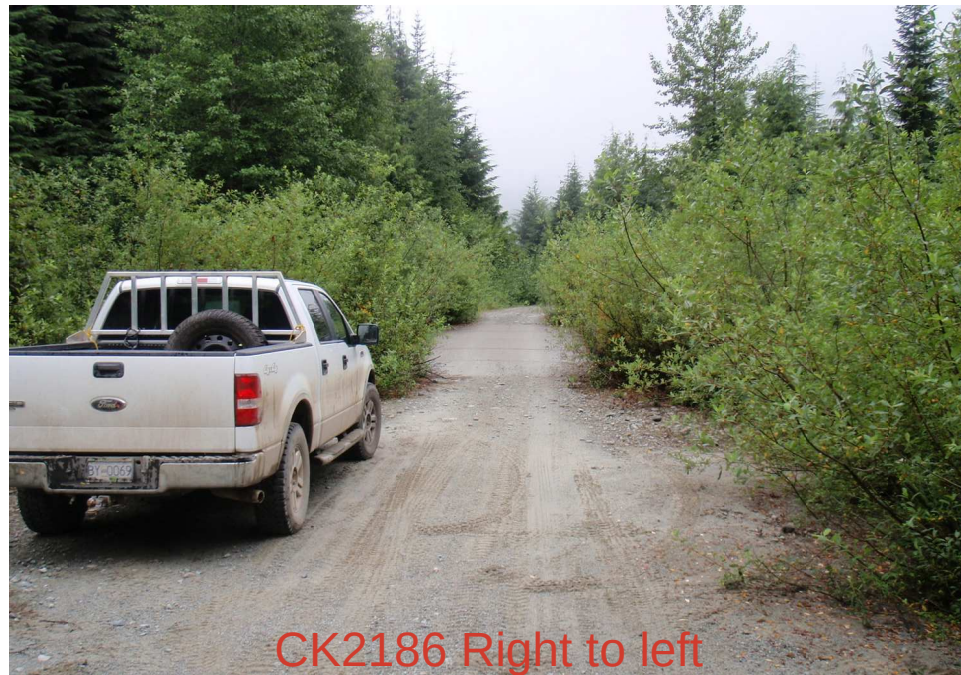
CK2186 Right to left

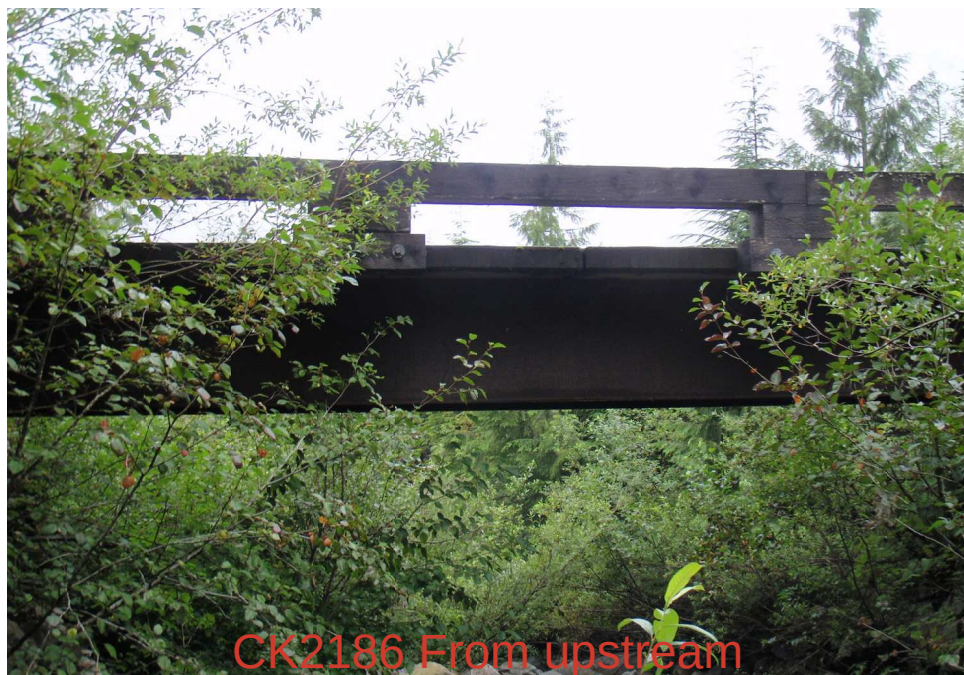
CK2186 From upstream

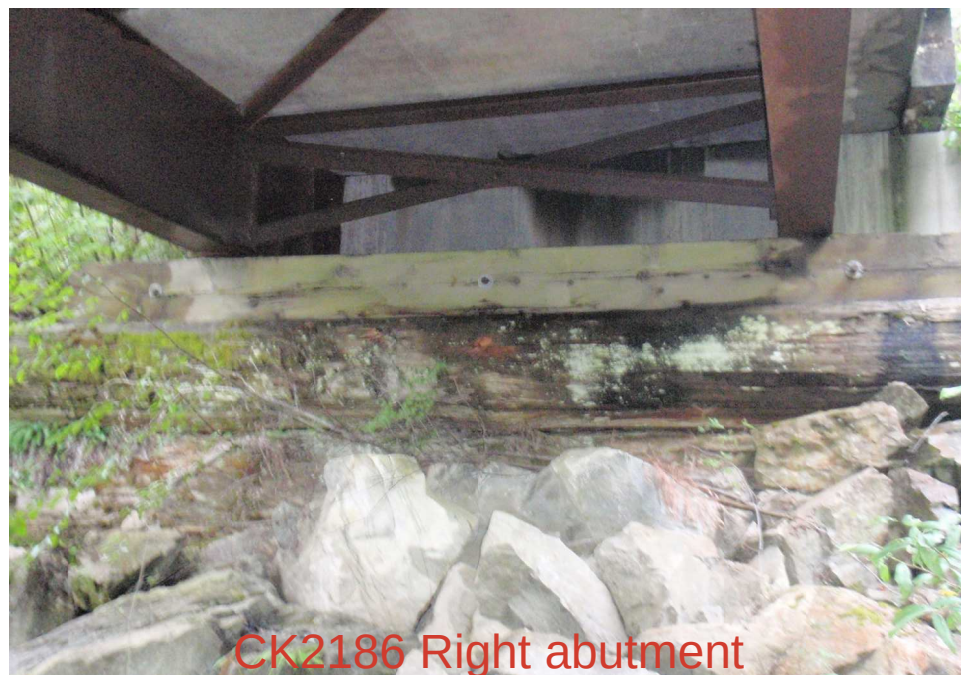
CK2186 Right abutment

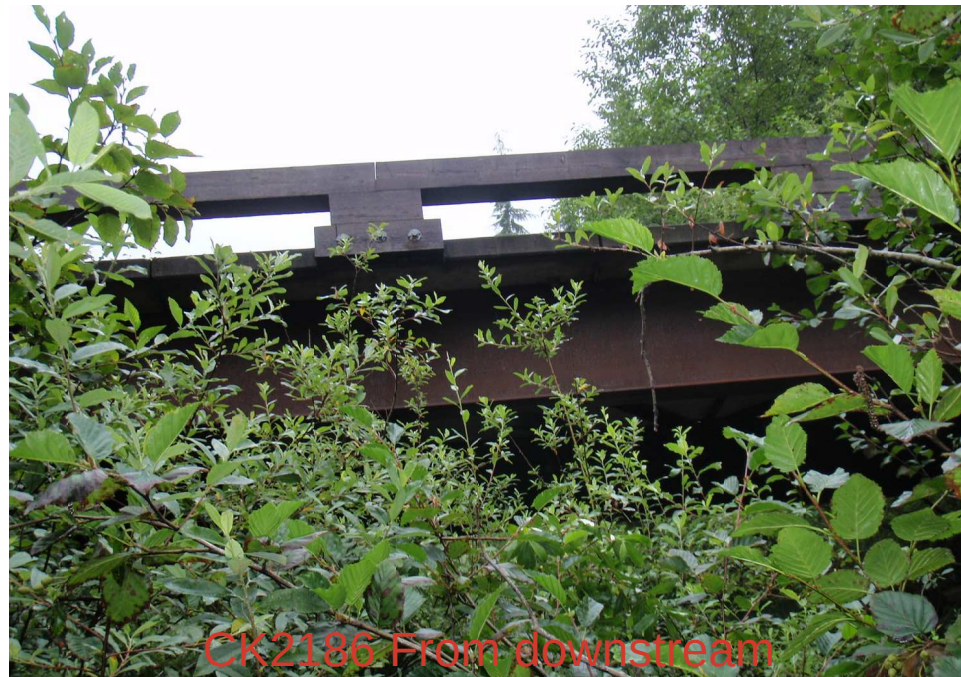
CK2186 From downstream

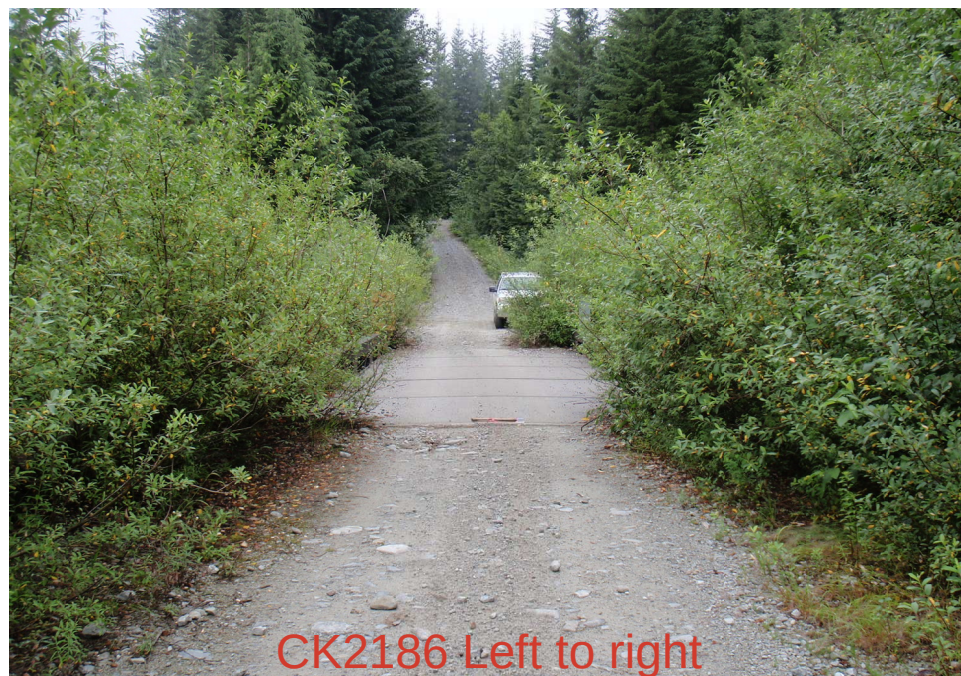
CK2186 Left to right

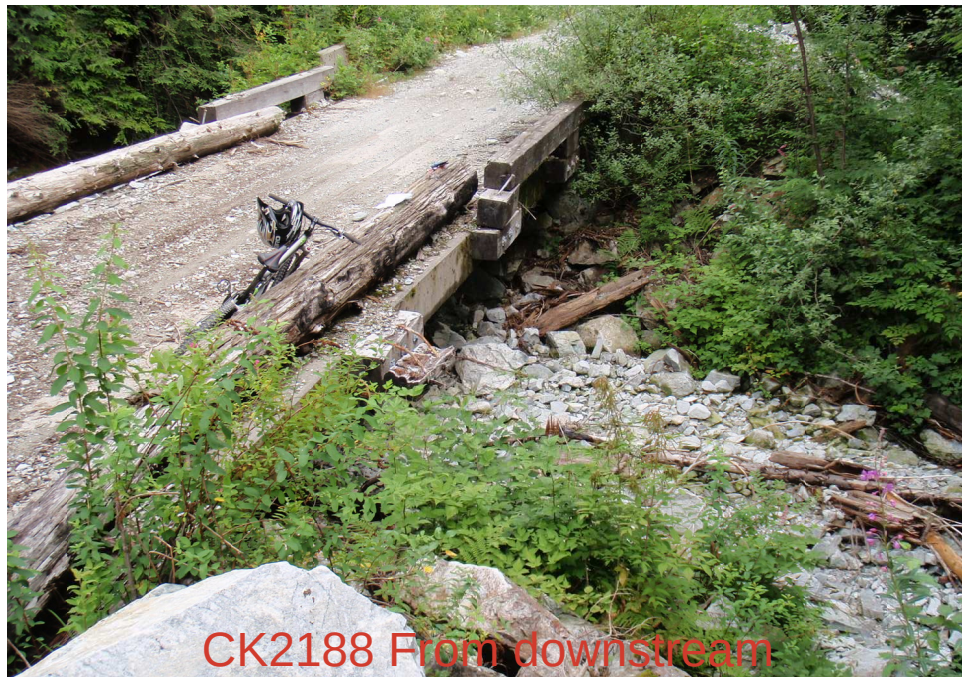
CK2188 From downstream

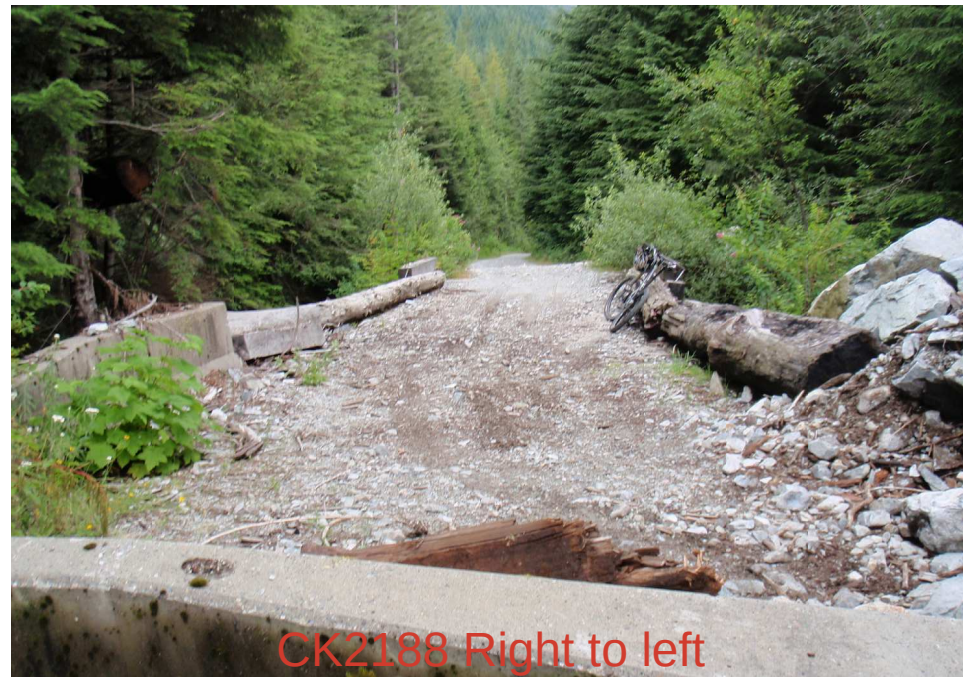
CK2188 Right to left

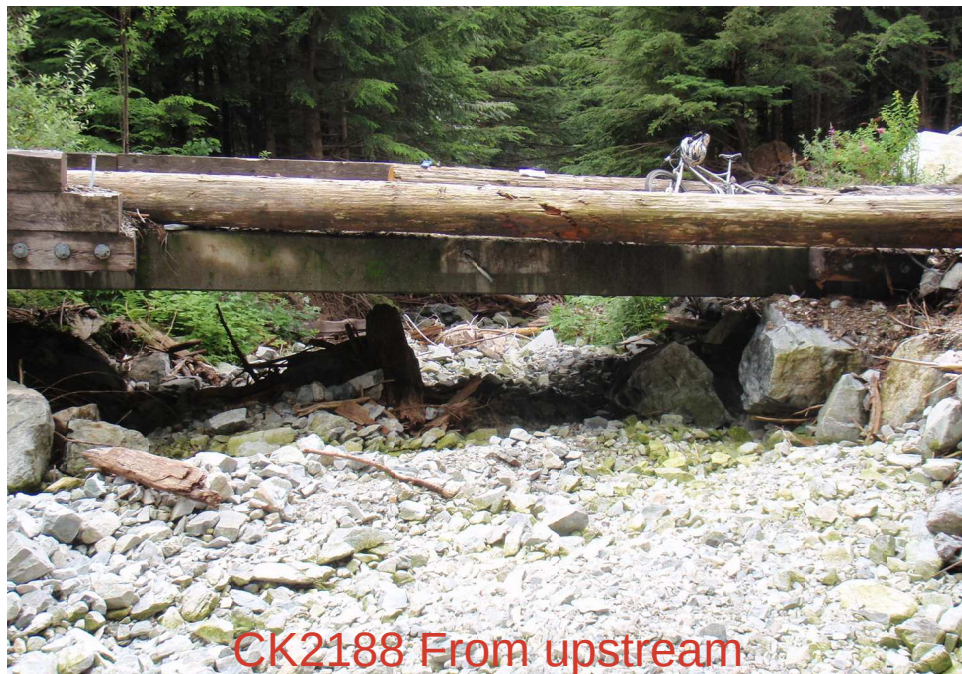
CK2188 From upstream

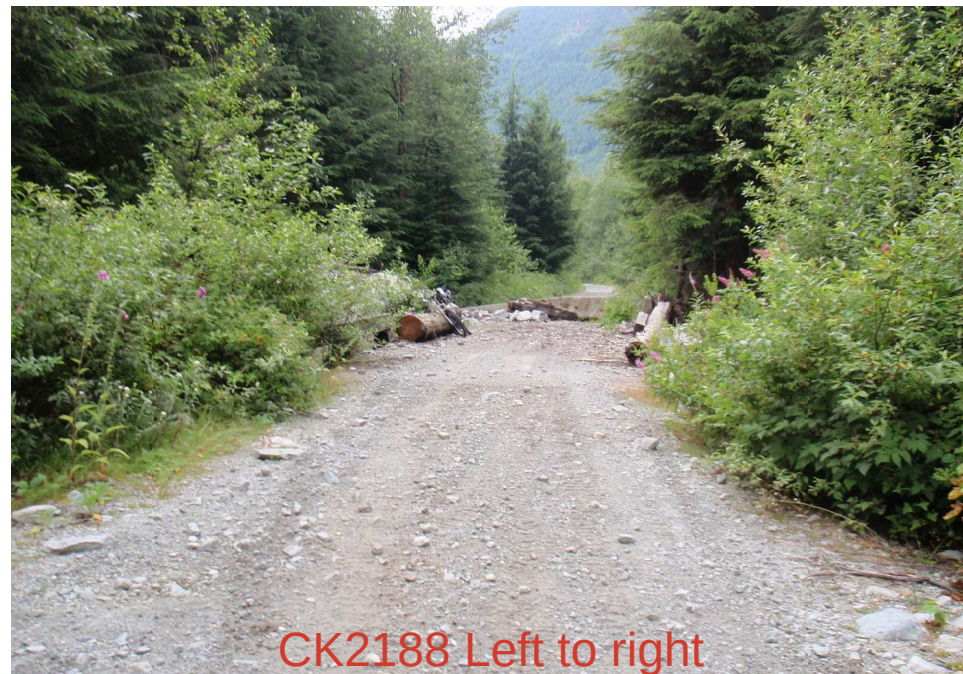
CK2188 Left to right

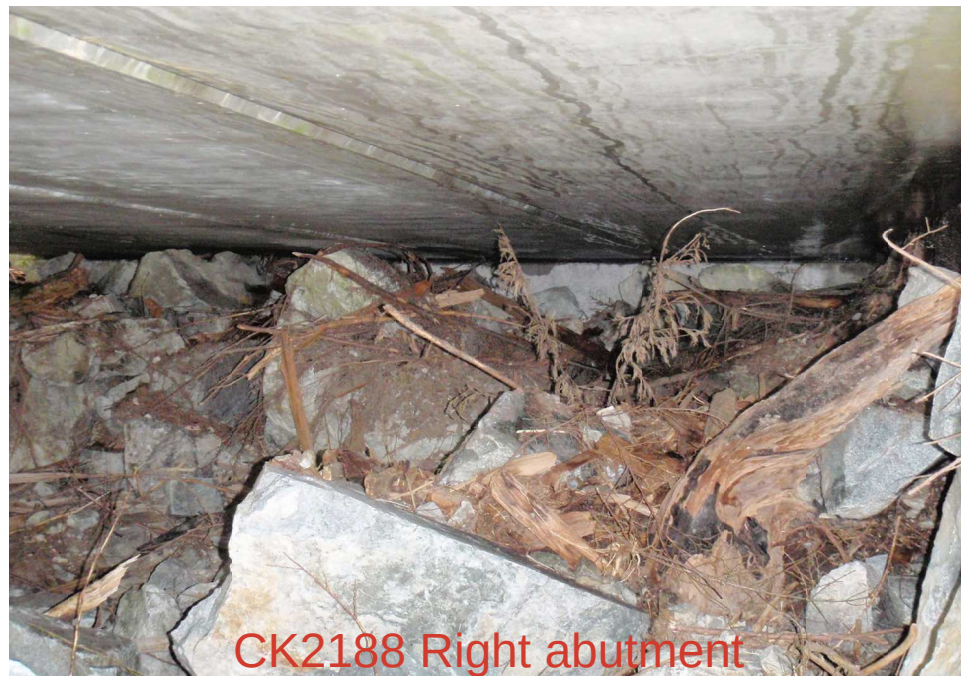
CK2188 Right abutment

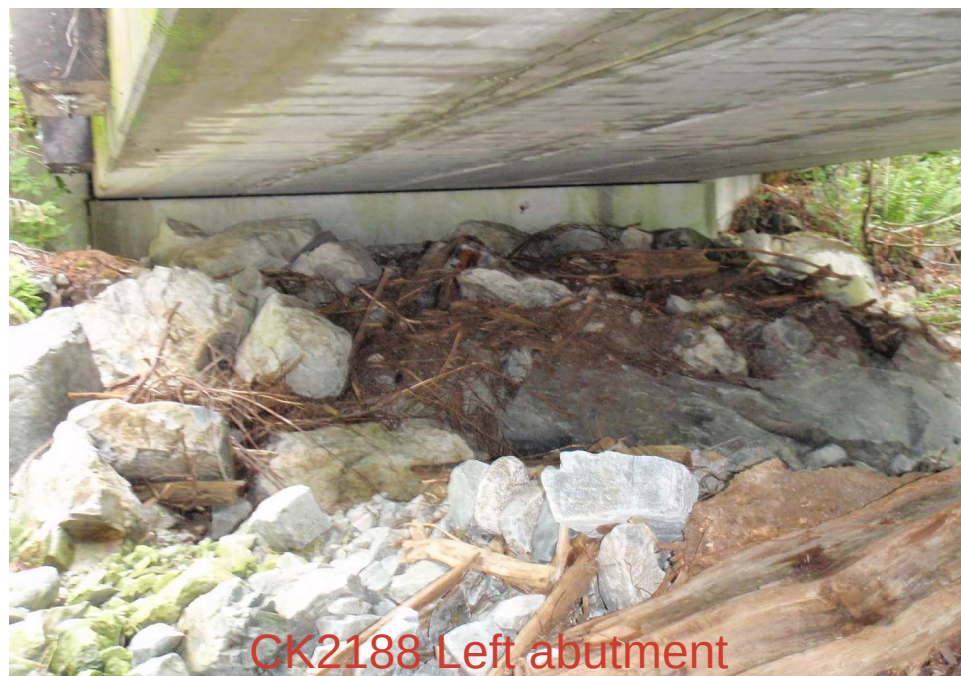
CK2188 Left abutment

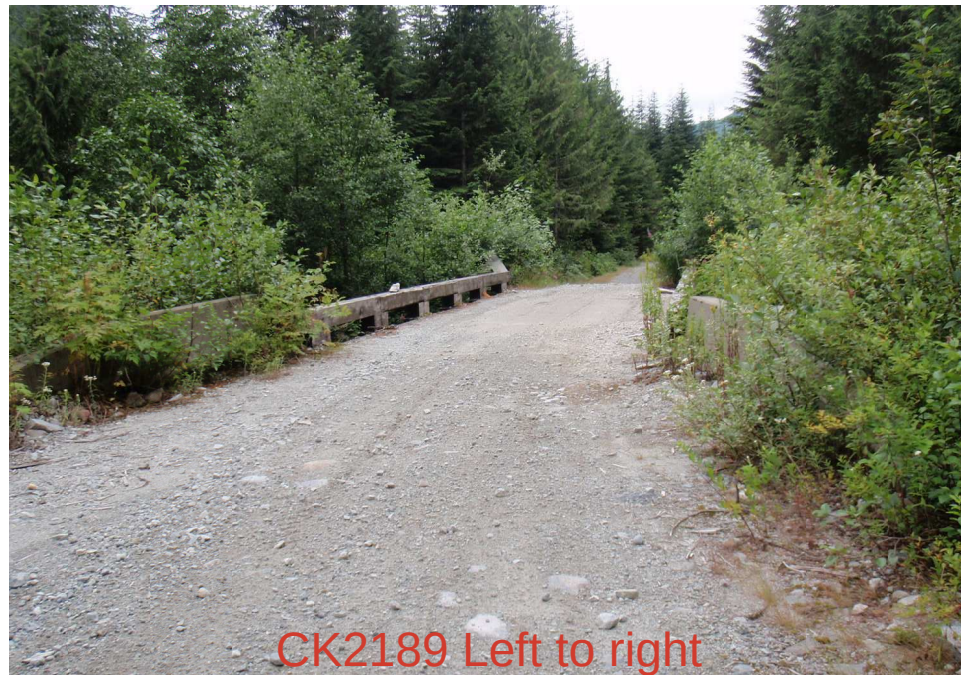
CK2189 Left to right

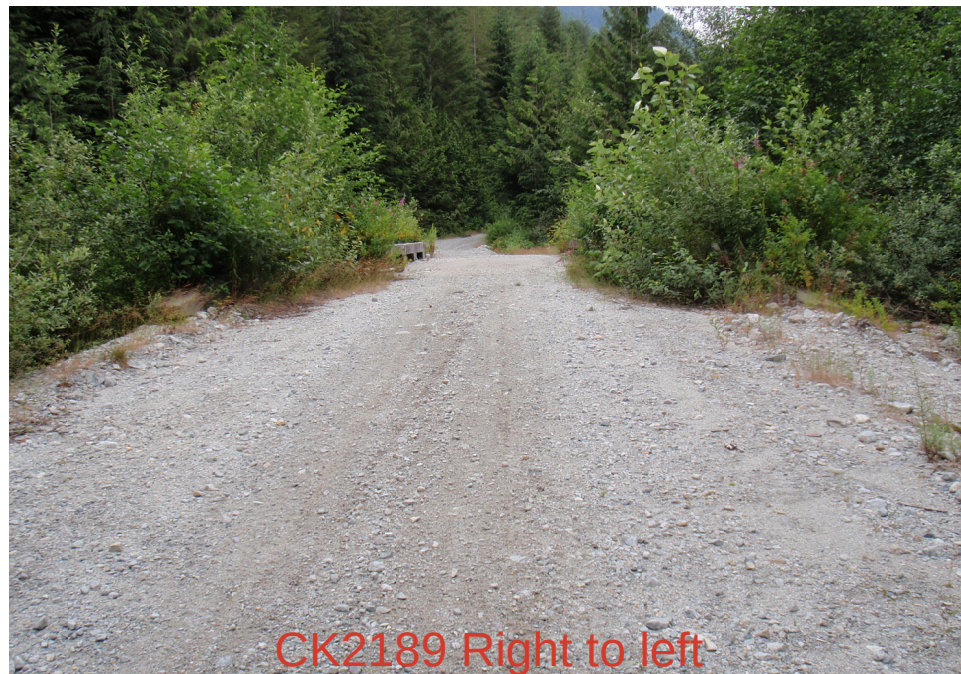
CK2189 Right to left

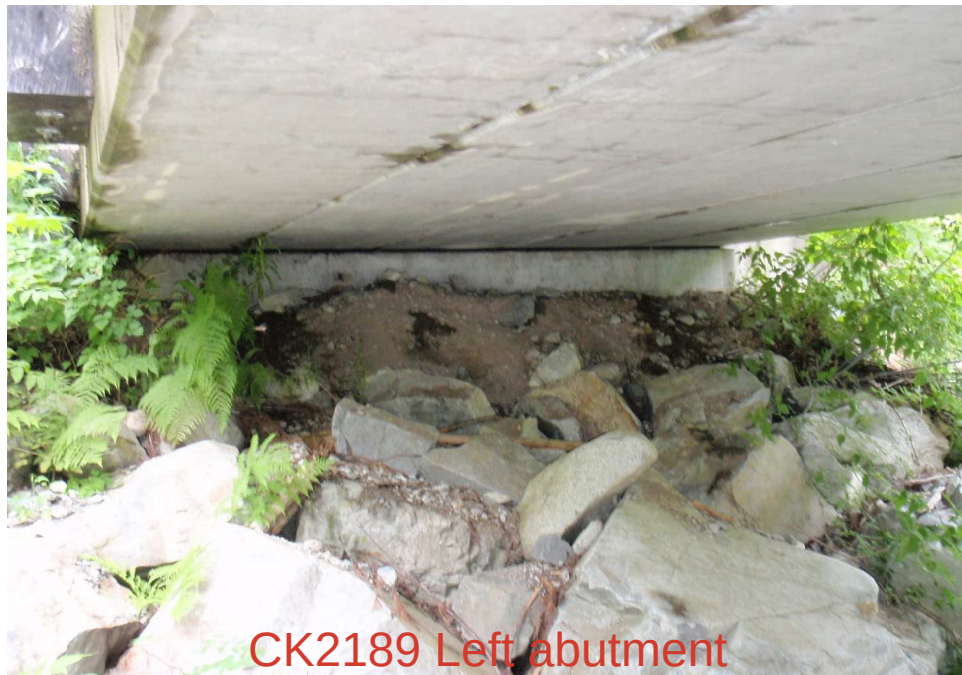
CK2189 Left abutment

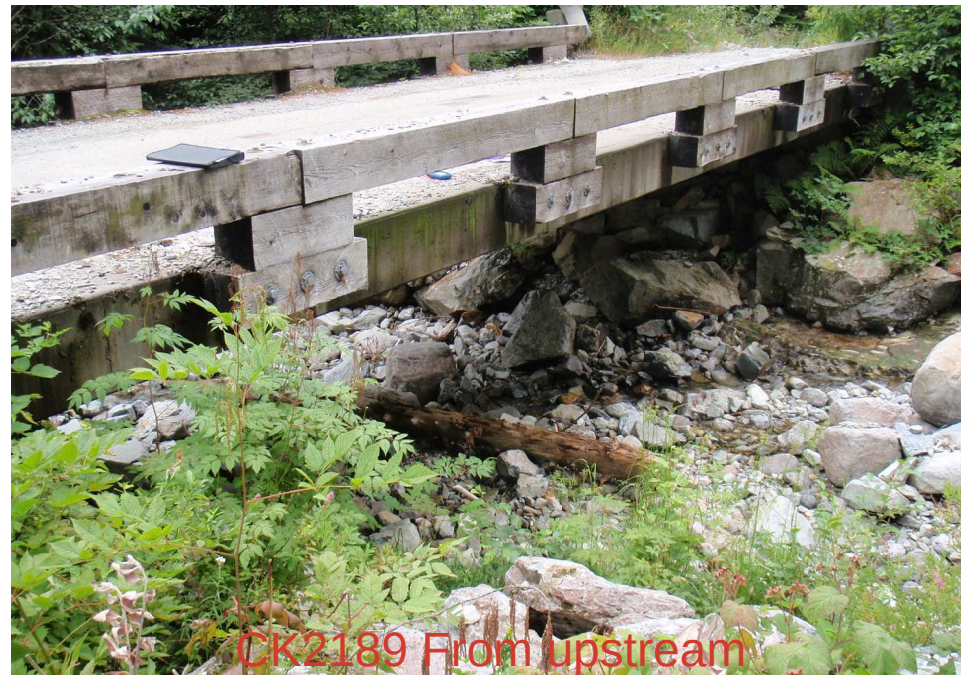
CK2189 From upstream

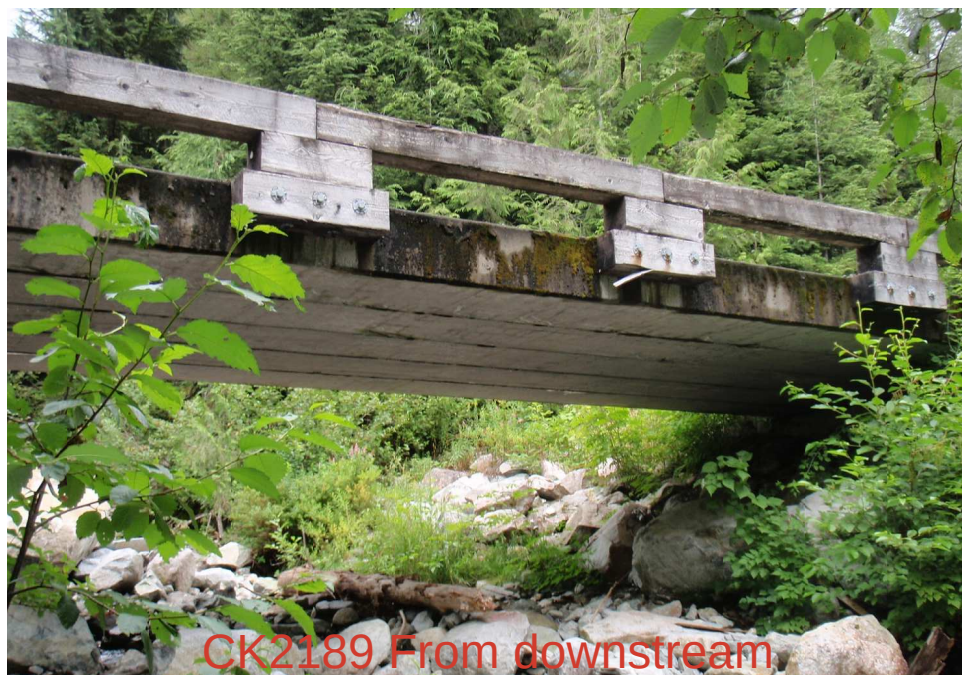
CK2189 From downstream

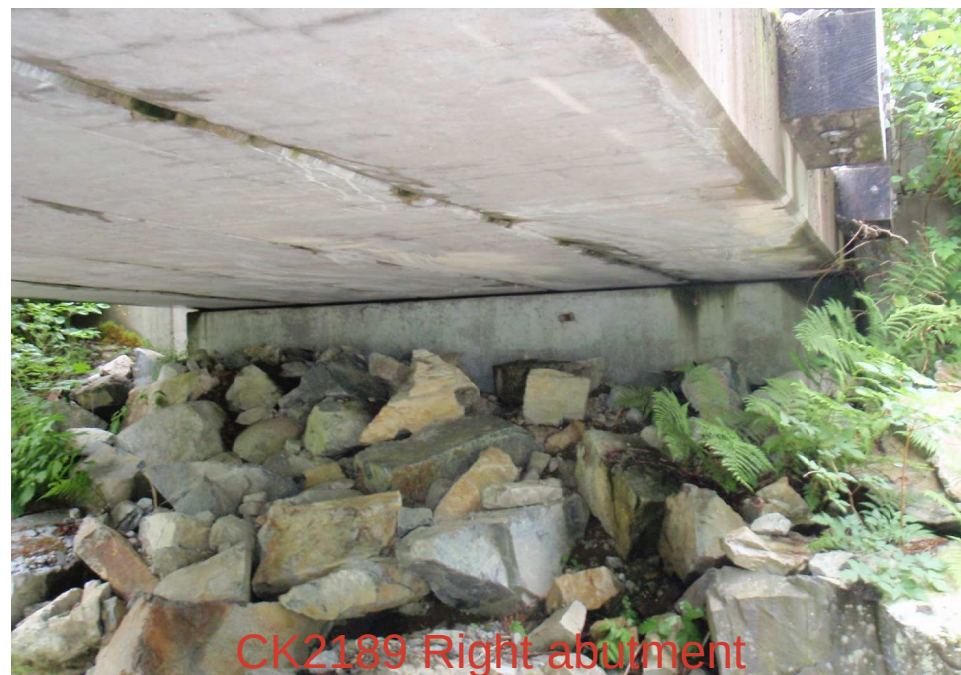
CK2189 Right abutment

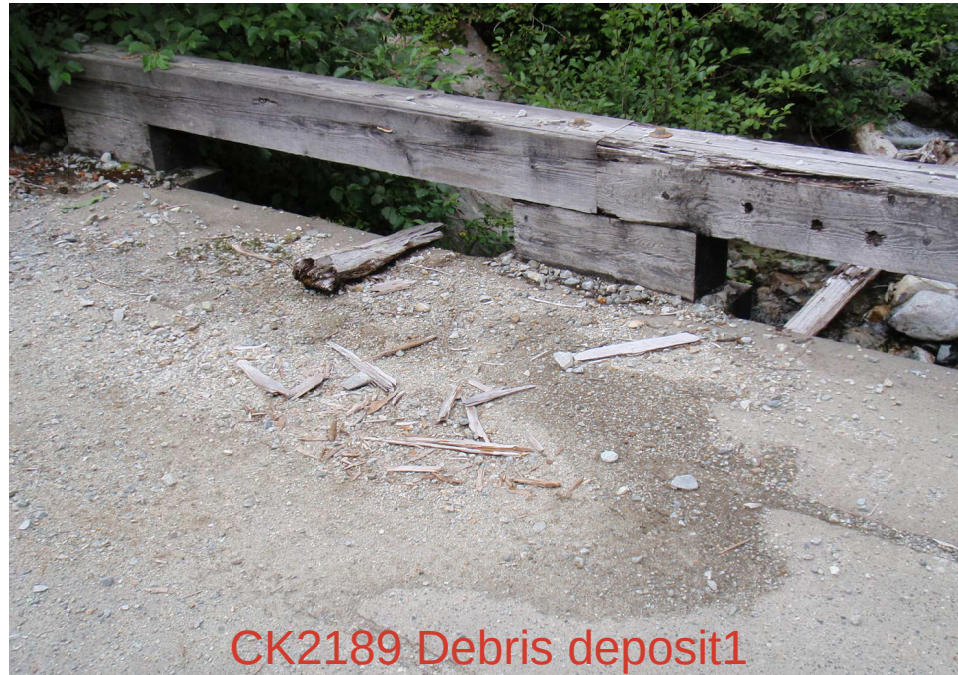
CK2189 Debris deposit1

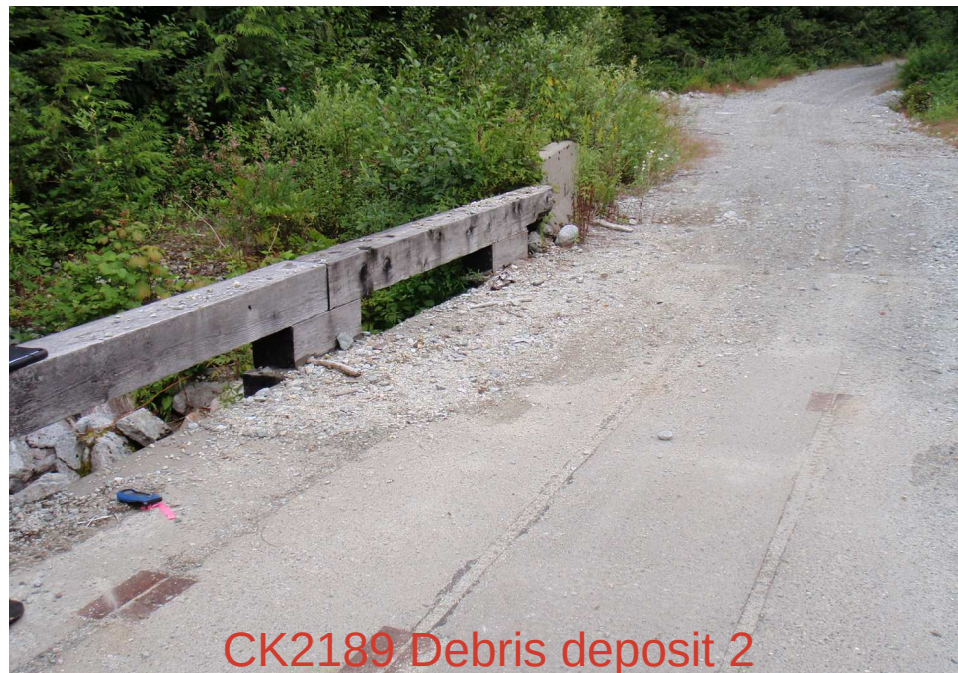
CK2189 Debris deposit 2

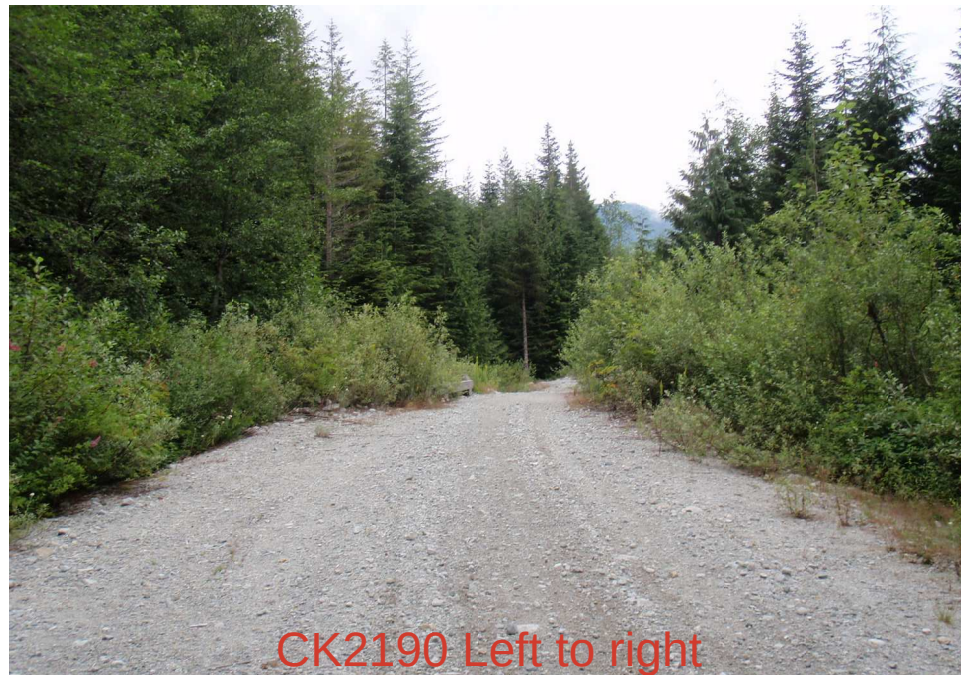
CK2190 Left to right

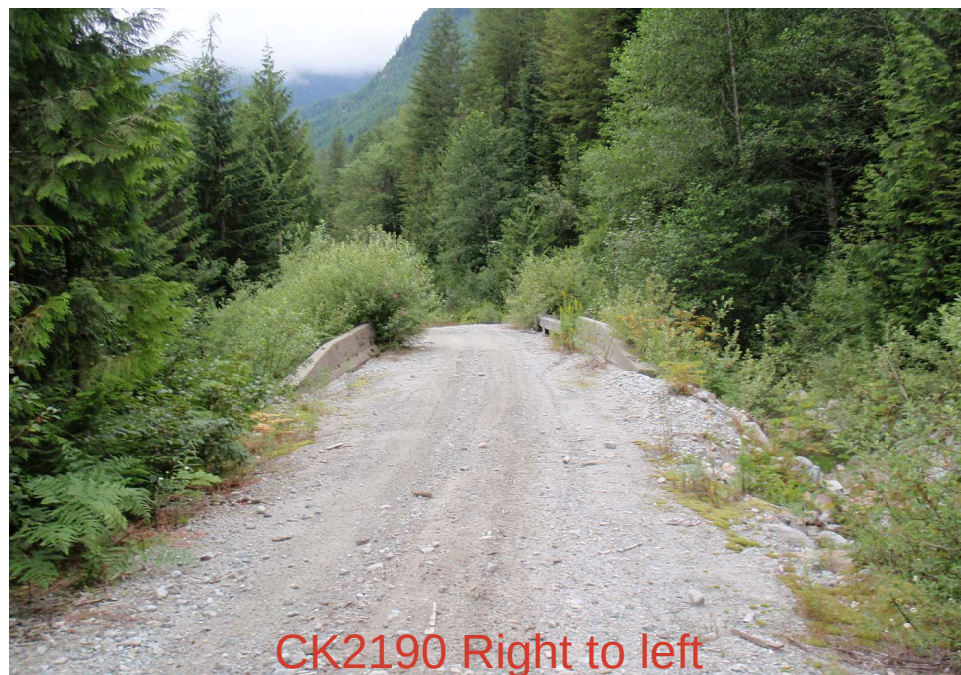
CK2190 Right to left

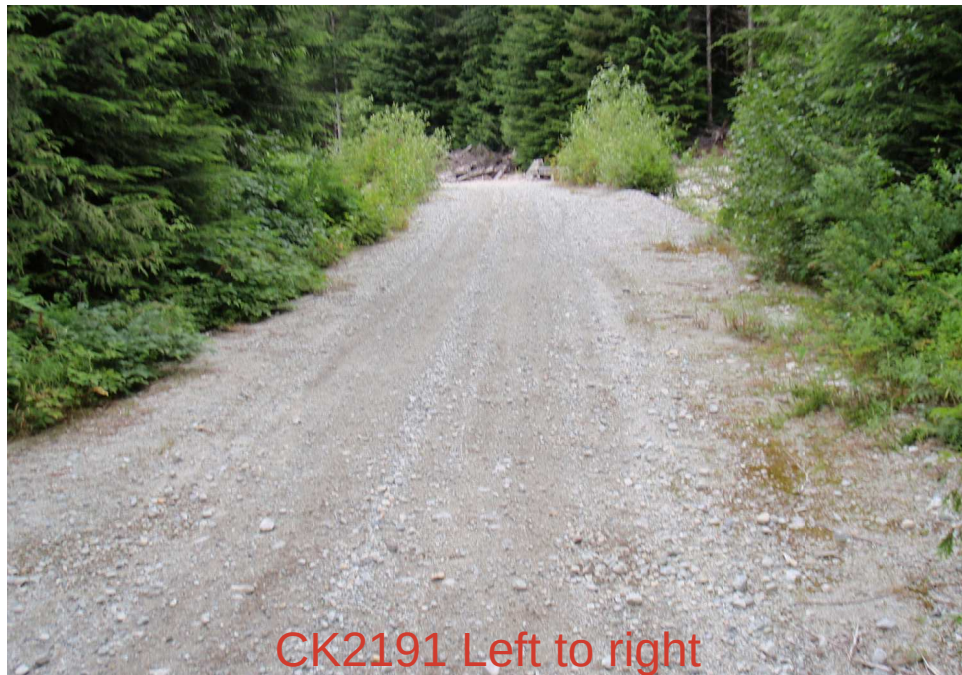
CK2191 Left to right

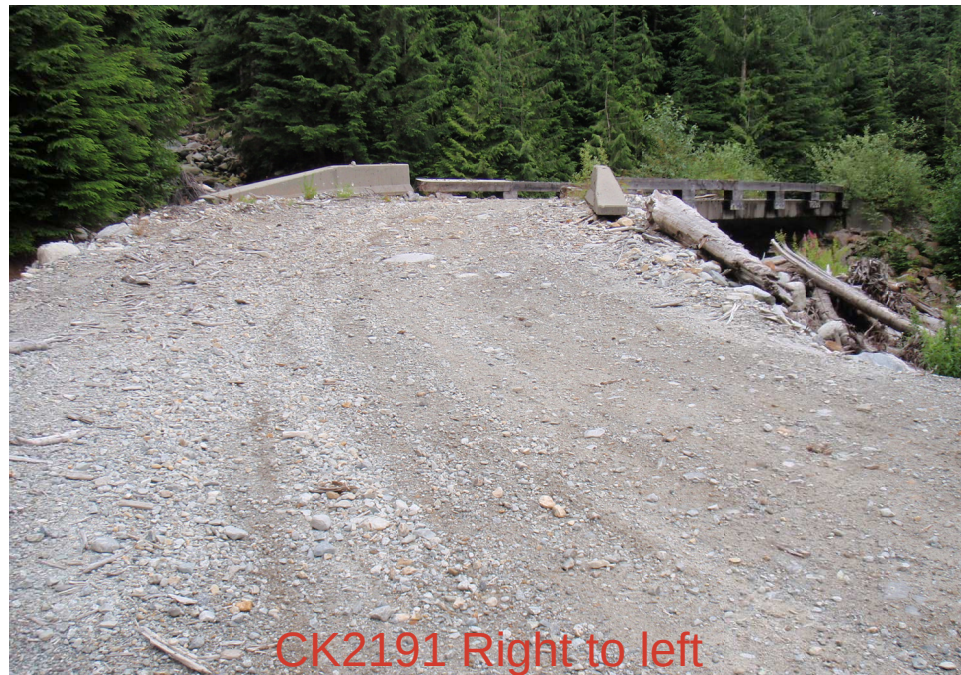
CK2191 Right to left

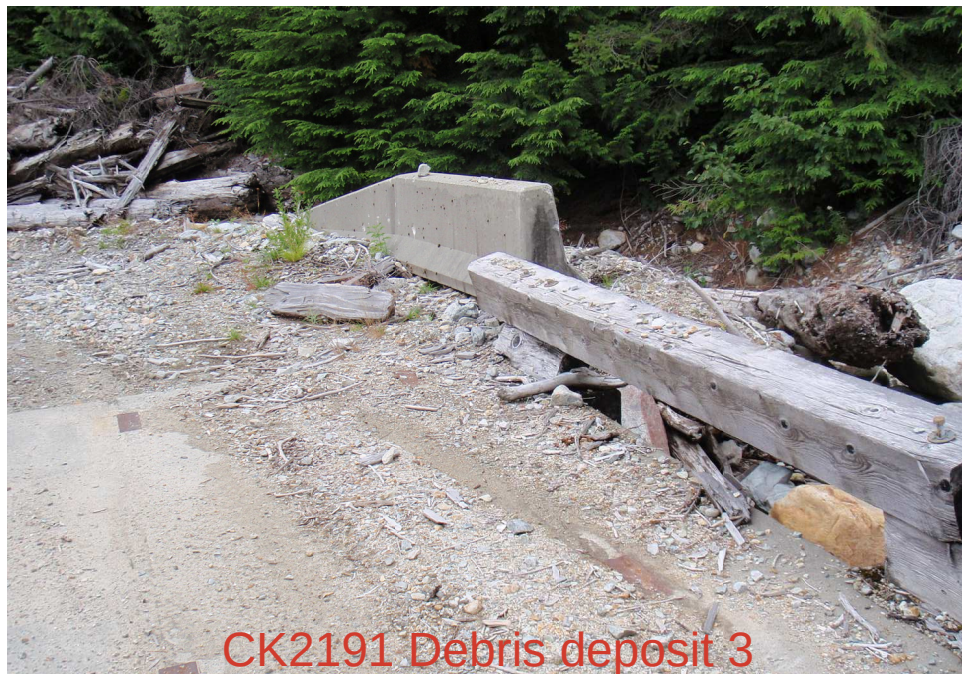
CK2191 Debris deposit 3

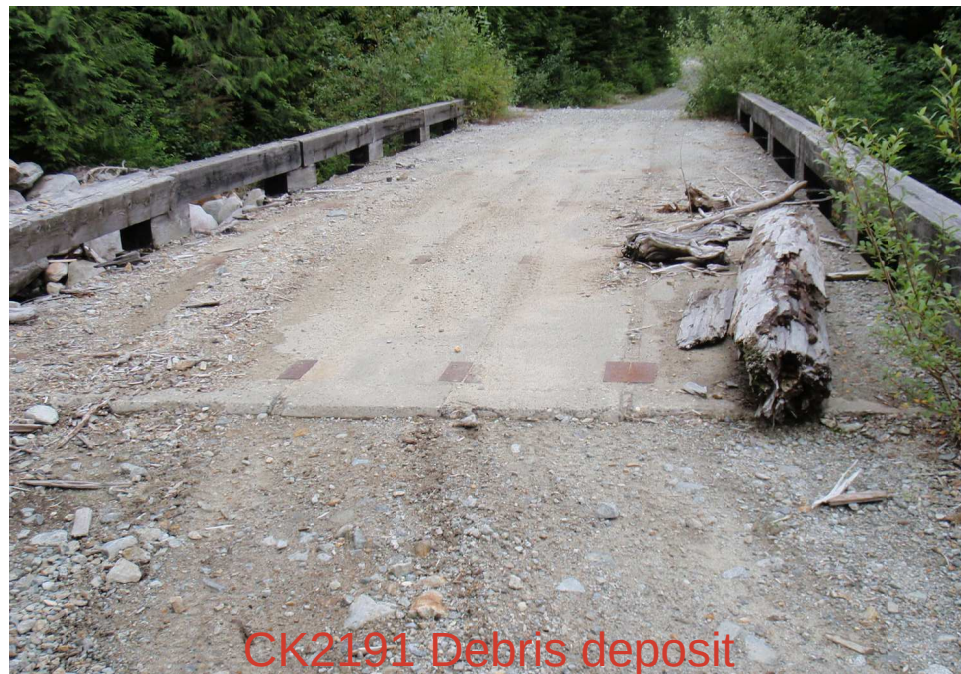
CK2191 Debris deposit

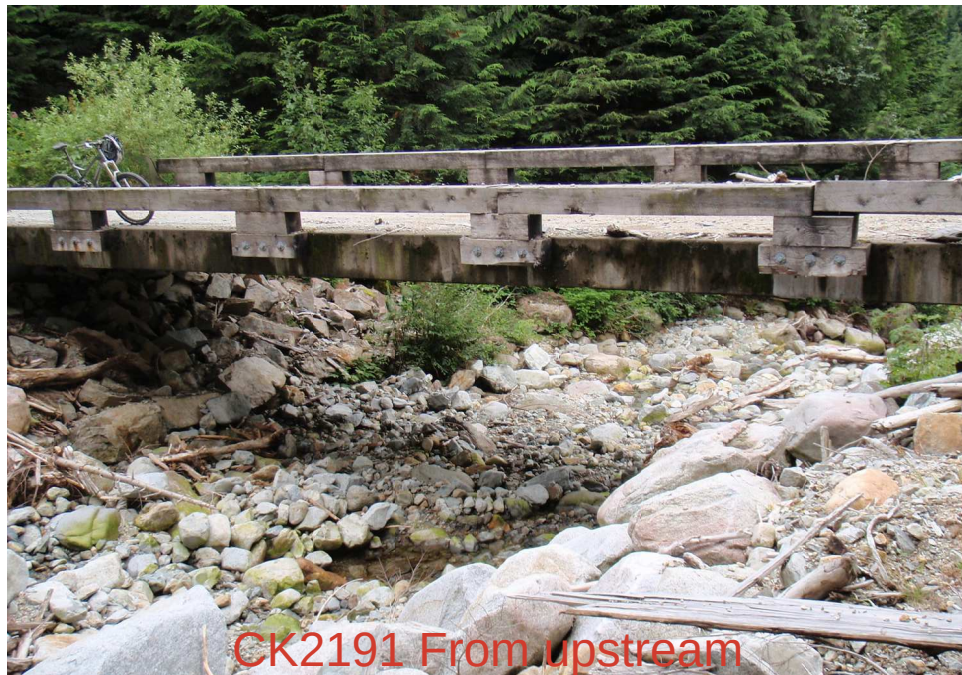
CK2191 From upstream
