BC Ministry of  
Forests and Range

## Corporate Bridge Register (CBR) Structure Inventory Data Form "BRIDGES"

| *Structure # | *Site #: CK-2177 |
| *Forest Service Road: Lost-South | Kilometres: 4.9 |

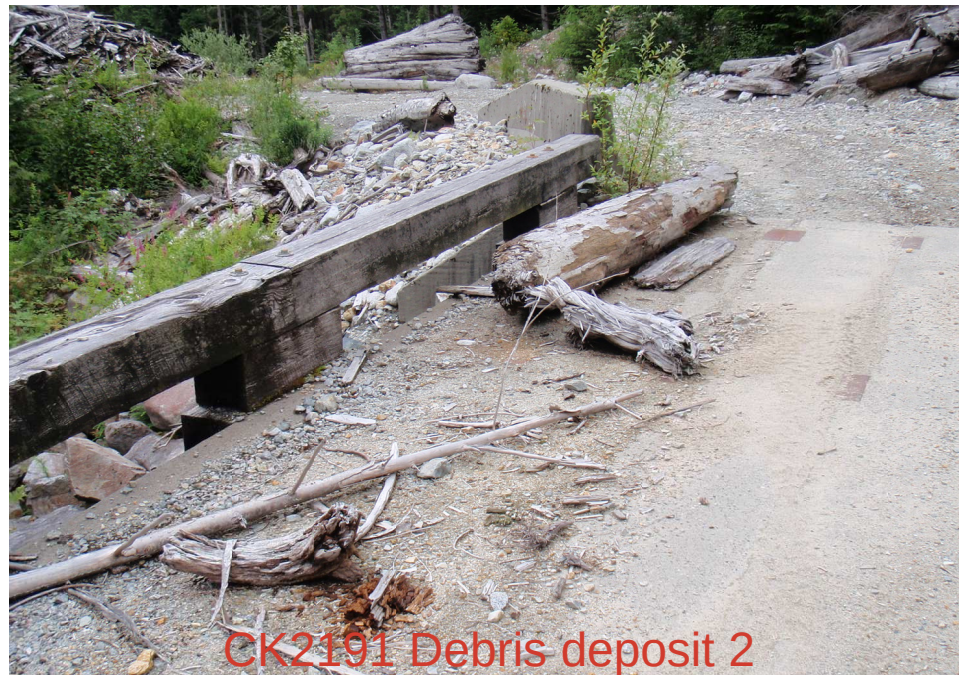
CK2191 Debris deposit 2

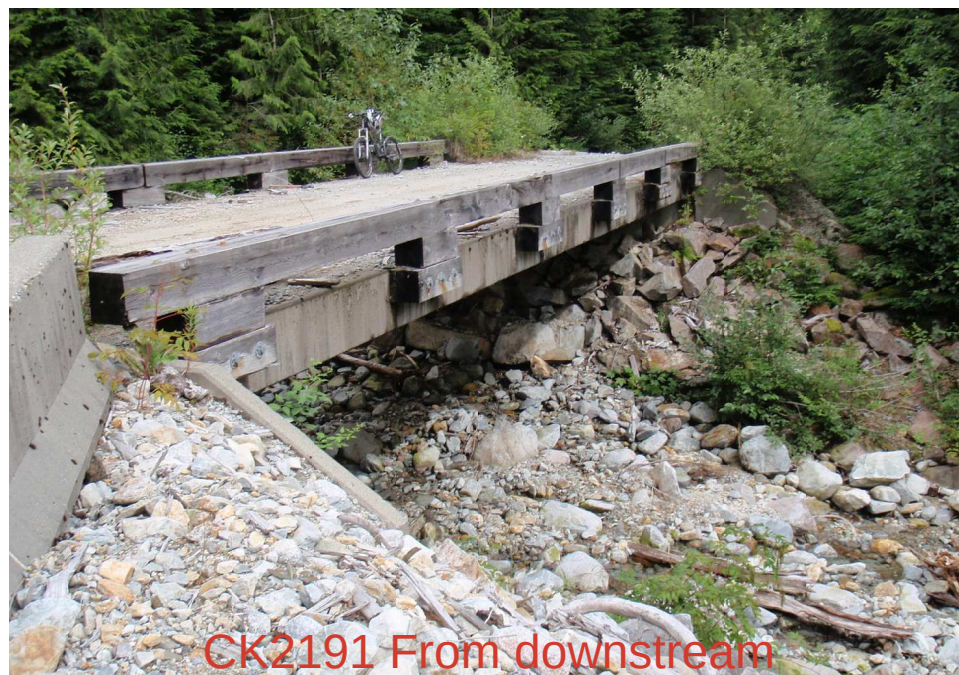
CK2191 From downstream

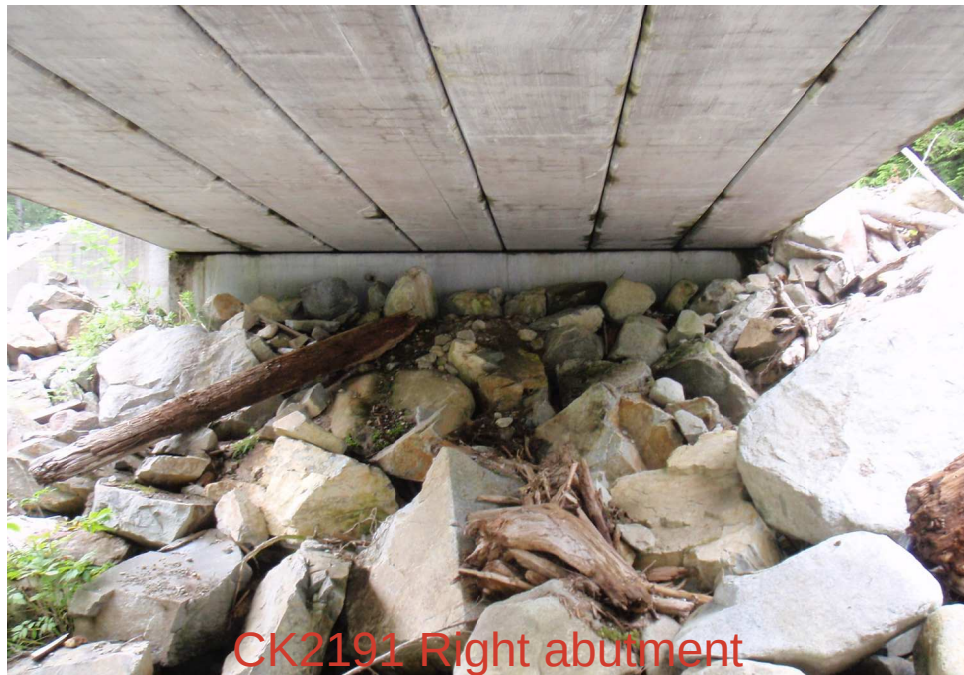
CK2191 Right abutment

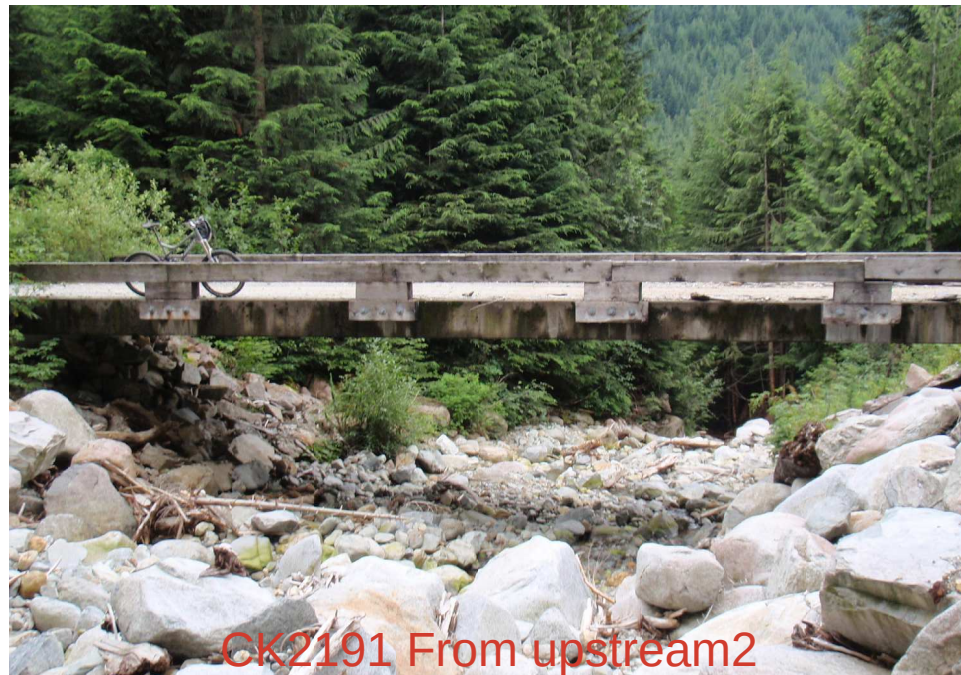
CK2191 From upstream2

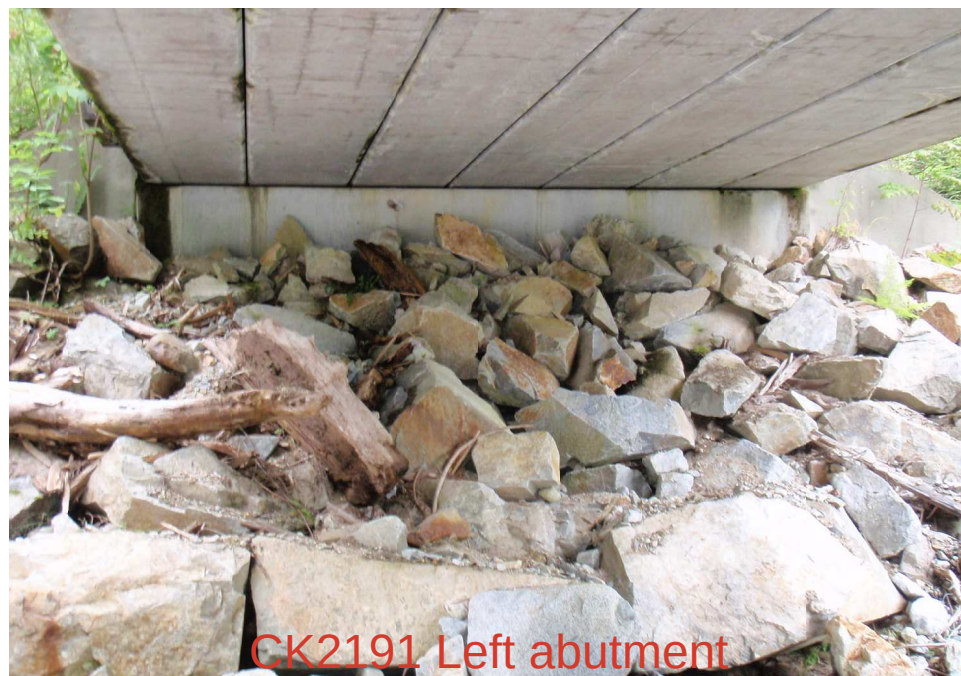
CK2191 Left abutment
